Town of Auburn, Massachusetts

ADA Self-Evaluation and Transition Plan

September 2020

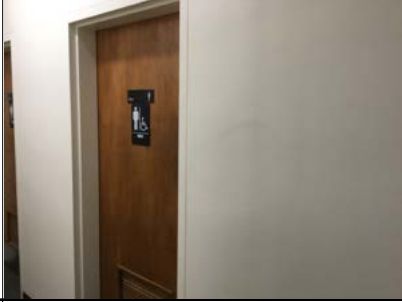
Sign not located on the latch side of the door	-	Locate sign alongside the door on the latch side.	1	Labor	\$0
16	Women's Toilet Room	1		Signage	Designation

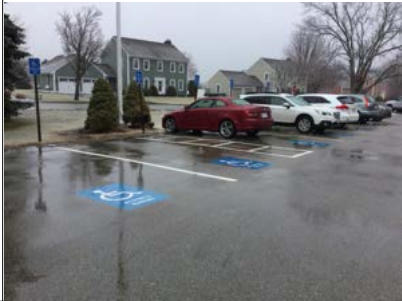
Total # of parking Total # of designated accessible parking spaces Total # of designated van accessible spaces Access aisle < 96" wide at van space Sign does not have the designation "Van Accessible"	60 5 1 52" -	Provide a marked access aisle that is at least 96" wide at the van accessible space. Add the designation "Van Accessible" to the sign located at the van accessible space. Provide a marked access aisle that is at least 60" wide at the car accessible space. (One compliant van and two compliant car accessible spaces are required.) (Cost based on striping two access aisle and a van sign.)	1	1100	\$1100
Emergency Exit												
6	Main Entrance	1		Emergency Exit	N/A

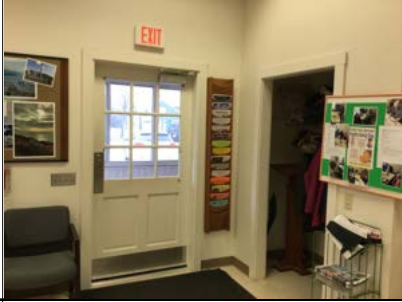
Tactile exit sign not provided	-	Ensure tactile exit signs with raised characters and braille are provided at exit doors. Mount signs between 48"- 60" above the finished floor located on the latch side of the door.	1	232	\$232
10	Dining Area	1		Means of Egress	N/A

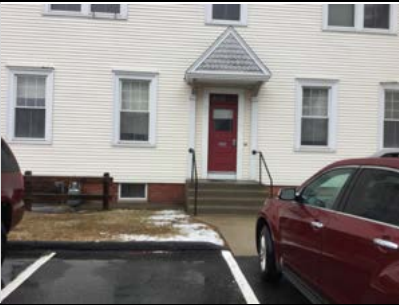
Entrance not on an accessible route Directional sign to accessible entrance not provided	- -	Provide a directional sign indicating the location of the nearest accessible entrance.	1	346	\$346
Access to Goods and Services												
Means of Egress												
7	Towards Second Floor	1		Means of Egress	N/A

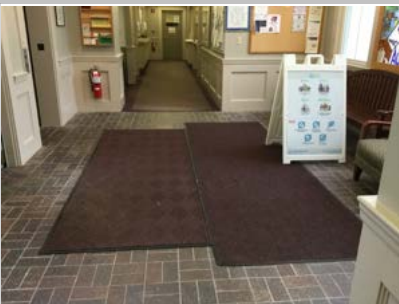
Mat not securely attached	-	Secure the mat to prevent tripping hazard.	1	Labor	\$0

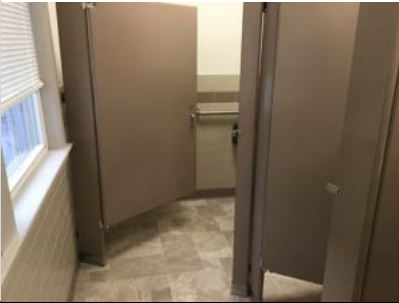
Door has malfunctioning self-closing hinge Coat hook > 48"	- 53.7"	Repair hinge. Lower coat hook so that it is no higher than 48".	1	150	\$150
42	Men's Toilet Room	2		Toilet Compartment	Accessible Compartment

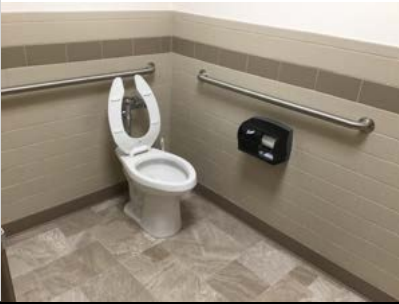
Door has malfunctioning self-closing hinge Coat hook > 48"	- 66.5"	Repair hinge. Lower coat hook so that it is no higher than 48".	1	150	\$150
43	Women's Toilet Room	2		Toilet Compartment	Accessible Compartment

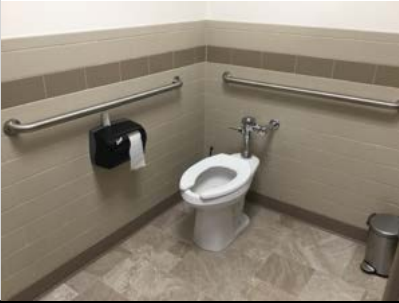
Flush control not on open side	-	Provide the flush control on the open side of the toilet (transfer side).	1	374	\$374

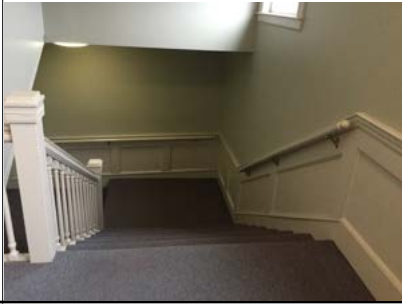
Recommend providing handrails extensions at top and bottom of handrails. Recommend adding contrasting strips at the edge of each step at all stairs.	1	-	\$0

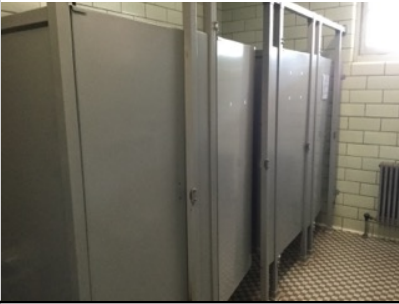
Clearance at toilet < 72" clear depth (MAAB)	- -	Provide a wheelchair accessible compartment that is 60" wide and 72" deep.	1	6182	\$6182
25	Women's and Girls' Toilet Room	1		Toilet Compartment	Accessible Compartment

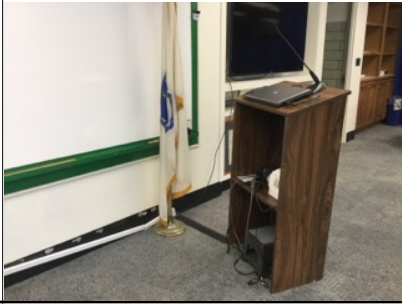
Recommend providing an adjustable height podium with toe and knee clearance positioned for a forward approach.	1	-	\$0

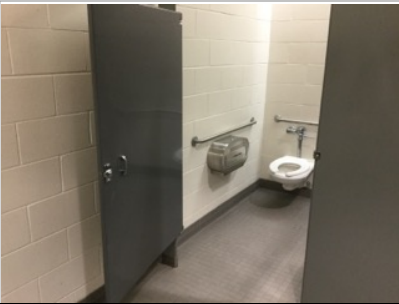
Door has malfunctioning self-closing hinge	-	Repair hinge.	1	Labor	\$0
138	Women's Toilet Room	1		Toilet Compartment	Accessible Compartment

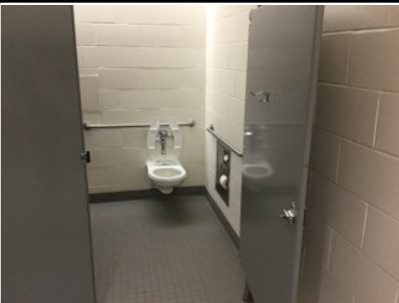
Door has malfunctioning self-closing hinge	-	Repair hinge.	1	Labor	\$0

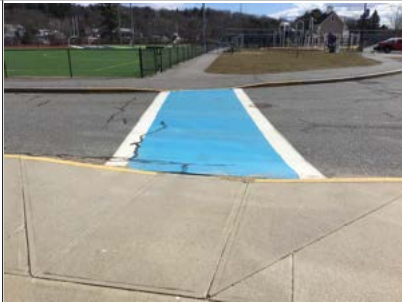
Recommend providing detectable warnings on both sides of crosswalk.	2	-	\$0
166	Exit by Football Field			Crosswalk	N/A

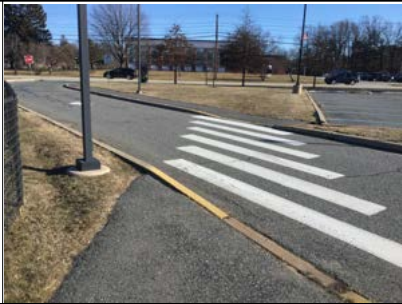
Recommend providing detectable warnings on both sides of crosswalk.	1	-	\$0
167	Exit by Southbridge Street			Crosswalk	N/A

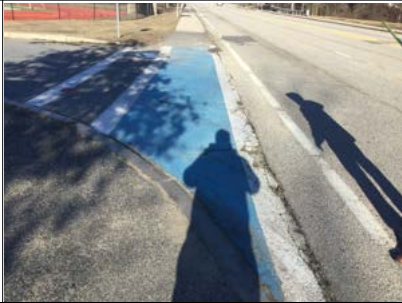
Recommend providing detectable warnings on both sides of crosswalk.	1	-	\$0
168	Crosswalk at Rear Drop-Off Area	Ext.		Crosswalk	N/A

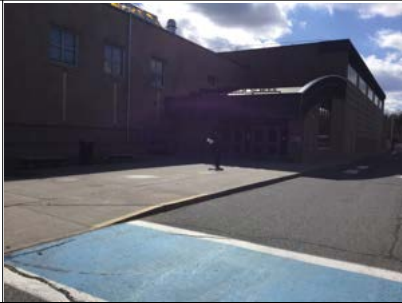
Recommend providing detectable warnings on both sides of crosswalk.	1	-	\$0

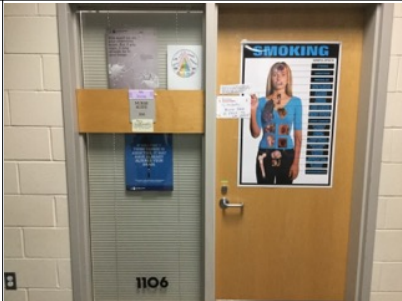
Having so much information around the designation sign makes it difficult to see the sign from afar. Recommend removing the excess of information.	1	-	\$0
Stairs												
177	Towards B	2		Stairs	N/A

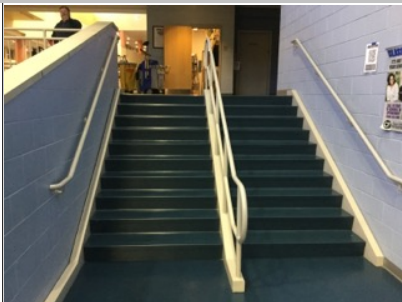
Recommend providing contrasting strips at each steps.	1	-	\$0

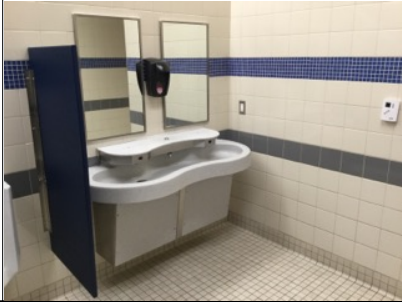
Controls > 42" high	56"	Relocate soap dispenser so that it is 42" max. above the finished floor.	1	353	\$353

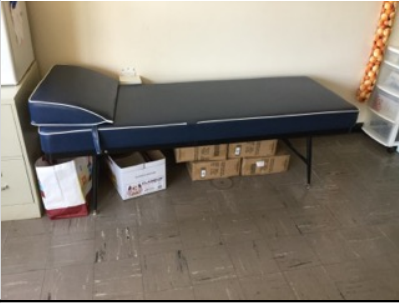
Recommend providing an adjustable table.	1	-	\$0

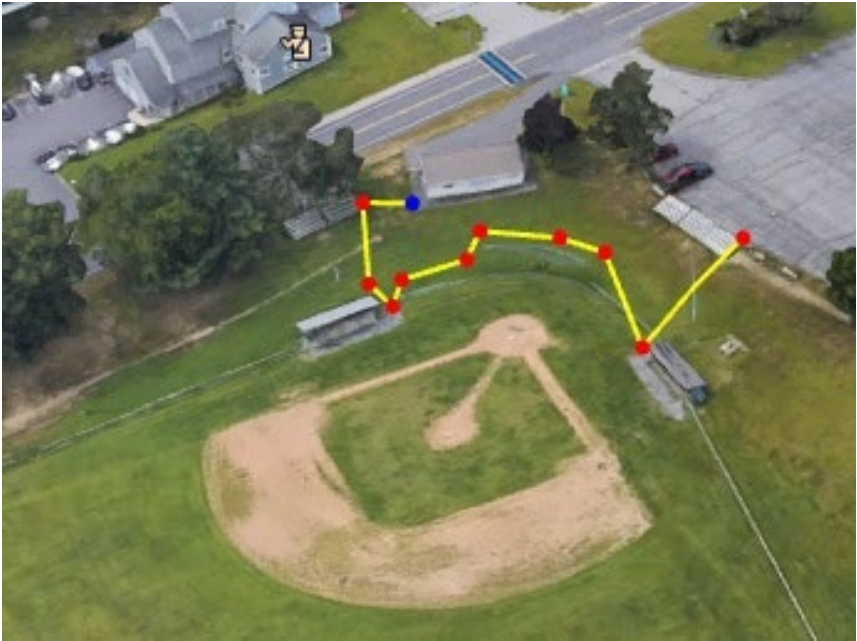
Figure 2: The yellow line shows the approximate suggested location of an accessible route connecting the accessible route at the baseball field shown in Figure 1 to the softball field, the softball field bleachers, dugouts, and the boundary of sport activity at the softball field.
