## **Second Five-Year Review Report**

**Tibbetts Road Superfund Site**

**Town of Barrington**

**August 2008**

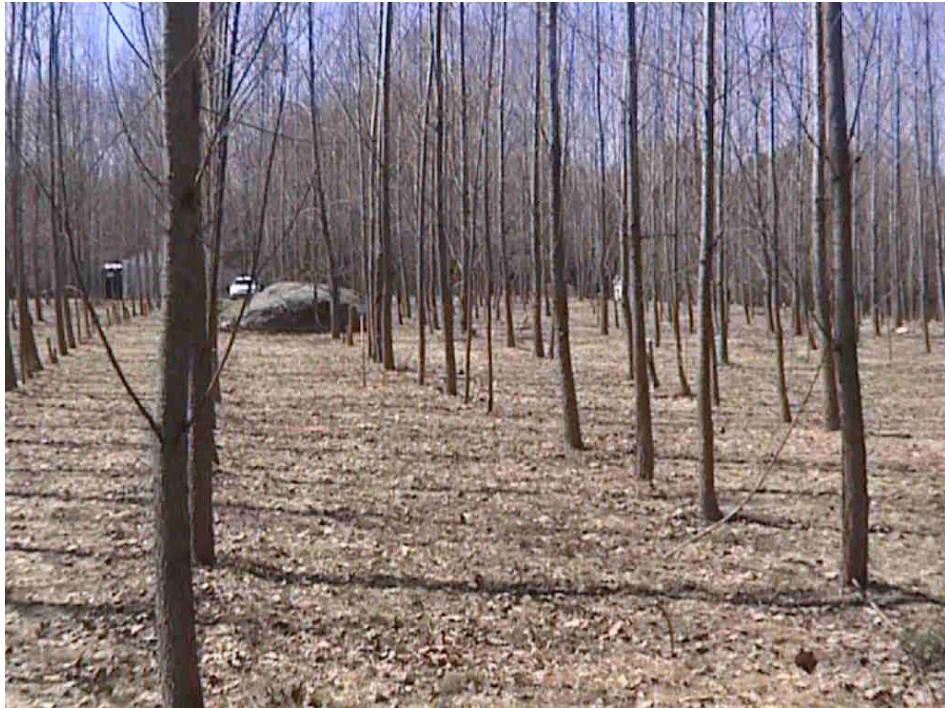
**SCENE:** Standing on the northern edge of the property line for the site and looking southward towards Tibbetts Road. The poplar trees were planted as part of the phytoremediation and are now 10 years old.

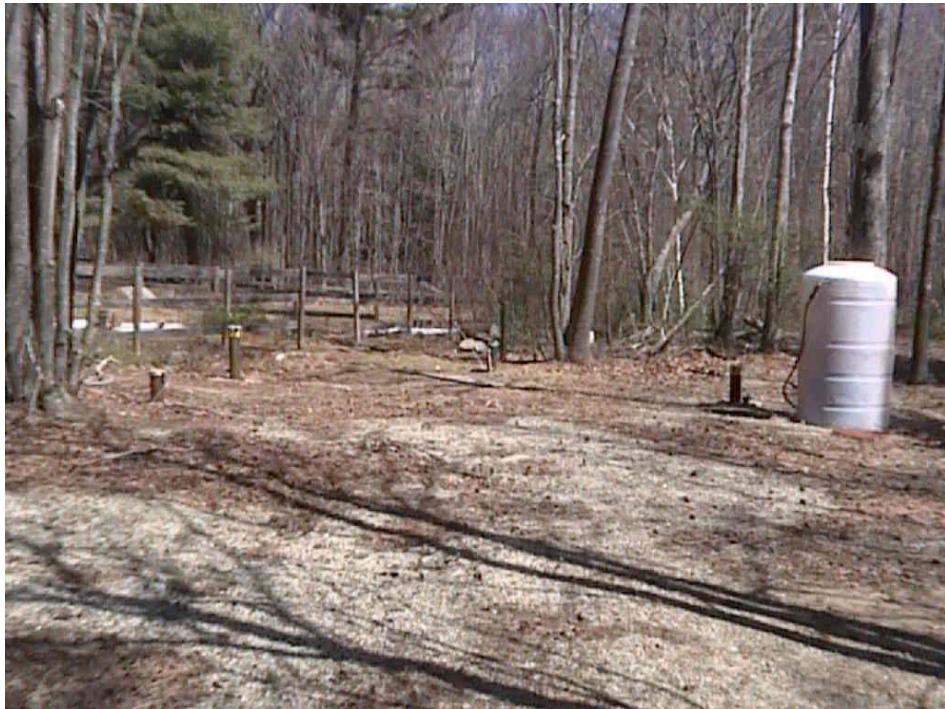
**SCENE:** Standing on the northern edge of the property line for the site and looking northward at wells 69R and 169R.

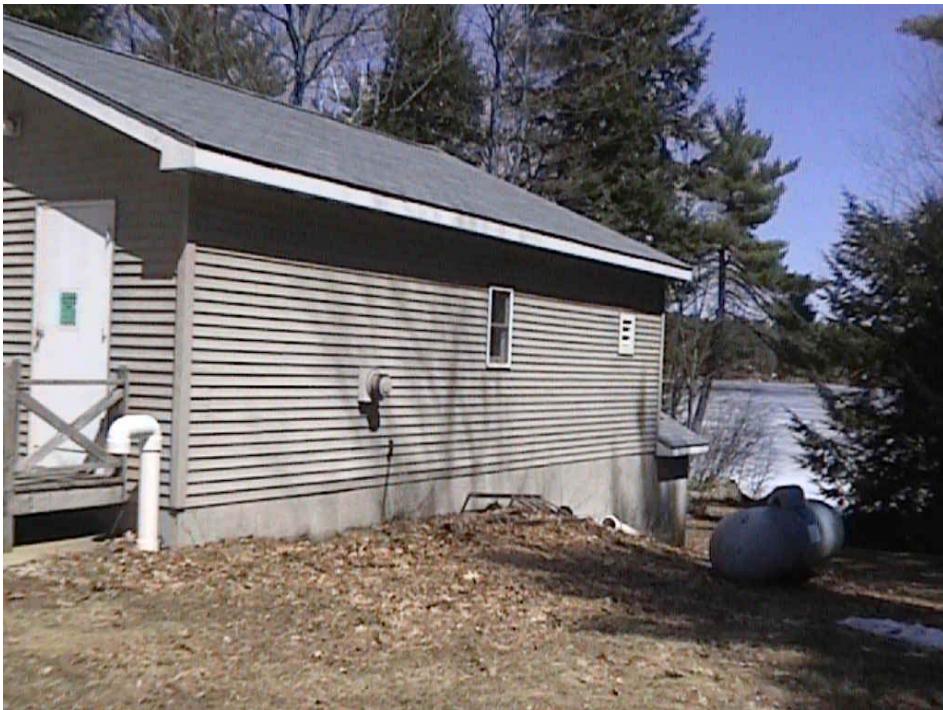
The Commissioners also pointed out that many of the components are worn. The drinking water treatment plant is now 20 years old. Back-up equipment has been installed to monitor and control the treatment system that is not the most compatible equipment or application. The Commissioners also made the point that they are the operators of the system and responsible for responding to emergencies, maintaining the aging equipment, and maintaining their training

**SCENE:** The Swains Lake Village Water District Treatment House Building looking northward towards Swains Lake (covered in ice).

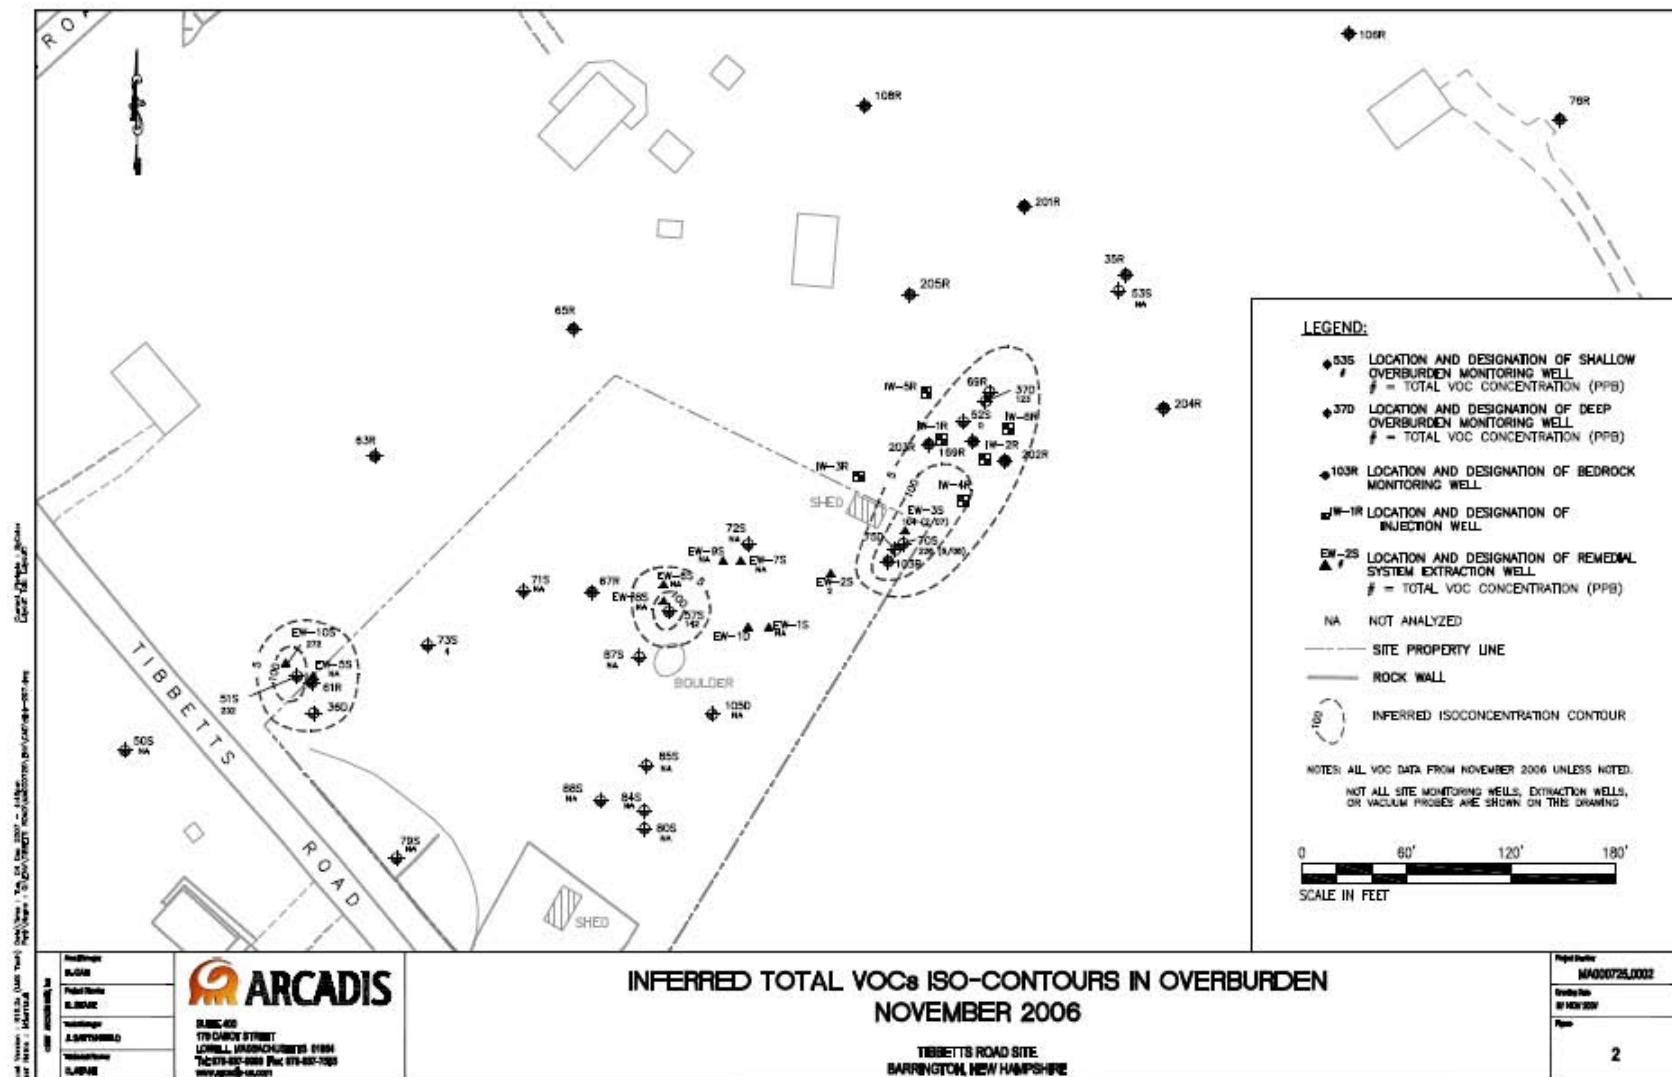
As seen in the preceding figure, any contamination is limited to essentially the footprint of the former drum storage areas. Table 1 presents the maximum concentrations found in the shallow, overburden aquifer at the site at critical junctures in the site's history. Overall, as seen in Table 1, below, concentrations are at or near their cleanup levels for nearly all the compounds with the exception of arsenic. All compounds have downward trends that indicate progress towards attaining cleanup levels. These concentrations reflect all contaminants from the drum storage areas A, B, and C as well as their associated plumes.
