**PHASE II ENVIRONMENTAL SITE ASSESSMENT**

Ernie's Auto Sales Property  
180 East Main Street  
Tilton, New Hampshire  
DES#199311019

## Phase II Environmental Site Assessment

Ernie's Auto Sales Property  
180 East Main Street  
Tilton, New Hampshire  
NHDES Site #199311019

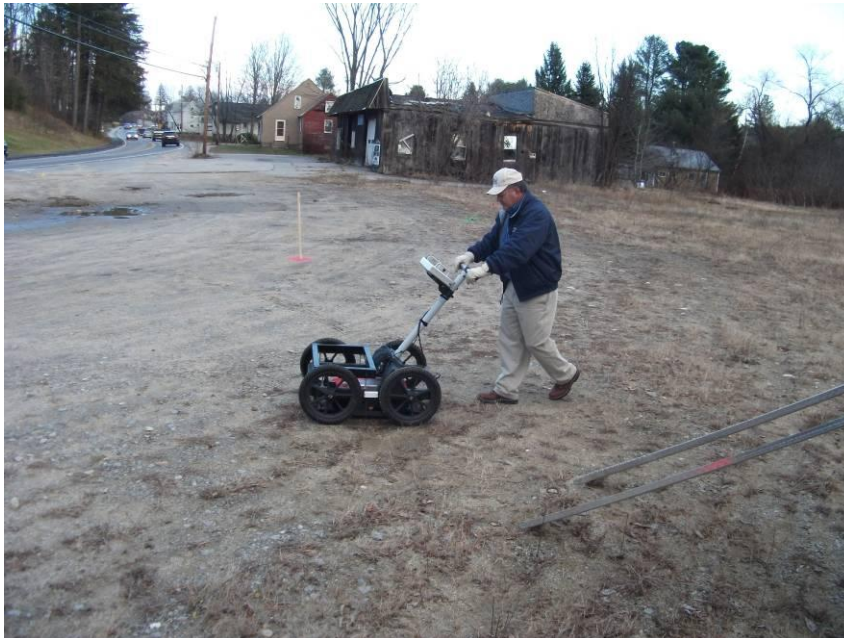
**Picture 2**  
Representative  
view of the ground  
penetrating radar  
(GPR) survey by  
Dig Smart of  
Maine.

Results of the GPR survey did not show the presence of any USTs beneath the subject property, suggesting that they have been removed as reported. A faint anomaly was identified in the lawn area south of the buildings. According to Dig Smart, the anomaly appeared to be approximately 2 feet wide by 4 feet long at a depth of approximately 2 to 4 feet bgs. A test pit was excavated by hand to a depth of 2 feet in the area of the anomaly. No structures were observed, but small clusters of asphalt were identified within the test pit. It is likely that these small clusters of asphalt were the cause of the faint anomaly noted. No other suspect subsurface structures were detected during the survey.

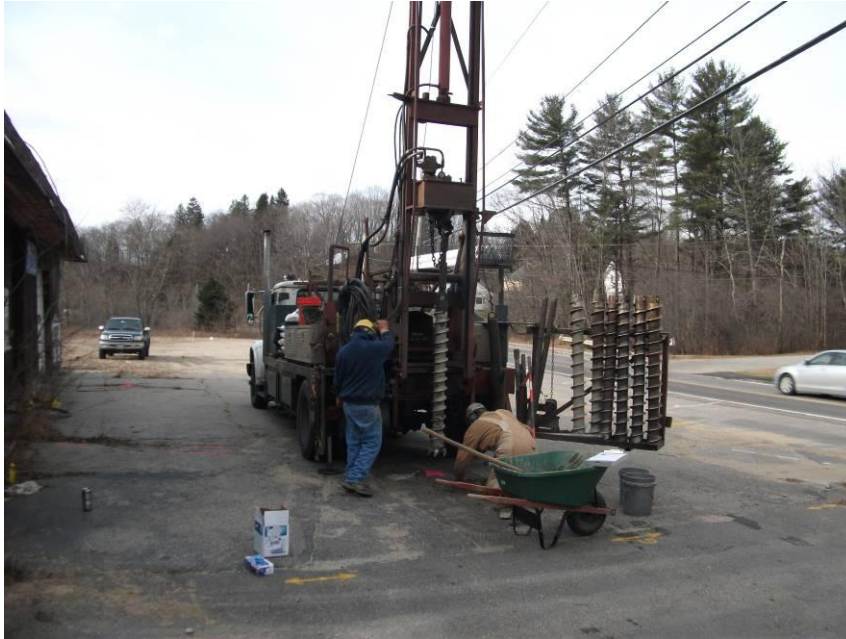
Picture 3

Installation of soil boring and monitoring well SB-3/MW-3 by T&K Drilling.

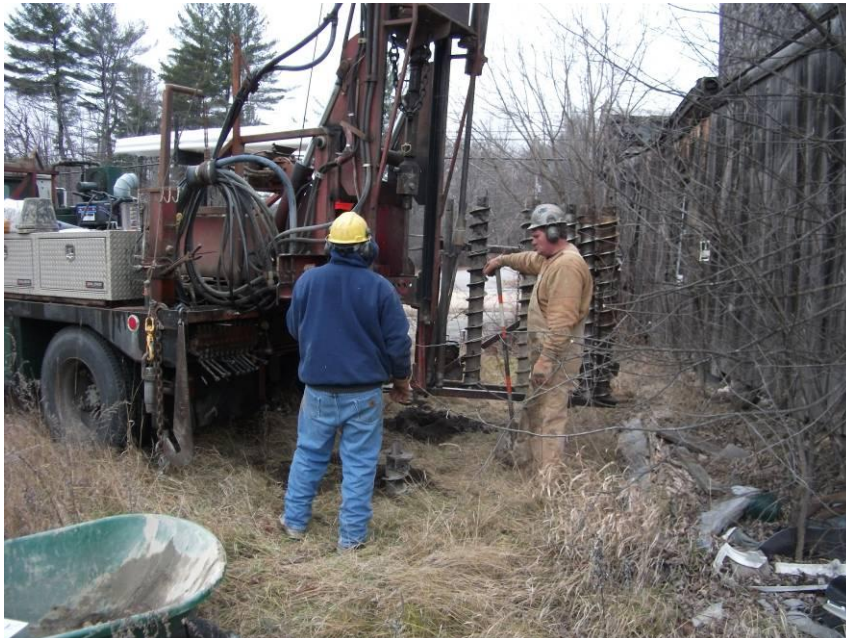
Picture 4

- It should be noted that two subsurface soil samples were submitted for laboratory analysis from soil boring SB-5 because a high XRF reading was noted in the sample screened from 4 to 6 feet bgs and a high PID reading was noted at a depth of 8 to 10 feet bgs. As such, RCRA 8 metals, PAHs, and PCBs were analyzed in sample SB-5(4-6) while SB-5(8-10) was analyzed for VOCs and TPH.

Installation of soil boring and monitoring well SB-5/MW-5 by T&K Drilling.

- Additional subsurface soil sampling in the vicinity of soil boring SB-5 is recommended to determine the vertical and horizontal extent of the metals that exceed the NDHES SRS because the soil represents a potential health risk. In addition, we recommend that the soils should be managed in accordance with a soil management plan during any future redevelopment of the subject property.

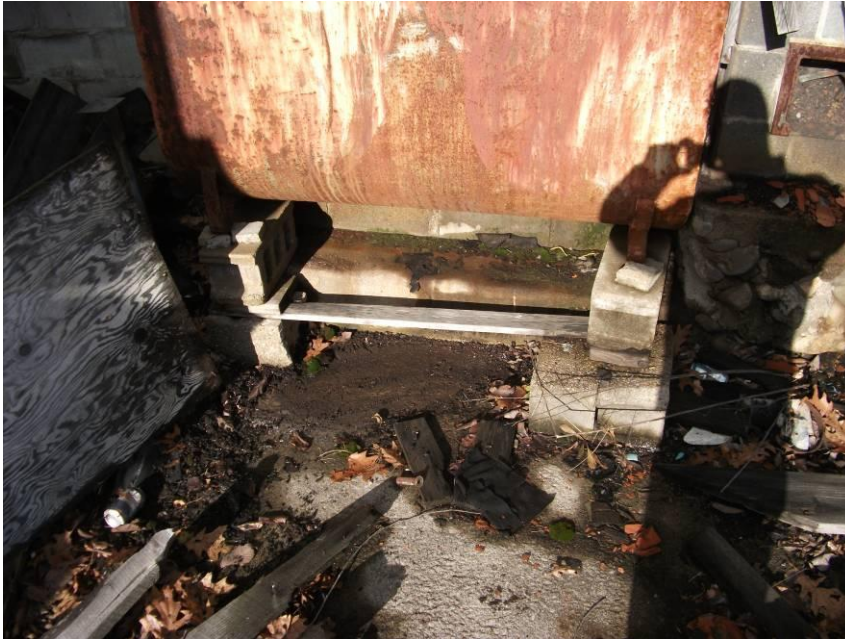
Picture 5

1. INFORMATION SHOWN ON THIS PLAN IS FROM A SURVEY PROVIDED BY THE WINNIPESAUKEE RIVER TRAIL ASSOCIATION AND BY FIELD OBSERVATIONS ON AUGUST 26, 2010.
2. SAMPLE SS-1 COULD NOT BE COLLECTED DUE TO CONCRETE SLAB BELOW TANK.

View of concrete slab under 275-gallon aboveground storage tank.

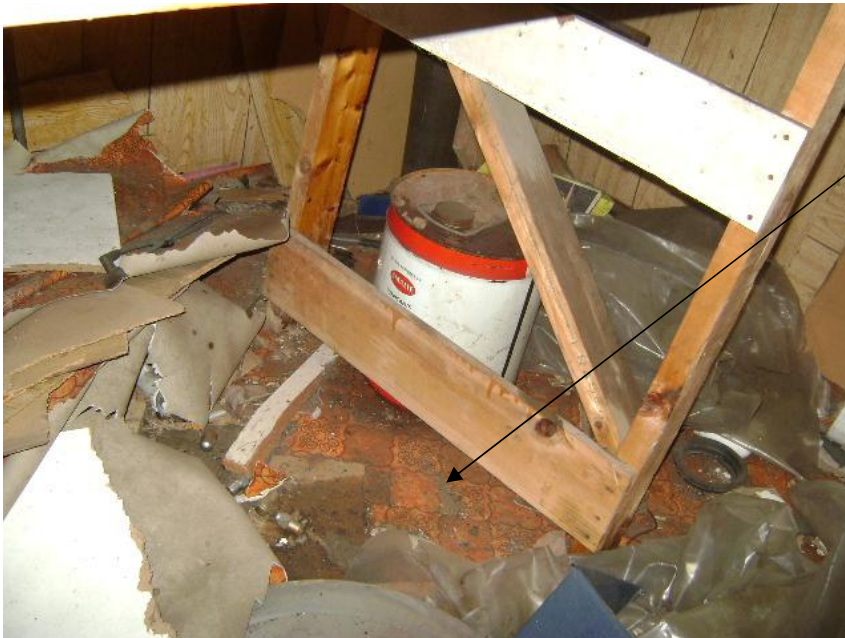
Picture 6

AAQ collected samples from all suspect asbestos-containing building materials observed in the buildings and laboratory analysis indicated that chrysotile was identified in multiple areas of floor tile, mastic, and roofing materials within the garage building. Crumbled asbestos containing floor tile was identified scattered throughout the cottage. The asbestos survey report and results are included as **Appendix G**. AAQ estimates that asbestos abatement for the subject property will cost approximately \$10,000.

Representative view of asbestos containing floor tile in cottage.

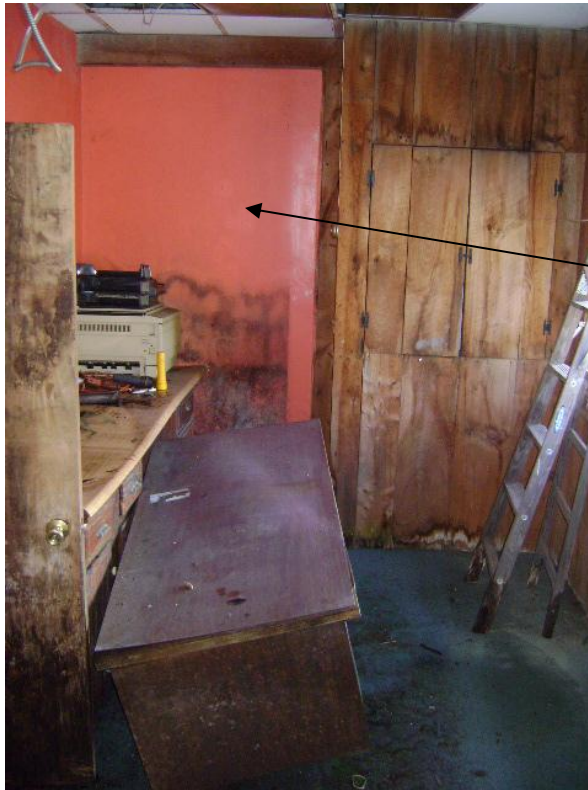
Picture 7

- NEC-3, which is associated with PCB-containing bulk products within the subject property buildings, has been confirmed because PCBs have been identified in bulk products within both buildings. Concentrations of PCBs identified in paint in both buildings (samples BM-2 and BM-4) exceeded 1 part per million (ppm), but were below 50 ppm. Based on observed conditions, these materials have been characterized as excluded PCB products. Though these materials are not regulated for disposal, if removed from use, these products must be disposed at a facility authorized to accept PCB-containing materials at the applicable concentrations. All other bulk products analyzed had total PCB concentrations of less than 1 ppm; therefore, they are unregulated.

Representative view of pink PCB-containing paint within the garage building.
