HISTORIC RESOURCES INVENTORY

ASHLAND - 1982

HISTORIC RESOURCE INVENTORY  
Lakes Region Planning Commission  
Meredith, New Hampshire

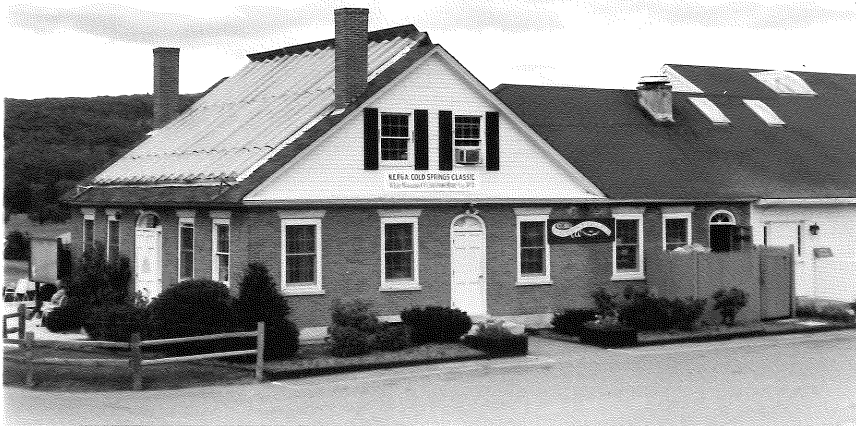
PHOTO:

CONDITION: Exc. Good x Fair Poor Ruins

Major Alterations & Date:  
Additions in 1970's and 1980's, include solar panels on south roof.

1. STYLE: Vernacular Federal BUILDING TYPE: House
2. # STORIES: 1½ DIMENSIONS: 40x30 approx BAYS: 5 x 4 FORM: Cape
3. FOUNDATION: Cut Granite Blocks 4. STRUCTURE: Brick Common Bond

5. WALLS: Sheathing Brick (common bond) Ornamentation: Gables are clapboarded
6. ROOF: Type Gable Sheathing Asphalt shingles  
Dormers/Cupolas ----- Details Solar panels cover south slope

7. CHIMNEYS: # 2 Location Interior endslope Materials Brick  
Description Tall, simple crowns
8. EAVES TREATMENT: Lateral Box cornice with mouldings  
Gable End East-box cornice with mouldings, pedimented/west-close verges

9. WINDOWS: Placement Symmetrical Shape Rectangular Sash 6/6  
Surrounds Smooth cut stone lintels and sills
10. ENTRIES-MAIN: Location Center south facade Door 6 panel  
Surround: Flanked ½ sidelights, panels below Topped louvred fan, semi-elliptical brick arch  
Framed

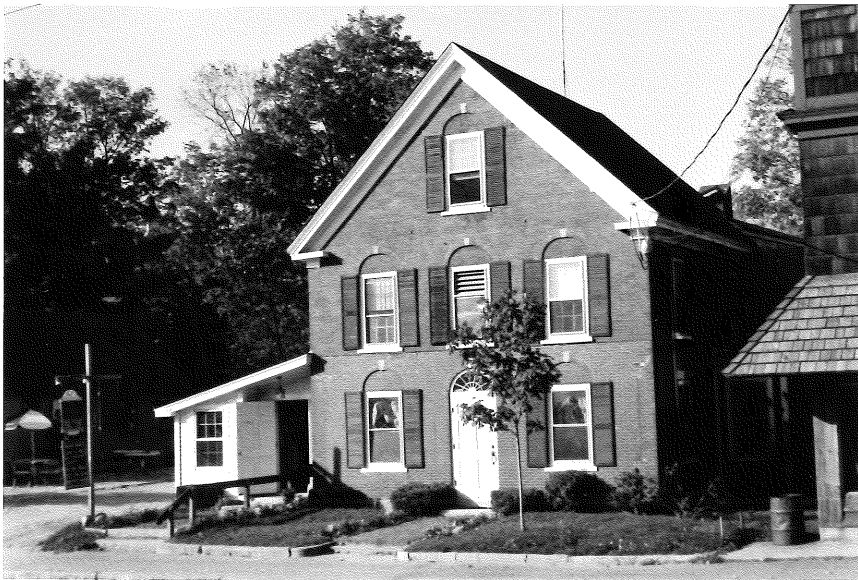
PHOTO:

- 1. STYLE: Vernacular Federal BUILDING TYPE: house
- 2. # STORIES: 2½ DIMENSIONS: 25 x 26 BAYS: 3 x 2 FORM: gable front
- 3. FOUNDATION: cut granite blocks 4. STRUCTURE: brick (common bond, flemish variation)

- 5. WALLS: Sheathing brick Ornamentation:
- 6. ROOF: Type gable Sheathing asphalt shingles  
Dormers/Cupolas Details
- 7. CHIMNEYS: # 1 Location interior end, slope Materials brick  
Description plain square stove chimney

- 8. EAVES TREATMENT: Lateral box cornice with narrow frieze  
Gable End box cornice with narrow frieze and short returns
- 9. WINDOWS: Placement symmetrical Shape rectangular Sash 6/6 (also 1/1)  
Surrounds south-semi-circular brick arches, granite keystones/E&W granite sills & lintels

- 10. ENTRIES-MAIN: Location center south Door 6 panel  
Surround: Flanked Topped radiating fanlight  
~~XXXXXX~~ semi-circular brick arch with granite keystone

- 13. ELLS/WINGS: # 3 letter on map Stories A 1 B 1 C 2 Bays A 1x2 B 1x1 C irreg.  
Description(s) A-shed roof modern addition (restaurant entrance); B-wooden addition  
C-includes a number of wooden additions

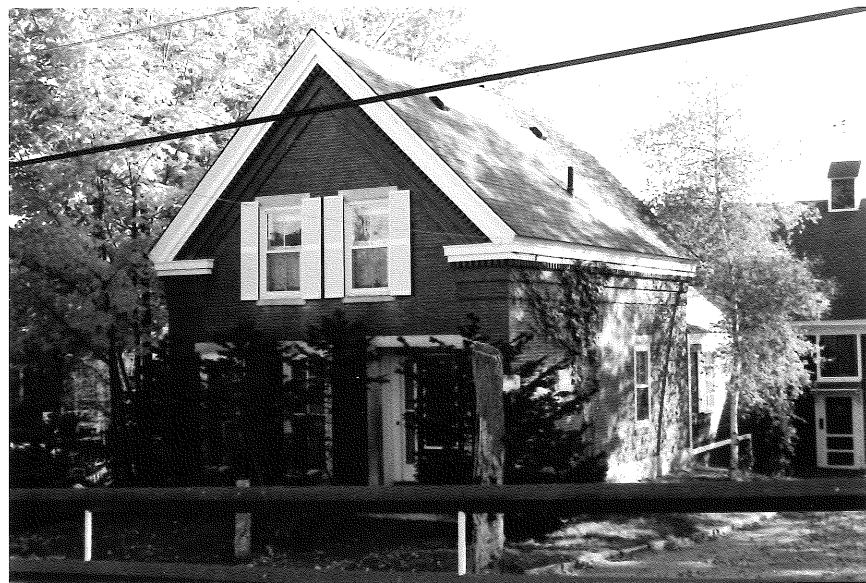
PHOTO:

COMMENTS: Well preserved interior woodwork. The Edward Dupuis house to east of Proulx House is virtually identical, although the roof has been altered by addition of gables and dormers.

1. STYLE: Greek Revival BUILDING TYPE: house
2. # STORIES: 1½ DIMENSIONS: 23 x 29 BAYS: 3 x 4 FORM: sidehall plan
3. FOUNDATION: cut granite blocks 4. STRUCTURE: brick common bond, flemish variation

5. WALLS: Sheathing brick, common bond, Flemish variation Ornamentation: \_\_\_\_\_
6. ROOF: Type gable Sheathing asphalt shingles  
Dormers/Cupolas \_\_\_\_\_ Details \_\_\_\_\_

7. CHIMNEYS: # 1 Location S end exterior, slope Materials brick  
Description tall and plain
8. EAVES TREATMENT: Lateral brick frieze w/dentils, close wooden eaves w/frieze & mouldings  
Gable End same with short returns

9. WINDOWS: Placement symmetrical Shape rectangular Sash 2/2  
Surrounds granite sills and lintels, louvered shutters
10. ENTRIES-MAIN: Location off center N (gable end) Door 4 panel  
Surround: Flanked full, flush sidelights Topped flush transom window  
Framed recessed entryway framed by smooth cut granite, paneled side walls  
OTHERS: # \_\_\_\_\_ Location \_\_\_\_\_ Surrounds \_\_\_\_\_

13. ELLS/WINGS: # 3 letter on map Stories A 1 B 1 C 2½ Bays A 2 B 4 C 2x3  
Description(s) all wooden clapboarded. A-gable-roofed kitchen wing; B-enclosed porch, shed roof; C-connected barn, gable roof, modern cupola

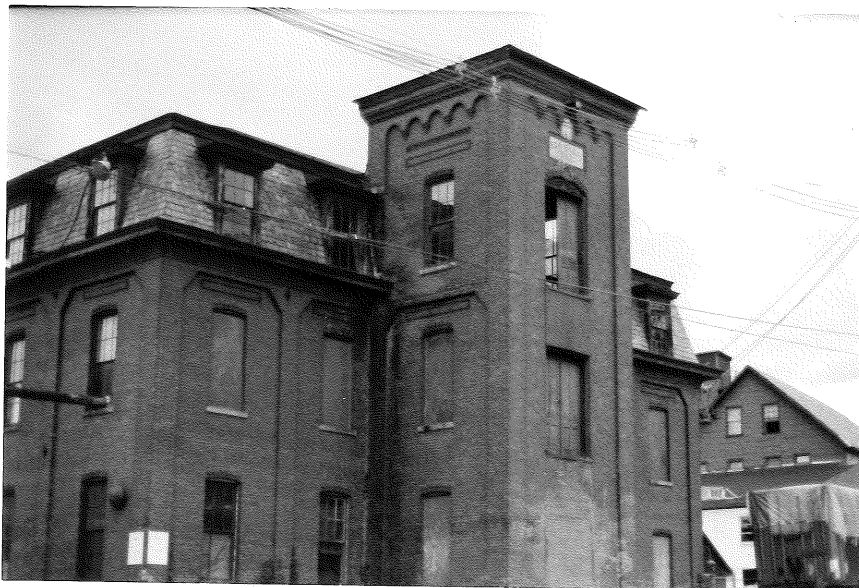
PHOTO:

UTM: \_\_\_\_\_  
 USGS QUAD: Holderness  
 FUNCTIONAL TYPE: Hosiery Type  
 PRESENT USE: Woolen Mill Storage  
 ARCHITECT/BUILDER: \_\_\_\_\_  
 CONDITION: Exc. Good X Fair Poor Ruins  
 INTEGRITY: Original Site X Moved \_\_\_\_\_  
 Date \_\_\_\_\_  
 Major Alterations & Date:  
Tower roof removed before 1919, chimney removed.  
 LEVEL/SIGNIFICANCE: Natl. State X Local

1. STYLE: Second Empire BUILDING TYPE: mill
2. # STORIES: 2½ DIMENSIONS: 40 x 50' BAYS: 6 x 4 FORM: rectangular plan
3. FOUNDATION: brick 4. STRUCTURE: brick (common bond)

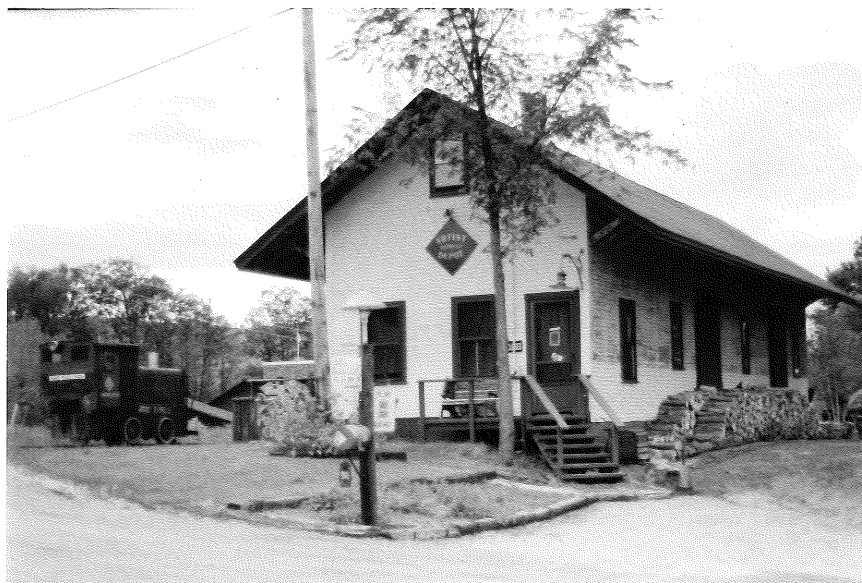
PHOTO:

COMMENTS: Built for Boston, Concord & Montreal Railroad, as first Ashland RR Station.  
Served as both passenger & freight depot until #9 was built, subsequently used as freight  
depot.

1. STYLE: Vernacular industrial BUILDING TYPE: railroad station
2. # STORIES: 1½ DIMENSIONS: 20 x 20 BAYS: 3 x 6 FORM: rectangular plan
3. FOUNDATION: granite piers 4. STRUCTURE: post & beam

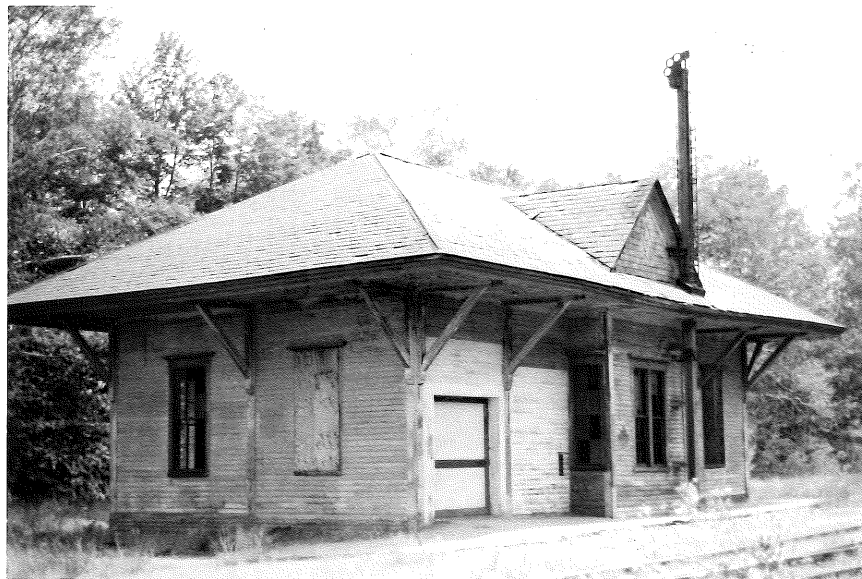
PHOTO:

COMMENTS: Virtually unaltered interiors (dating from 1891 remodeling) with beaded boarded  
walls and ceilings. Application for National Register status has been submitted.

- 1. STYLE: Vernacular industrial BUILDING TYPE: RR station
- 2. # STORIES: 1 DIMENSIONS: 44 x 24 BAYS: 5 x 2 FORM: cruciform plan
- 3. FOUNDATION: brick 4. STRUCTURE: post & beam

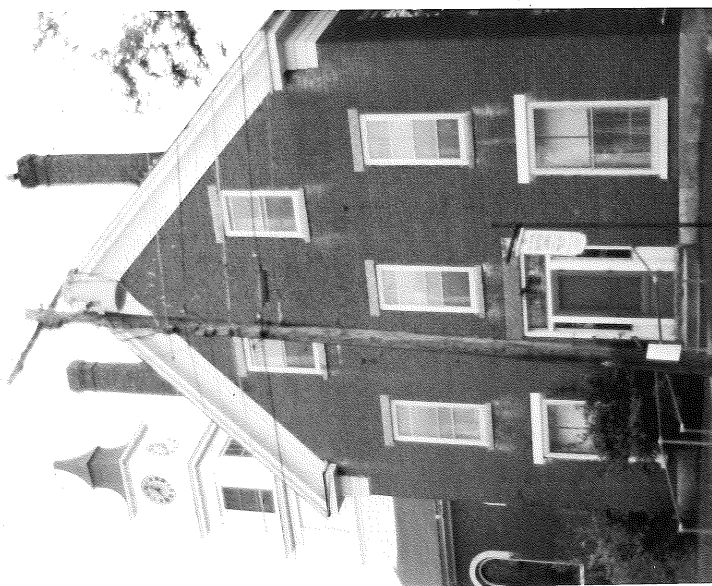
PHOTO:

1. STYLE: Vernacular BUILDING TYPE: school  
2. # STORIES: 2 1/2 DIMENSIONS: 46 x 30 BAYS: 3 x 4 FORM: rectangular plan  
3. FOUNDATION: cut granite blocks 4. STRUCTURE: brick (common bond) flemish variation  
5. WALLS: Sheathing brick (common bond) flemish variation  
6. ROOF: Type gable Sheathing asphalt shingles  
Dormers/Cupolas 1 gabled fire escape dormer Details:

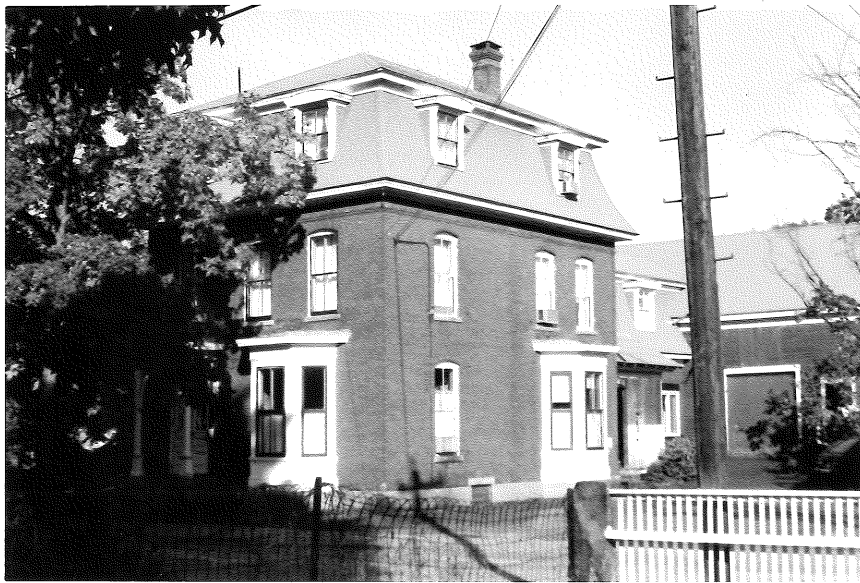
PHOTO:

1. STYLE: Second Empire BUILDING TYPE: House
2. # STORIES: 2½ DIMENSIONS: 25 x 25 BAYS: 3 x 3 FORM: sidehall plan
3. FOUNDATION: cut granite block 4. STRUCTURE: brick

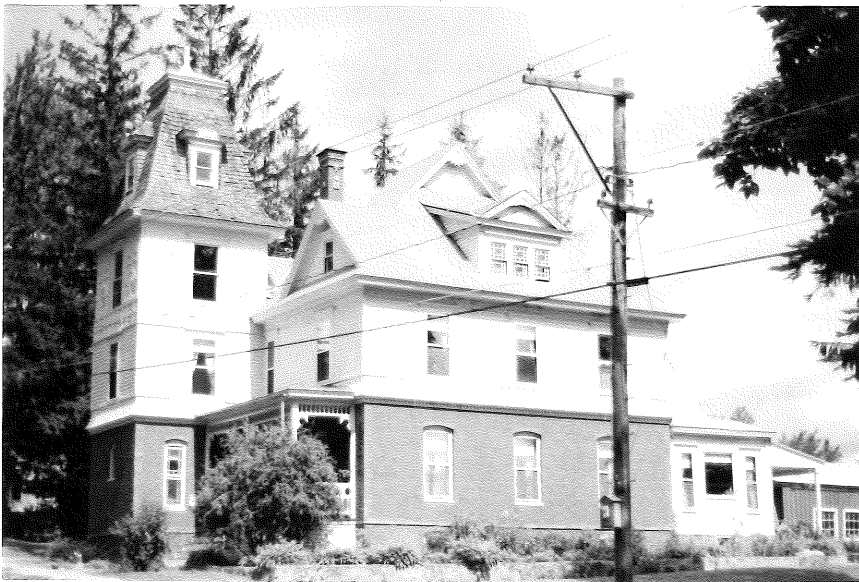
PHOTO:

COMMENTS: Fine, well-preserved Victorian interiors, with elaborate woodwork.

1. STYLE: Queen Anne BUILDING TYPE: house
2. # STORIES: 2½ DIMENSIONS: 32 x 44 BAYS: 3 x 4 FORM: assymmetrical plan
3. FOUNDATION: brick 4. STRUCTURE: balloon frame
