HISTORIC RESOURCE INVENTORY
Lakes Region Planning Commission
Meredith, New Hampshire

TOWN: Centre Harbor COUNTY: Belknap
 SURVEY NUMBER: 1
 COMMON NAME: Leavitt House
 HISTORIC NAME: Leavitt House
 LOCATION: Rte. 25, 1 mi. from Meredith
 OWNER: Sally Chase
 ADDRESS: Box 517
Centre Harbor, NH 03226
 MAP & PARCEL NO: 128d-2 (sheet 8)
 DATE: c. 1790
 SOURCE: Mrs. Chase, Gladys Bickford
 STYLE: Cape
 BOUNDARY AND ACREAGE DESCRIPTION: 2.7 acres, bounded on east by Route 25, on north,
west and south by Aaron Smith

SURVEY NUMBER: 2

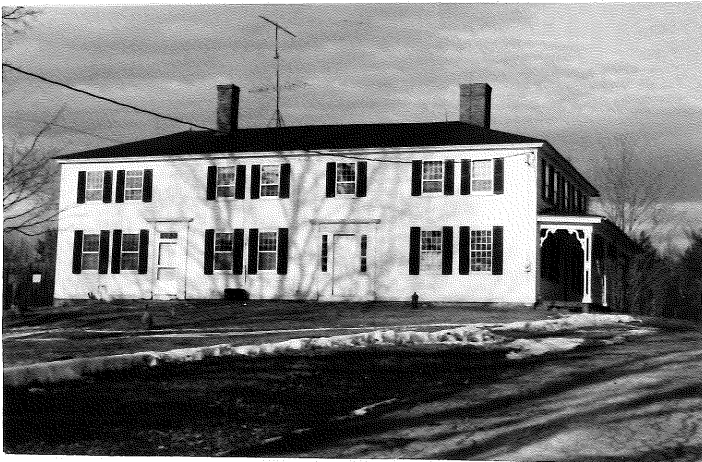
PHOTO:

COMMENTS: Well preserved interior woodwork. Indian shutters in front room.

1. STYLE: vernacular Georgian BUILDING TYPE: house
2. # STORIES: 2 DIMENSIONS: 38 x 62 BAYS: 5 x 8 FORM: L-shaped plan
3. FOUNDATION: cut granite blocks 4. STRUCTURE: post and beam

5. WALLS: Sheathing clapboards Ornamentation: sillboards, corner boards
6. ROOF: type intersecting hip roofs Sheathing asphalt shingles
Dormers/Cupolas _____ Details _____

7. CHIMNEYS: # 2 Location interior, slope, ell Materials brick
Description central ridge, main block
corbelled caps
8. EAVES TREATMENT: Lateral box cornice with mouldings and frieze
Gable End _____

9. WINDOWS: Placement symmetrical Shape rectangular Sash 1st - 12/12
Surrounds moulded trim, louvred shutters 2nd - 12/8
10. ENTRIES-MAIN: Location center SE facade Door 4 panel
Surround: Flanked pilasters Topped transom window
Framed entablature with wide cornice

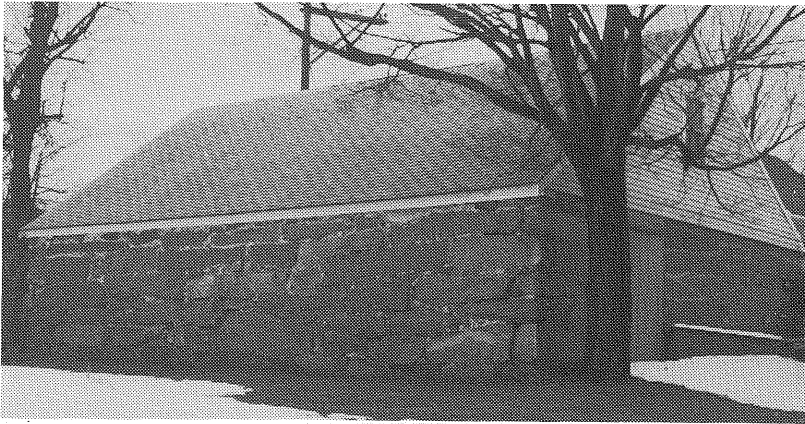
PHOTO:

COMMENTS: Built from granite blocks quarried on the farm. A Hawkins family tradition would date this mill to the late 18th Century.

1. STYLE: Vernacular BUILDING TYPE: cider mill
2. # STORIES: 1 1/2 DIMENSIONS: 26 x 40 BAYS: 1 x 1 FORM: rectangular plan
3. FOUNDATION: fieldstone 4. STRUCTURE: coursed cut granite blocks

5. WALLS: Sheathing split granite blocks Ornamentation: _____
clapboards in gables
6. ROOF: Type _____ Sheathing asphalt shingles
Dormers/Cupolas _____ Details _____

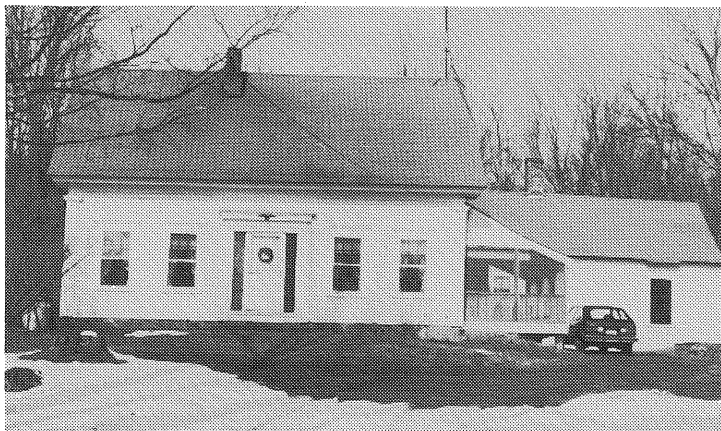
PHOTO:

1. STYLE: Cape (Greek Revival influence) BUILDING TYPE: house
2. # STORIES: 1 1/2 DIMENSIONS: 32 x 24 BAYS: 5 x 2 FORM: Cape
3. FOUNDATION: cut granite block 4. STRUCTURE: balloon frame

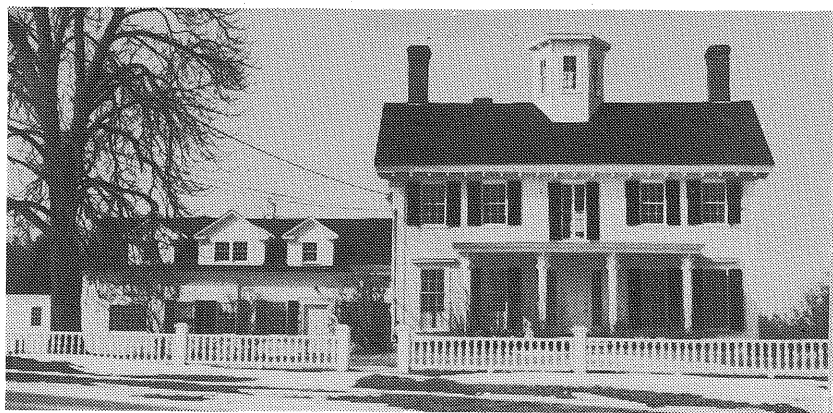
PHOTO:

1. STYLE: Early Victorian BUILDING TYPE: house
2. # STORIES: 2 1/2 DIMENSIONS: 40 x 20 BAYS: 5 x 2 FORM: house
3. FOUNDATION: cut granite blocks 4. STRUCTURE: wooden frame

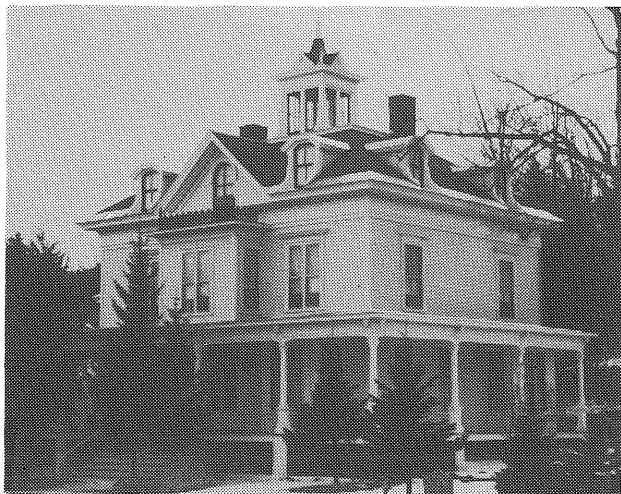
PHOTO:

1. STYLE: Second Empire BUILDING TYPE: house
2. # STORIES: 2 1/2 DIMENSIONS: 43 x 34 BAYS: 3 x 3 FORM: rectangular plan
3. FOUNDATION: fieldstone (where visible) 4. STRUCTURE: wooden frame

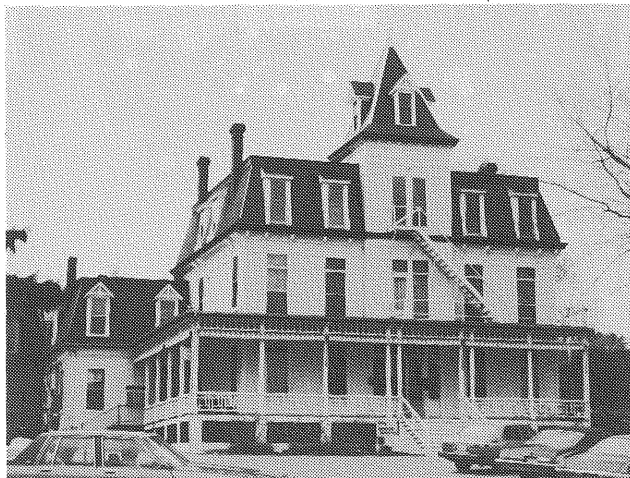
PHOTO:

1. STYLE: Second Empire BUILDING TYPE: house
2. # STORIES: 2 1/2 DIMENSIONS: 45 x 38 BAYS: 5 x 4 FORM: rectangular plan
3. FOUNDATION: brick 4. STRUCTURE: balloon frame

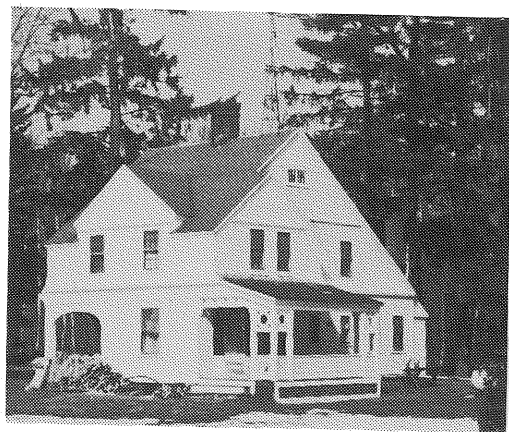
PHOTO:

1. STYLE: Victorian BUILDING TYPE: house
2. # STORIES: 2 1/2 DIMENSIONS: 23x44 BAYS: irreg. FORM: rect. plan
3. FOUNDATION: brick 4. STRUCTURE: wooden frame

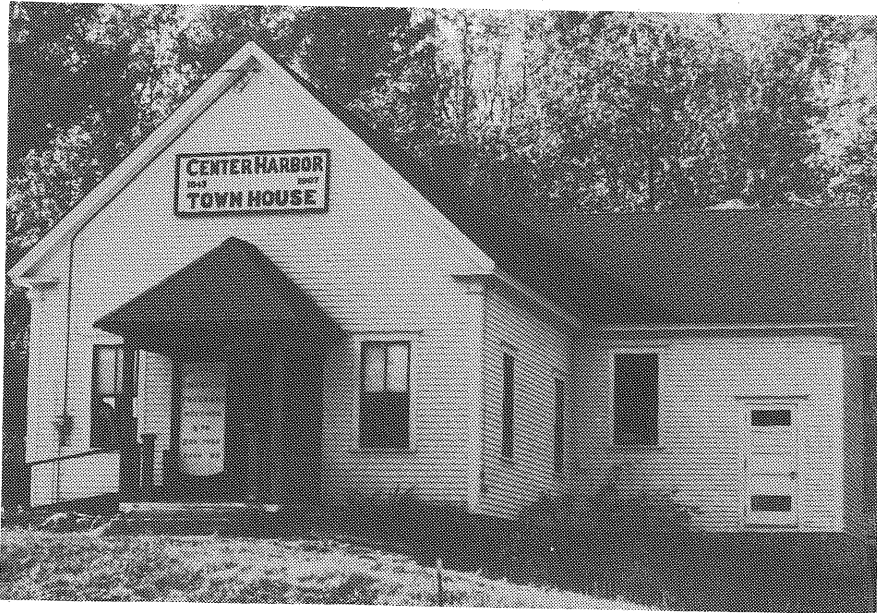
PHOTO:

1. STYLE: Vernacular BUILDING TYPE: Town House
2. # STORIES: 1 DIMENSIONS: 24 x 40 BAYS: 3 x asym. FORM: rectangular plan
3. FOUNDATION: fieldstone 4. STRUCTURE: wooden frame

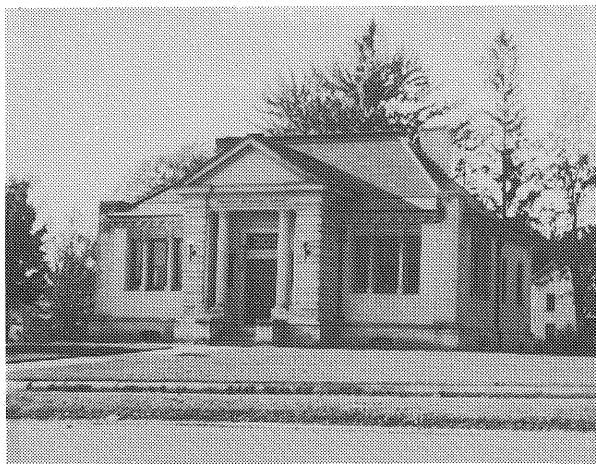
PHOTO:

1. STYLE: Classical BUILDING TYPE: library
2. # STORIES: 1 DIMENSIONS: 49 x 35 BAYS: 3 x 2 FORM: cruciform plan
3. FOUNDATION: high, cut granite blocks 4. STRUCTURE: brick

11. PORCHES/HOODS: # 1 Style/Roof Type pedimented portico
 Location(s) center, northeast Supports 2 Tuscan columns, between rusticated piers
 Other Features full classical entablature and pediment, library name in bronze letters on frieze

12. BAY WINDOWS/TOWERS: # _____ Location _____ Stories _____ Shape _____
 Description _____
13. ELLS/WINGS: # 1 letter A Stories A 1 B C Bays A 7 B C
 on map _____
 Description(s) semi-circular projection to southwest, same foundation and wall treatment as main block, same cornice with another cornice above it, covered by a gable
