HISTORIC RESOURCE INVENTORY
 Lakes Region Planning Commission
 Meredith, New Hampshire

TOWN: Danbury COUNTY: Merrimack

COMMON NAME: Michels House

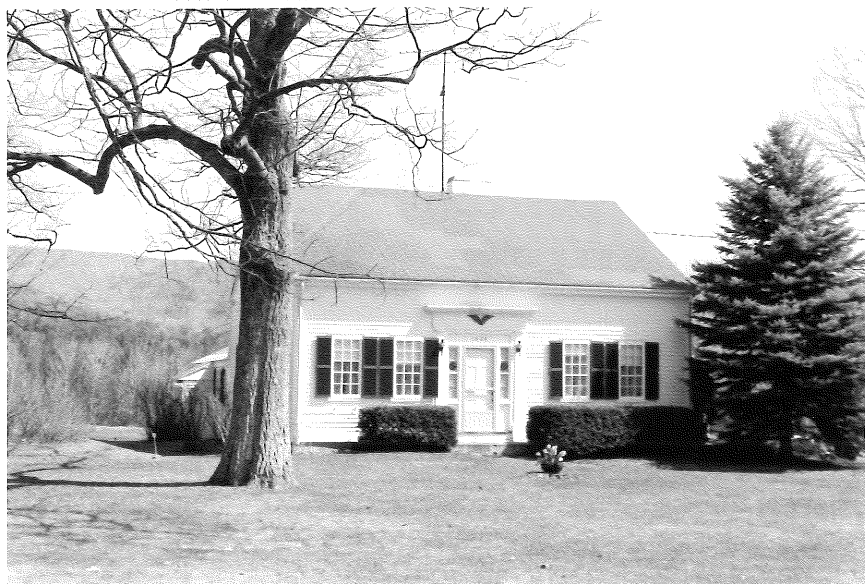
PHOTO:

1. STYLE: vernacular Federal BUILDING TYPE: house
2. # STORIES: 1 1/2 DIMENSIONS: 34 x 31 BAYS: 5 x asym. FORM: cape
3. FOUNDATION: cut granite block 4. STRUCTURE: wooden frame

5. WALLS: Sheathing clapboards
Ornamentation sillboards, cornerboards
6. ROOF: Type gable
Sheathing asphalt shingles
Dormers/Cupolas 1 wide shed roofed wall dormer Details TV antenna

7. CHIMNEYS: # 2 Location exterior, N facade Materials brick
8. EAVES TREATMENT: Lateral box cornice with returns of lateral cornices
Gable End close verges with returns of lateral cornices

9. WINDOWS: Placement symmetrical Shape rectangular Sash 9/6 -1st
6/6 -gable
Surrounds moulded trim, louvred shutters
10. ENTRIES-MAIN: Location center, south facade Door eight panel
Surround: Flanked two-thirds sidelights Topped recessed panel
Framed granite step, pilasters w/bases & capitals supporting entablature with pro-
nounced cornice
OTHERS: # Location Surrounds

16. ARCHITECTURAL IMPORTANCE/INTEGRITY: Fine early 19th century cape, notable for its
excellent doorway.
17. SITE INTEGRITY: A landmark on North Road.
18. HISTORIC ASSOCIATIONS:

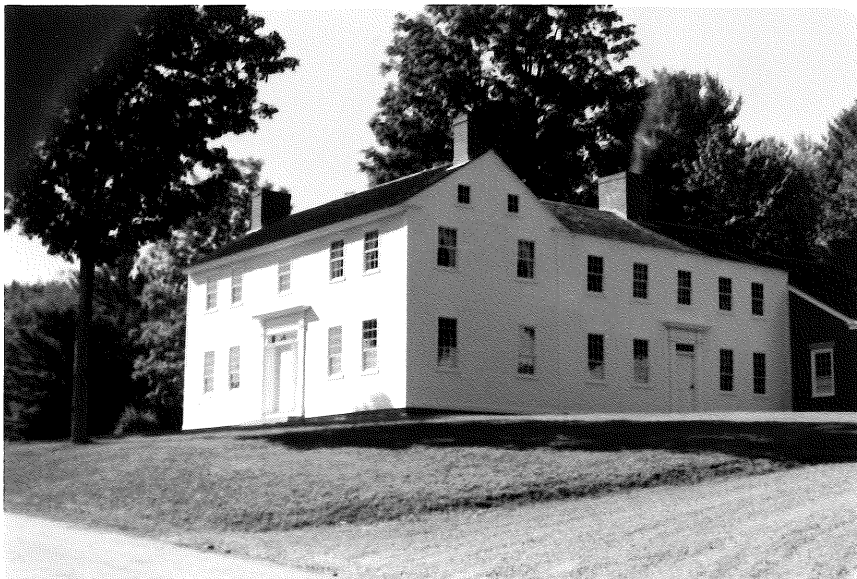
PHOTO:

2. # STORIES: 2 1/2 DIMENSIONS: 41 x 18 BAYS: 5 x 2 FORM: house

3. FOUNDATION: cut granite block 4. STRUCTURE: post and beam

5. WALLS: Sheathing clapboards

6. ROOF: Type gable (w/saltbox to NW)

8. EAVES TREATMENT: Lateral S-box cornice with mouldings, modillions & frieze
N-close moulded eaves

16. ARCHITECTURAL IMPORTANCE/INTEGRITY: Danbury's finest early two-story house. One of the best Federal style houses in the region.

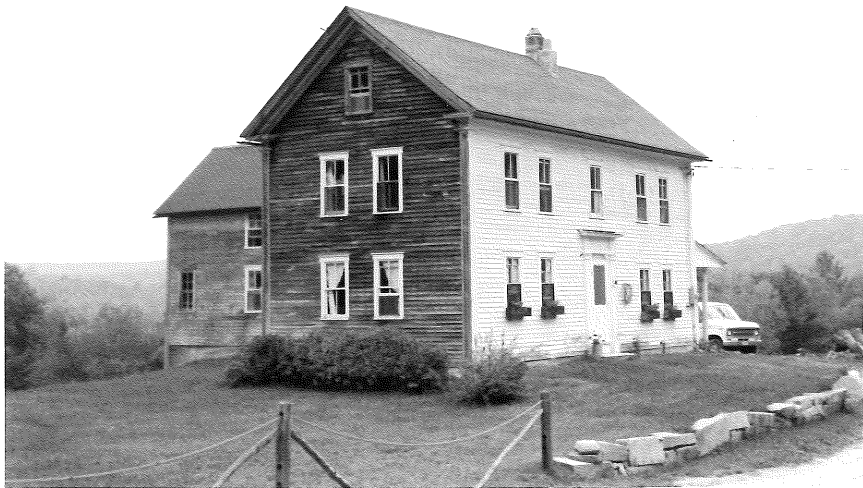
PHOTO:

- 1. STYLE: vernacular Federal BUILDING TYPE: house
- 2. # STORIES: 2 1/2 DIMENSIONS: 39 x 20 BAYS: 5 x 2 FORM: house
- 3. FOUNDATION: cut granite block 4. STRUCTURE: post and beam

- 5. WALLS: Sheathing clapboards (board & batten-NE)
Ornamentation: paneled corner pilasters
- 6. ROOF: Type gable
Sheathing asphalt shingles
Dormers/Cupolas _____ Details _____

- 7. CHIMNEYS: # 1 Location interior, ridge Materials concrete block
- 8. EAVES TREATMENT: Lateral box cornice with mouldings and frieze
Gable End box cornice with mouldings, frieze and returns

- 16. ARCHITECTURAL IMPORTANCE/INTEGRITY: An attractive early 19th century 2 1/2 story house, notable for its fine entry, framed by tall pilasters and entablature, paneled corner pilasters and box cornice.
- 17. SITE INTEGRITY: Contributes to the historic character of Walker Brook Road.
- 18. HISTORIC ASSOCIATIONS: _____

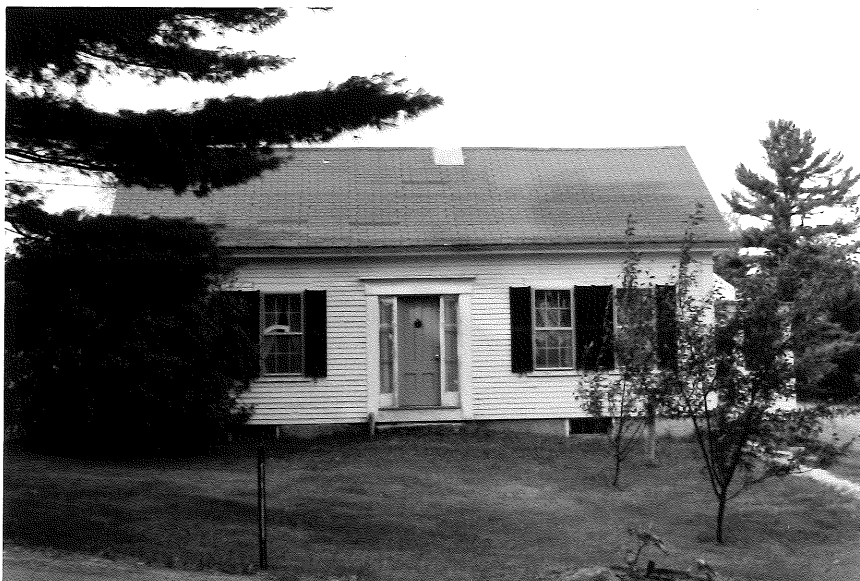
PHOTO:

2. # STORIES: 1 1/2 DIMENSIONS: 36 x 19 BAYS: 5 x 1 FORM: cape

3. FOUNDATION: cut granite block 4. STRUCTURE: wooden frame

8. EAVES TREATMENT: Lateral box cornice with mouldings and frieze

11. PORCHES/HOODS: # 1 Style/Roof Type screened veranda, hip roof

16. ARCHITECTURAL IMPORTANCE/INTEGRITY: Well proportioned cape representative of the better early to mid 19th century vernacular capes.

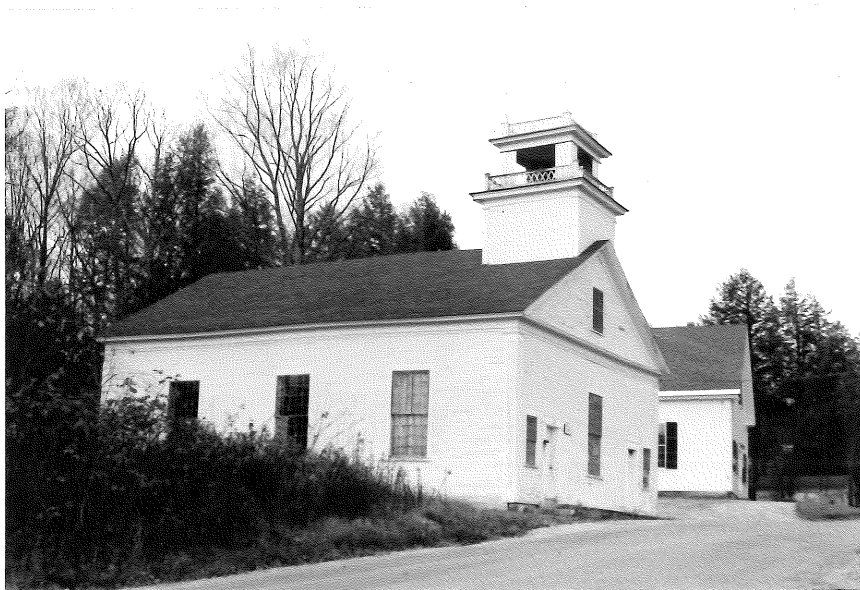
PHOTO:

- 1. STYLE: provincial Greek Revival BUILDING TYPE: church
- 2. # STORIES: 1 1/2 DIMENSIONS: 41 x 51 BAYS: 5 x 3 FORM: rectangular plan
- 3. FOUNDATION: cut granite block 4. STRUCTURE: wooden frame

- 5. WALLS: Sheathing clapboards
Ornamentation paneled corner pilasters
- 6. ROOF: Type gable
Sheathing asphalt shingles
Dormers/Cupolas tower (which see) Details _____

- 7. CHIMNEYS: # _____ Location _____ Materials _____
- 8. EAVES TREATMENT: Lateral wide box cornice with mouldings and frieze
Gable End wide box cornice with mouldings & frieze; pedimented-N, with returns-S

- 16. ARCHITECTURAL IMPORTANCE/INTEGRITY: The strong influence of the Greek Revival can be seen in the paneled corner pilasters and the pedimented box cornice.
 - 17. SITE INTEGRITY: One of the village's most prominent buildings.
 - 18. HISTORIC ASSOCIATIONS: Built as a Baptist Church on School Pond Road, later moved to the village. Still used in the summer months by the United Church of Danbury.
- REFERENCES: Interview - Rev. Gay and Rev. William Kitto, Rev. Donald Towle

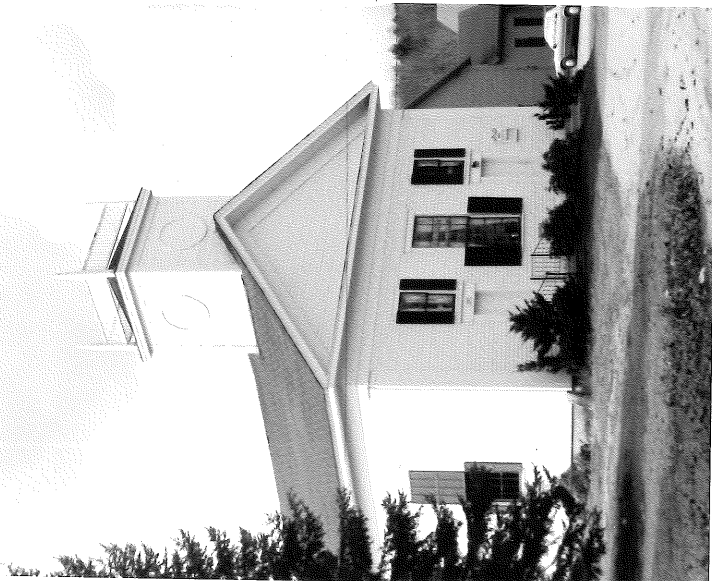
PHOTO:

Major Alterations & Date:
Steeple & belfry lost in 1938 hurricane
Wooden platform replaced by new steps - 1970's

- 1. STYLE: Greek Revival BUILDING TYPE: church
- 2. # STORIES: 2 DIMENSIONS: 38 x 50 BAYS: 3 x 3 FORM: rectangular plan
- 3. FOUNDATION: cut granite block 4. STRUCTURE: wooden frame

- 5. WALLS: Sheathing clapboards
Ornamentation corner pilasters, church sign, (sillboard-NE only)
- 6. ROOF: Type gable
Sheathing asphalt shingles
Dormers/Cupolas tower (which see) Details _____

- 7. CHIMNEYS: # 2 Location exterior, southwest Materials brick
- 8. EAVES TREATMENT: Lateral wide box cornice with mouldings, deep frieze
Gable End wide box cornice with mouldings & deep freize, pedimented-NE, with returns-SW

- 16. ARCHITECTURAL IMPORTANCE/INTEGRITY: An attractive Greek Revival church, well preserved despite the loss of its steeple.
 - 17. SITE INTEGRITY: One of the village's most prominent buildings.
 - 18. HISTORIC ASSOCIATIONS: Built as a Congregational Church, now the main church of the United Church of Danbury.
- REFERENCES: Interivew - Rev. Gay and Rev. William Kitto, Rev. Donald Towle

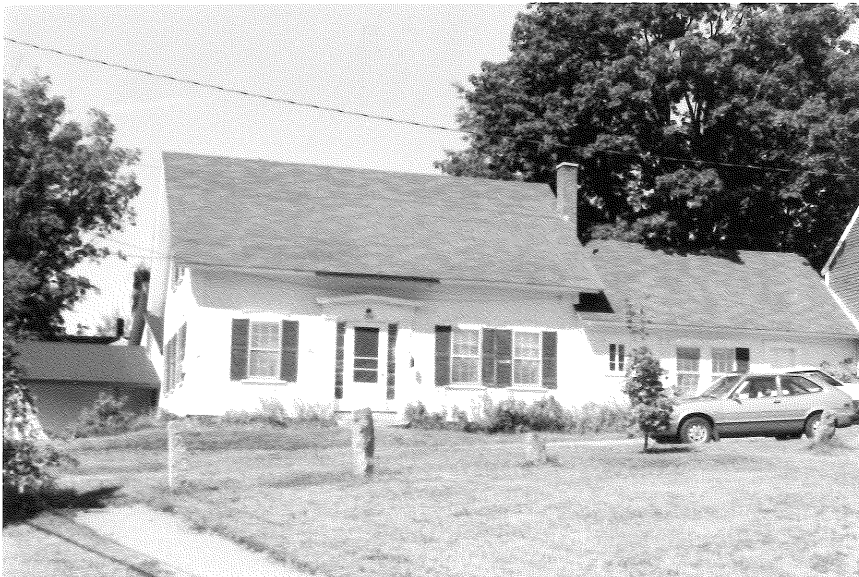
PHOTO:

- 1. STYLE: Greek Revival BUILDING TYPE: house
- 2. # STORIES: 1 1/2 DIMENSIONS: 33 x 25 BAYS: 4 x 3 FORM: three-quarter cape
- 3. FOUNDATION: cut granite block 4. STRUCTURE: wooden frame

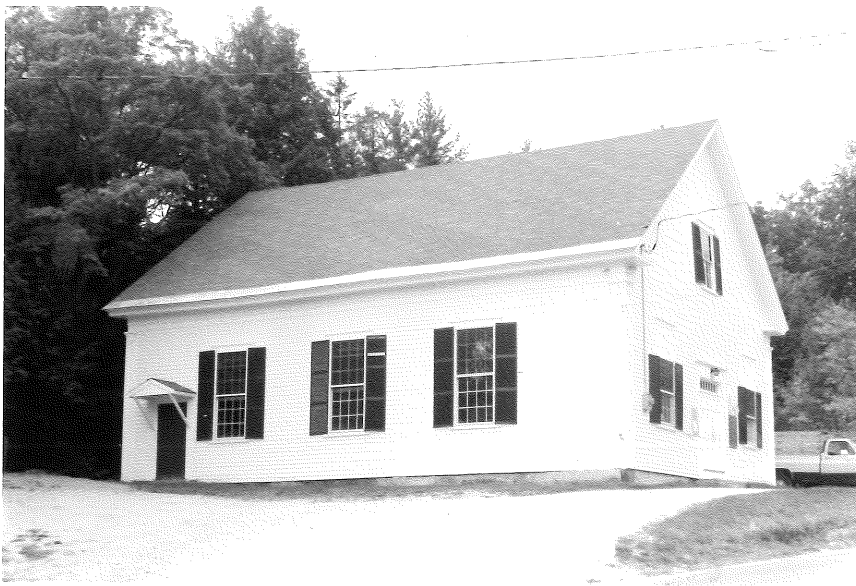
PHOTO:

- 1. STYLE: provincial Greek Revival BUILDING TYPE: town hall
- 2. # STORIES: 1 1/2 DIMENSIONS: 41 x 51 BAYS: 3 x 3 FORM: rectangular plan
- 3. FOUNDATION: cut granite block, fieldstone 4. STRUCTURE: balloon frame
(rear)

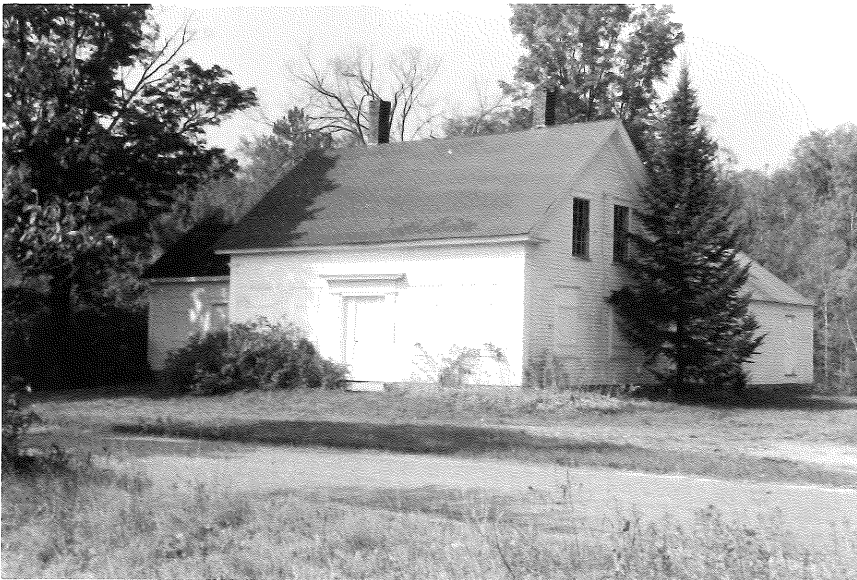
PHOTO:

3. FOUNDATION: cut granite block 4. STRUCTURE: balloon frame

Description(s) Both gable-roofed ells, cut granite block foundations, clapboarded

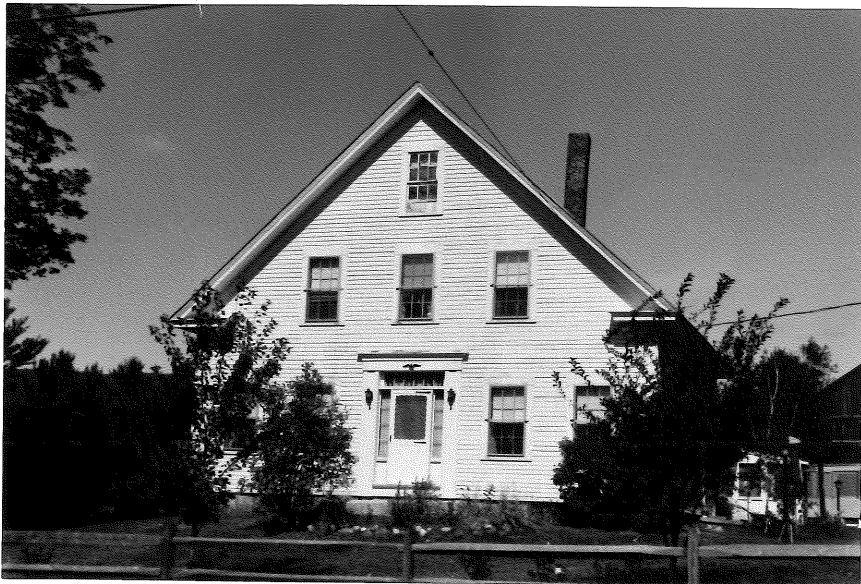
PHOTO:

COMMENTS: The e11 is said to be older than the main block.

1. STYLE: Greek Revival BUILDING TYPE: house
2. # STORIES: 2 1/2 DIMENSIONS: 35 x 31 BAYS: 5 x 3 FORM: gable end house
3. FOUNDATION: cut granite block 4. STRUCTURE: post and beam

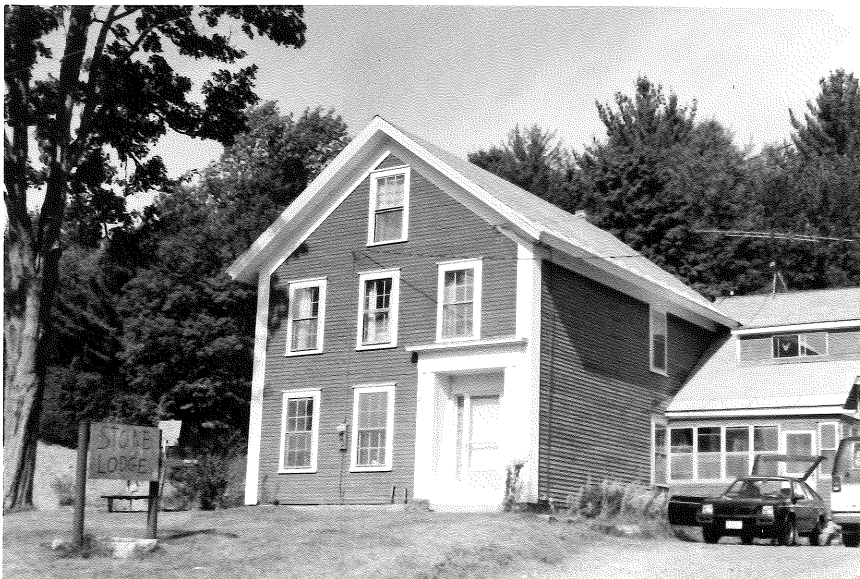
PHOTO:

3. FOUNDATION: cut granite block 4. STRUCTURE: post and beam

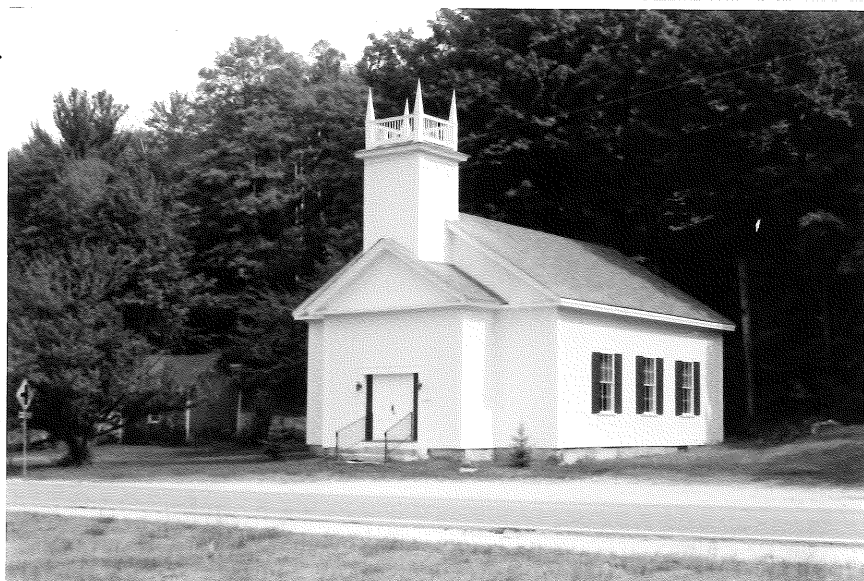
PHOTO:

- 3. FOUNDATION: cut granite block 4. STRUCTURE: wooden frame
- 5. WALLS: Sheathing clapboards
Ornamentation cornerboards
- 6. ROOF: Type gable
Sheathing asphalt shingles
Dormers/Cupolas tower (which see) Details _____

- 13. ELLS/WINGS: # 1 ^{letter} on map A Stories A 1 B C D Bays A x B C D
Description(s) entry pavilion, gable roof, same foundation, clapboarded walls with cornerboards and pedimented box cornice as main block.

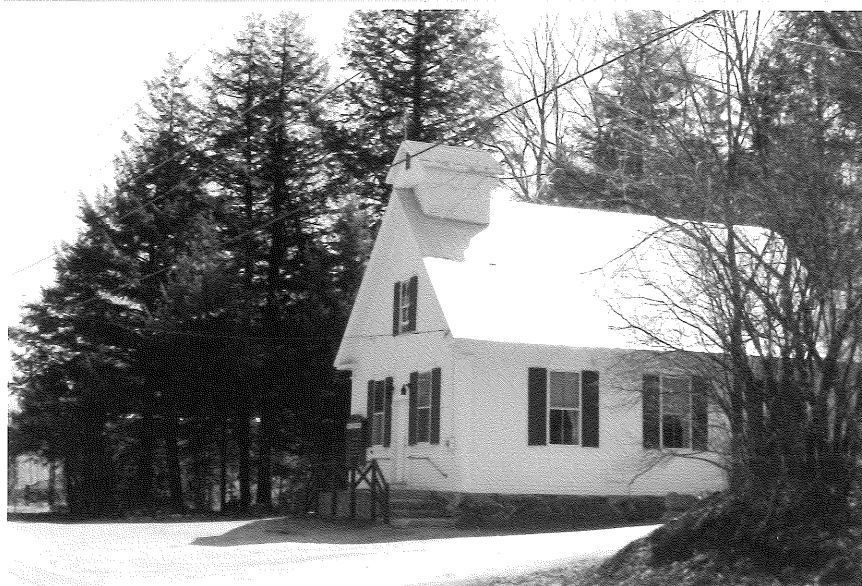
PHOTO:

1. STYLE: late 19th century vernacular BUILDING TYPE: church
2. # STORIES: 1 1/2 DIMENSIONS: 27 x 38 BAYS: 3 x 3 FORM: rectangular plan
3. FOUNDATION: fieldstone 4. STRUCTURE: post and beam

13. ELLS/WINGS: # 1 ^{letter} on map A Stories A 1/2 C D Bays A 2x2B C D
Description(s) concrete foundation, wide clapboards with cornerboards, close verges, simple lateral box cornices, metal sheathed gable-roof, wooden stairs and landing on rear (S) facade.

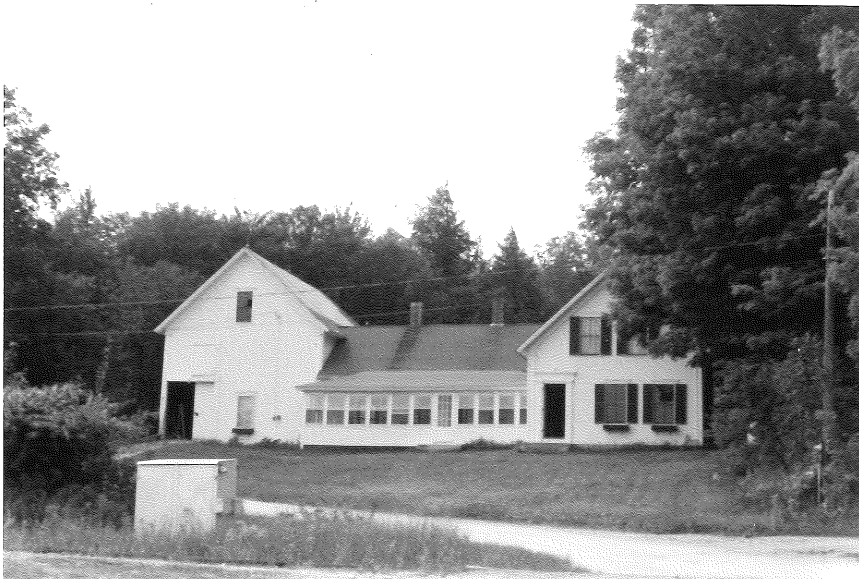
PHOTO:

3. FOUNDATION: cut granite block 4. STRUCTURE: wooden frame

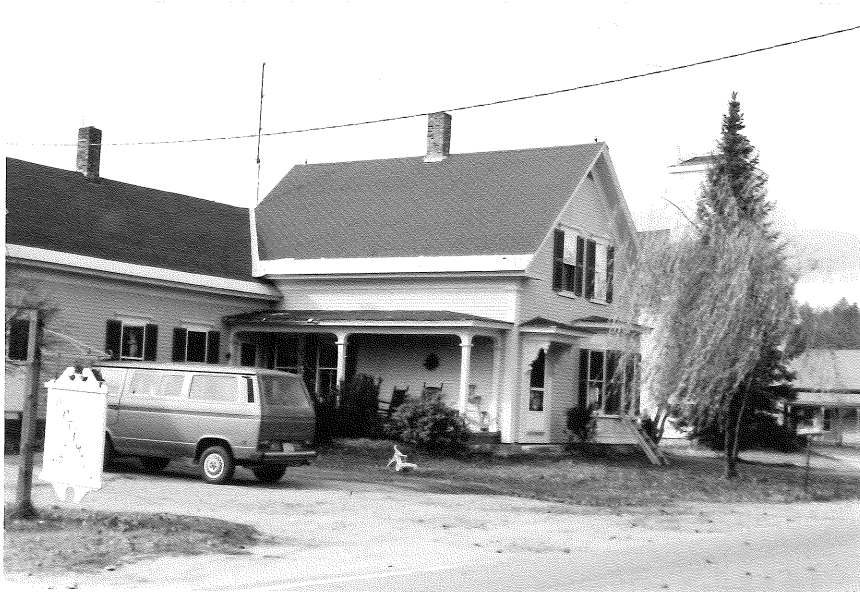
PHOTO:

1. STYLE: Victorian BUILDING TYPE: house
2. # STORIES: 1 1/2 DIMENSIONS: 25 x 30 BAYS: 2 x asym. FORM: sidehall plan
3. FOUNDATION: cut granite block 4. STRUCTURE: post and beam frame

12. BAY WINDOWS/TOWERS: # 1 Location offcenter NE Stories 1 Shape 3 sided
Description granite foundation, sillboard, paneled base & top, 1/1 sash windows, box
cornice, hip roof

13. ELLS/WINGS # 5 Stories A 1 B 1/12 C 1 D 2 E 1 Bays: A 1x3 Basym C 5x8 D 3x3 E 1x1
Description(s): A-shed roof, B,C,D,E-gable roof, A,B,D,E-clapboarded; A,B,D-same
granite foundation, window trim and box cornice as house. A. rear addition; B. ell;
C-greenhouse, concrete block walls topped by banks of plastic covered windows, corru-
gated plastic roof; D. attached barn; E. attached shed, fieldstone foundation, box
cornice with mouldings, frieze and returns.

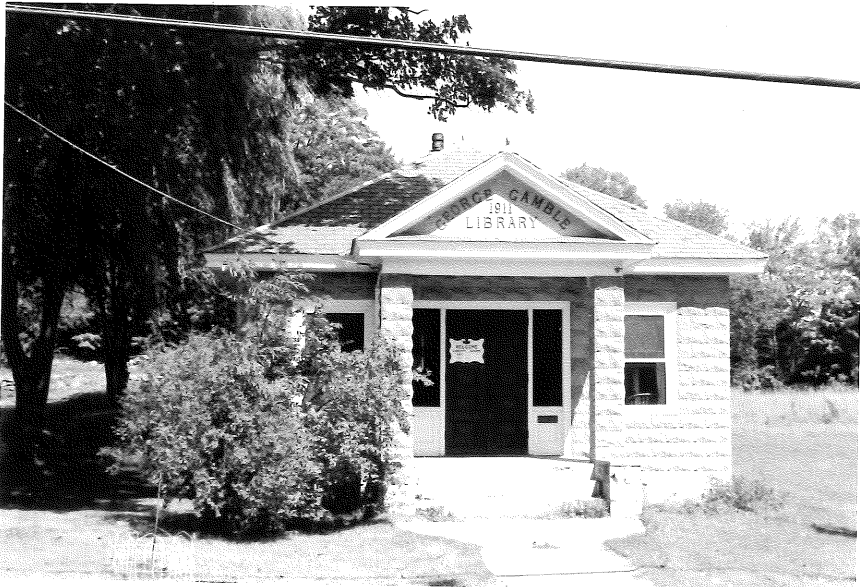
PHOTO:

1. STYLE: vernacular BUILDING TYPE: library
2. # STORIES: 1 DIMENSIONS: 24 x 30 BAYS: 3 x 3 FORM: rectangular plan
3. FOUNDATION: smooth concrete block 4. STRUCTURE: concrete block
5. WALLS: Sheathing "rock-faced" concrete block

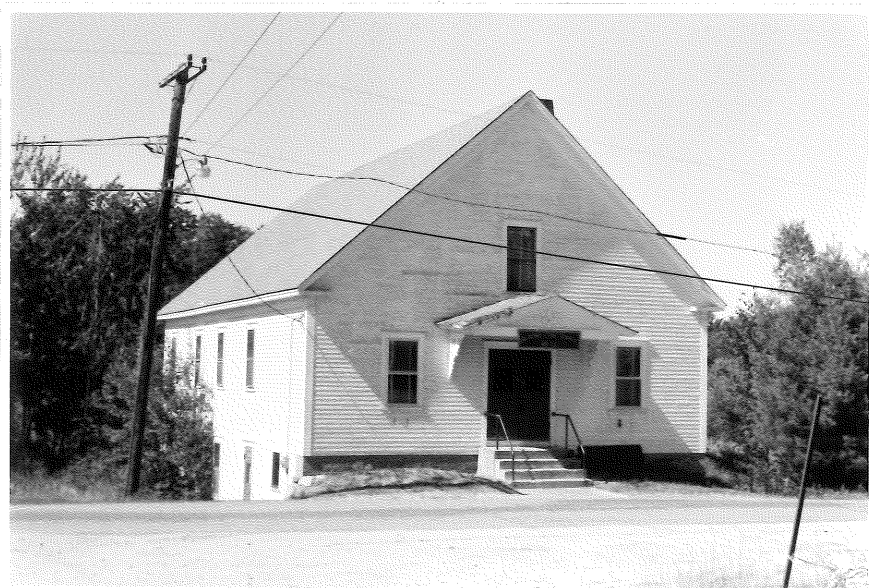
PHOTO:

COMMENTS: Lot purchased and construction begun in spring of 1911. Building committee members - Noah Lund, Fred Huntoon, Charles Martin, Wilbur Webster, Miles Roby, First
~~XXXXXX~~ Occupied May, 1912. Dedicated October 10, 1912. XXXX

1. STYLE: vernacular BUILDING TYPE: grange hall
2. # STORIES: 2 1/2 DIMENSIONS: 35 x 56 BAYS: 3 x 5 FORM: rectangular plan
3. FOUNDATION: fieldstone (brick-E only) 4. STRUCTURE: wooden frame
