URBAN AREA - BRISTOL, N.H.

HISTORIC RESOURCE INVENTORY
Lakes Region Planning Commission
Meredith, New Hampshire

COMMON NAME: Homestead Restaurant

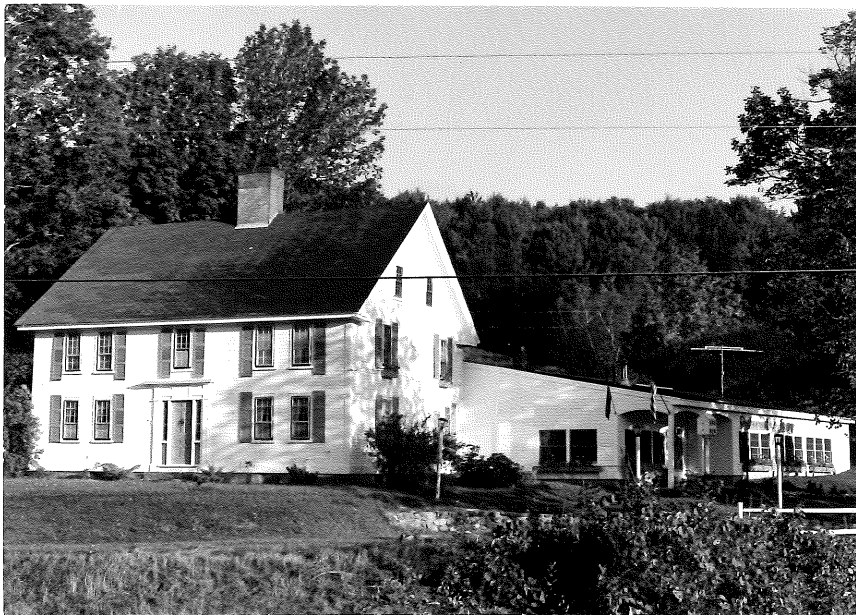
PHOTO:

COMMENTS: Good interiors with fine paneled fireplace walls.

1. STYLE: Georgian Vernacular BUILDING TYPE: House
2. # STORIES: 2½ DIMENSIONS: 38 x 31 BAYS: 5 x 2 FORM: House
3. FOUNDATION: cut granite block 4. STRUCTURE: post & beam

5. WALLS: Sheathing clapboard Ornamentation: corner boards, sillboards
6. ROOF: Type gable Sheathing asphalt shingles
Dormers/Cupolas _____ Details _____

7. CHIMNEYS: # 1 Location central ridge Materials brick
Description large with simple cap
8. EAVES TREATMENT: Lateral box cornice with mouldings
Gable End box cornice with frieze and mouldings, short returns

9. WINDOWS: Placement sym. Shape rect. Sash 9/6
Surrounds plain trim, shutters
10. ENTRIES-MAIN: Location center S facade Door 8 panel
Surround: Flanked 2/3 sidelights Topped dentablature w/central panel
Framed fluted pilasters

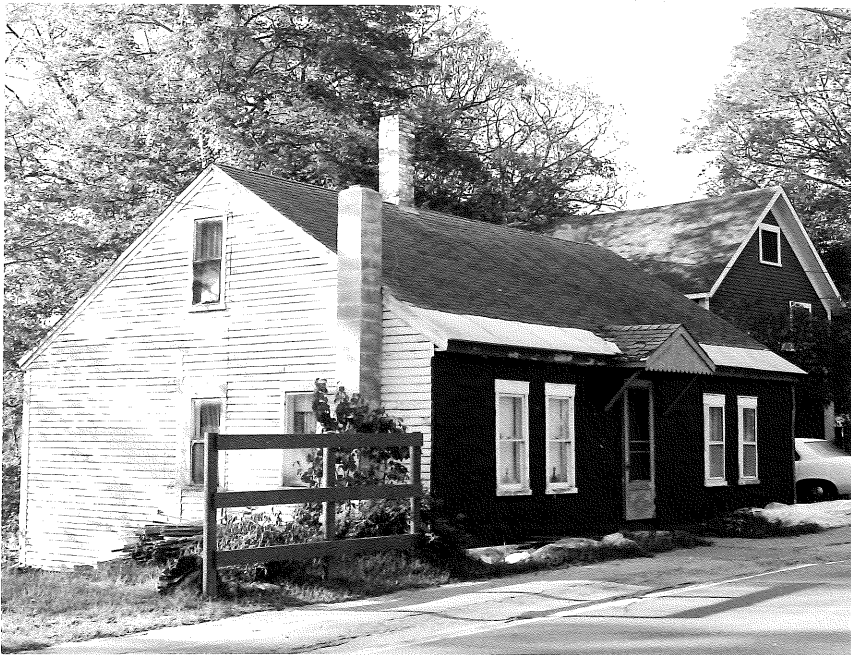
PHOTO:

1. STYLE: Vernacular BUILDING TYPE: House
2. # STORIES: 1½ DIMENSIONS: 26 x 34 BAYS: 5 x 2 FORM: Cape
3. FOUNDATION: brick, where visible 4. STRUCTURE: post & beam

5. WALLS: Sheathing clapboards Ornamentation: corner boards
6. ROOF: Type gable Sheathing asphalt shingles
Dormers/Cupolas _____ Details _____
7. CHIMNEYS: # 3 Location central ridge/exterior E/W Materials brick/concrete block
Description tall & plain

8. EAVES TREATMENT: Lateral simple box cornice N (front), close eaves S (rear)
Gable End close verges
9. WINDOWS: Placement sym. Shape rect. Sash 1/1
Surrounds plain trim

10. ENTRIES-MAIN: Location center N facade Door paneled w/rectangular window
Surround: Flanked plain trim Topped plain trim
Framed hood (which see)
- OTHERS: # _____ Location _____ Surrounds _____

11. PORCHES/HOODS: # 1 Style/Roof Type gabled hood over entry
Location(s) center N facade Supports plain braces
Other Features _____
12. BAY WINDOWS/TOWERS: # _____ Location _____ Stories _____ Shape _____
Description _____

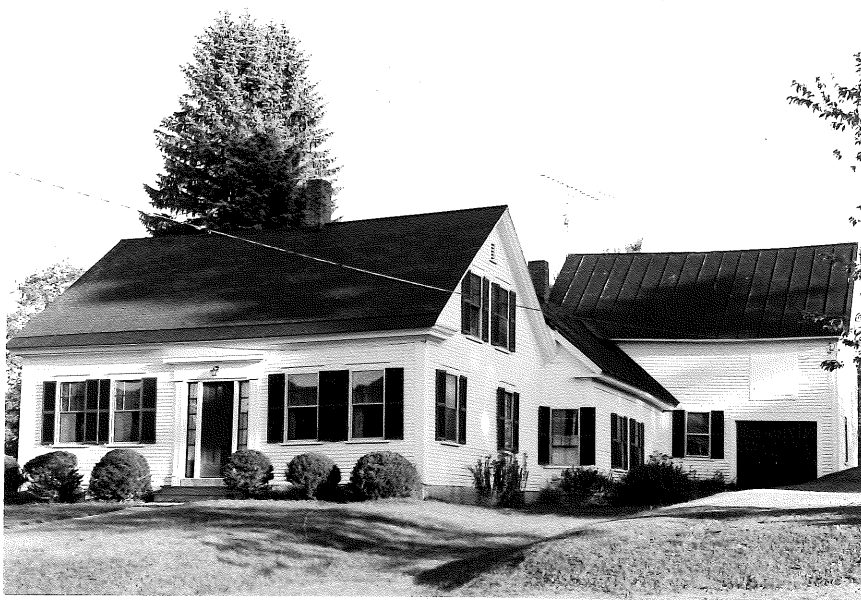
PHOTO:

1. STYLE: Vernacular BUILDING TYPE: House
2. # STORIES: 1½ DIMENSIONS: 32 x 26 BAYS: 5 x 2 FORM: Cape
3. FOUNDATION: cut granite block 4. STRUCTURE: horizontal plank wall

5. WALLS: Sheathing clapboards Ornamentation: corner boards
6. ROOF: Type gable Sheathing asphalt shingles
Dormers/Cupolas _____ Details _____
7. CHIMNEYS: # 1 Location center ridge Materials brick
Description plain & narrow

8. EAVES TREATMENT: Lateral box cornice with narrow frieze
Gable End box cornice with narrow frieze, short returns
9. WINDOWS: Placement sym Shape rect. Sash 6/1
Surrounds lintel with simple moulding, louvred shutters

10. ENTRIES-MAIN: Location center N facade Door 4 panel
Surround: Flanked full sidelights Topped entablature w/deep frieze
Framed paneled pilasters
OTHERS: # _____ Location _____ Surrounds _____

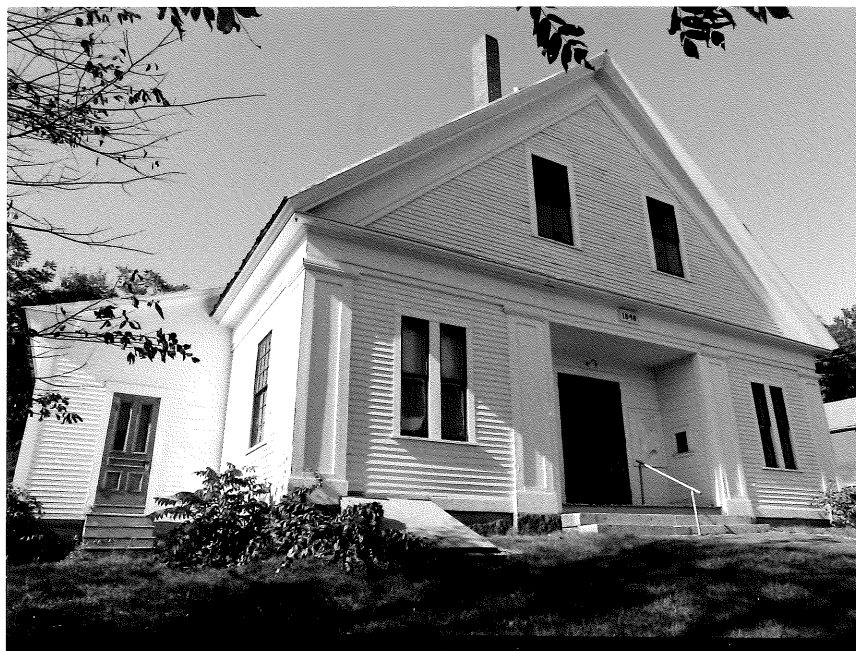
PHOTO:

1. STYLE: Greek Revival BUILDING TYPE: Town Hall
2. # STORIES: 1½ DIMENSIONS: 45 x 74 BAYS: 3 x 5 FORM: rectangular plan
3. FOUNDATION: cut granite block 4. STRUCTURE: wooden frame (prob. post & beam)

5. WALLS: Sheathing clapboards Ornamentation: wide paneled corner pilasters,
6. ROOF: Type gable Sheathing sheet metal sillboard
- Dormers/Cupolas _____ Details _____

7. CHIMNEYS: # 3 Location 1-interior/2-exterior N Materials brick
- Description tall & plain
8. EAVES TREATMENT: Lateral box cornice, deep frieze
- Gable End box cornice, deep frieze, pedimented

9. WINDOWS: Placement sym. Shape rect. Sash 6/6 (also 2/2, 1/1)
- Surrounds plain trim
10. ENTRIES-MAIN: Location center S facade Door diagonal boarding, dbl.

- Surround: Flanked plain trim Topped plain trim door
- Framed recessed entryway, with flush boarding walls, flanked by paneled pilasters
- OTHERS: # _____ Location _____ Surrounds _____

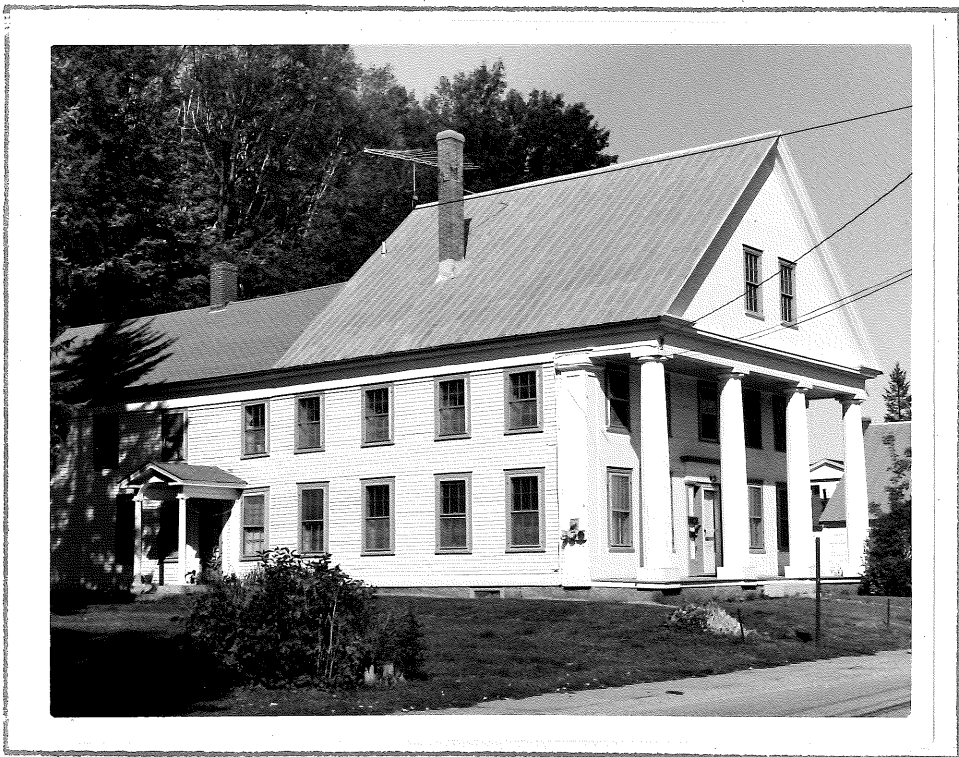
COMMENTS: Built for Warren White, who came to Bristol in 1837. Well-preserved interior woodwork.

1. STYLE: Greek Revival BUILDING TYPE: House
2. # STORIES: 2½ DIMENSIONS: 30 x 36 BAYS: 5 x 4 FORM: central hall plan
3. FOUNDATION: cut granite block 4. STRUCTURE: horizontal plank wall

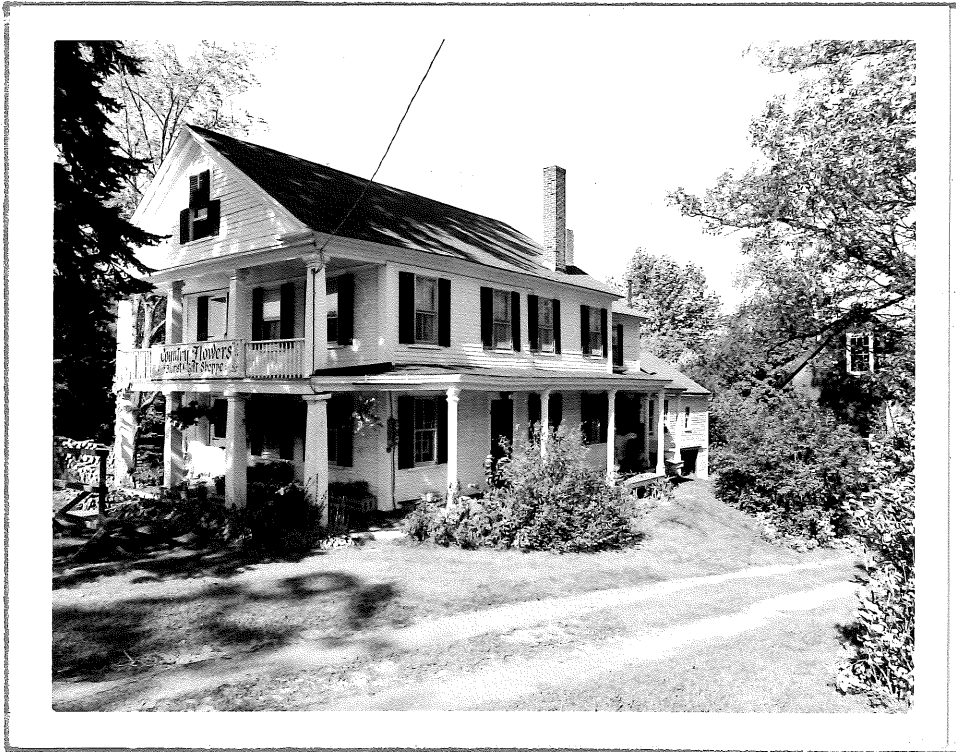
1. STYLE: Greek Revival BUILDING TYPE: House
2. # STORIES: 2½ DIMENSIONS: 26 x 32 BAYS: 3 x 4 FORM: sidehall plan
3. FOUNDATION: cut granite block 4. STRUCTURE: post and beam

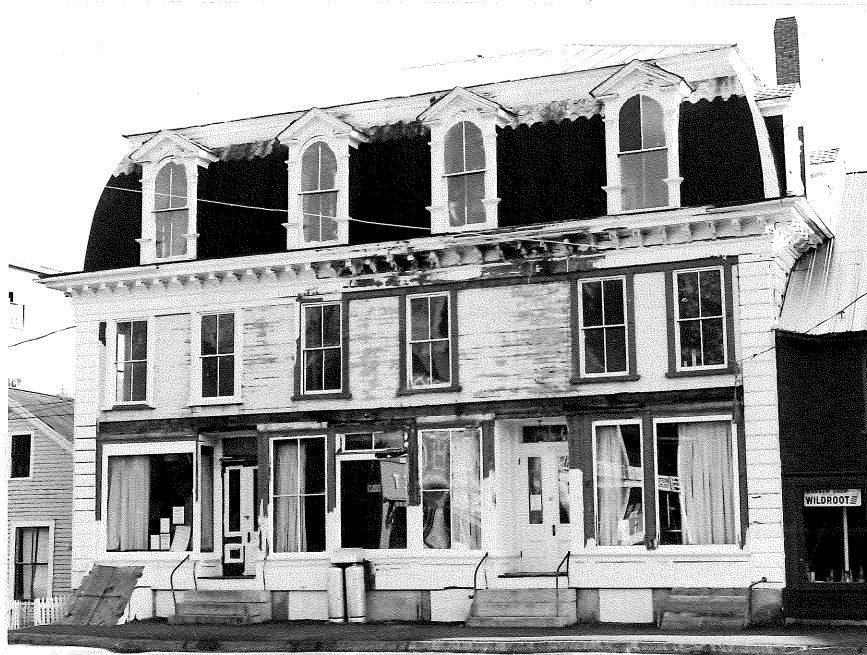
PHOTO:

1. STYLE: Second Empire BUILDING TYPE: commercial block
2. # STORIES: 2½/3½ DIMENSIONS: 50 x 36 BAYS: 6 x 2 FORM: rectangular plan
3. FOUNDATION: cut granite block N/brick & stone S 4. STRUCTURE: balloon frame

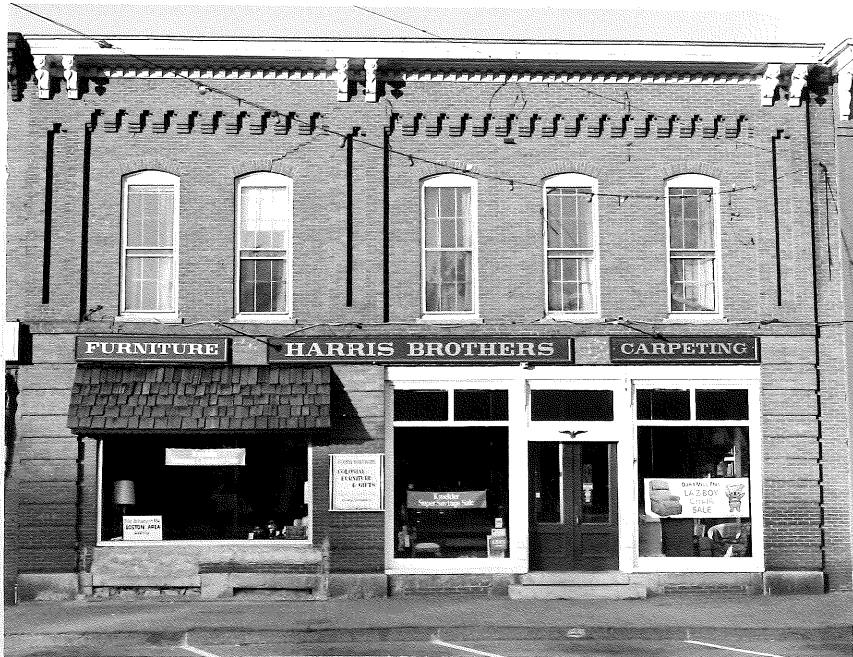
PHOTO:

1. STYLE: Victorian Commercial BUILDING TYPE: commercial block
2. # STORIES: 2 DIMENSIONS: 42 x 57 BAYS: 5 FORM: commercial block
3. FOUNDATION: cut granite block 4. STRUCTURE: brick

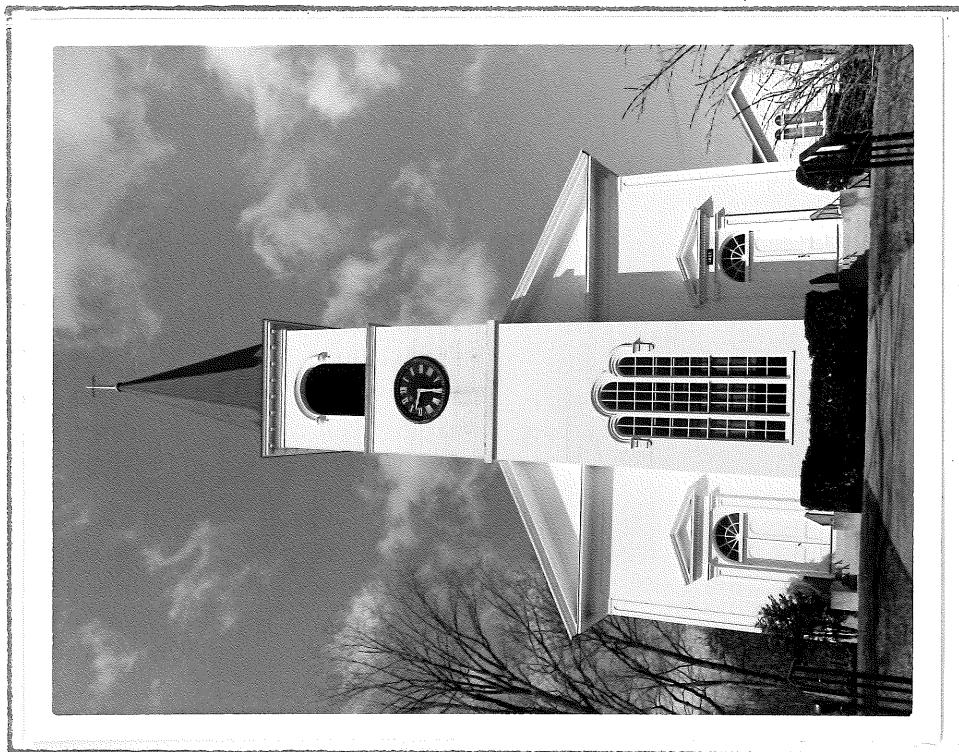
COMMENTS: Original church modeled after Salisbury Meeting House. Enlarged and
Victorianized in 1870.

1. STYLE: Victorian BUILDING TYPE: Church
2. # STORIES: 1½ DIMENSIONS: 44 x 70 BAYS: 3 x 4 FORM: rectangular plan
3. FOUNDATION: cut granite blocks 4. STRUCTURE: post and beam

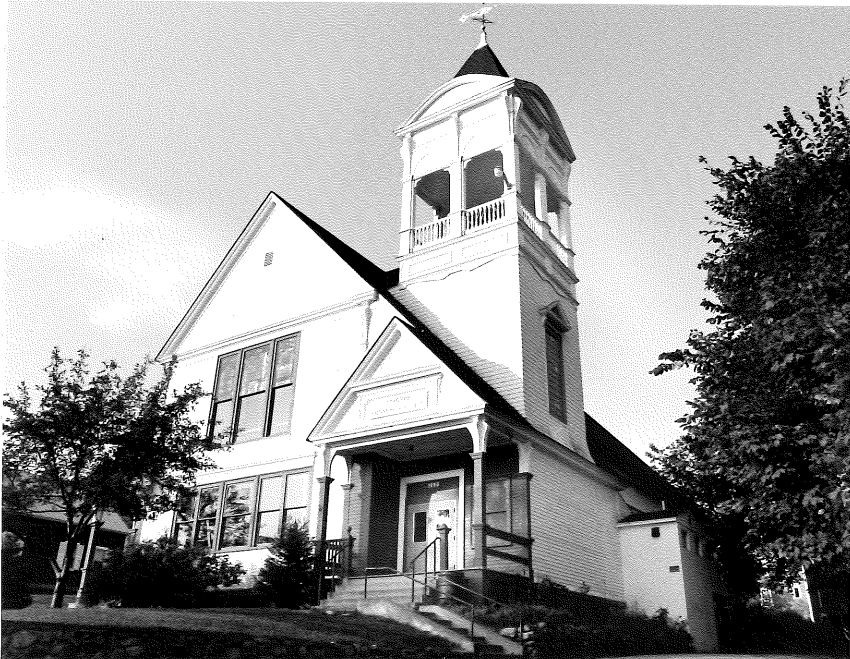
PHOTO:

COMMENTS: Daniel M. Page of Tilton was master workman.

- 1. STYLE: Queen Anne BUILDING TYPE: church
- 2. # STORIES: 1 1/2 DIMENSIONS: 51 x 94 BAYS: asymmetrical FORM: rectangular plan
- 3. FOUNDATION: brick 4. STRUCTURE: balloon frame

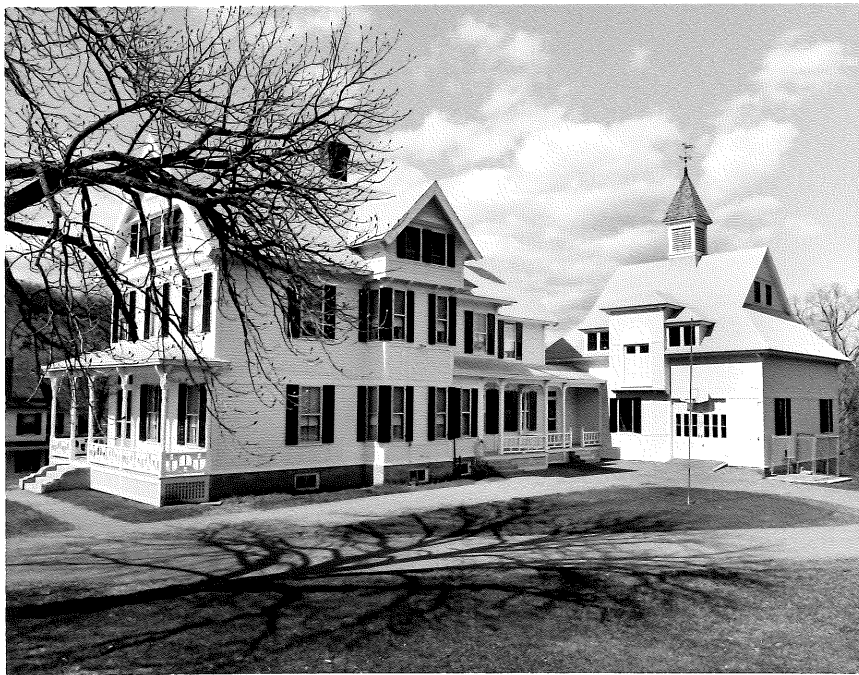
1. STYLE: Queen Anne BUILDING TYPE: House
2. # STORIES: 2½ DIMENSIONS: 32 x 72 BAYS: 3 x irreg. FORM: asymmetrical plan
3. FOUNDATION: cut granite block 4. STRUCTURE: balloon frame

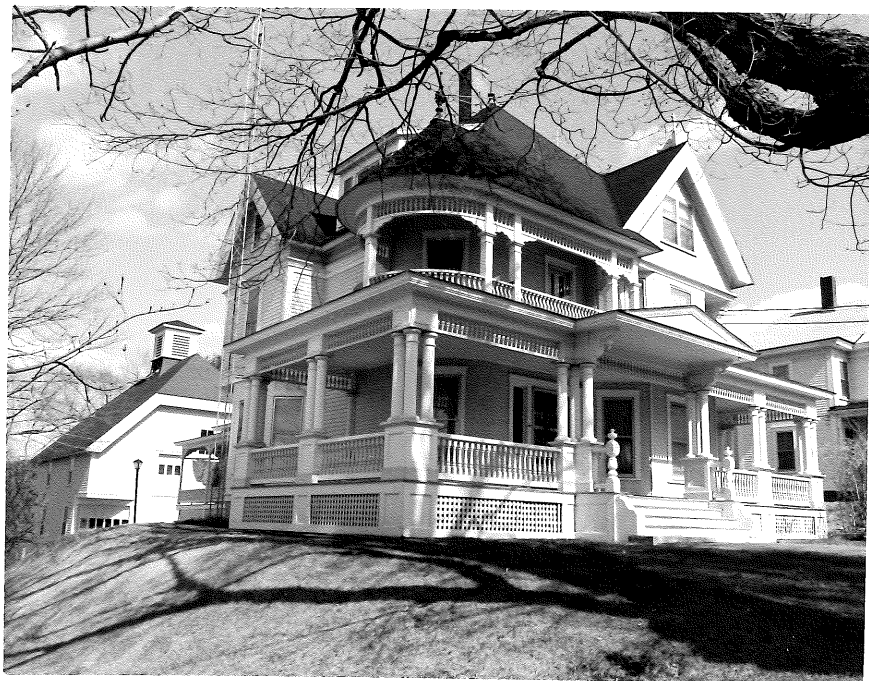
1. STYLE: Queen Anne BUILDING TYPE: House
2. # STORIES: 2½ DIMENSIONS: 35 x 50 BAYS: irreg. FORM: assymmetrical plan
3. FOUNDATION: cut granite block 4. STRUCTURE: balloon frame

10. ENTRIES-MAIN: Location off center W Door paneled wooden door with window
 Surround: Flanked 1/2 sidelights (stained glass) Topped lintel with moulding
 Framed W porch (see)
