HISTORIC RESOURCE INVENTORY
Lakes Region Planning Commission
Meredith, New Hampshire

TOWN: Ossipee COUNTY: Carroll UTM: _____
 SURVEY NUMBER: 1 USGS QUAD: Wolfeboro
 COMMON NAME: Oscaneha Farm FUNCTIONAL TYPE: House
 HISTORIC NAME: Jerediah Abbott House PRESENT USE: House
 LOCATION: Leighton Rd., 1 mi. from Walker Hill ARCHITECT/BUILDER: Hubbard Goldsmith
 OWNER: Lloyd E. Smith CONDITION: Exc. X Good Fair Poor Ruins
 ADDRESS: RFD, Box 14 INTEGRITY: Original Site X Moved
Ossipee, NH 03864 Date
 MAP & PARCEL NO: _____ Major Alterations & Date:
 DATE: c. 1797 Porch added c. 1920
 SOURCE: Lloyd Smith "The Story of Home" LEVEL/SIGNIFICANCE: Natl. State Local X
 STYLE: Vernacular
 BOUNDARY AND ACREAGE DESCRIPTION: Approximately 25 acres bordered on west by Leighton Road, on north by Polly Allen Road, on east and south by Russell Bennett and south by Peter Oikkola.

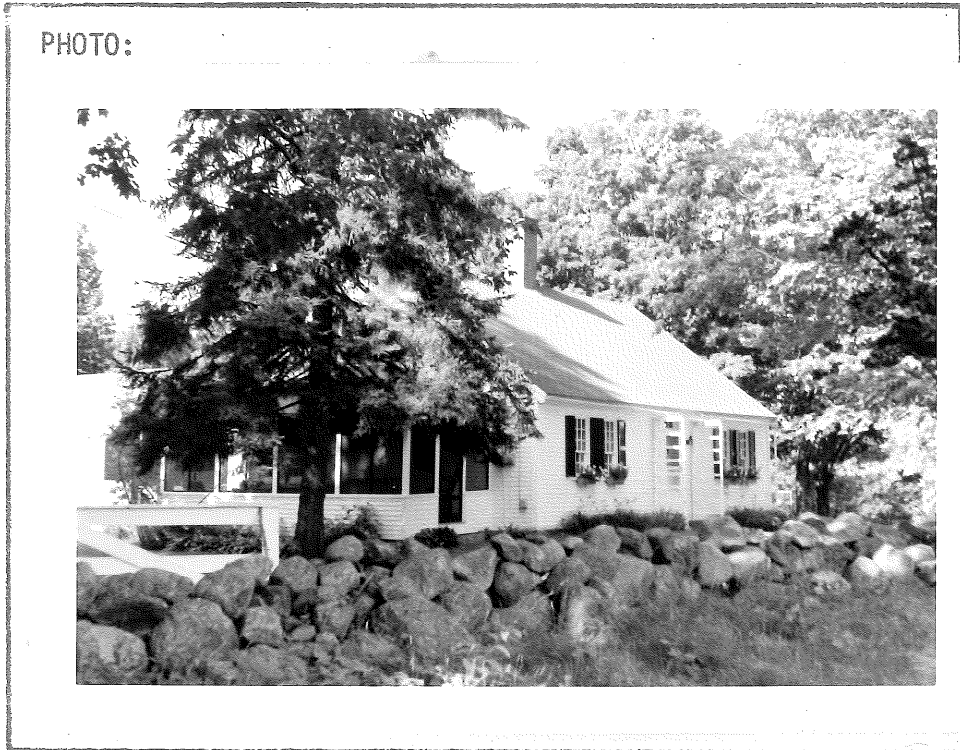
1. STYLE: Vernacular BUILDING TYPE: House
2. # STORIES: 1½ DIMENSIONS: app. 40x30 BAYS: 5 x 2 FORM: Cape
3. FOUNDATION: cut granite block 4. STRUCTURE: post & beam

5. WALLS: Sheathing clapboards Ornamentation: corner boards
6. ROOF: Type gable Sheathing asphalt shingles
Dormers/Cupolas _____ Details _____
7. CHIMNEYS: # 1 Location central ridge Materials brick
Description tall, corbeled cap

8. EAVES TREATMENT: Lateral narrow cornice with mouldings and frieze
Gable End close verges
9. WINDOWS: Placement symmetrical Shape rectangular Sash 9/6
Surrounds moulded trim, louvered shutters

10. ENTRIES-MAIN: Location center S facade Door 4 panel
Surround: Flanked wide plain trim Topped recessed transom window
Framed modern trellis, granite steps
OTHERS: # 1 Location W on porch Surrounds plain trim

11. PORCHES/HOODS: # 1 Style/Roof Type hip roof, screened porch
Location(s) W facade Supports clapboarded lower wall, plain wooden posts
Other Features screen door

12. BAY WINDOWS/TOWERS: # _____ Location _____ Stories _____ Shape _____
Description _____
13. ELLS/WINGS: # 2 letter A 1 B 1 C on map Stories A 1 B 1 C Bays Airreg B 1x1 C
Description(s) A-gable roofed kitchen-woodshed ell, clapboarded on S, shingled on N&E;
B-gable roofed storage shed & wellhouse, shingled walls

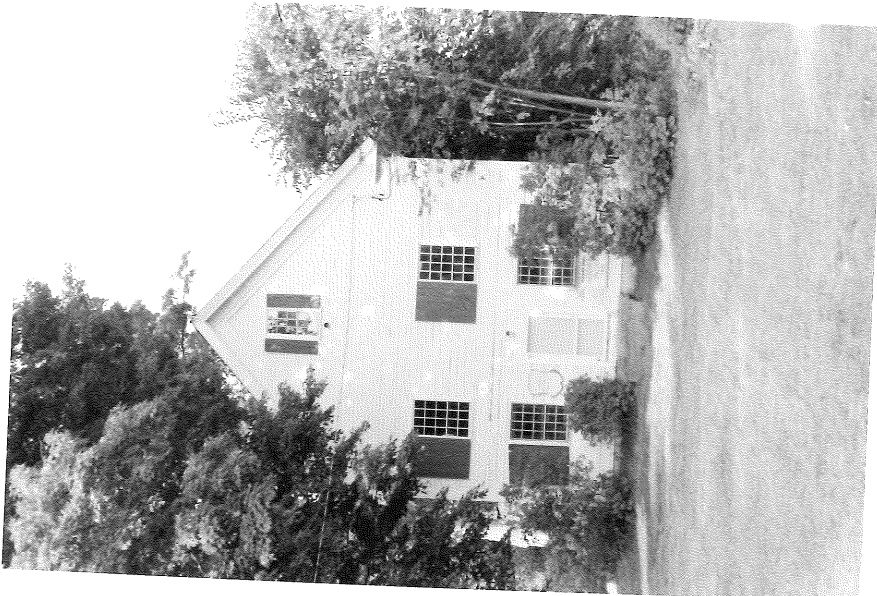
PHOTO:

1. STYLE: Vernacular BUILDING TYPE: store
2. # STORIES: 2½ DIMENSIONS: 26½ x 40 BAYS: 3 x irreg. FORM: rectangular plan
3. FOUNDATION: cut granite block 4. STRUCTURE: post and beam

5. WALLS: Sheathing clapboards Ornamentation: corner pilasters
6. ROOF: Type gable Sheathing asphalt shingles
Dormers/Cupolas Details
7. CHIMNEYS: # 1 Location interior ridge E end Materials brick
Description large, concrete cap

8. EAVES TREATMENT: Lateral plain box cornice with frieze
Gable End plain box cornice with fireze and short return
9. WINDOWS: Placement assymetrical Shape rectangular Sash 12/8 & 9/6
Surrounds plain trim, vertical board shutters

10. ENTRIES-MAIN: Location center W Door vertical board
Surround: Flanked plain trim Topped plain trim
Framed wide granite steps
- OTHERS: # Location Surrounds

11. PORCHES/HOODS: # Style/Roof Type
Location(s) Supports
Other Features
12. BAY WINDOWS/TOWERS: # Location Stories Shape
Description
13. ELLS/WINGS: # 1 letter on map Stories A 1 B C Bays A B C
Description(s) small windowless clapboarded hiproofed addition, concrete foundation

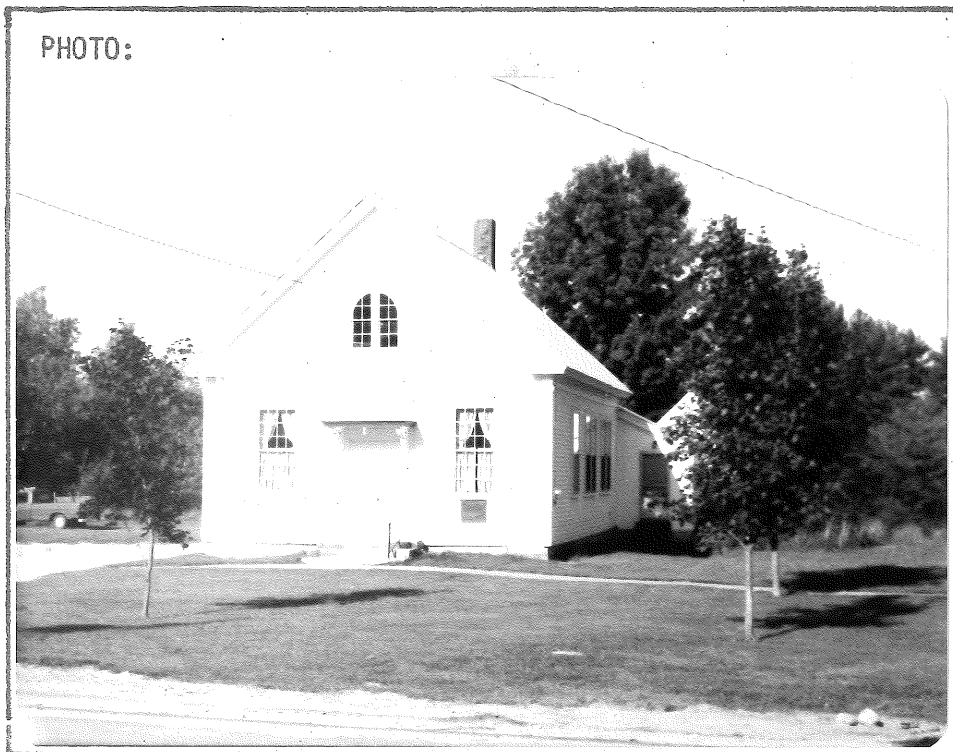
1. STYLE: Victorian vernacular BUILDING TYPE: schoolhouse
2. # STORIES: 1½ DIMENSIONS: app. 25x35 BAYS: 3 x 3 FORM: rectangular plan
3. FOUNDATION: cut granite block 4. STRUCTURE: wooden frame

5. WALLS: Sheathing clapboards Ornamentation: corner pilasters
6. ROOF: Type gable Sheathing sheet metal
Dormers/Cupolas _____ Details _____
7. CHIMNEYS: # 1 Location interior ridge E end Materials brick
Description plain

8. EAVES TREATMENT: Lateral box cornice with frieze
Gable End box cornice with frieze, short returns
9. WINDOWS: Placement symmetrical Shape rect., paired on S Sash 12/12
Surrounds moulded trim (arched double window in W gable)

10. ENTRIES-MAIN: Location center W facade Door dbl. 3-paneled doors
Surround: Flanked plain trim Topped hood (which see)
Framed granite steps
- OTHERS: # _____ Location _____ Surrounds _____

11. PORCHES/HOODS: # 1 Style/Roof Type flat-roofed hood over entry
Location(s) center W facade Supports large carved and decorated braces
Other Features _____

12. BAY WINDOWS/TOWERS: # _____ Location _____ Stories _____ Shape _____
Description _____
13. ELLS/WINGS: # 1 letter on map Stories A 1 B C Bays A 4x1 B C
Description(s) gable roof with leanto, concrete block foundation and chimney, clapboarded, a kitchen-restroom wing added by church

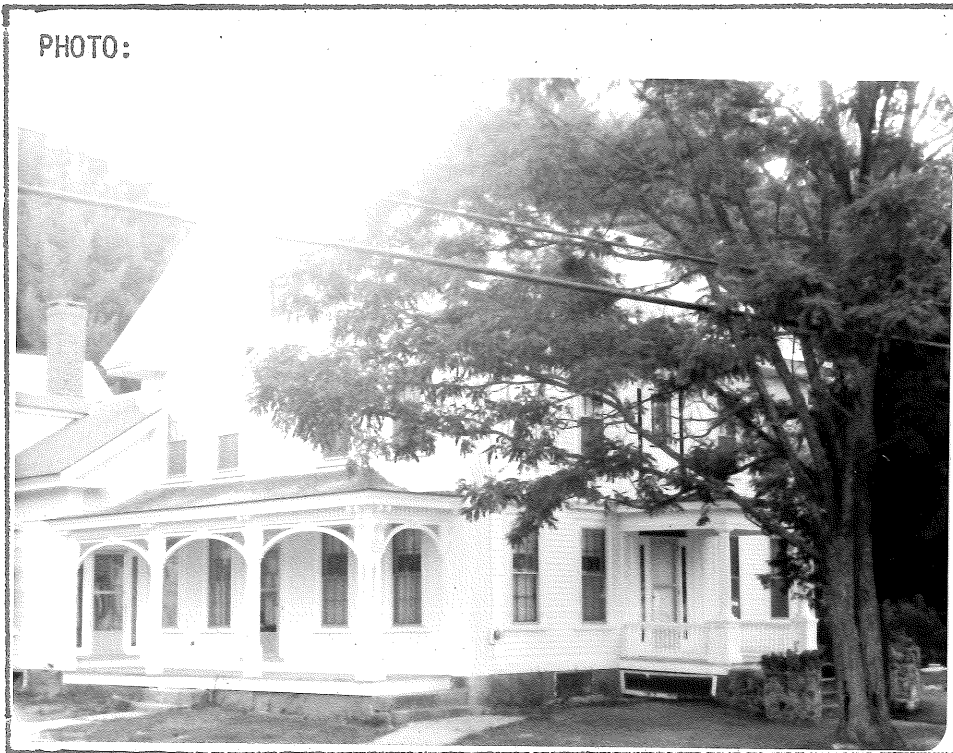
COMMENTS: Well-preserved interior woodwork.

1. STYLE: Victorian BUILDING TYPE: house
2. # STORIES: 2½ DIMENSIONS: 35 x 30 BAYS: 5 x 4 FORM: house
3. FOUNDATION: cut granite blocks 4. STRUCTURE: balloon frame w/diagonal bracing

5. WALLS: Sheathing clapboards Ornamentation: paneled corner pilasters
also - paneled pilasters flanking central bay E facade
6. ROOF: Type gable Sheathing asphalt shingles
Dormers/Cupolas _____ Details _____

7. CHIMNEYS: # 1 Location interior W slope Materials brick
Description corbeled cap
8. EAVES TREATMENT: Lateral box cornice w/mouldings and deep frieze (formerly w/ brackets)
Gable End box cornice with mouldings and deep frieze, short returns

9. WINDOWS: Placement symmetrical Shape rectangular Sash 6/6
Surrounds entablatures above most windows, moulded trim around all, louvered shutters
10. ENTRIES-MAIN: Location center W facade Door 4 panel
Surround: Flanked full sidelights Topped transom window
Framed W porch (which see)

- OTHERS: # 1 Location S (on porch) Surrounds moulded trim
11. PORCHES/HOODS: # 2 Style/Roof Type flat-roof entry / concave roof, side veranda
Location(s) W/S Supports columns on pedestals/carved posts w/brackets
Other Features side balustrades/"dentiled" cornice with scroll brackets, arched braces

12. BAY WINDOWS/TOWERS: # _____ Location _____ Stories _____ Shape _____
Description _____
13. ELLS/WINGS: # 2 ^{letter} on map _____ Stories A 1½ B 2½ C _____ Bays A 4 B _____ C _____
Description(s) A-gable-roofed ell with dormer windows, cornice and windows like main block; B-connected gable-roof barn; both clapboarded.

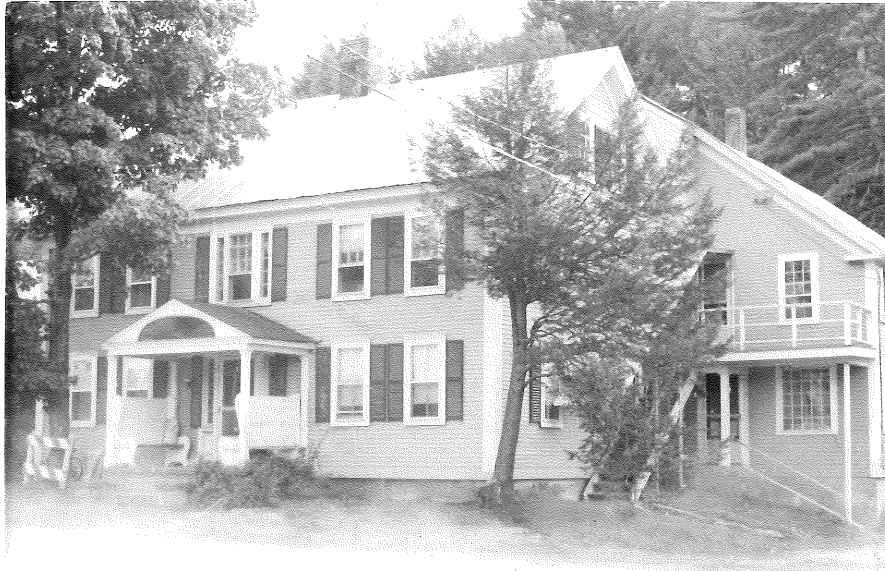
PHOTO:

1. STYLE: Vernacular BUILDING TYPE: house
2. # STORIES: 2½ DIMENSIONS: app. 40x30 BAYS: 5 x asym. FORM: house
3. FOUNDATION: cut granite blocks 4. STRUCTURE: post & beam (prob.)

5. WALLS: Sheathing clapboards Ornamentation: corner pilasters, sill boards
6. ROOF: Type gable Sheathing sheet metal
Dormers/Cupolas _____ Details _____

7. CHIMNEYS: # 1 Location central ridge Materials brick
Description plain, square
8. EAVES TREATMENT: Lateral box cornice with mouldings and frieze
Gable End box cornice with mouldings and frieze, short returns

9. WINDOWS: Placement sym. Shape rectangular Sash 9/6
Surrounds moulded trim (note: Triple window above entry, E facade)
10. ENTRIES-MAIN: Location center E facade Door paneled door w/windows
Surround: Flanked ¾ sidelights, shutters Topped _____
Framed porch (which see)

- OTHERS: # 1 Location S, off center Surrounds moulded trim
11. PORCHES/HOODS: # 1 Style/Roof Type gable roof entry porch
Location(s) center E. facade Supports pillars with bases and capitols
Other Features pediment with semi-elliptical louvered fan and "knob" ornaments

12. BAY WINDOWS/TOWERS: # _____ Location _____ Stories _____ Shape _____
Description _____
13. ELLS/WINGS: # 3 letter on map Stories A 1 B 2 C 2½ Bays A 2 B 3x2 C _____
Description(s) A&B-sun porches with shed roofs, many windows; C-gable roofed ell, clapboard walls with simple trim.

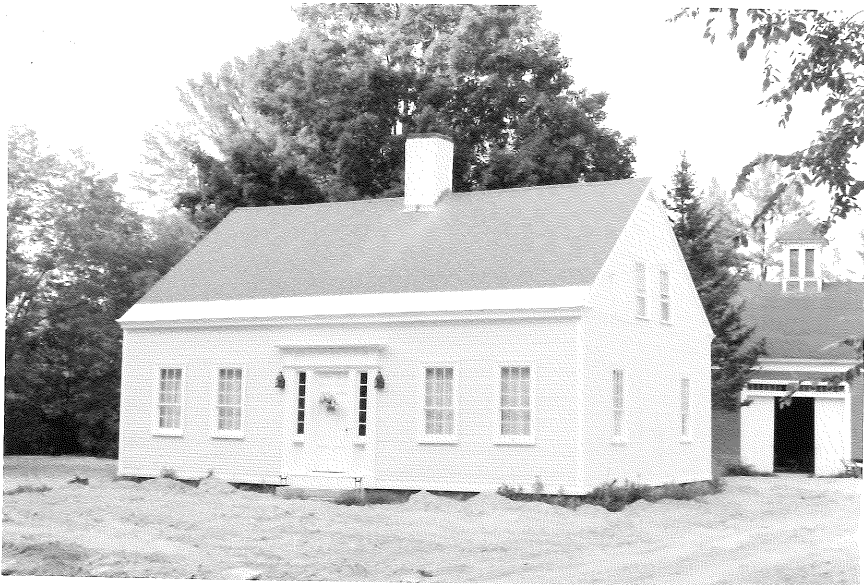
PHOTO:

1. STYLE: Vernacular BUILDING TYPE: house
2. # STORIES: 1½ DIMENSIONS: app. 35x25 BAYS: 5 x 2 FORM: Cape
3. FOUNDATION: cut granite block 4. STRUCTURE: post & beam

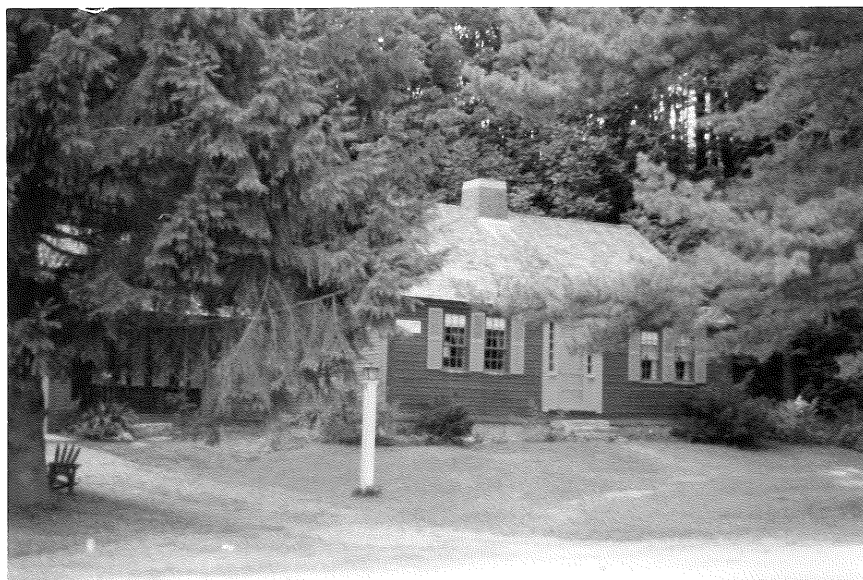
PHOTO:

1. STYLE: Vernacular BUILDING TYPE: house
2. # STORIES: 1½ DIMENSIONS: app. 30x20 BAYS: 5 x 2 FORM: Cape
3. FOUNDATION: cut granite block 4. STRUCTURE: post & beam

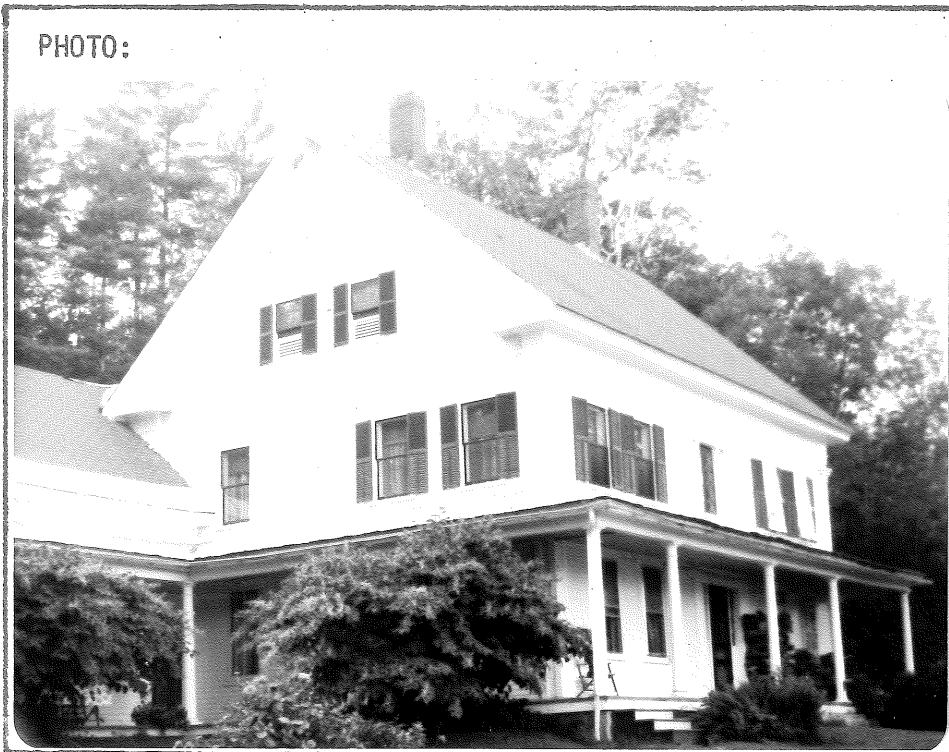
1. STYLE: Vernacular BUILDING TYPE: house
2. # STORIES: 2½ DIMENSIONS: app. 40x30 BAYS: 5 x 4 FORM: house
3. FOUNDATION: cut granite block 4. STRUCTURE: post & beam

12. BAY WINDOWS/TOWERS: # _____ Location _____ Stories _____ Shape _____
Description _____
13. ELLS/WINGS: # 3 letter on map Stories A 1½ B 1 C 2½ Bays A 4 B _____ C 3 x
Description(s) A-gable roofed kitchen ell, porch on front; B-shed roof addition, concrete foundation; C-connected gable roofed barn.

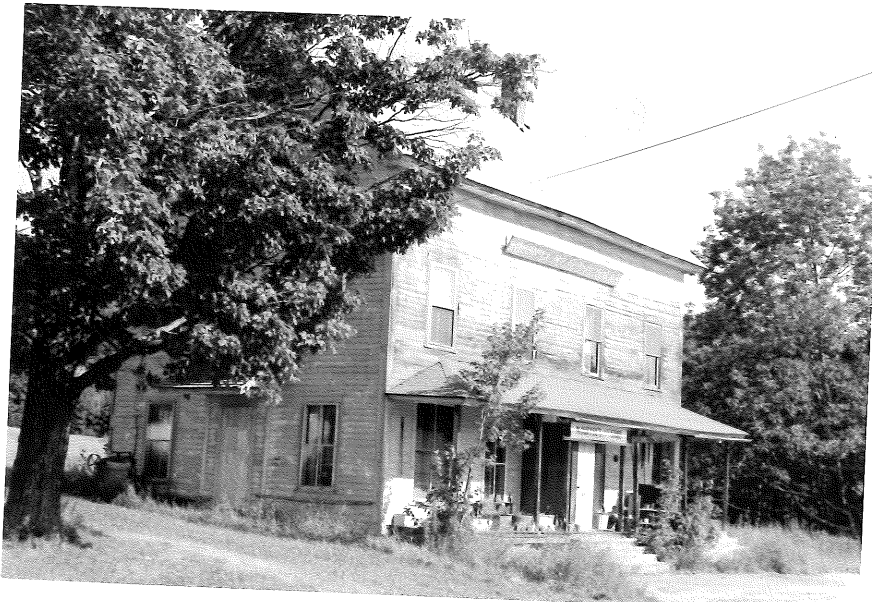
PHOTO:

1. STYLE: Vernacular (early 20th century) BUILDING TYPE: store and public hall
2. # STORIES: 2½ DIMENSIONS: 40 x 25 BAYS: 4 x 2 FORM: rectangular plan
3. FOUNDATION: fieldstone 4. STRUCTURE: balloon frame

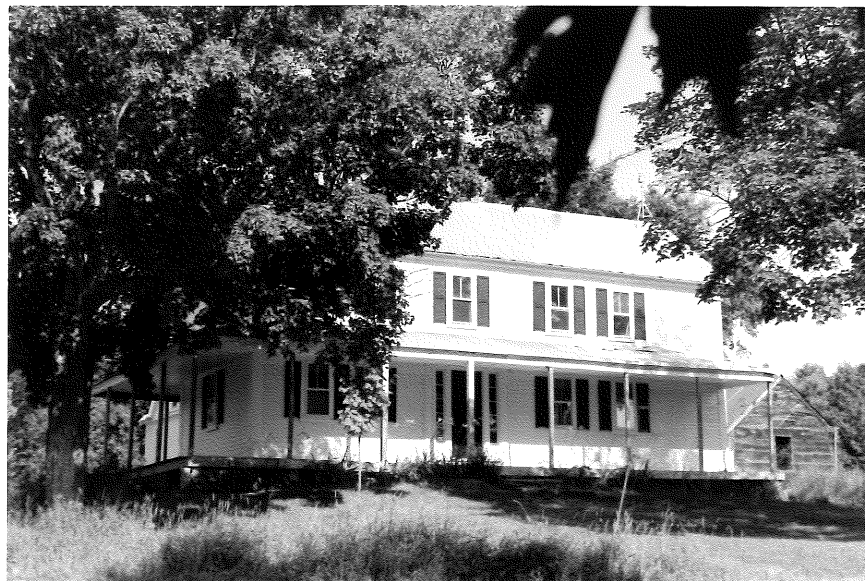
PHOTO:

1. STYLE: Vernacular BUILDING TYPE: house
2. # STORIES: 2½ DIMENSIONS: app. 50x20 BAYS: 5 x 1 FORM: house
3. FOUNDATION: cut granite blocks 4. STRUCTURE: post and beam

11. PORCHES/HOODS: # 1 Style/Roof Type veranda, hip roof
Location(s) W, N and NE sides Supports plain wooden posts
Other Features fieldstone foundation
12. BAY WINDOWS/TOWERS: # Location Stories Shape
Description

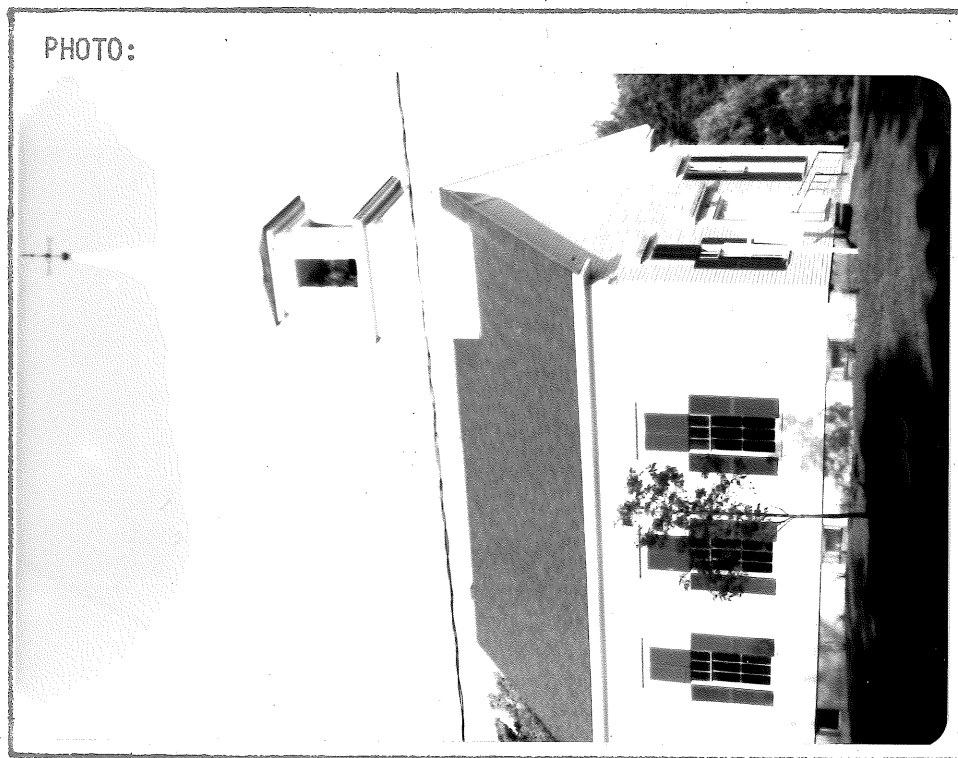
COMMENTS: Well-preserved interior woodwork, pews and lighting.

1. STYLE: late 19th century Vernacular BUILDING TYPE: church
2. # STORIES: 1 DIMENSIONS: app. 36x44 BAYS: 3 x 3 FORM: rectangular plan
3. FOUNDATION: cut granite block, concrete STRUCTURE: prob. balloon frame

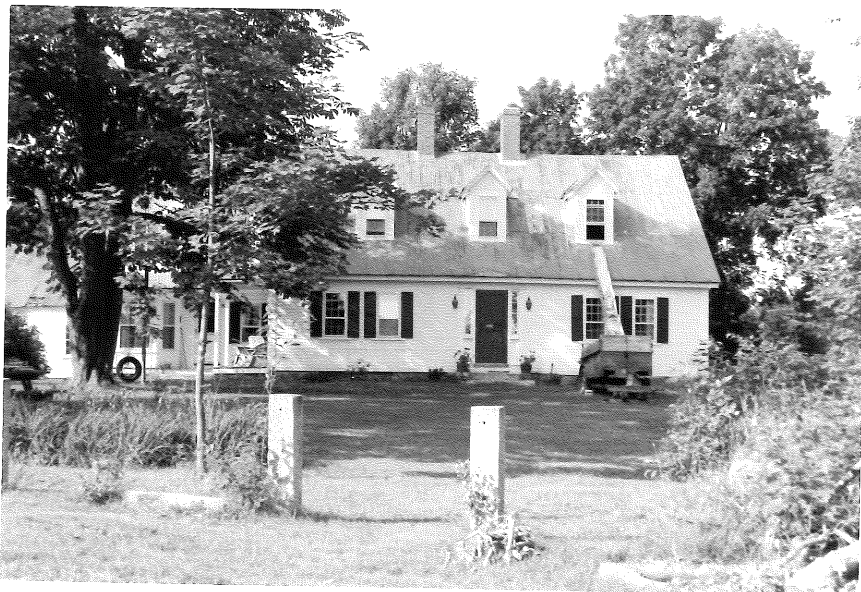
PHOTO:

1. STYLE: Vernacular BUILDING TYPE: house
2. # STORIES: 1½ DIMENSIONS: 42 x 32 BAYS: 5 x 2 FORM: cape
3. FOUNDATION: cut granite block 4. STRUCTURE: post and beam

- OTHERS: # Location Surrounds
11. PORCHES/HOODS: # 1 Style/Roof Type hip roof veranda
Location(s) E of house, S of ell Supports wooden posts
Other Features cut granite block foundation

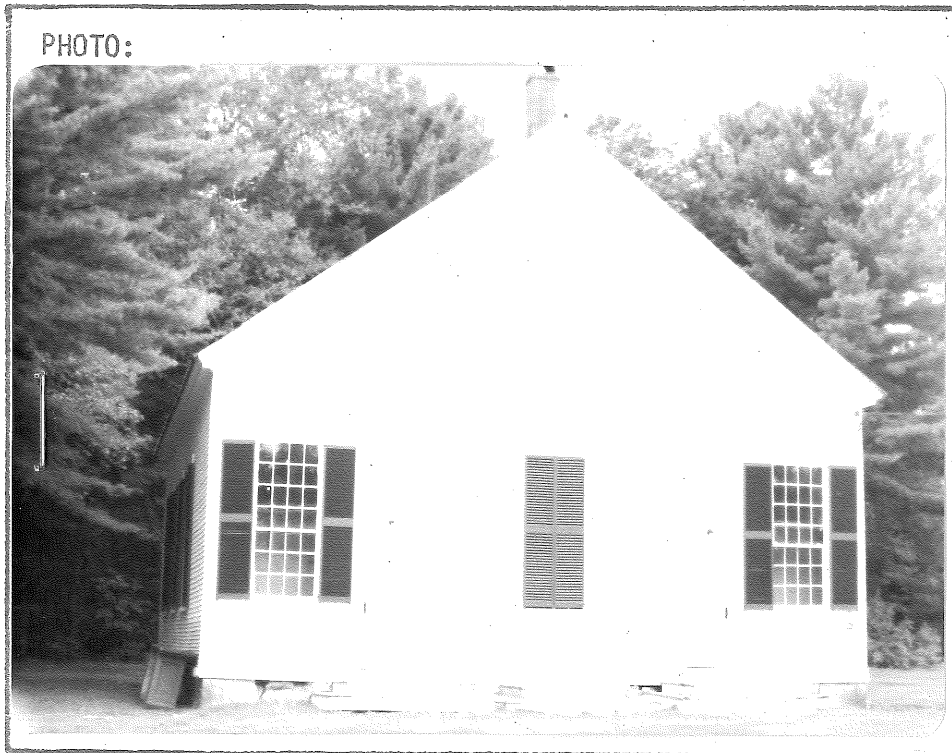
COMMENTS: Well-preserved interior woodwork and pews, coved ceiling.

- 1. STYLE: Vernacular (Greek Revival) BUILDING TYPE: church
- 2. # STORIES: 1 DIMENSIONS: app. 30x40 BAYS: 5 x 3 FORM: rectangular plan
- 3. FOUNDATION: cut granite block 4. STRUCTURE: post and beam

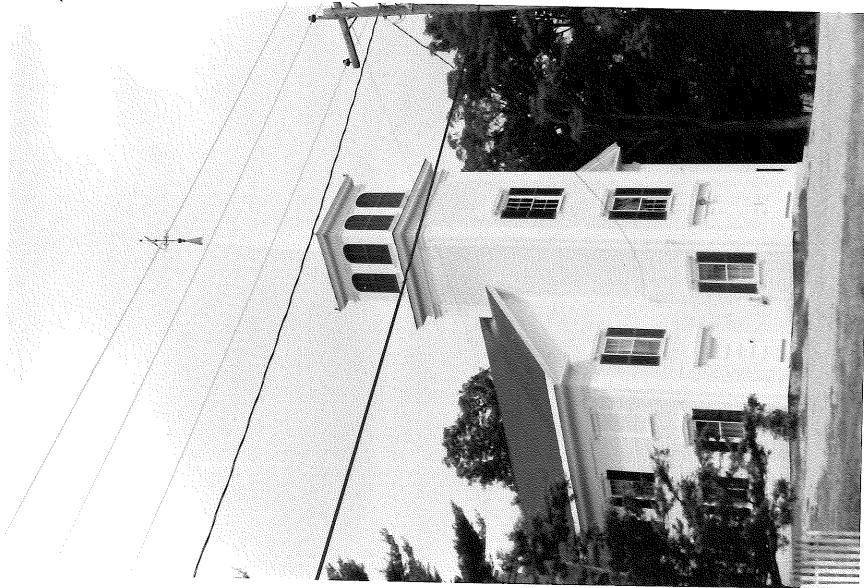
PHOTO:

1. STYLE: Victorian BUILDING TYPE: church
2. # STORIES: 2 DIMENSIONS: app. 35x45 BAYS: 3 x 5 FORM: rectangular plan
3. FOUNDATION: cut granite block 4. STRUCTURE: post and beam

13. ELLS/WINGS: # 2 Letter A 1 B 1 C on map Bays A 1x1 B 1x1 C
Description(s) A-cut stone foundation, brick walls, topped by clapboarded section, gable roof; B-concrete foundation, clapboard walls, shed roof
