**PHASE I ENVIRONMENTAL SITE ASSESSMENT**  
 Turchin Estate  
 180 East Main Street  
 Tilton, New Hampshire  
 DES#199311019

# DRAFT Phase I – Environmental Site Assessment

Turchin Estate  
180 East Main Street  
Tilton, New Hampshire  
DES Site #199311019

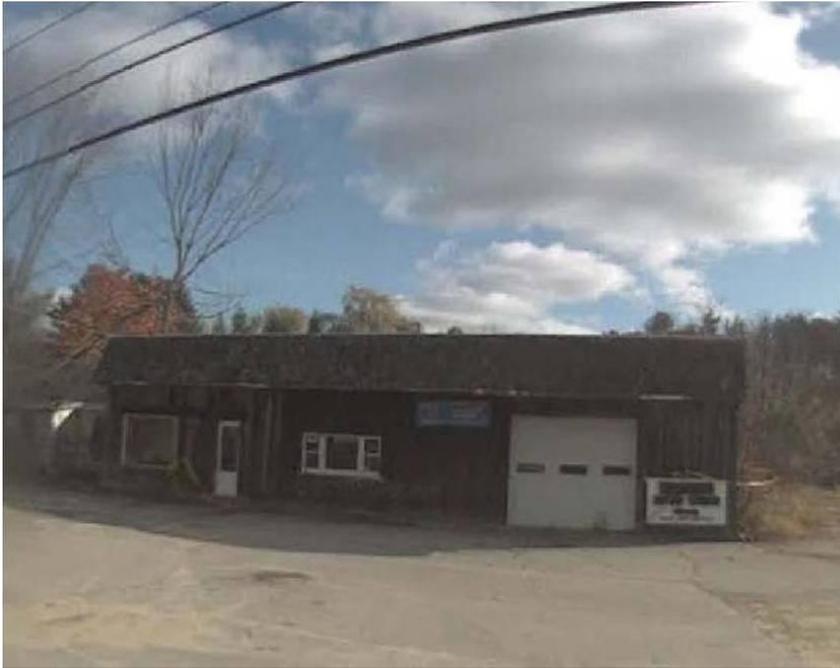
**Picture 1**  
Representative  
view of the subject  
property from East  
Main Street.

The subject property consists of an irregularly shaped parcel of land. The buildings are located in the northeast portion of the subject property (**Picture 1**). Developed areas of the subject property near the buildings are occupied by asphalt-paved parking areas on the north and west sides of the buildings, gravel parking areas on the west side of the garage (**Picture 2**), and an overgrown lawn area on the south side of the buildings (**Picture 3**). A pavement patch where the former fueling island was reported to be located was observed on the north side of the buildings (**Picture 4**). The east and southern portions of the subject property are wooded along the property lines. The surrounding properties are a mix of residential, municipal, and commercial uses.

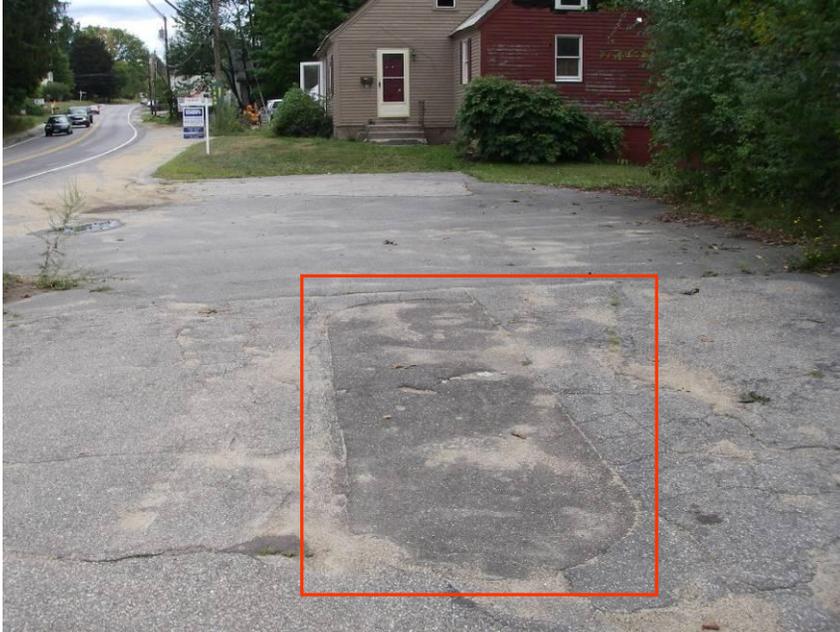
**Picture 4**  
View of pavement patch where former fueling island was located.

- REC-1 – The former use of the subject property as a gas station between 1939 and the 1970s represents a REC because past and present bulk storage and past distribution of petroleum products during this time frame may have resulted in releases of petroleum which may have impacted the environmental conditions of the subject property.

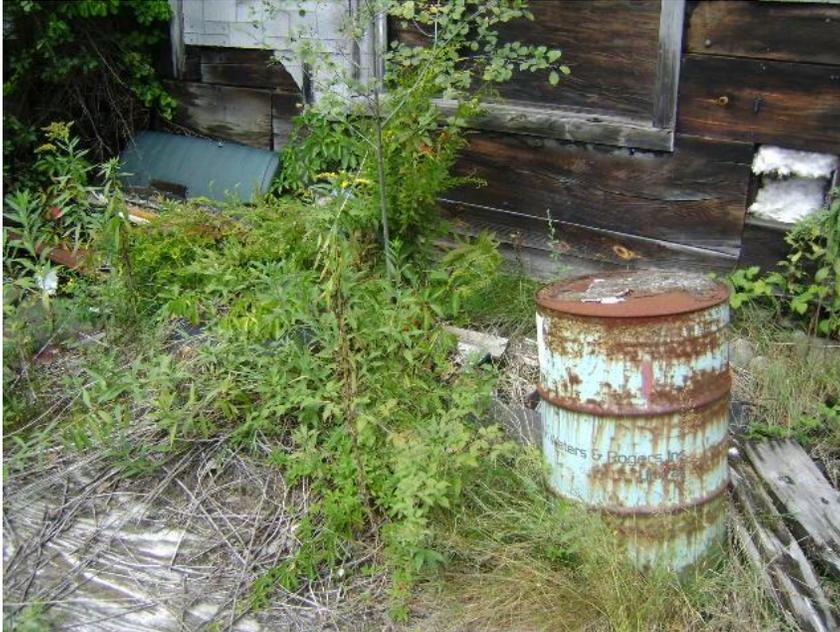
**Picture 5**  
View of the 55-gallon drum with unknown contents.

One (1) 55-gallon drum with unknown contents was observed adjacent to the southern exterior wall of the garage (**Picture 5**).

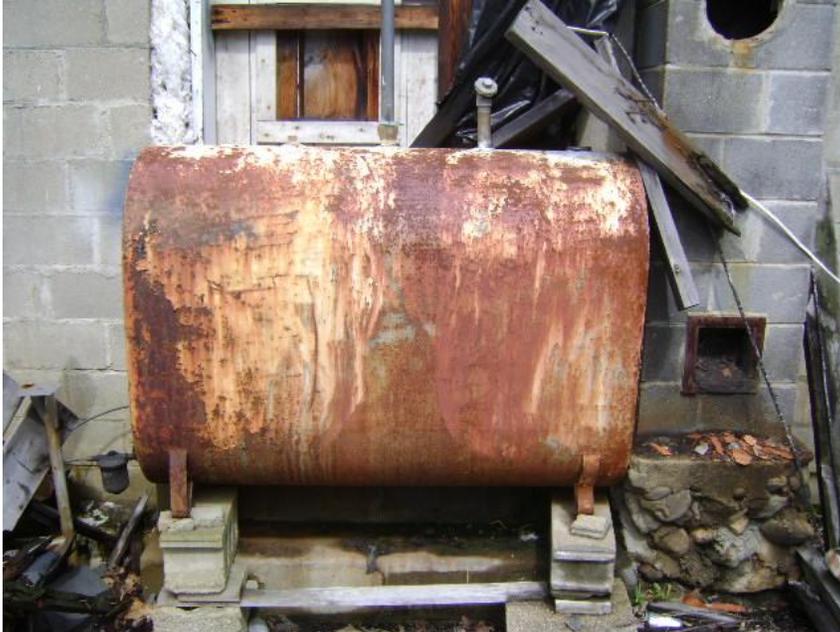
**Picture 6**  
View of the 275-gallon AST observed outside on the south side of the garage.

One (1) 275-gallon AST was observed adjacent to the southern exterior wall of the garage (**Picture 6**). The tank was corroded on the outside. There was no surficial visual evidence of a release on the AST. The concrete base below the tank was discolored, possibly indicative of a previous release of petroleum; however, the observed potential staining may have been the result of the previous day's rain event.

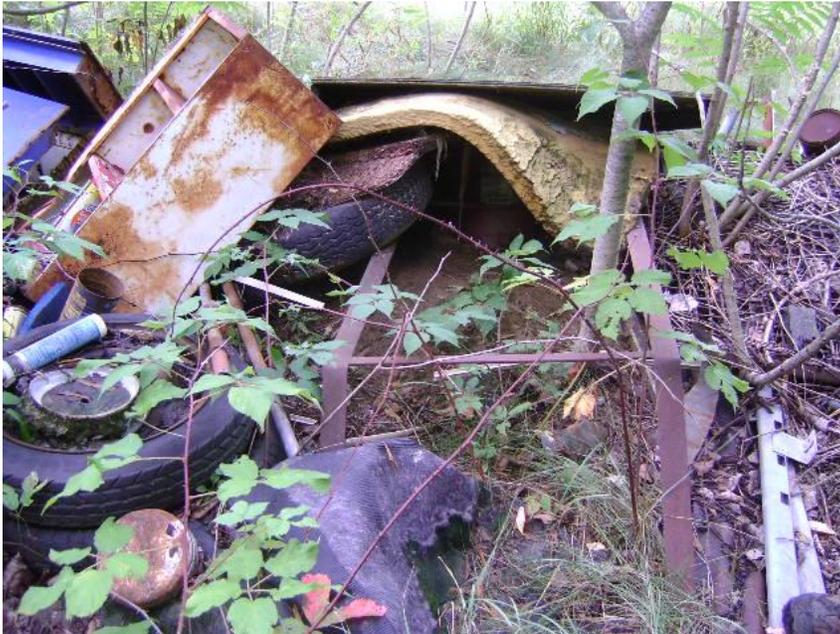
**Picture 7**  
Representative view of a debris pile located on the east side of the subject property.

Several debris piles were observed throughout the subject property. A surficial visual inspection of these piles identified scrap metal, discarded automobile parts, plastic, tires, scrap wood, and general household refuse (**Picture 7**). One (1) discarded automobile gas tank was observed in the debris pile located outside of the southwestern corner of the garage (**Picture 8**). One (1) discarded pickup truck bed (**Picture 9**) and one (1) pile of approximately 15 wooden utility pole sections (**Picture 10**) were observed in the wooded southeastern portion of the subject property.

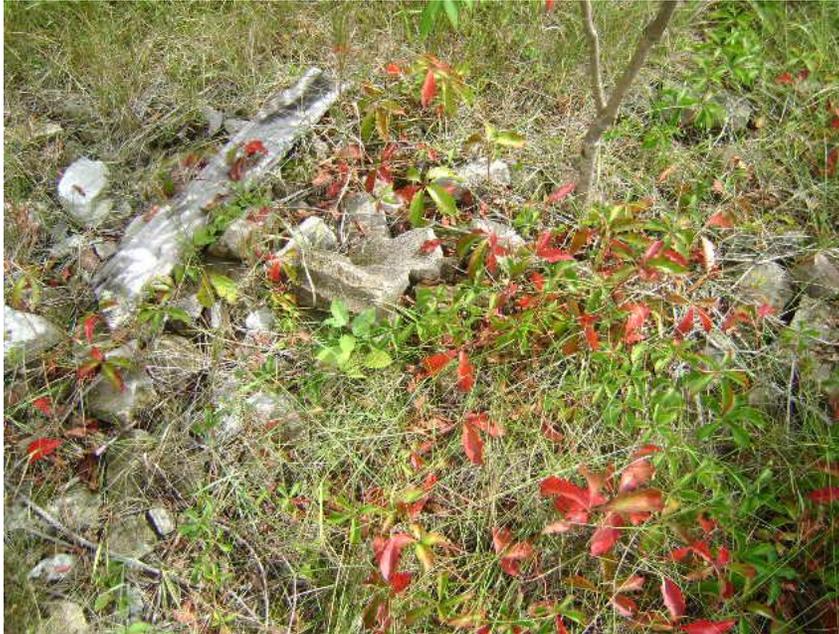
### Picture 11

- REC-5 – A suspected dump and fill area was observed along the southern portion of the subject property including items such as, but not limited to, urban fill, automobile parts, and utility pole sections. Petroleum products and/or hazardous substances associated with these materials may have been released and impacted the environmental conditions at the subject property.

The southern portion of the subject property was observed from the surface to have been filled with material containing gravel, brick, cinder block, pavement, and concrete (**Picture 11**). A mound in the southeast corner of the subject property appears to consist of similar fill material and waste asphalt (**Picture 12**).

Representative view showing fill material used on the subject property.

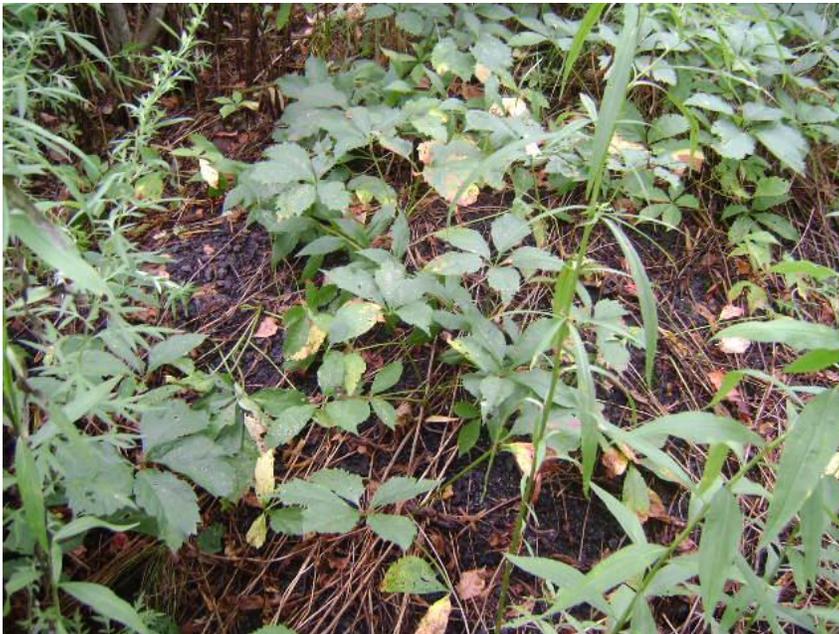
### Picture 12

Representative view of the mound of discarded asphalt located in the southeastern corner of the subject property.

(Note the black asphalt through the vegetation.)

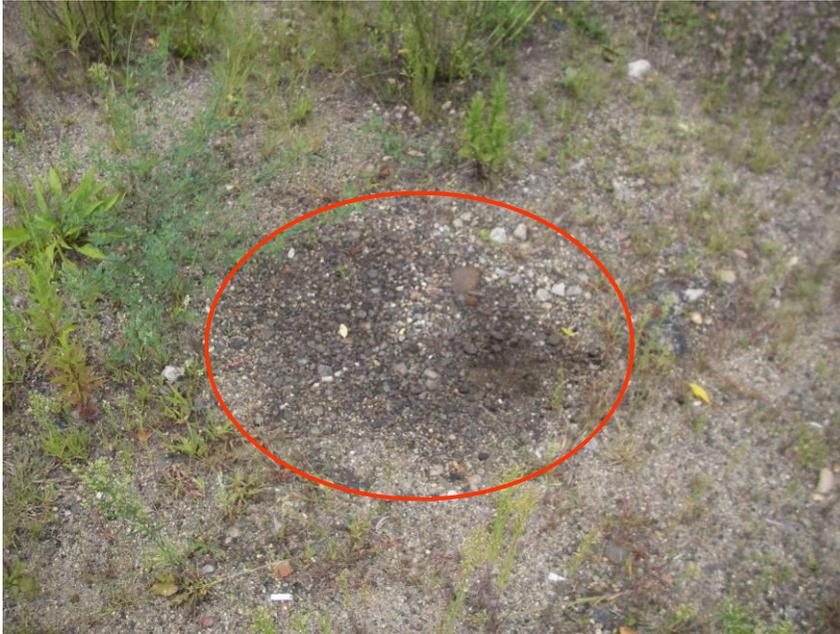
**Picture 13**  
Representative view showing one of the multiple stained gravel areas on the subject property.

Several small stains were observed on the gravel parking area on the west side of the subject property (**Picture 13**). Though additional investigation would be required to define the extent of the identified stained areas, based on observed conditions it is likely that these stains are associated with oil and gas dripping from automobiles that were parked on the subject property and not the result of a sudden release of oil and/or hazardous materials.

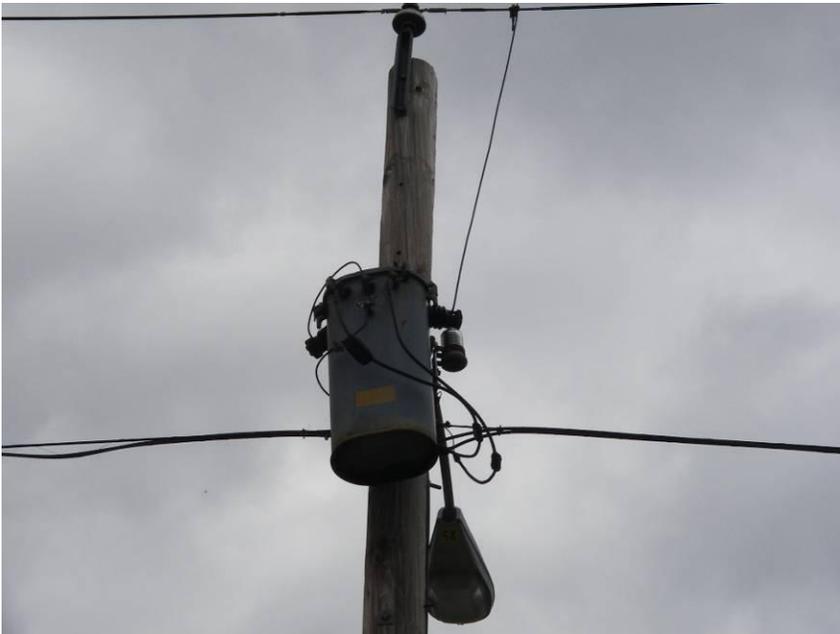
**Picture 14**  
View of the pole mounted electrical transformer observed on the subject property.

- REC-6 – Stressed vegetation was observed below a pole mounted electrical transformer located along the northern subject property boundary. This condition represents a REC because it could be indicative of a release of petroleum-based and/or polychlorinated biphenyl (PCB)-containing dielectric fluid that may have impacted the environmental conditions of the subject property.

One (1) electrical transformer was observed mounted on the utility pole located in the northwest portion of the subject property (**Picture 14**). Stressed vegetation was observed below the transformer. No labeling indicating the polychlorinated biphenyl (PCB) concentration, if any, of dielectric fluid contained within this transformer was observed.

- Phase II investigation activities are recommended to confirm or dismiss the above RECs and/or other documented bulk storage or releases of petroleum products and/or hazardous substances that may have impacted the environmental conditions at the subject property.
- An asbestos, lead-based paint, and PCB-containing hazardous building materials survey should be completed to confirm or dismiss the presence of hazardous building materials within the buildings.
- A universal and hazardous waste survey should be completed to inventory universal and hazardous waste which may be present at the subject property.
- If the buildings will be re-used, a mold survey should be completed to identify the presence of hazardous molds within the subject property buildings.

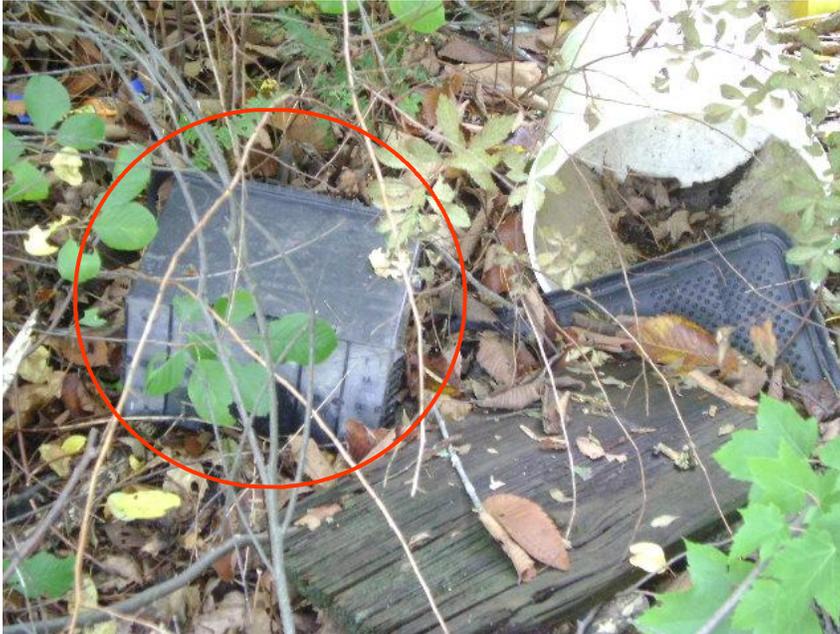
**Picture 15**  
View of the discarded car battery observed in a debris pile on the north side of the subject property.

One (1) discarded car battery was observed on the ground on the north side of the cottage (**Picture 15**).

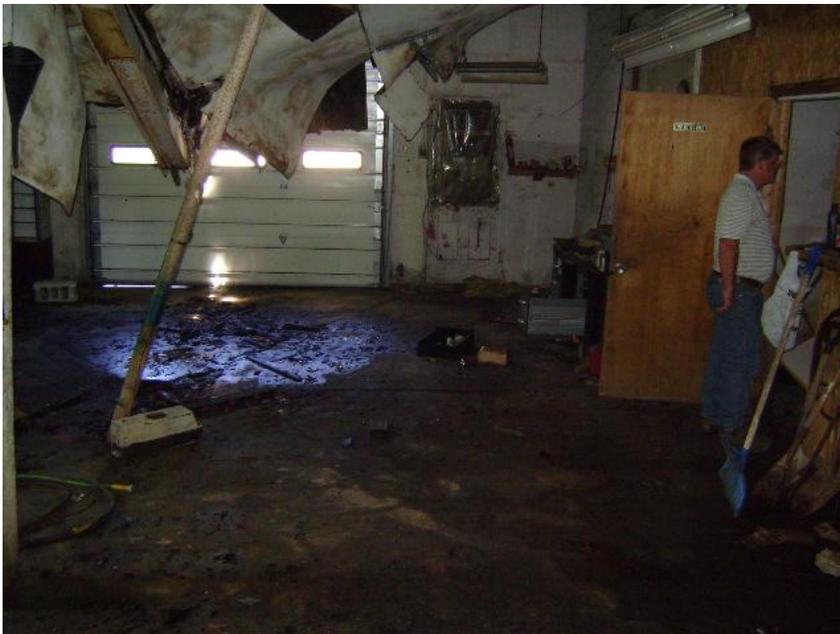
**Picture 16**  
Representative view of the garage bay and collapsed roof and ceiling.

The garage bay consists of a concrete slab floor, painted and unpainted wooden panel and concrete block walls, and a sheetrock ceiling. The ceiling in the garage bay has collapsed (**Picture 16**). A floor drain was observed in the garage bay (**Picture 17**). Though additional investigation is needed to determine the outfall of this floor drain, it is likely that it is connected to the municipal sewer system. Water leaking onto the floor from the collapsed roof prevented identification of staining around the floor drain. However, staining was observed on the floor in other areas of the garage bay (**Picture 18**). Multiple small volume automotive fluid containers were also observed in the garage bay (**Pictures 19 and 20**). No evidence of the use of hydraulic equipment was identified during the site visit. However, tax records indicate that a hydraulic lift was present in the garage in 1978 (see **Sections 6.1 and 12**).

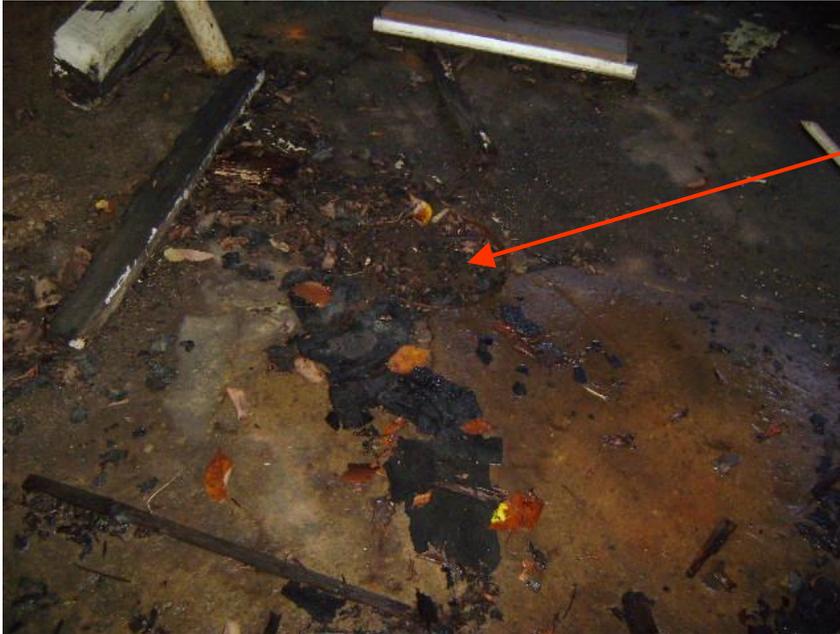
**Picture 17**  
View of the floor  
drain in the garage  
bay.

- REC-4 – At least one floor drain was observed within the garage bay with an unknown discharge point. This condition represents a REC because the drain is a potential conduit to the environment whereby releases of petroleum products and hazardous substances from former activities may have impacted the environmental conditions at the subject property.

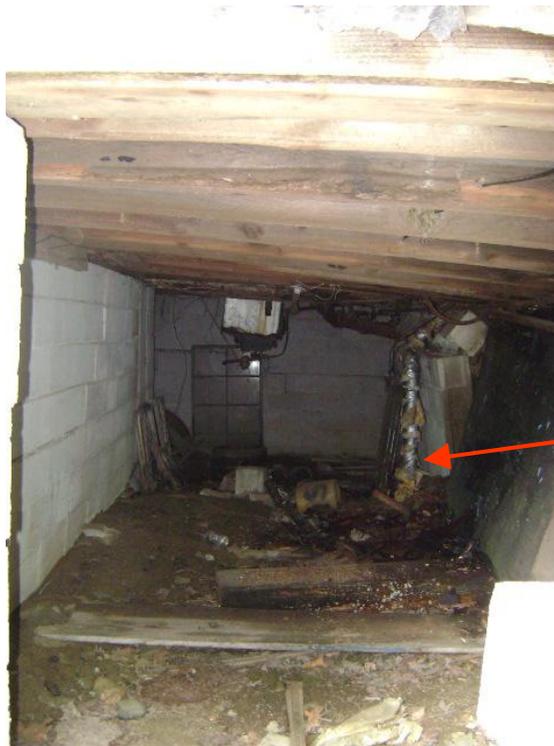
**Picture 26**  
Representative view of the crawlspace below the garage building.

The dirt floor crawl space basement is located under the eastern side of the garage building. An insulated pipe was observed going into the ground from the eastern side wall of the crawlspace (**Picture 26**). Though additional investigation is required to determine the nature of this pipe, it is unlikely that it is associated with the bulk storage or release of oil and/or hazardous materials. This feature may potentially be a sewer pipe coming from the cottage located adjacent to the garage building.

(Note the insulated pipe on the right side.)

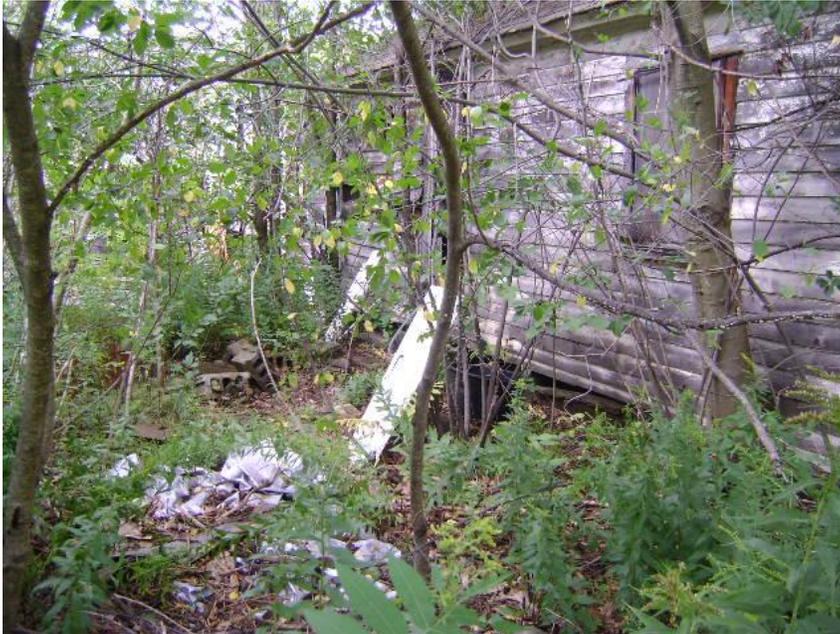
**Picture 27**  
Representative view of the south side of the cottage.

The exterior of the cottage consists of an asphalt shingle roof, painted and unpainted wood siding, and a concrete slab foundation (**Picture 27**). The interior consists of two rooms and a bathroom. The entire cottage is in poor structural condition with a significant amount of refuse spread about the floor. The bathroom contained wood flooring and wood walls (**Picture 28**). The two additional rooms contained wood flooring and wood panel walls. Approximately 20 fluorescent light ballasts were observed in the cottage (**Picture 29**). Approximately five (5) five-gallon containers of unknown contents were observed in the cottage (**Picture 30**). Staining on the floor of the cottage was observed near the entrance (**Picture 31**). One (1) gas canister of unknown contents was observed near the entrance of the cottage (**Picture 32**).

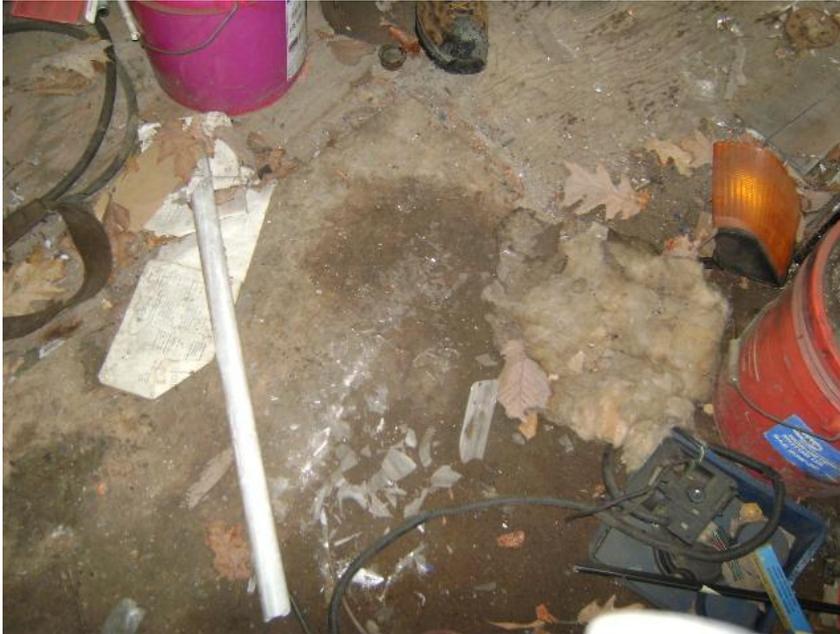
**Picture 31**  
Representative view of the stains observed on the floor of the cottage.

- DMEC-1 – Oil staining observed on the floor of the cottage represents a DMEC because it is evidence of a release; however, a pathway to the environment is not likely.
