**PHASE II ENVIRONMENTAL SITE ASSESSMENT  
REPORT**

Former Mica Factory Property  
8 (a.k.a. 5) Central Street  
Bristol, New Hampshire  
DES#200105002  
Brownfields Grant #BF-96111801

**Subject: Phase II Environmental Site Assessment  
Former Mica Factory Property  
8 (a.k.a. 5) Central Street, Bristol, NH  
NHDES Site # 200105002**

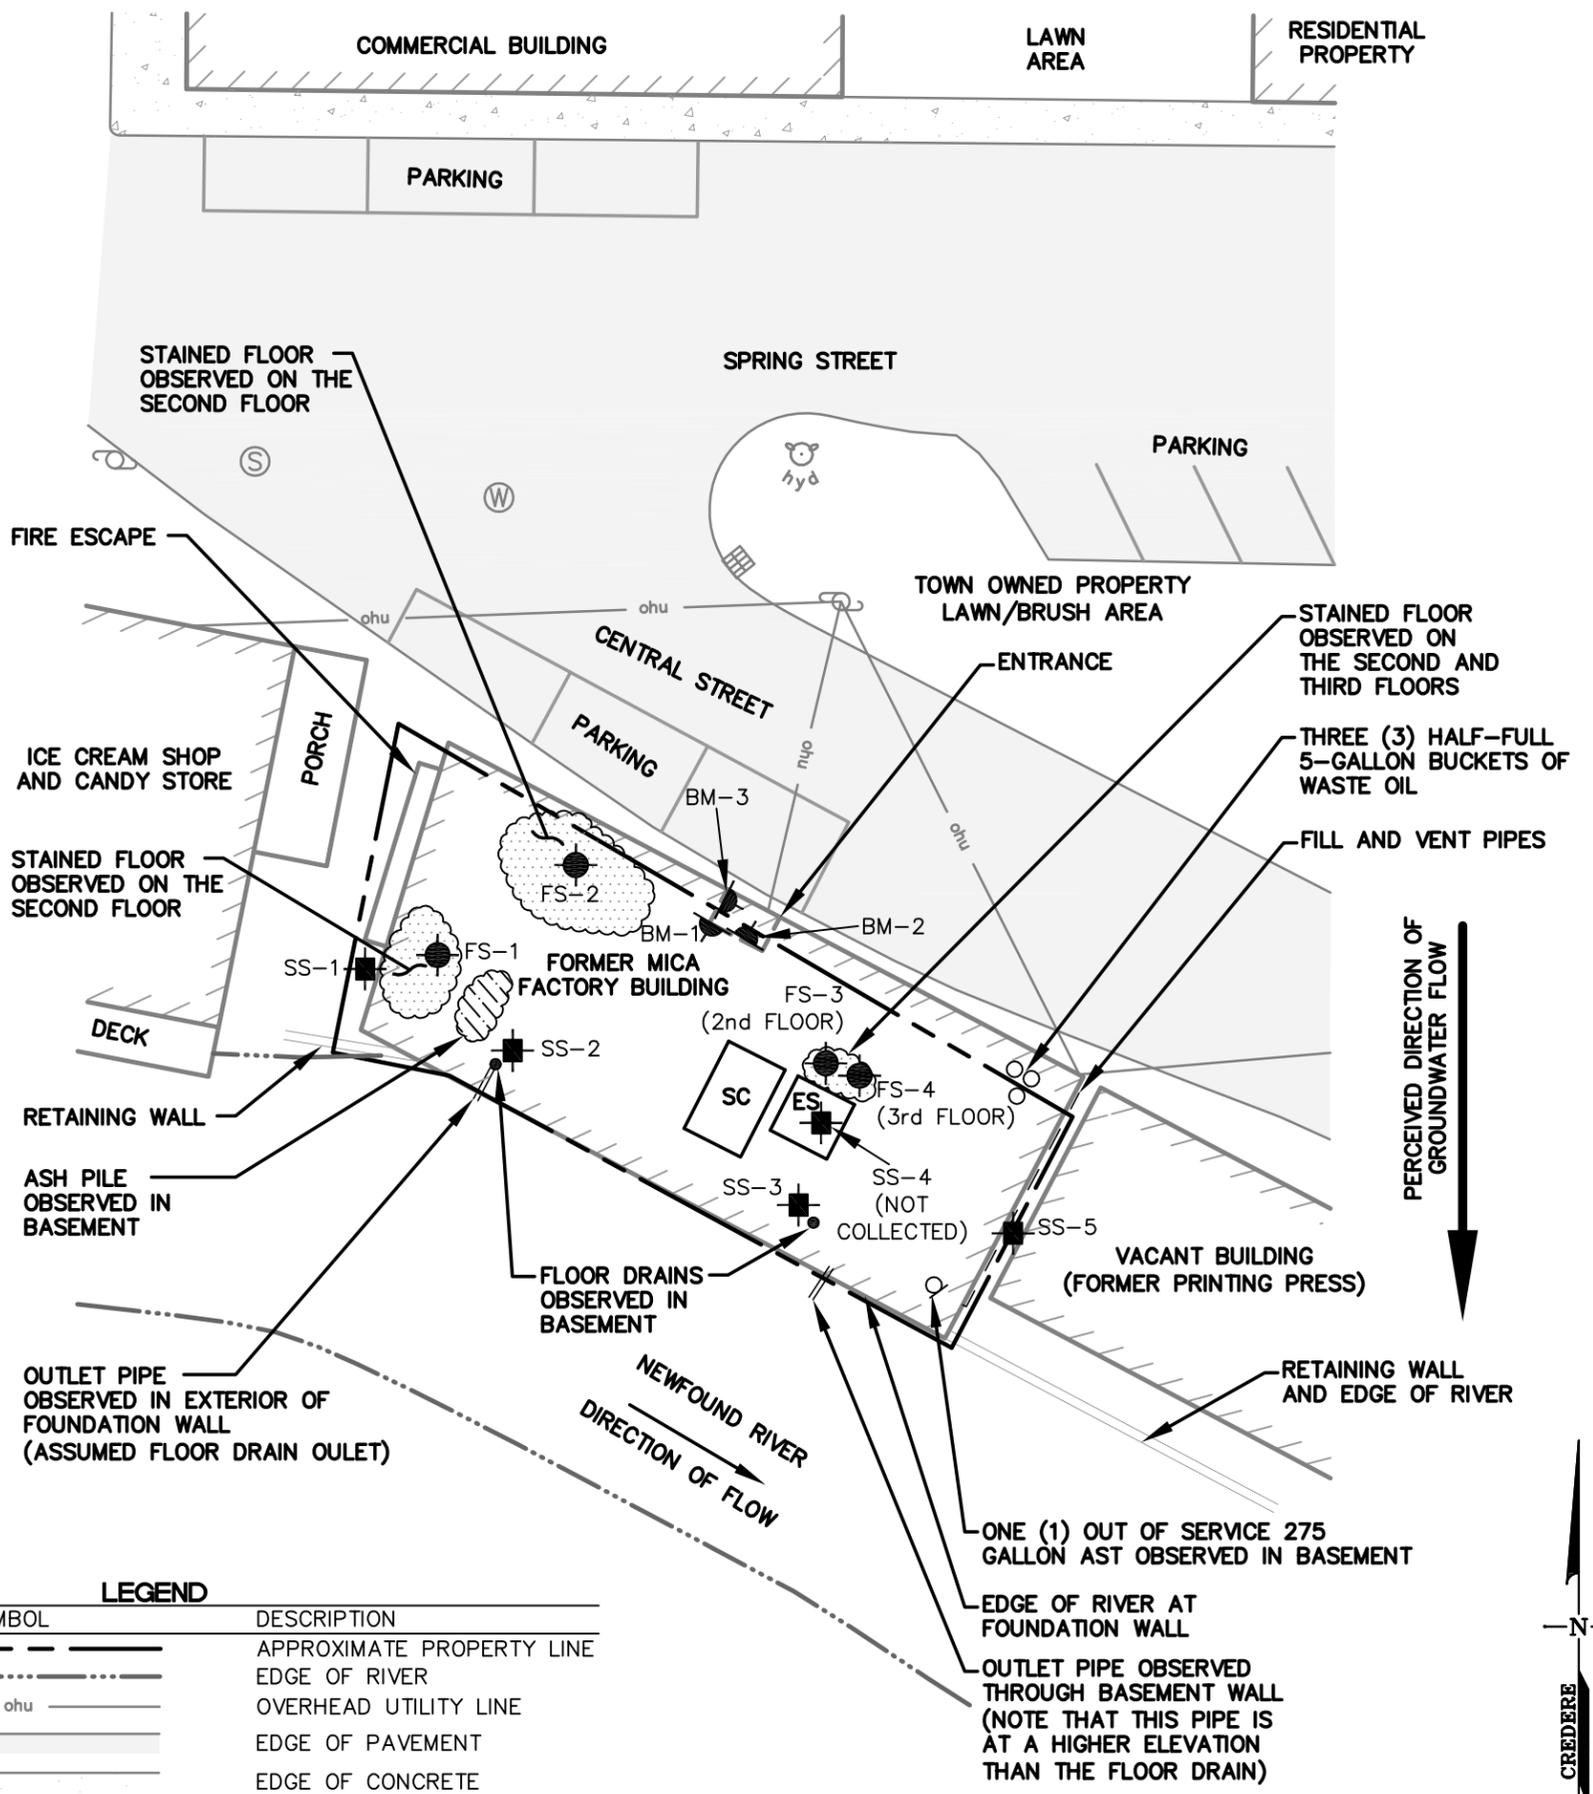
This sampling program was developed to investigate soil and building material conditions at the subject property to confirm or dismiss the RECs and NECs identified during the Phase I ESA (see SSQAPP Addendum in **Appendix A**). All laboratory analytical samples collected by Credere were submitted to Absolute Resource Associates of Portsmouth, New Hampshire for analysis. Requirements relative to Chain of Custody, Data Management and Documentation, Data Validation, and Data Usability Assessments contained in the SSQAPP were followed. **Figure 2** shows the approximate locations of the building, pertinent subject property features, and sample locations.

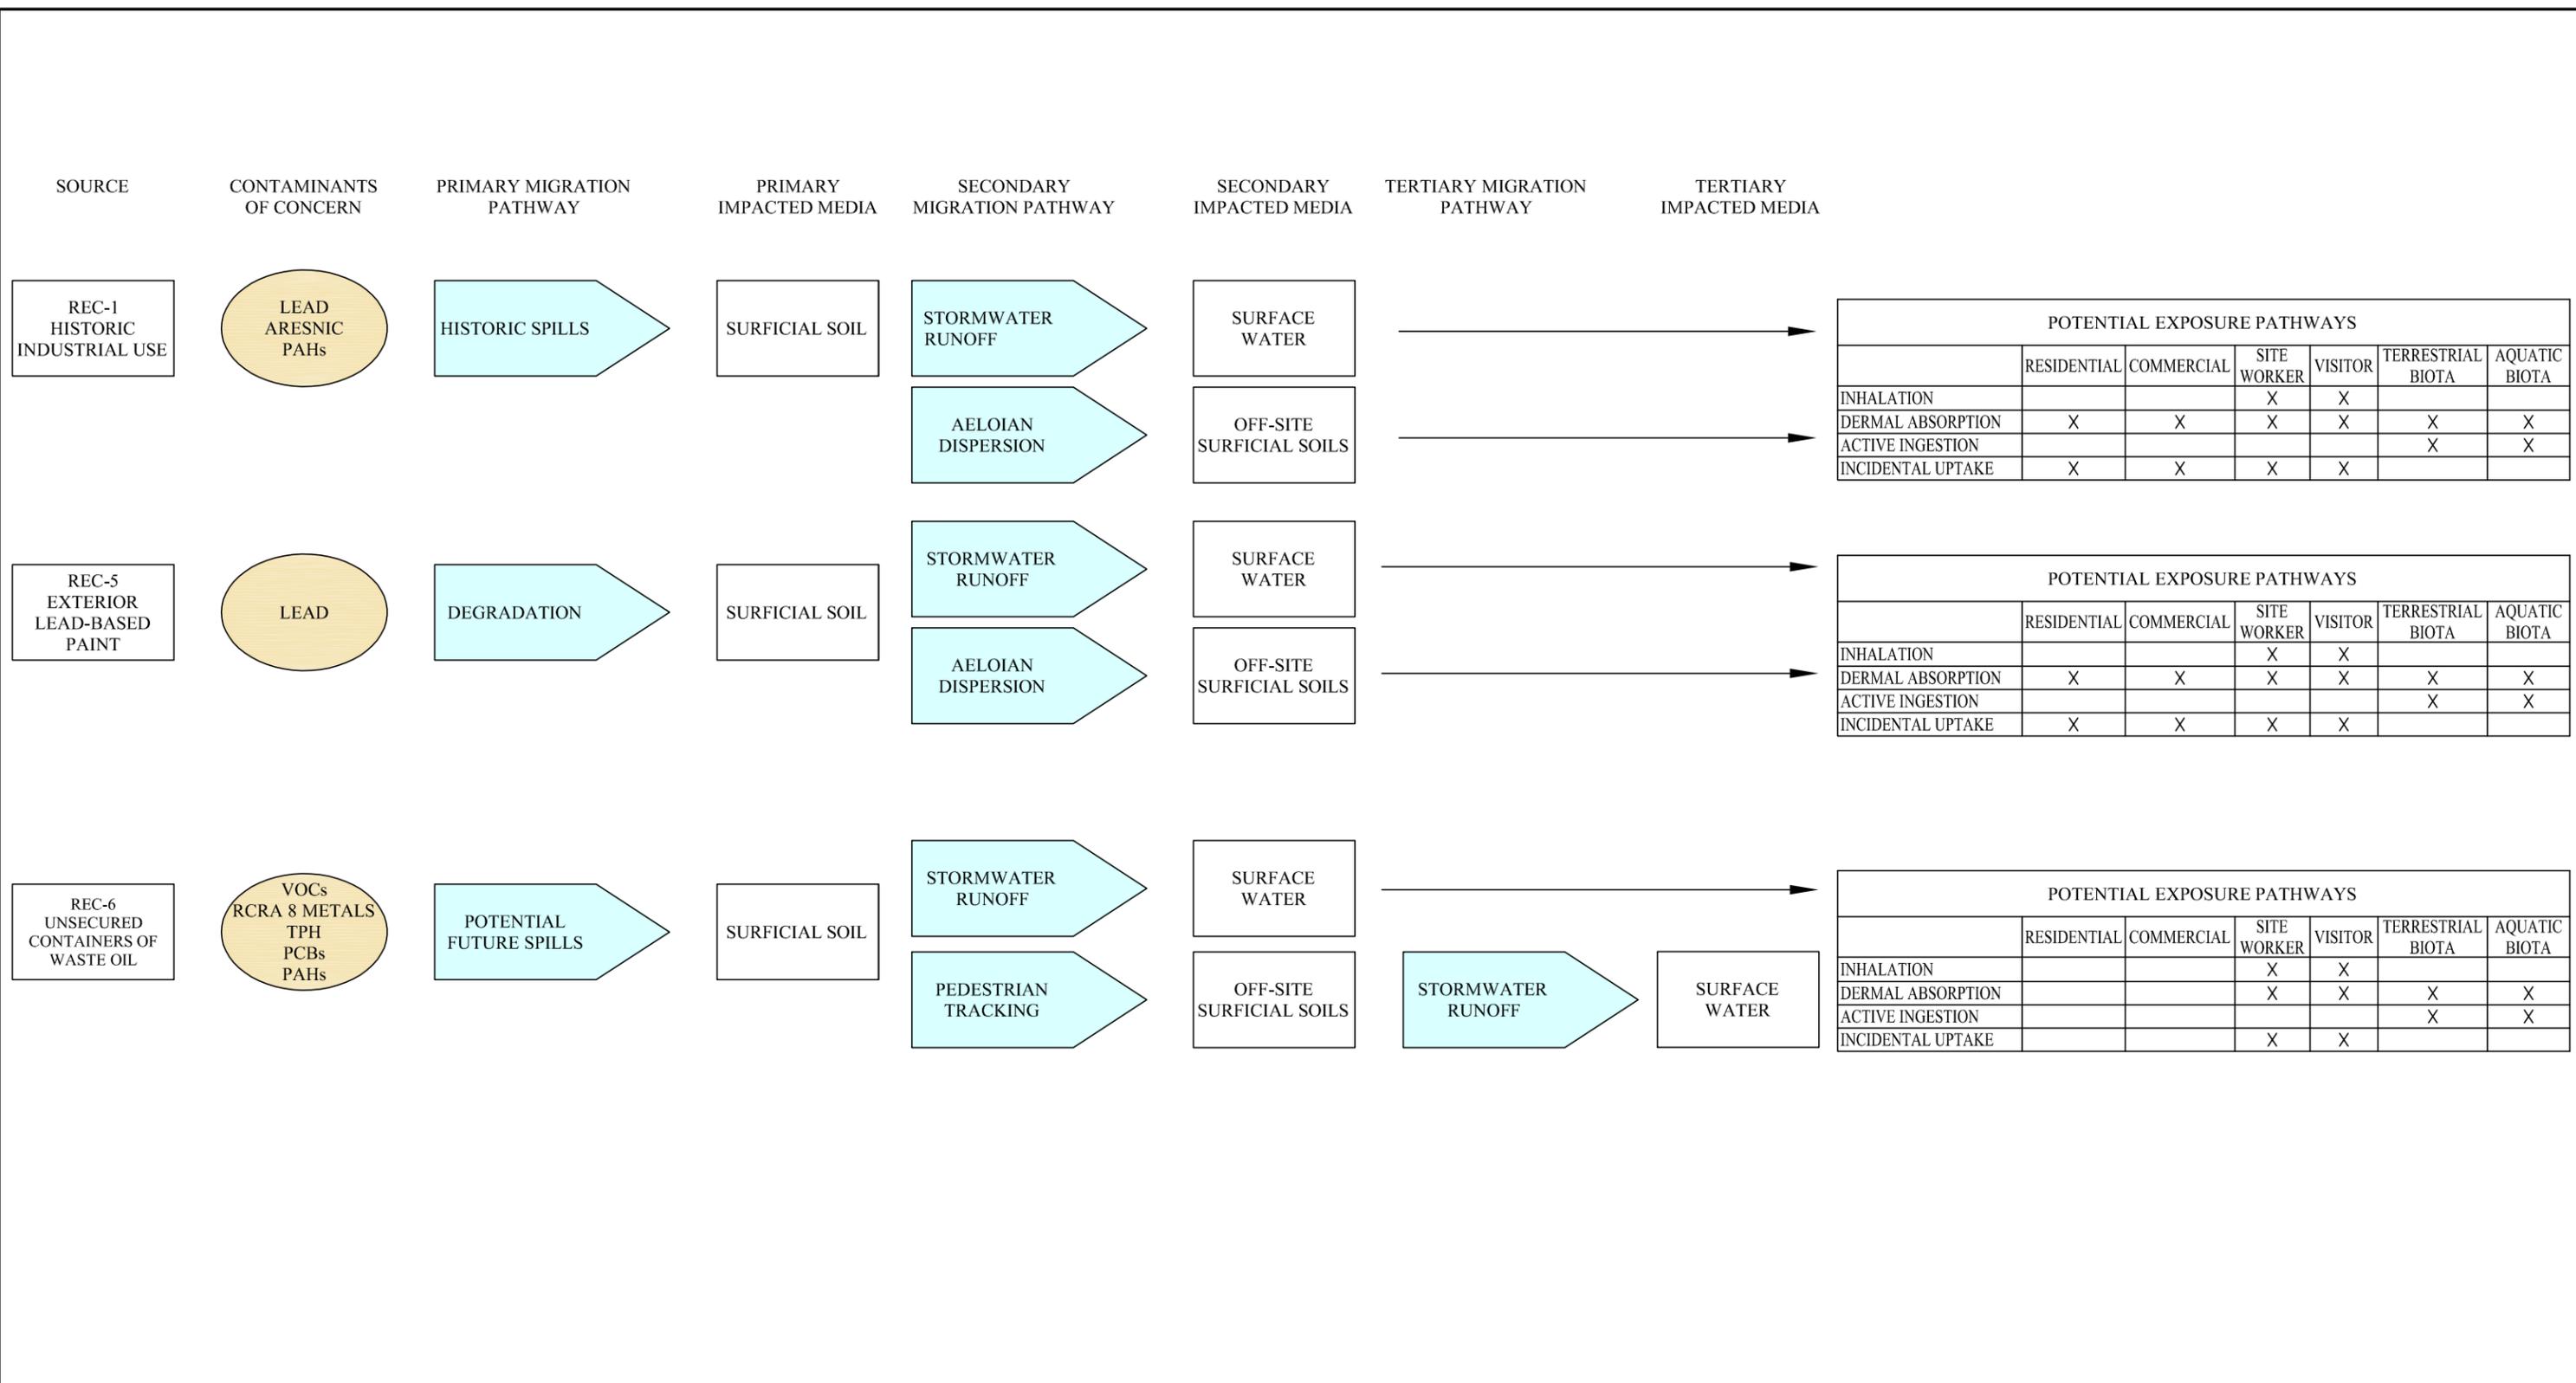
**FIGURE 4**  
**CONCEPTUAL SITE MODEL**  
**(SHEET 1 OF 2)**

Based on known subject property history, PAHs and arsenic have the potential to have been released to the environment through surficial releases associated with previous subject property usage, , or have the potential to be consistent with background conditions. Lead has the potential to have been released to the environment through surficial releases associated with subject property usage, degraded paint, and deposition of coal, coal ash, or wood ash. Primary impacted media includes surficial soil. PAHs, arsenic, and lead in surficial soils have the potential to migrate through Aeolian dispersion or groundwater flow and impact both on-site and off-site receptors. No evidence of the migration of PAHs, arsenic, and/or lead to groundwater was identified during these Phase II ESA activities. PAHs, lead, and arsenic have the potential to impact site worker, visitor, and terrestrial biota receptors on-site; and residential, commercial, and aquatic biota off-site.

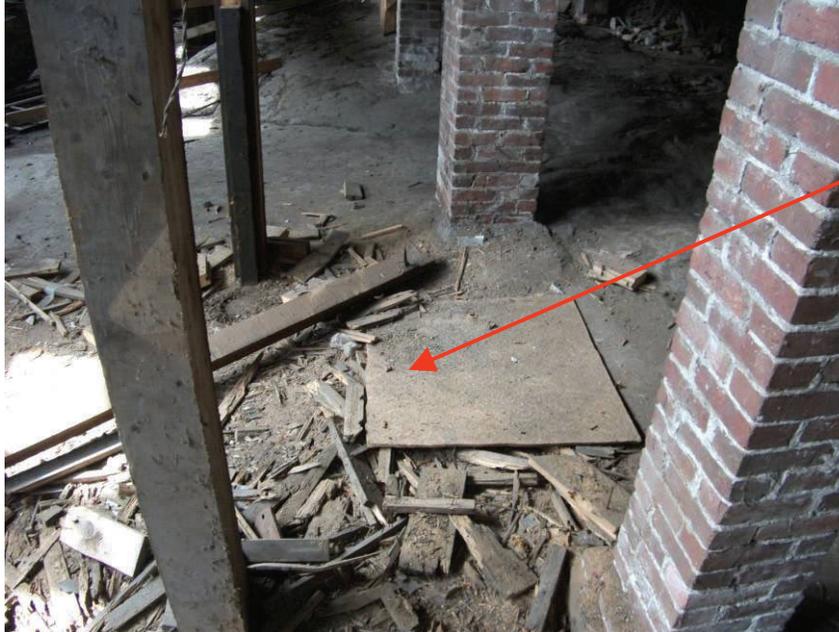
**Picture 2**  
View of the base of the elevator shaft.

- REC-4 – The presence of an elevator in the building represents a REC. Though the mechanical components have been removed, lubrication and hydraulic fluids may have previously been released from the elevator and may have impacted the environmental conditions of the subject property.

- REC-4, which was associated with the former elevator in the subject property building, was dismissed because laboratory analysis indicated that PCB and total petroleum hydrocarbon (TPH) concentrations were not detected above the laboratory practical quantitation limit (PQL) in surficial soil sample SS-3. It should be noted that surficial soil sample SS-4 was not collected due to the lack of soil material on top of the bedrock/concrete basement floor. The laboratory analysis originally proposed for sample

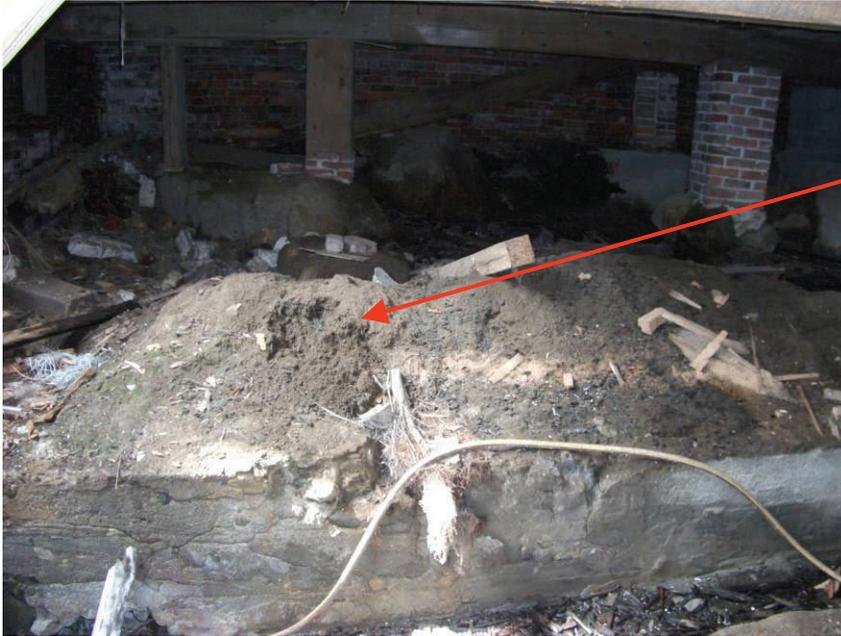
**Picture 3**

A pile of ash was observed on the east side of the basement (**Photograph 3**). It is likely that this ash pile was used to stockpile ash removed from the former coal stove that was used to heat the building. Based on Credere's experience, concentrations of various PAHs in ash piles typically exceed the applicable NHDES SRS.

View of the ash pile  
in the basement of  
the building.

- The ash pile observed in the basement during Phase II ESA activities represents a potential source of PAHs and may represent a health risk to subject property workers and users.

- Contaminated soil and ash was identified at the subject property. Although the detected concentrations of PAHs, lead, and arsenic may be the result of background or other conditions that would not be regulated by the NHDES, they do exceed the applicable SRSs and represent a potential health risk. As such, Credere recommends that a remedial action plan be implemented to address this impacted media. Additional assessment of off-site soils in the vicinity of the subject property is also recommended to determine if the arsenic concentrations are consistent with background conditions, or are a result of subject property activities.

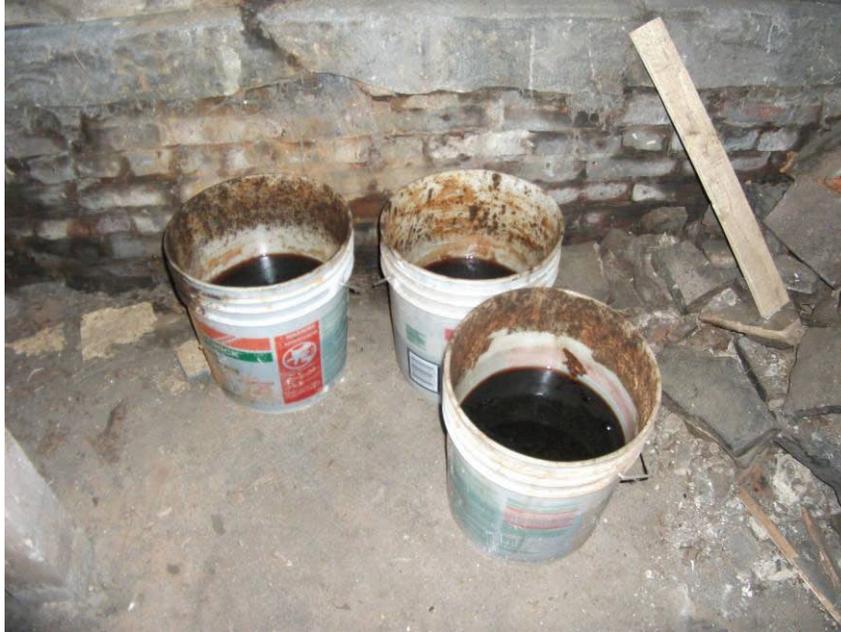
**Picture 4**

- REC-6 – Although no evidence of a prior release was observed, the presence of uncovered and unsecured small containers of petroleum products (several 5-gallon buckets of waste oil) in the basement represents a REC due to the imminent threat of release from these containers.
- REC-7 – The presence of unknown staining on the floors of the building represents a REC because the stains are indicative of a potential past release of petroleum products and/or hazardous substances which may have impacted the building structure; however, it is unlikely that releases causing these stains have impacted the environmental conditions of the subject property.

View of the  
unsecured buckets  
of waste oil in the  
basement.

- REC-6, which was associated with the imminent threat of release from the unsecured 5-gallon buckets of waste oil in the basement, was not addressed with sampling because there was no evidence of a past release from the containers. However, Credere recommends the above-mentioned material be consolidated and removed from the building.
