**PHASE I ENVIRONMENTAL SITE ASSESSMENT
FORMER POLYCLAD LAMINATES PROPERTY
Volume 1 of 2
Map 116, Lot 171
45 Tannery Street
Franklin, New Hampshire 03235**

NHDES Site No. 199902062 / Project No. 25885

**NHDES Brownfields State Response Program Grant
No. RP96128501**

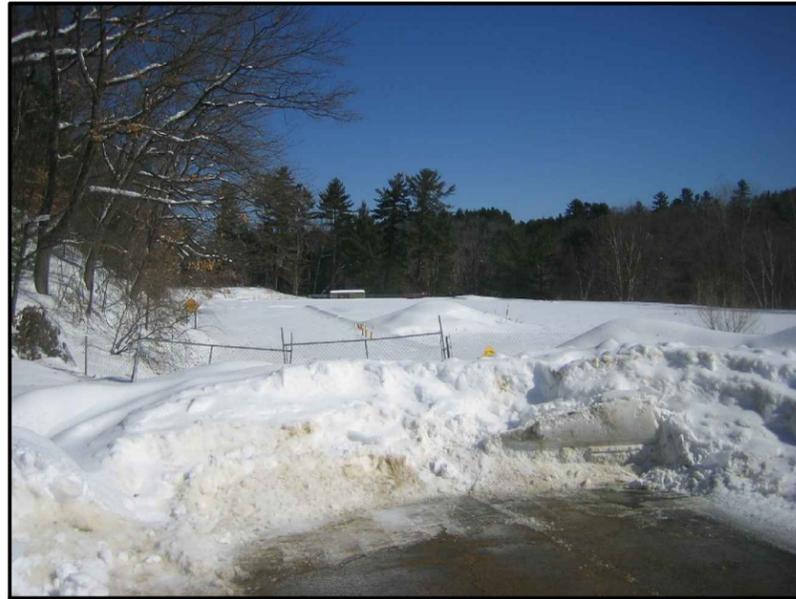
SUBJECT PROPERTY LOOKING NORTHEAST. A SMALL PILE OF CONSTRUCTION DEBRIS IS VISIBLE IN THE CENTER OF THE PHOTOGRAPH.

Empty drums were previously stored on wood pallets in an earthen-floored shed on the northern side of the property. A pile of unknown debris was observed on the southwestern portion of the concrete slab for the former building and appeared to contain large pieces of concrete.

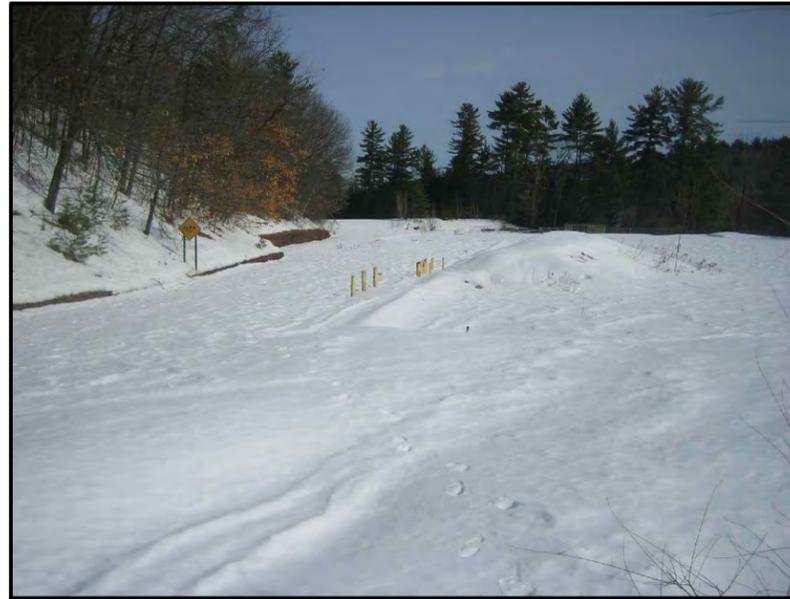
SUBJECT PROPERTY LOOKING NORTH. A PORTION OF THE ABUTTING UNDEVELOPED PROPERTY TO THE WEST, 75-FOOT RIGHT-OF-WAY (ROW) EASEMENT, AND A PORTION OF THE FORMER BUILDING LOCATION ARE VISIBLE.

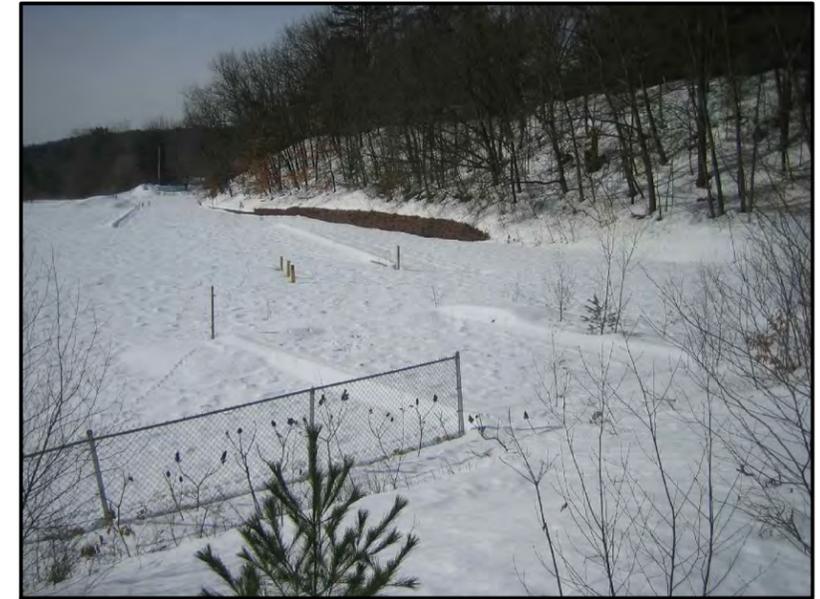
SUBJECT PROPERTY LOOKING SOUTH/SOUTHWEST. FORMER DRUM STORAGE LOCATION, ABUTTING UNDEVELOPED PROPERTY TO THE WEST, 75-FOOT ROW, AND A PORTION OF THE FORMER BUILDING LOCATION ARE VISIBLE.

- Empty drums were observed to be stored on wood pallets in a shed on the north side of the subject property. The shed was observed to have a dirt floor. The potential for residual material in the drums to spill onto the ground surface was considered a REC.

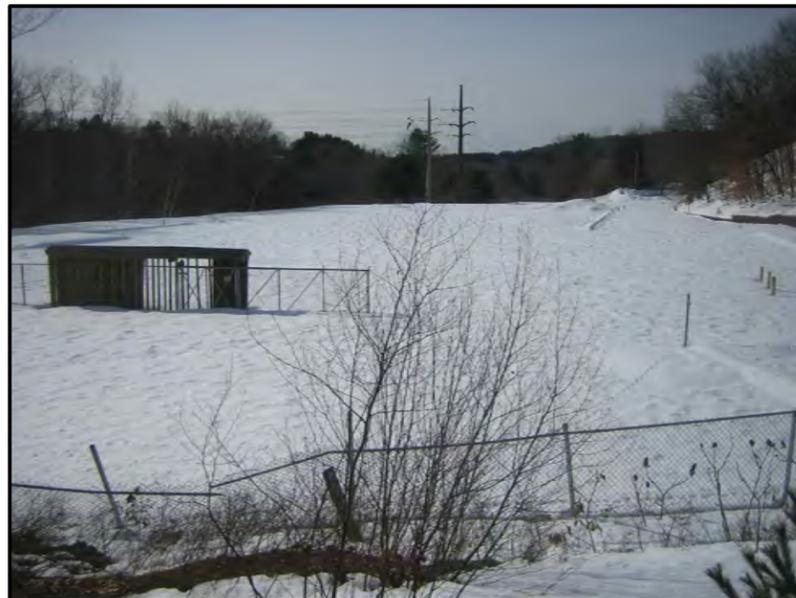
SUBJECT PROPERTY LOOKING SOUTH/SOUTHWEST. FORMER BUILDING LOCATION VISIBLE.

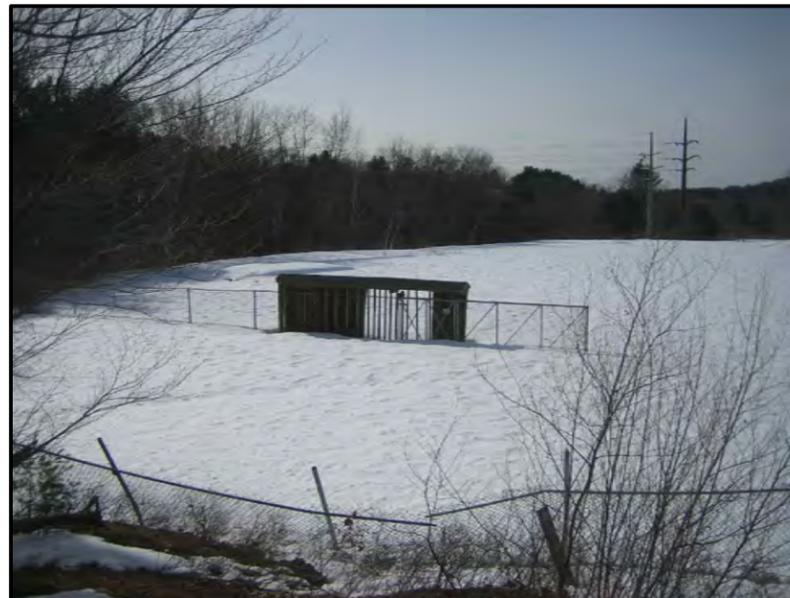
SUBJECT PROPERTY LOOKING SOUTH. ABUTTING UNDEVELOPED, WOODED PROPERTY AND THE FORMER BUILDING LOCATION ARE VISIBLE.

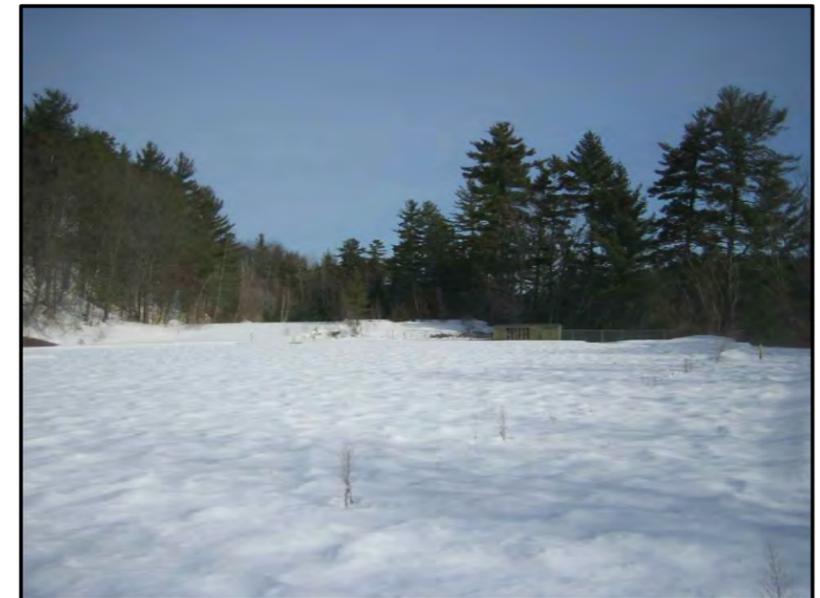
SUBJECT PROPERTY LOOKING NORTH. A PORTION OF THE FORMER BUILDING LOCATION, FORMER DRUM STORAGE LOCATION, AND THE ABUTTING UNDEVELOPED PROPERTY TO THE NORTH ARE VISIBLE.
