HISTORIC RESOURCE INVENTORY  
Lakes Region Planning Commission  
Meredith, New Hampshire

TOWN: Barnstead COUNTY: Belknap

SURVEY NUMBER: 1

COMMON NAME: Hartshorn House

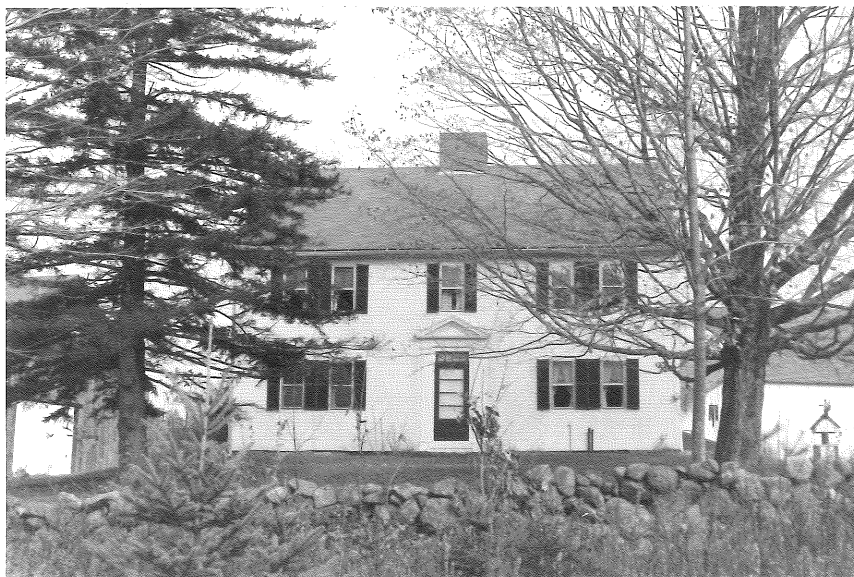
PHOTO:

asphalt shingles on rear-c.1950  
exterior chimney-c.1955; new rear window-  
c.1960; porch-1970's

16. ARCHITECTURAL IMPORTANCE/INTEGRITY: A fine Federal style house, notable for its excellent pedimented entry.
17. SITE INTEGRITY: A fine example of an early farmstead.
18. HISTORIC ASSOCIATIONS: Built for Capt. Daniel Bunker (1773-1842).

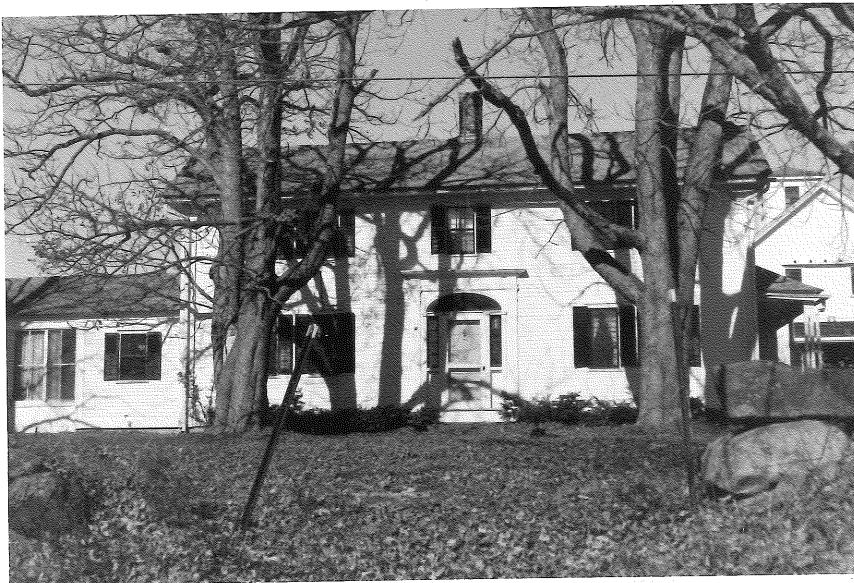
PHOTO:

Major Alterations & Date:  
A added- prob. 20th century  
eastern ell (C) windows- c.1975

16. ARCHITECTURAL IMPORTANCE/INTEGRITY: A fine Federal style house, noteworthy for its impressive entry and its, presumably later, corner pilasters.
17. SITE INTEGRITY: A landmark on Coles Ledge Road.
18. HISTORIC ASSOCIATIONS: Built for Simeon Lougee (1767-1855). Home of Robert St. John, journalist and author.

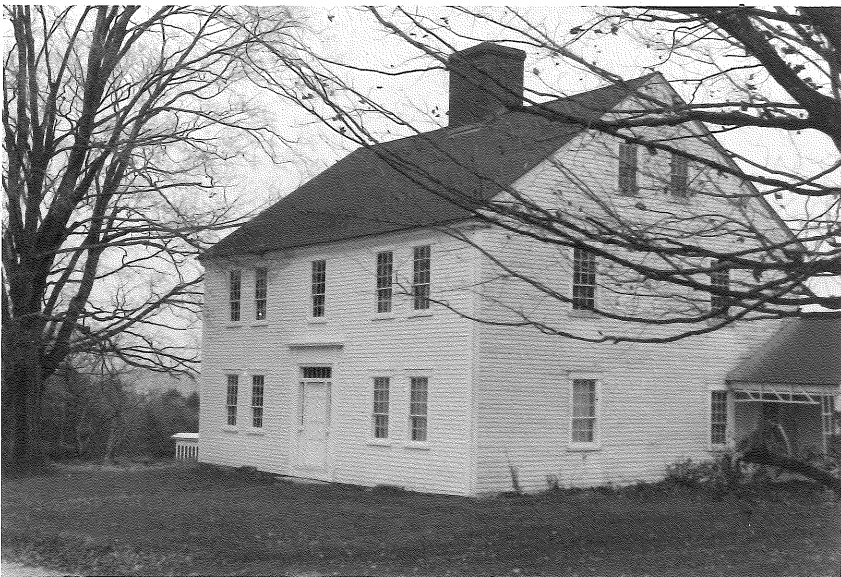
PHOTO:

shed converted into rear porch  
and extended, new rear windows-1932-33

COMMENTS: The dates of 1808 and 1818 have both been attributed to the house.

16. ARCHITECTURAL IMPORTANCE/INTEGRITY: A well preserved attractive Federal style house, with good proportions, and simple but effective ornament.
17. SITE INTEGRITY: Part of a small cluster of attractive early houses.
18. HISTORIC ASSOCIATIONS: \_\_\_\_\_

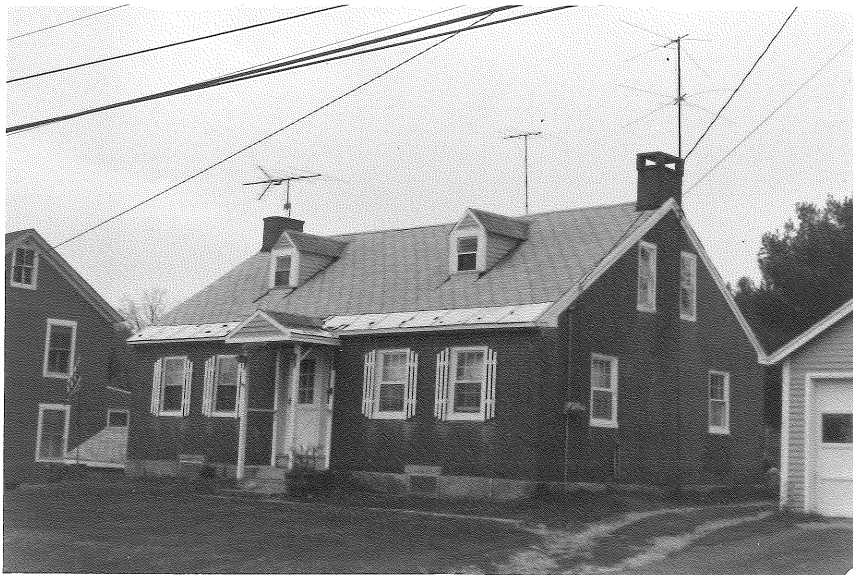
PHOTO:

basement vestibule-1960's; rear porch-  
1960's; entry porch-1970's; new entry-  
c.1980; exterior chimney-1984

COMMENTS: One of the bricks at the northwest corner of the house is signed  
"John D. Clark" and dated "1832" (although the last numeral is unclear).

16. ARCHITECTURAL IMPORTANCE/INTEGRITY: An interesting brick cape. The only brick house in Barnstead.
17. SITE INTEGRITY: Contributes to the historic character of the village.
18. HISTORIC ASSOCIATIONS: May have been built for either Oliver P.H. Young or John H. Collins.

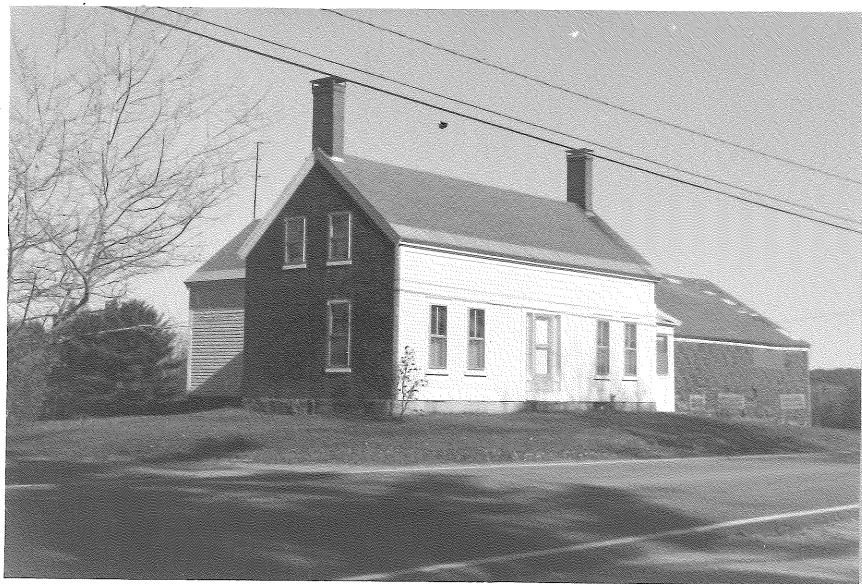
PHOTO:

porch, new ell windows, and 2nd ell(B)  
added c. 1970

16. ARCHITECTURAL IMPORTANCE/INTEGRITY: A good example of a rare building type. Perhaps the only brick-ended cape in the Lakes Region.
17. SITE INTEGRITY: Dominates the intersection of Route 126 and Welch Road.
18. HISTORIC ASSOCIATIONS: Built by the Howe family, with bricks made on the property.

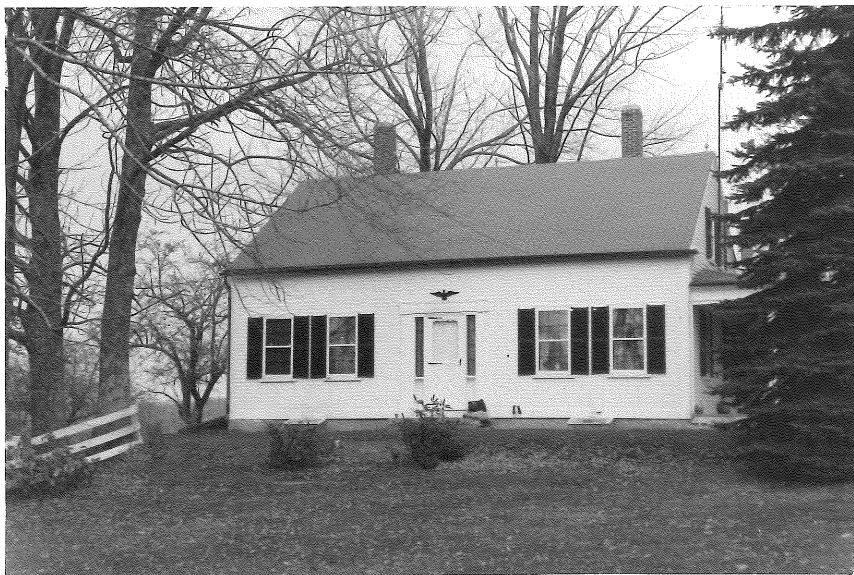
PHOTO:

1. STYLE: mid 19th century vernacular BUILDING TYPE: house
2. # STORIES: 1½ DIMENSIONS: 36 x 26 BAYS: 5 x 2 FORM: cape
3. FOUNDATION: cut granite block 4. STRUCTURE: post and beam

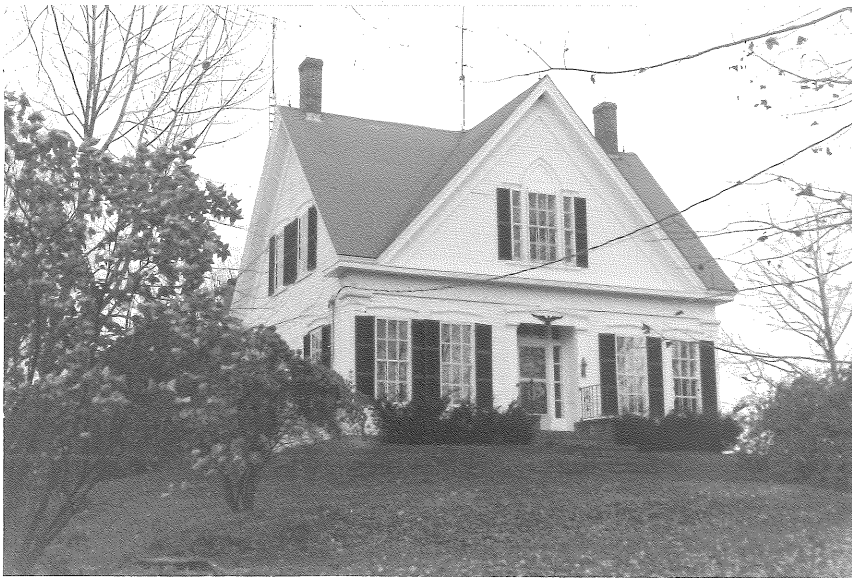
PHOTO:

1. STYLE: Greek Revival BUILDING TYPE: house
2. # STORIES: 1½ DIMENSIONS: 32 x 26 BAYS: 5 x 2 FORM: cross gable cape
3. FOUNDATION: cut granite block 4. STRUCTURE: wooden frame

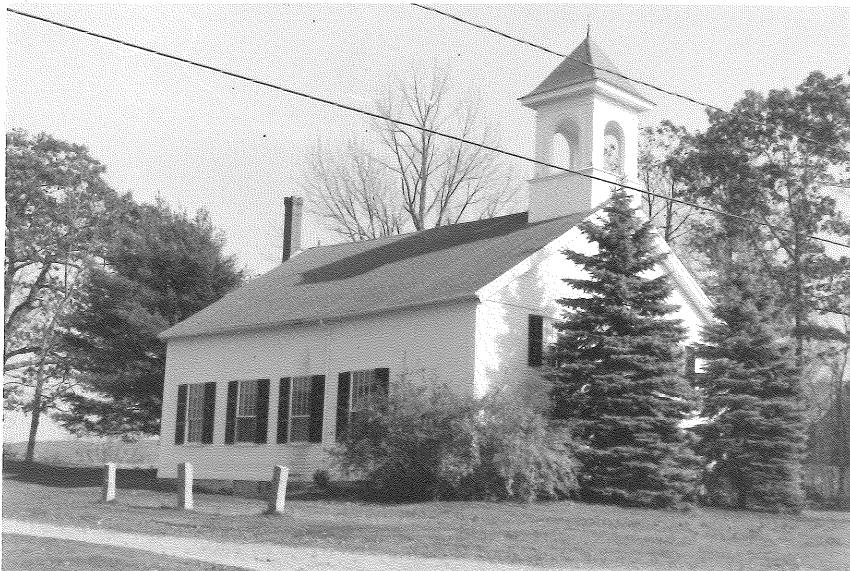
PHOTO:

1. STYLE: vernacular BUILDING TYPE: church
2. # STORIES: 2½ DIMENSIONS: 36 x 52 BAYS: 3 x 4 FORM: rectangular
3. FOUNDATION: cut granite block 4. STRUCTURE: wooden frame

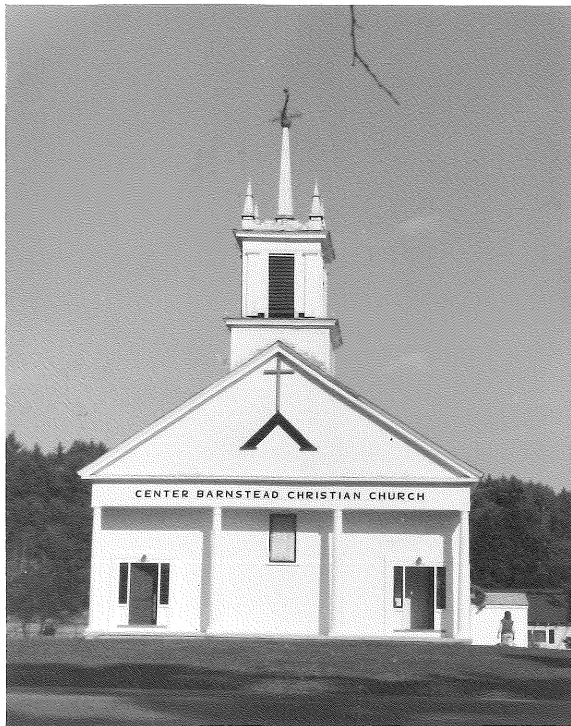
PHOTO:

1. STYLE: Greek Revival BUILDING TYPE: church
2. # STORIES: 1½ DIMENSIONS: 41 x 60 BAYS: 3 x 3 FORM: temple style
3. FOUNDATION: concrete 4. STRUCTURE: wooden frame

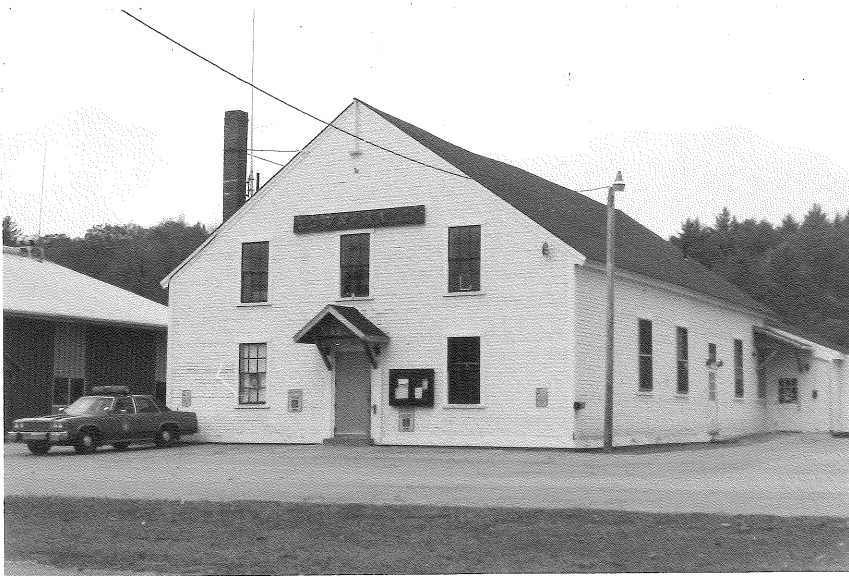
PHOTO:

1. STYLE: vernacular BUILDING TYPE: town hall
2. # STORIES: 1½ DIMENSIONS: 41 x 66 BAYS: 3 x 5 FORM: rectangular plan
3. FOUNDATION: cut granite block 4. STRUCTURE: wooden frame

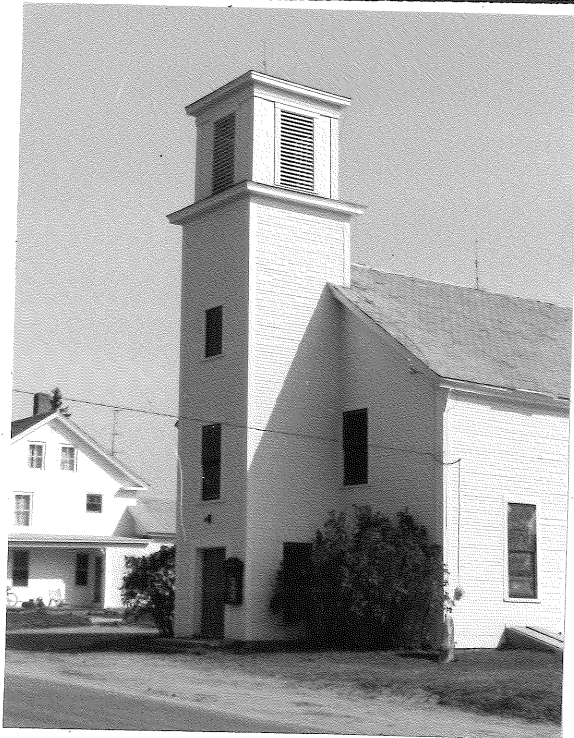
PHOTO:

COMMENTS: Dedicated Sept. 16, 1799. Built on Barnstead Parade, donated  
to Town by Eli Bunker in 1796, for meetinghouse and a parade.  
SURVEYOR: David Ruell DATE: 1986  
PHOTOGRAPHER: David Ruell

1. STYLE: Victorianized vernacular BUILDING TYPE: church
2. # STORIES: 1½ DIMENSIONS: 37 x 49 BAYS: 3 x 3 FORM: rectangular plan
3. FOUNDATION: cut granite block 4. STRUCTURE: wooden frame

9. WINDOWS: Placement symmetrical Shape rectangular Sash stained glass  
Surrounds plain frames (arched-SE) NW-diamond paned
10. ENTRIES-MAIN: Location NW (street), in tower Door double 4-paneled  
Surround: Flanked plain trim Topped plain lintel  
Framed granite and concrete steps

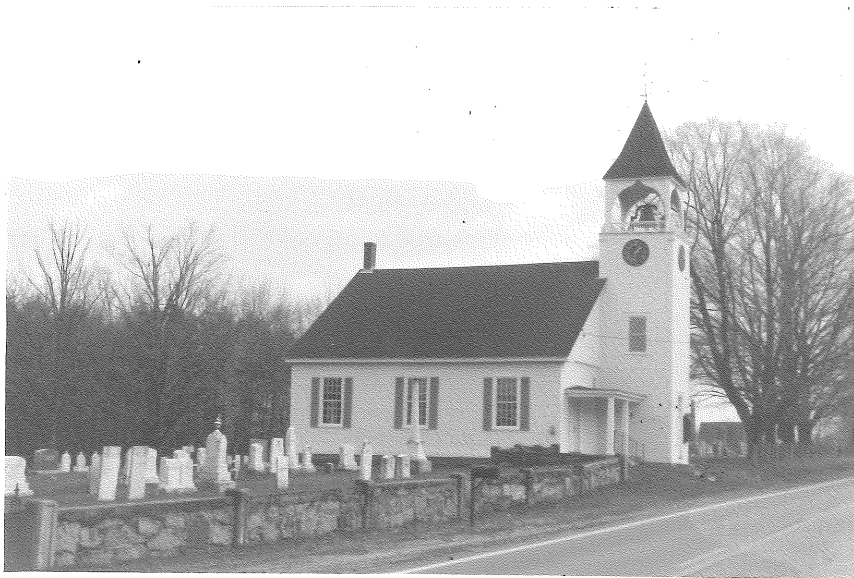
PHOTO:

1. STYLE: Victorianized vernacular BUILDING TYPE: church
2. # STORIES: 1½ DIMENSIONS: 38 x 46 BAYS: 3 x 3 FORM: rectangular plan
3. FOUNDATION: brick 4. STRUCTURE: wooden frame

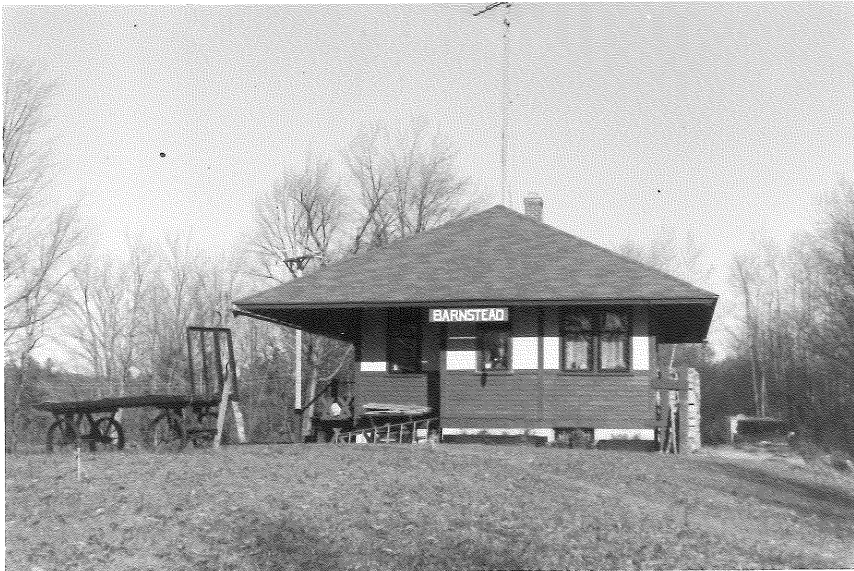
PHOTO:

1. STYLE: vernacular BUILDING TYPE: railroad station
2. # STORIES: 1 DIMENSIONS: 24 x 20 BAYS: 3 x 4 FORM: rectangular plan
3. FOUNDATION: concrete 4. STRUCTURE: balloon frame

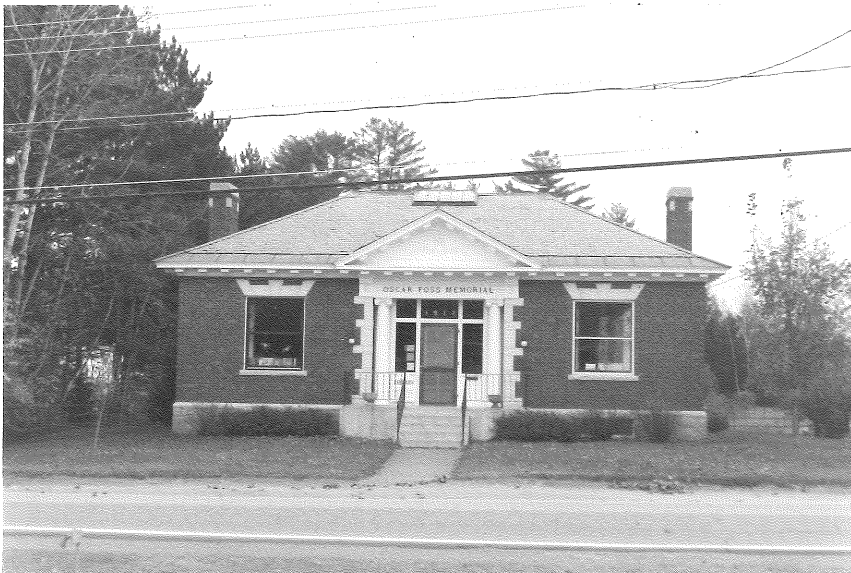
PHOTO:

old steps replaced by present

1. STYLE: Classical BUILDING TYPE: library
2. # STORIES: 1 DIMENSIONS: 28 x 46 BAYS: 3 x 2 FORM: rectangular plan
3. FOUNDATION: granite block w/watertable 4. STRUCTURE: brick

7. CHIMNEYS: # 2 Location center, NW, SE ends Materials brick w/granite found.
8. EAVES TREATMENT: Lateral wooden box cornice with mouldings, modillions, frieze  
Gable End same box cornice, pedimented, w/ cartouche & foliage in tympanum

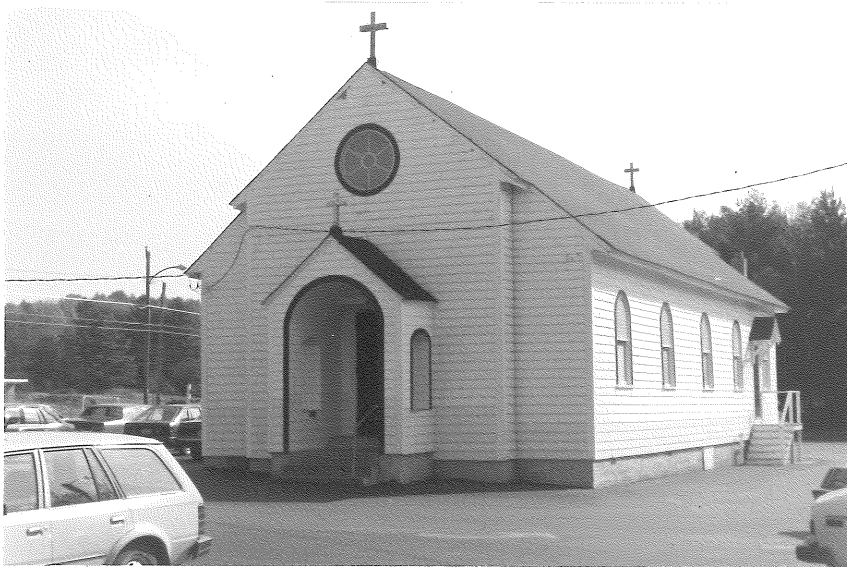
PHOTO:

1. STYLE: vernacular Italianate BUILDING TYPE: church
2. # STORIES: 1 DIMENSIONS: 30 x 58 BAYS: 1 x 6 FORM: rectangle with pavilion
3. FOUNDATION: concrete block 4. STRUCTURE: wooden frame

9. WINDOWS: Placement symmetrical Shape semicircular arch Sash stained glass  
Surrounds plain arched frames (N gable- round window)
10. ENTRIES-MAIN: Location center, N gable end Door large 6 panel  
Surround: Flanked plain frame Topped plain lintel  
Framed in arched recessed entry, shared with porch, shingled walls  
OTHERS: # 2 Location towards rear, E & W sides Surrounds plain frames

13. ELLS/WINGS: # 1 <sup>letter</sup> on map Stories A 1 B C D D Bays A 1x-B C C D D  
Description(s) shallow apse with bowed south wall, shingled walls, cornerboards, simple box cornice, hipped roof, one high semicircular arched stained glass window

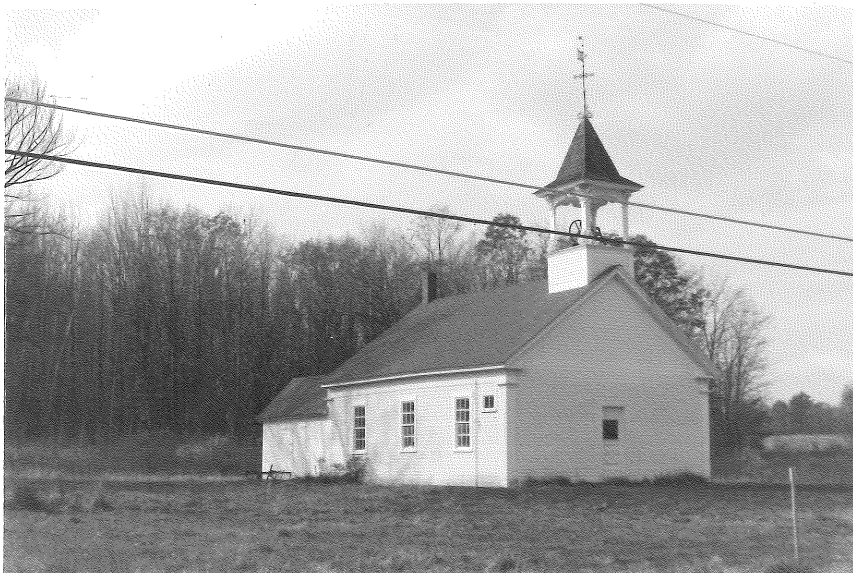
PHOTO:

two entries replaced by one;

1. STYLE: vernacular BUILDING TYPE: schoolhouse
2. # STORIES: 1 DIMENSIONS: 26 x 34 BAYS: 1 x asym FORM: rectangular
3. FOUNDATION: cut granite block 4. STRUCTURE: wooden frame plan
