Town of Auburn, Massachusetts

ADA Self-Evaluation and Transition Plan

September 2020

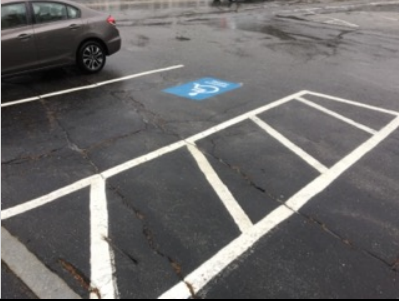
Total # of parking Total # of designated accessible parking spaces Sign not provided	17 1 -	Provide a van accessible sign with the bottom of the sign 60" min. above the ground and the top 96" max. above the ground.	1	500	\$500
2	Parking Lot	Outdoor		Off-Street Parking Lot or Garage	Visitor

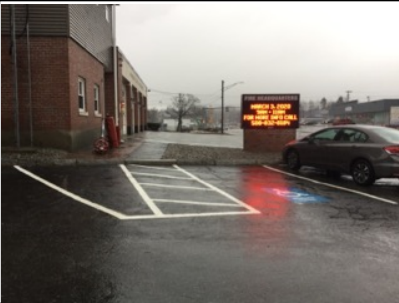
Access aisle does not adjoin an accessible route	-	Provide a curb ramp to ensure the access aisle adjoins an accessible route.	1	2800	\$2800
Entrance												
3	Entrance	Outdoor		Entrance	Main Entrance

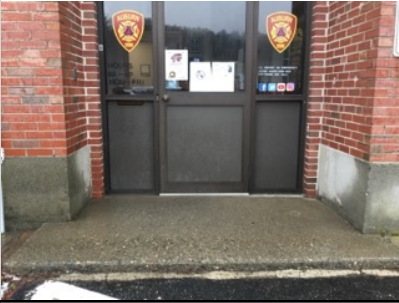
Level changes > 1/4"	3"	Alter change in level to be 1/4" high max.	1	320	\$320
4	Reception	1		Entrance	Main Entrance

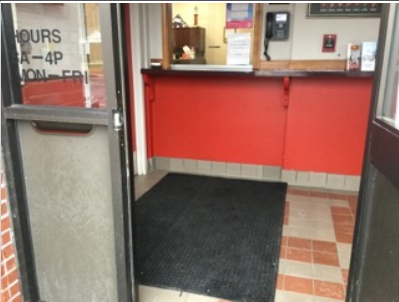
Mat not securely attached	-	Secure the mat to prevent tripping hazard.	1	Labor	\$0

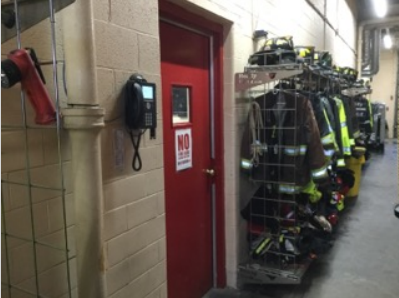
Maneuvering clearance(s) not provided Hardware not operable with a closed fist	- -	Relocate uniform hanger to maintain the maneuvering clearance at the door. Provide hardware that can be operable with one hand and not require tight grasping, pinching, or twisting of the wrist.	1	484	\$484
6	Entrance	Outdoor		Doors, Doorways, & Gates	108

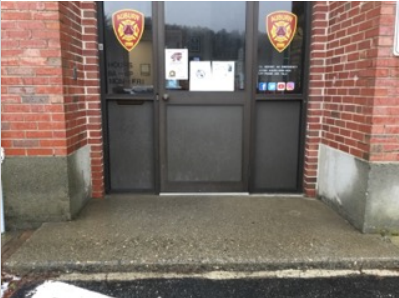
Hardware not operable with a closed fist	-	Provide hardware that can be operable with one hand and not require tight grasping, pinching, or twisting of the wrist.	1	484	\$484
7	Single-User Toilet	1		Doors, Doorways, & Gates	Toilet Room

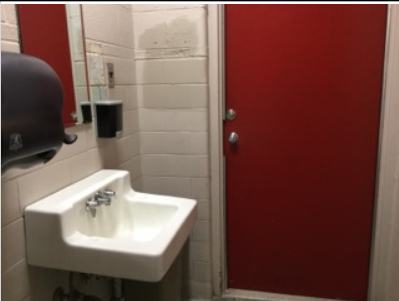
Hardware not operable with a closed fist	-	Provide hardware that can be operable with one hand and not require tight grasping, pinching, or twisting of the wrist.	1	484	\$484

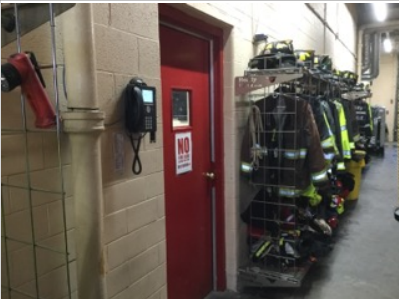
Signage is not provided	-	Locate compliant signage alongside the door on the latch side.	1	232	\$232
9	Egress	1		Signage	Egress

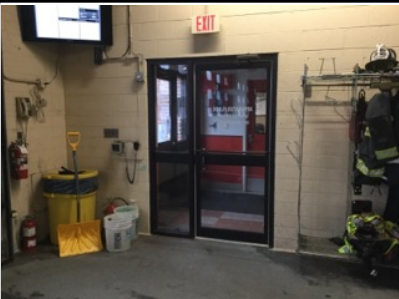
Signage is not provided International Symbol of Acc. not compliant	- -	Locate compliant signage alongside the door on the latch side. Replace exit sign with a sign containing the International Symbol of Accessibility.	1	232	\$232

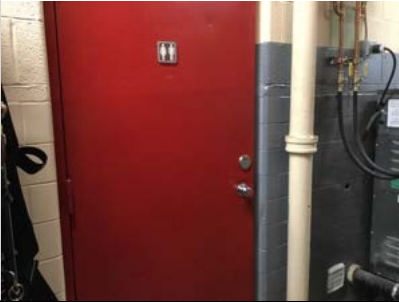
Raised characters not provided on sign Braille not provided on sign Sign not located on the latch side of the door	- - -	Provide text with raised characters duplicated in braille on sign. Locate sign alongside the door on the latch side. Add the International Symbol of Accessibility.	1	232	\$232
11	Deputy Chief Office	1		Signage	Designation

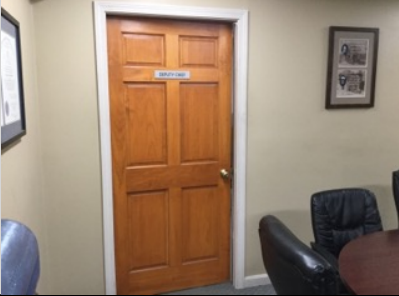
Raised characters not provided on sign Braille not provided on sign Sign not located on the latch side of the door	- - -	Provide text with raised characters duplicated in braille on sign. Locate sign alongside the door on the latch side.	1	232	\$232
12	Chief Office	1		Signage	Designation

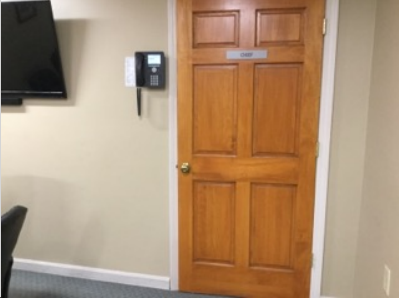
Raised characters not provided on sign Braille not provided on sign Sign not located on the latch side of the door	- - -	Provide text with raised characters duplicated in braille on sign. Locate sign at permanent rooms alongside the door on the latch side.	1	232	\$232

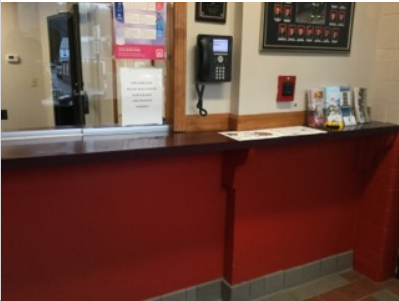
Reach < 15" or > 48"(forward/side approach)	57"	Relocate telephone so that controls are 48" above the finished floor.	1	256	\$256
Toilet & Bathing Rooms												
Lavatory												
14	Single-User Toilet	1		Lavatory	N/A

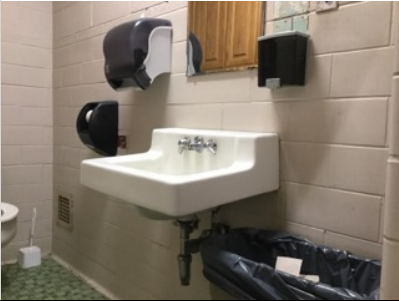
Plumbing underneath is exposed Mirror above lavatory w/reflective surface > 40" Dispensers not within reach range	- 47.5" 48"	Insulate or otherwise configure pipes to prevent contact at lavatory. Lower mirror so that the bottom surface is at 40" max. above the finished floor. Lower dispensers to 42" max. above the the finished floor.	1	701	\$701

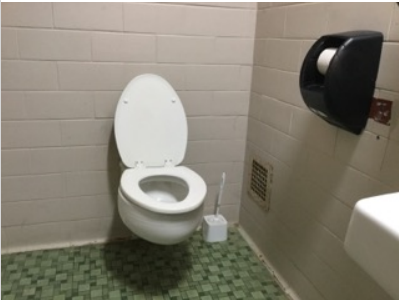
Toilet seat < 17" or > 19" high Grab bar not provided Centerline < or > 18" (MAAB)	19.5" 22" -	Install a toilet with a seat between 17"- 19" high above the finished floor. Relocate toilet so that the centerline is 18" from the side wall. Provide one (1) grab bar on the side wall of the toilet and one (1) on the rear wall. Relocate toilet paper so that it is 24" min. high, located under the grab bar, and between 7" and 9" from the front of the toilet.	1	4079	\$4079
Dispensers												
16	Single-User Toilet	1		Dispensers	Wood Cabinet

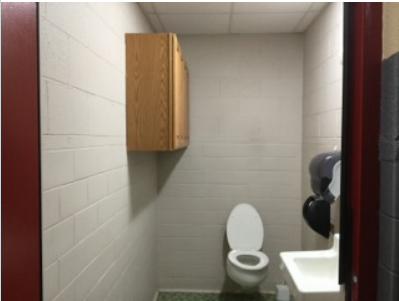
Dispenser acts as a protruding object	13"	Remove wood cabinet out of the circulation path.	1	353	\$353

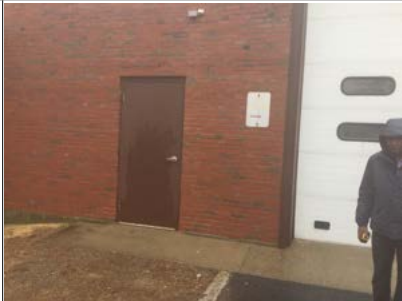
Directional sign to accessible entrance not provided	-	Provide a directional sign indicating the location of the nearest accessible entrance.	1	346	\$346

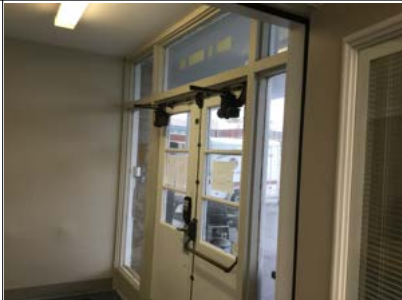
3	Main Entrance	1		Emergency Exit	N/A

Illuminated Int. Symbol of Acc. not provided (MAAB) Tactile exit sign not provided	-	Provide an illuminated sign with the International Symbol of Accessibility. Ensure tactile exit signs with raised characters and braille are provided at exit doors. Mount signs between 48"- 60" above the finished floor located on the latch side of the door.	1	1116	\$1116
Access to Goods and Services												
Doors, Doorways, & Gates												
4	Interior Entry to Fire Prevention Office	1		Doors, Doorways, & Gates

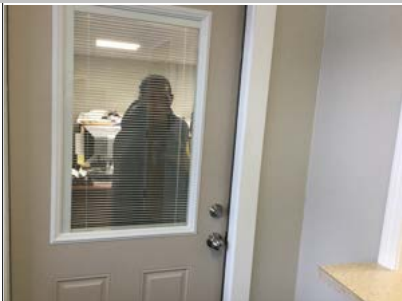
Hardware not operable with a closed fist	-	Provide hardware that can be operable with one hand and not require tight grasping, pinching, or twisting of the wrist.	1	484	\$484

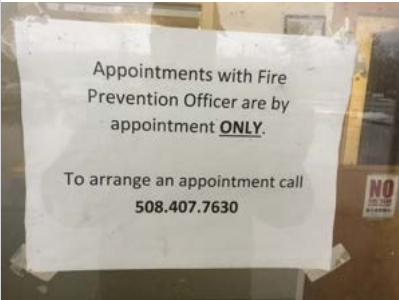
ID	Location	Floor	Room	Element	Type	Photo	Issues	Current Measure	Recommendations	Quantity	Price	Cost Estimation
Signage												
5	Main Entrance	Ext.		Signage	Informational

Non glare finish and contrast not provided on sign	-	Install a sign with a non-glare finish with characters that have a high contrast to the background.	1	232	\$232
Service Counter												
6	Interior Entry to Fire Prevention Office	1		Service Counter	N/A

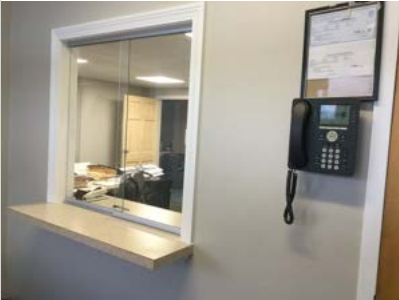
Counter > 36" high	41"	Provide a counter that is 36" max. above the ground or finished floor.	1	880	\$880
Operable Parts												
7	Interior Entry to Fire Prevention Office	1		Operable Parts	Other

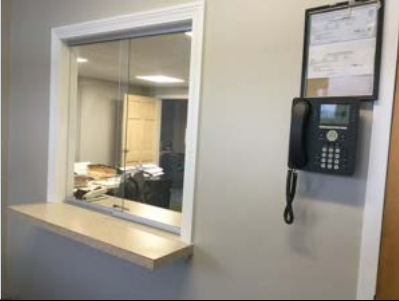
Side reach > 54"	59"	Relocate phone so that controls are between 15" - 48" above the finished floor.	1	256	\$256
Best Practice												
Main Entrance												
8	Main Entrance	Ext.		Main Entrance	N/A

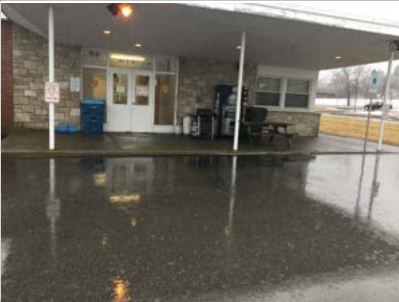
Recommend providing a doorbell at the main entrance so visitors without a working phone have a way to notify staff in the Fire Safety Office.	1	-	\$0

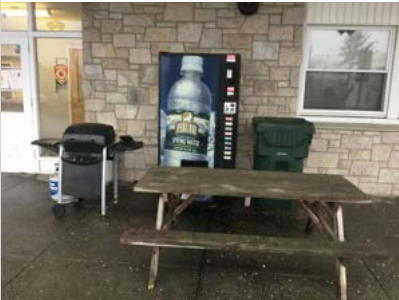
ID	Location	Floor	Room	Element	Type	Photo	Issues	Current Measure	Recommendations	Quantity	Price	Cost Estimation
Picnic Table												
9	Main Entrance	Ext.		Picnic Table	N/A

Recommend providing at least one accessible picnic table with knee and toe clearance.	1	-	\$0
Sign												
10	Main Entrance	Ext.		Sign	N/A

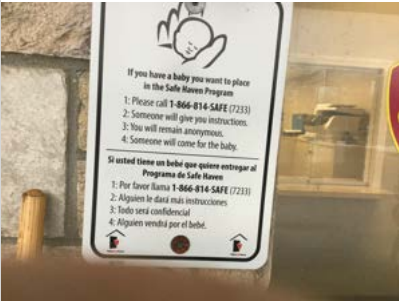
Recommend providing information in an accessible format about the Safe Haven program on the fire department and town web sites, and in town buildings.	1	-	\$0
Valkway												
11	Main Entrance	Ext.		Valkway	N/A

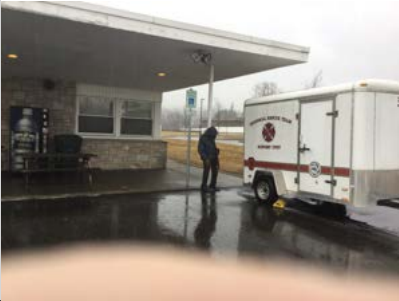
Recommend providing 48' min. x 60" min. striping so vehicles or equipment such as the pictured trailer do not block the accessible route to the main entry. (There is a 2" curb at the entry at all points except where the pictured trailer is parked.)	1	-	\$0

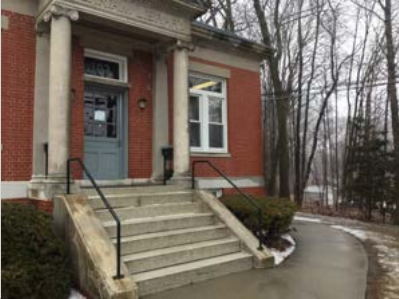
ID	Location	Floor	Room	Element	Type	Photo	Issues	Current Measure	Recommendations	Quantity	Price	Cost Estimation
Approach and Entrance												
Entrance												
1	Main Entrance	Ext.		Entrance	Main Entrance

Entrance not on an accessible route	-	Providing an accessible route might be technically infeasible.	1	-	\$0
Access to Goods and Services												
Means of Egress												
2	Main Entrance	1		Means of Egress	147

- Cost to provide an accessible route to the main entrance is not included. IHCD recommends either exploring the possibility of an accessible entrance via a ramp, if technically feasible, or moving the program to an accessible location.

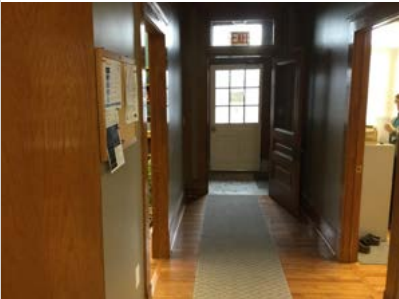
Tactile exit sign not provided	-	Ensure a tactile exit sign with raised characters and braille is provided at exit door. Mount sign between 48"- 60" above the finished floor located on the latch side of the door.	1	232	\$232
3	Exit	1		Means of Egress	N/A

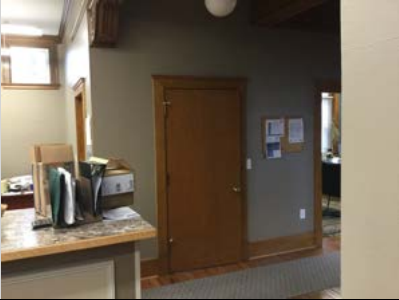
Tactile exit sign not provided	- -	Ensure a tactile exit sign with raised characters and braille is provided at exit door. Mount sign between 48"- 60" above the finished floor located on the latch side of the door.	1	232	\$232

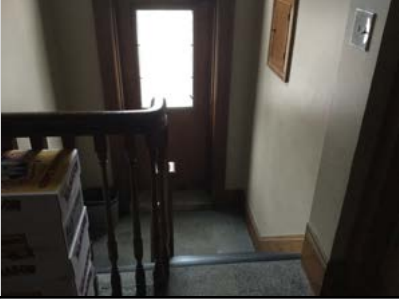
4	Exit - Employees Only	1		Means of Egress	N/A

Tactile exit sign not provided	-	Ensure a tactile exit sign with raised characters and braille is provided at exit door. Mount sign between 48"- 60" above the finished floor located on the latch side of the door.	1	232	\$232

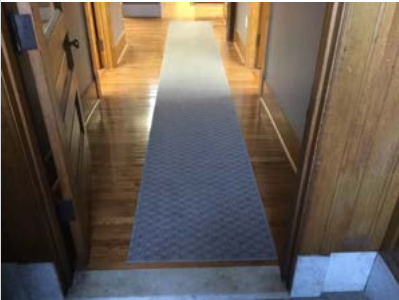
ID	Location	Floor	Room	Element	Type	Photo	Issues	Current Measure	Recommendations	Quantity	Price	Cost Estimation
Interior Access Route												
5	Hallway	1		Interior Access Route	N/A

Surface not stable, firm, and slip-resistant	-	Ensure walk-off mat is securely attached.	1	Labor	\$0
Doors, Doorways, & Gates												
6	Women's Toilet Room	1		Doors, Doorways, & Gates	Toilet Room

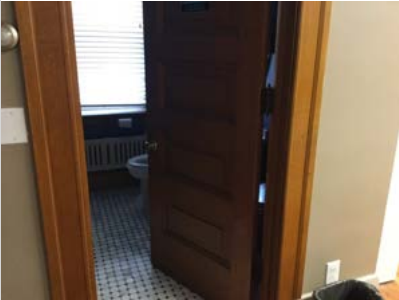
Hardware not operable with a closed fist	-	Provide hardware that can be operable with one hand and not require tight grasping, pinching, or twisting of the wrist. See ID #10 for cost.	1	-	\$0
7	Exit	1		Doors, Doorways, & Gates	Emergency Egress

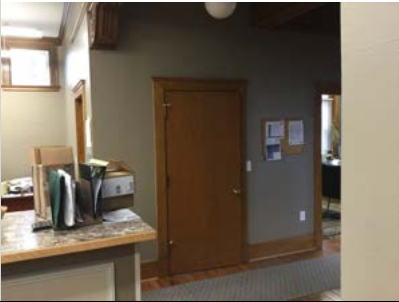
Hardware not operable with a closed fist	-	Provide hardware that can be operable with one hand and not require tight grasping, pinching, or twisting of the wrist.	1	484	\$484
Signage												
8	Women's Toilet Room	1		Signage	Designation

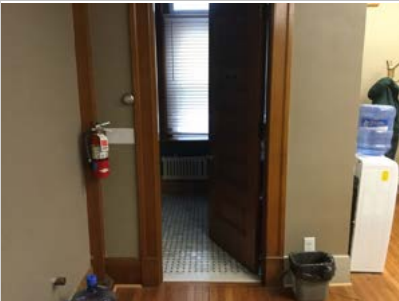
Raised characters not provided on sign Braille not provided on sign Sign not located on the latch side of the door	- - -	Provide text with raised characters duplicated in braille on sign. Locate sign alongside the door on the latch side.	1	232	\$232

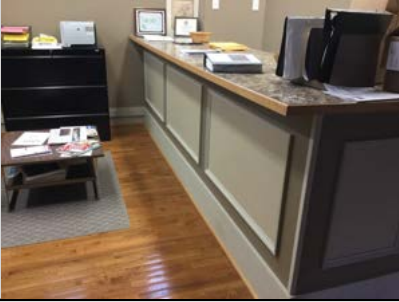
ID	Location	Floor	Room	Element	Type	Photo	Issues	Current Measure	Recommendations	Quantity	Price	Cost Estimation
Service Counter												
9	License Office	1		Service Counter	N/A

Counter > 36" high	45"	Provide a counter that is 36" max. above the ground or finished floor.	1	880	\$880
Toilet & Bathing Rooms												
Overall Access												
10	Women's Toilet Room	1		Overall Access	439

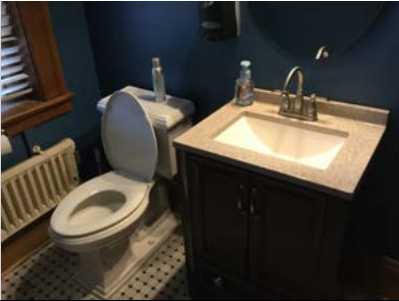
Accessible plumbing fixtures or stalls not provided		Provide one accessible single-user toilet room.	1	24604	\$24604
11	Women's Toilet Room	1		Overall Access	Toilet Room

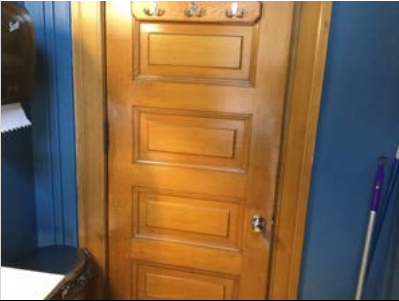
Hook located > 48" high	70.5"	Locate hook no higher than 48" above the finished floor. See ID #10 for cost.	1	-	\$0
Lavatory												
12	Women's Toilet Room	1		Lavatory	N/A

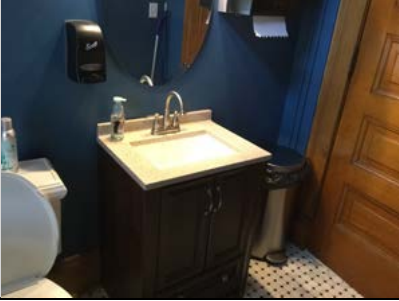
Toe or knee clearances not provided Mirror above lavatory w/reflective surface > 40" Dispensers not within reach range	- 41" 55"	Provide a lavatory with knee and toe clearance positioned for a forward approach. Lower mirror so that the bottom surface is at 40" max. above the finished floor. Lower dispensers to 42" max. above the floor. See ID #10 for cost.	1	-	\$0

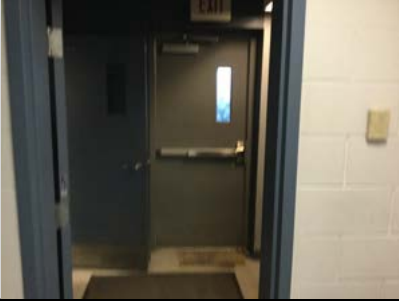
ID	Location	Floor	Room	Element	Type	Photo	Issues	Current Measure	Recommendations	Quantity	Price	Cost Estimation
Access to Goods and Services												
Means of Egress												
1	Employee Entrance	B		Means of Egress	N/A

Tactile exit sign not provided	-	Ensure tactile exit signs with raised characters and braille are provided at exit doors. Mount signs between 48"- 60" above the finished floor located on the latch side of the door.	1	232	\$232
2	Main Entrance	1		Means of Egress	N/A

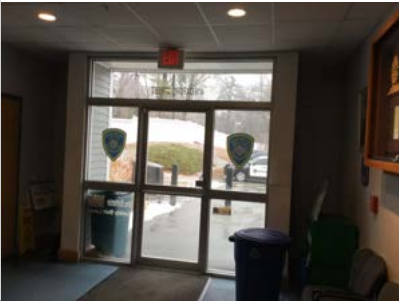
Illuminated Int. Symbol of Acc. not provided (MAAB) Tactile exit sign not provided	- -	Provide an illuminated sign with the International Symbol of Accessibility. Ensure tactile exit signs with raised characters and braille are provided at exit doors. Mount signs between 48"- 60" above the finished floor located on the latch side of the door.	1	423	\$423
Doors, Doorways, & Gates												
3	Sally Port	B		Doors, Doorways, & Gates	Other

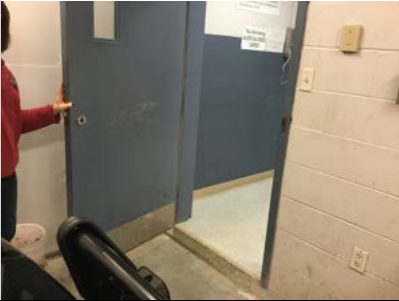
Threshold > 1/2" high	4.5"	Alter the threshold to be 1/2" high max. (Provide a portable ramp.) (Cost based on a portable ramp.)	1	500	\$500

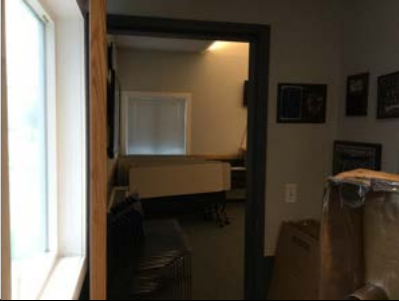
Signage												
4	Community Room	1		Signage	Designation

Signage is not provided	-	Locate compliant signage alongside the door on the latch side.	1	232	\$232

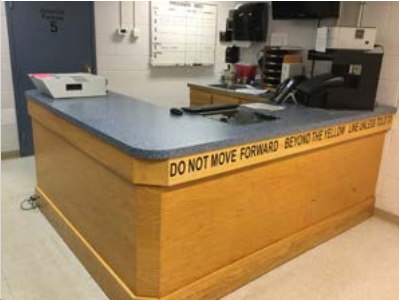
Counter > 36" high	40"	Provide a counter that is 36" max. above the ground or finished floor.	1	440	\$440
Operable Parts												
7	Prisoner Entrance Phone	B		Operable Parts	Other

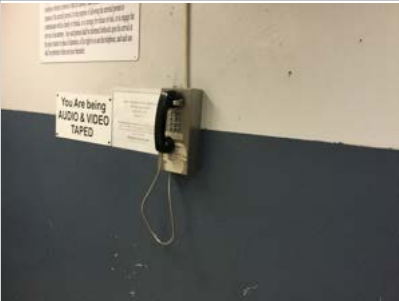
. Reach < 15" or > 48"(forward/side approach)	61"	Relocate phone so that controls are between 15"- 48" above the finished floor.	1	256	\$256

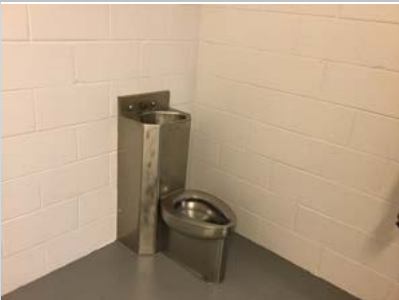
Detention Facilities												
8	Adult Men's Mobility Cell	B		Detention Facilities	Men's

Mobility cell lacks access to accessible toilet/lavatory	-	Ensure an accessible toilet room is provided.	1	1010	\$1010
Toilet & Bathing Rooms

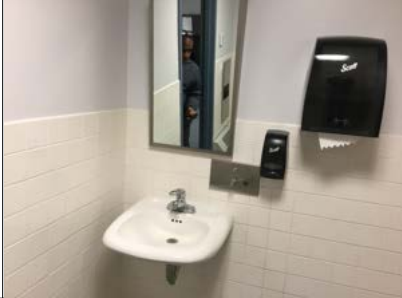
ID	Location	Floor	Room	Element	Type	Photo	Issues	Current Measure	Recommendations	Quantity	Price	Cost Estimation
Lavatory												
9	Men's Single-User Toilet	2		Lavatory	N/A

Plumbing underneath is exposed	-	Insulate or otherwise configure pipes to prevent contact for at least one lavatory.	1	92	\$92
10	Women's Single-User Toilet	2		Lavatory	N/A

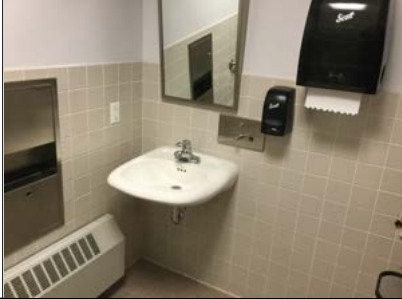
Plumbing underneath is exposed	-	Insulate or otherwise configure pipes to prevent contact for at least one lavatory.	1	92	\$92
Single-User Toilet												
11	Men's Single-User Toilet	2		Single-User Toilet	N/A

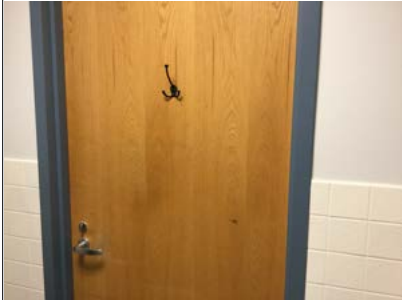
Hook located > 48" high	61"	Locate hook no higher than 48" above the finished floor.	1	150	\$150
Additional Access												
Sink												
12	Community Room	1		Sink	Kitchenette

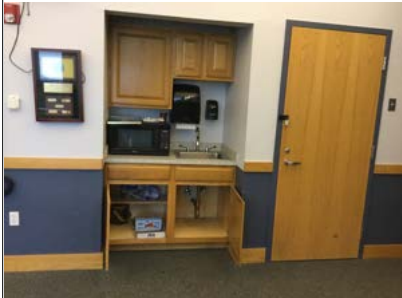
Toe and knee clearances not provided	-	Ensure there is a 27" knee clearance positioned for a forward approach.	1	1686	\$1686

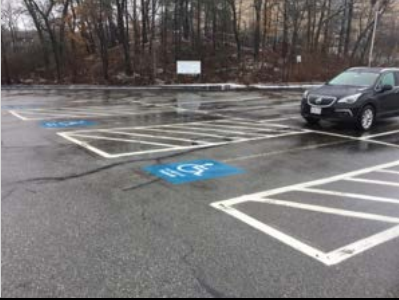
ID	Location	Floor	Room	Element	Type	Photo	Issues	Current Measure	Recommendations	Quantity	Price	Cost Estimation
Approach and Entrance												
Off-Street Parking Lot or Garage												
1	Parking	Outdoor		Off-Street Parking Lot or Garage	Visitor

Total # of parking Total # of designated accessible parking spaces Total # of designated van accessible spaces Access aisle < 60" wide at car/van space Sign not provided	51 3 1 50" -	Provide a marked access aisle that is at least 60" wide. Provide three (3) signs with the bottom of the sign 60" min. above the ground and the top 96" max. above the ground.	3	800	\$2400
Exterior Ramp												
2	Main Entrance	Outdoor		Exterior Ramp	N/A

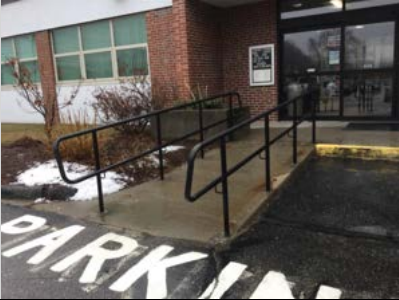
Accessibility issues include lack of an accessible route to the picnic tables and the landing at the exterior ramp is not maintained in operable working condition.

Surface is not stable, firm, and slip-resistant	-	Repair surface at landing.	1	256	\$256
Entrance												
3	Main Entrance	1		Entrance	Main Entrance

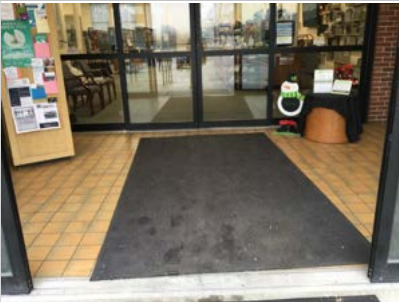
Mat not securely attached	-	Secure the mat to prevent tripping hazard.	1	Labor	\$0

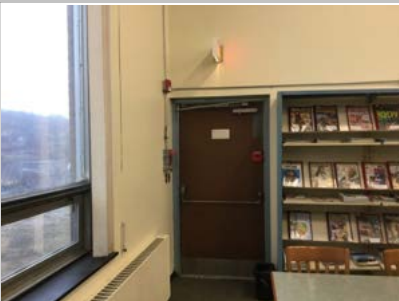
Emergency Exit												
4	Emergency Exit	1		Emergency Exit	N/A

Emergency exit not on an accessible route Directional sign to accessible emergency exit not provided Maneuvering clearance(s) not provided	- - -	Provide a directional sign indicating the location of the nearest accessible emergency exit. Remove the trash can.	1	232	\$232

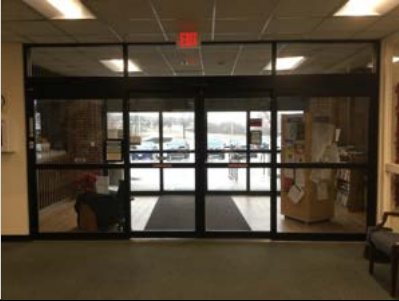
ID	Location	Floor	Room	Element	Type	Photo	Issues	Current Measure	Recommendations	Quantity	Price	Cost Estimation
5	Main Entrance	1		Emergency Exit	Egress

Illuminated Int. Symbol of Acc. not provided (MAAB)	-	Provide an illuminated sign with the International Symbol of Accessibility.	1	200	\$200
Access to Goods and Services												
Interior Access Route												
6	Corridor Leading to Toilet Rooms	1		Interior Access Route	N/A

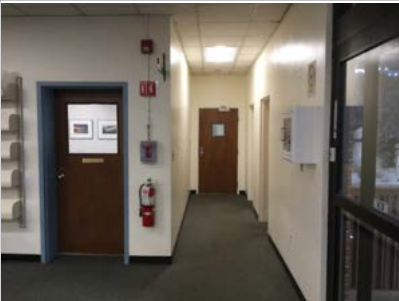
Obstructed by protruding objects	7"	Provide a cane-detectable barrier under the AED.	1	306	\$306
7	Merriam Room	1		Interior Access Route	N/A

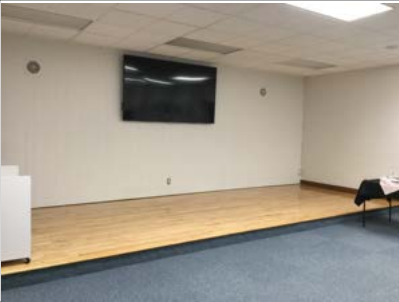
Level changes > 1/4" Assistive listening devices not provided	6" -	Provide a temporary ramp as needed to ensure an accessible route to the stage. If audible communication is integral to the use of the space, provide an assistive listening system.	1	1714	\$1714
Doors, Doorways, & Gates												
8	History Room	1		Doors, Doorways, & Gates	Study Room

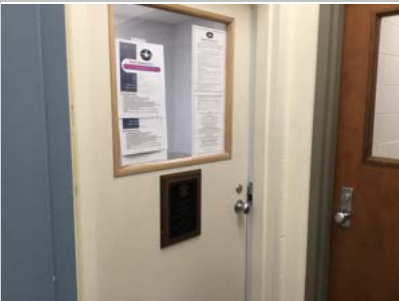
Signage is not provided Hardware not operable with a closed fist	- -	Locate compliant signage alongside the door on the latch side. Provide hardware that can be operable with one hand and not require tight grasping, pinching, or twisting of the wrist.	1	716	\$716

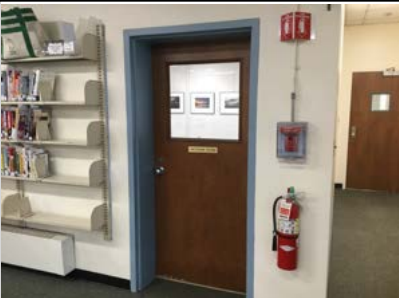
9	Marriam Room	1		Doors, Doorways, & Gates	Meeting Room

Maneuvering clearance(s) not provided Hardware not operable with a closed fist	- -	Keep door open as needed. Provide hardware that can be operable with one hand and not require tight grasping, pinching, or twisting of the wrist.	1	484	\$484

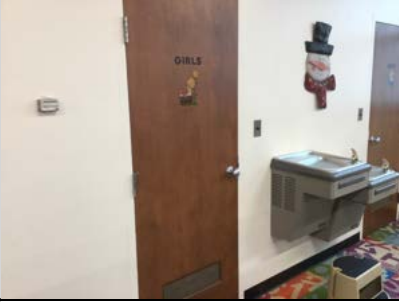
Maneuvering clearance(s) not provided Hardware not operable with a closed fist	- 12.5"	Relocate drinking fountain. Provide hardware that can be operable with one hand and not require tight grasping, pinching, or twisting of the wrist See ID #28 for cost regarding toilet room.	2	2028	\$4056
11	Men's Toilet Room	1		Doors, Doorways, & Gates	Toilet Room

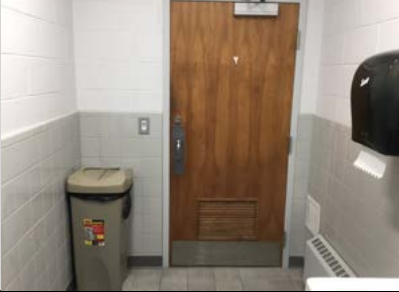
Maneuvering clearance(s) not provided Door requires > 5 lbs. of force to open Hook located > 48" high	- 20 lbs 63"	Relocate the trash can. Adjust closers so door does not require more than 5 pounds of force to open. Locate hook no higher than 48" above the finished floor.	1	150	\$150
12	Women's Toilet Room	1		Doors, Doorways, & Gates	Toilet Room

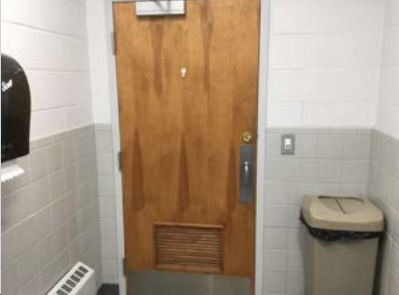
Maneuvering clearance(s) not provided Door requires > 5 lbs. of force to open Hook located > 48" high	- 20 lbs 63"	Relocate the trash can. Adjust closers so door does not require more than 5 pounds of force to open. Locate hook no higher than 48" above the finished floor.	1	150	\$150

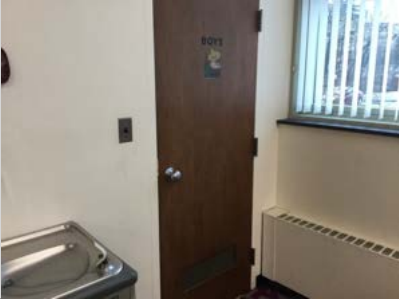
Signage												
13	Boys' and Girls' Toilet Room	1		Signage	183

Raised characters not provided on sign Braille not provided on sign Sign not located on the latch side of the door	- - -	Provide text with raised characters duplicated in braille on sign. Locate sign at permanent rooms alongside the door on the latch side.	2	232	\$464
14	Merriam Room	1		Signage	Designation

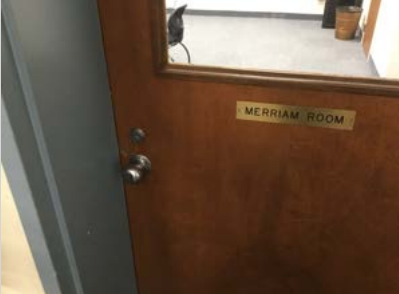
Raised characters not provided on sign Braille not provided on sign Sign not located on the latch side of the door	- - -	Provide text with raised characters duplicated in braille on sign. Locate sign at permanent rooms alongside the door on the latch side.	1	232	\$232

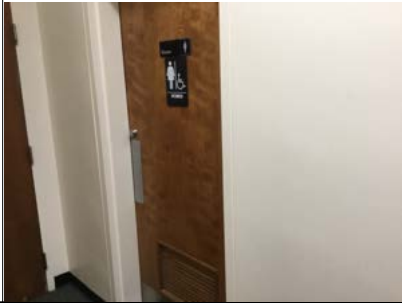
Sign not located on the latch side of the door	-	Locate sign alongside the door on the latch side.	1	Labor	\$0
Service Counter												
17	Reception	1		Service Counter	N/A

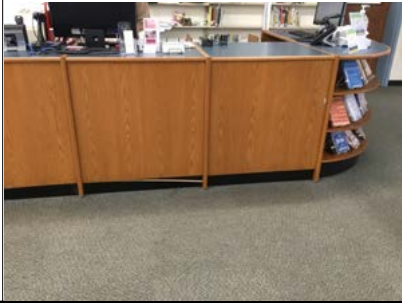
Counter > 36" high	39"	Provide a counter that is 36" max. above the ground or finished floor.	1	880	\$880
Dining or Work Surfaces												
18	Children's Section	1		Dining or Work Surfaces	Work Surface

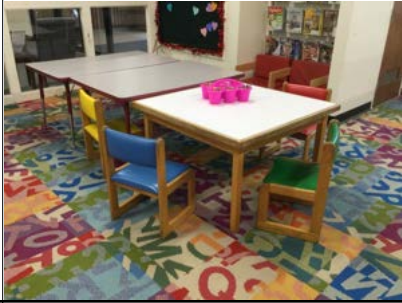
Top of dining/work surface < 26" or > 30"	23"	Provide one (1) play surface with top between 28"- 30" above the floor.	1	200	\$200
19	Library Catalog	1		Dining or Work Surfaces	Work Surface

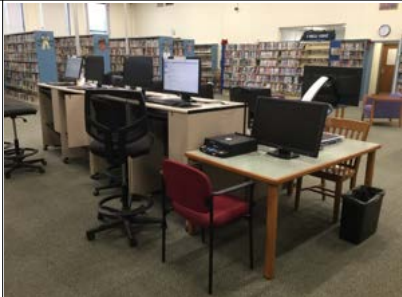
Top of dining/work surface < 28" or > 34"	41.5"	Relocate one (1) library catalog computer on a work surface with tops between 28"- 34" above the floor and 27" clear height underneath.	1	Labor	\$0

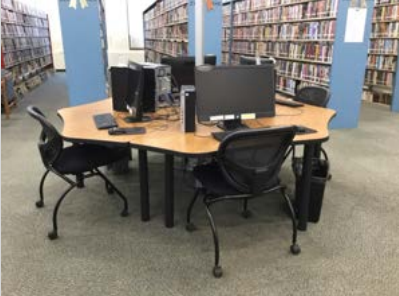
Top of dining/work surface < 28" or > 34"	37"	Provide at least one (1) work surface with top between 28"- 34" above the floor and 27" clear height underneath.	1	700	\$700
21	Adults Section	1		Dining or Work Surfaces	Work Surface

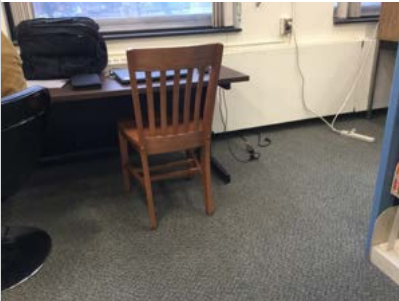
Top of dining/work surface < 28" or > 34"	26.5"	Provide at least one (1) work surface with top between 28"- 34" above the floor and 27" clear height underneath.	1	700	\$700
Picnic Tables												
22		Outdoor		Picnic Tables	N/A

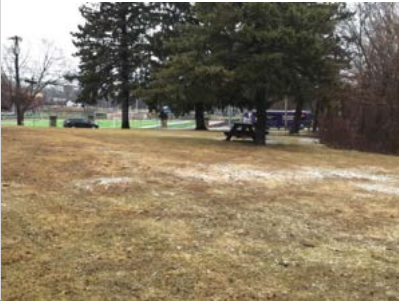
At least 5% accessible spaces not provided Toe or knee clearance at tables not provided Picnic table not on an accessible route	- - -	Ensure that one (1) picnic table is accessible and has toe and knee clearance. Ensure that the picnic table is connected to an accessible route.	1	1400	\$1400

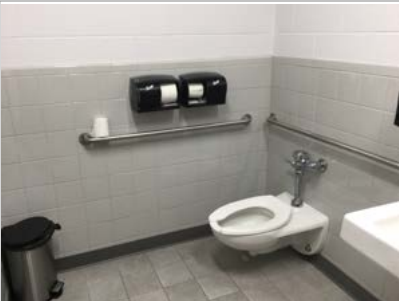
Toilet & Bathing Rooms												
Single-User Toilet												
23	Women's Toilet Room	1		Single-User Toilet	Toilet Paper Dispenser

Toilet seat < 17" or > 19" high Flush control not on open side Centerline < or > 18" (MAAB) Toilet paper dispenser is not compliant	14" - 19" -	Install a toilet with a seat between 17"- 19" high above the finished floor. Relocate the flush control to the open side. Relocate toilet so that the centerline is 18" from the side wall. Relocate toilet paper so that it is 24" min. high, located under the grab bar, and between 7" and 9" from the front of the toilet.	1	3555	\$3555
24	Women's Toilet Room	1		Single-User Toilet	N/A

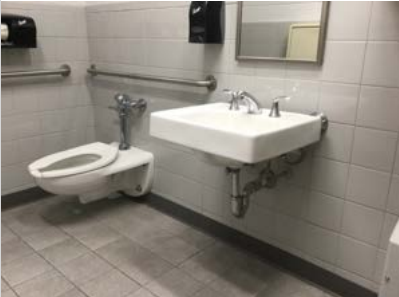
Plumbing underneath is exposed	19"	Insulate or otherwise configure pipes to prevent contact for at least one lavatory.	1	92	\$92

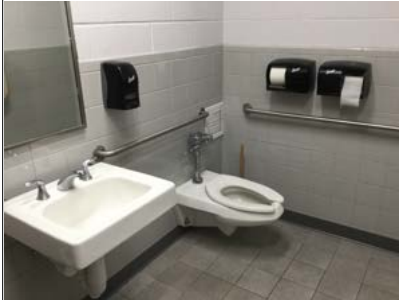
. Toilet paper dispenser is not compliant	-	Relocate toilet paper so that it is 24" min. high, located under the grab bar, and between 7" and 9" from the front of the toilet.	1	353	\$353	
Dispensers													
26	Men's Toilet Room	1		Dispensers	Paper Towel Dispenser

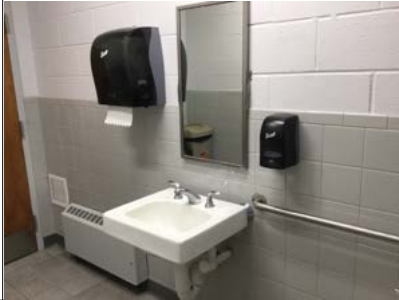
Controls > 42" high . Not operable with a closed fist	52.5" -	Relocate so the operable part is 42" max. above the finished floor. Provide a dispenser that can be operable with one hand and not require tight grasping, pinching, or twisting of the wrist.	1	456		\$456
27	Women's Toilet Room	1		Dispensers	Paper Towel Dispenser

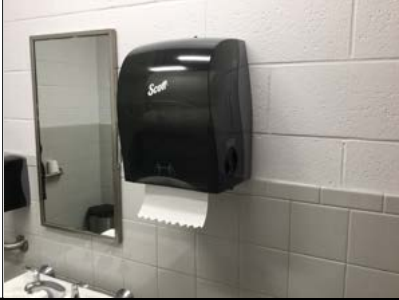
Controls > 42" high . Not operable with a closed fist	53" -	Relocate so the operable part is 42" max. above the finished floor. Provide a dispenser that can be operable with one hand and not require tight grasping, pinching, or twisting of the wrist.	1	456	\$456

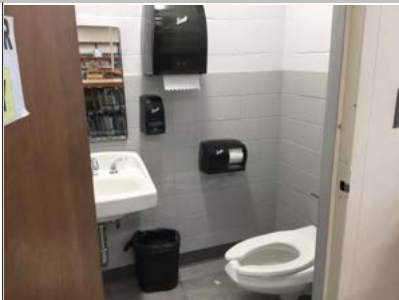
Toilet Rooms for Children													
Single-User Toilet (Children)													
28	Girls' and Boys' Toilet Room	1		Single-User Toilet (Children)	N/A

Clearance at toilet < 72" clear deep Clearance at toilet < 60" clear wide	- -	Provide one (1) accessible girls' and one (1) accessible boys' single-user toilet room.	2	24604	\$49208	
Best Practice

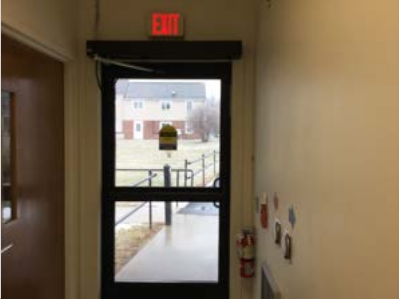
Illuminated Int. Symbol of Acc. not provided (MAAB) Tactile exit sign not provided		Provide an illuminated sign with the International Symbol of Accessibility. Ensure tactile exit signs with raised characters and braille are provided at exit doors. Mount signs between 48"- 60" above the finished floor located on the latch side of the door.	1	432	\$432
Approach and Entrance												
Exterior Access Route												
2	Towards Back Entrance	Ext.		Exterior Access Route	Exterior

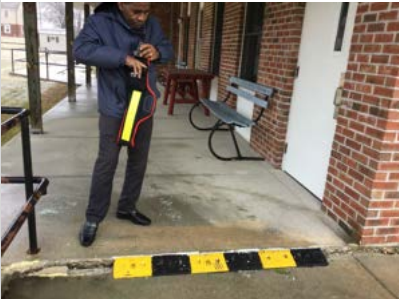
Level changes > 1/4"	2"	Alter change in level to be 1/4" high max. (Cost based on a 4'x4' concrete patch.)	1	256	\$256
3	Near Back Entrance	Ext.		Exterior Access Route	Walkway

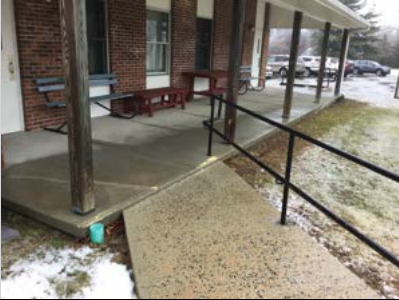
Level changes > 1/4"	2"	Alter change in level to be 1/4" high max. (Cost based on a 4'x4' concrete patch.)	1	256	\$256

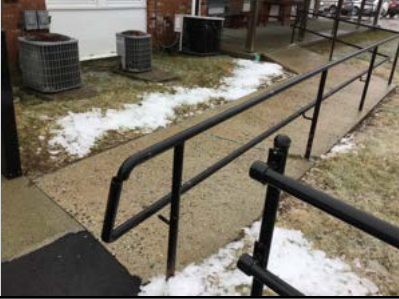
4	Near Back Entrance	Ext.		Exterior Access Route	N/A

Route not maintained in operable working condition	-	Ensure railing at the accessible route is maintained in operable working condition. (Repair railing.)	1	Labor	\$0

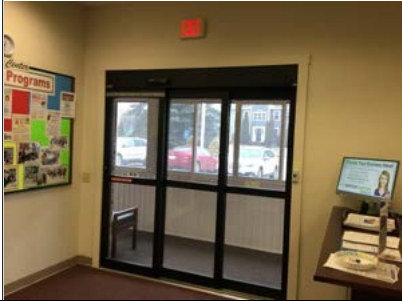
Illuminated Int. Symbol of Acc. not provided (MAAB) Tactile exit sign not provided	-	Provide an illuminated sign with the International Symbol of Accessibility. Ensure tactile exit signs with raised characters and braille are provided at exit doors. Mount signs between 48"- 60" above the finished floor located on the latch side of the door.	1	432	\$432

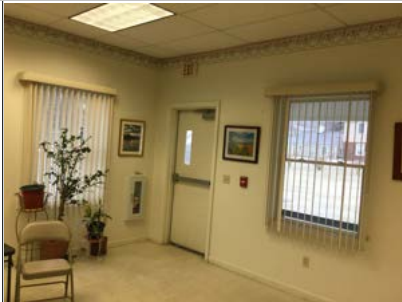
Access to Goods and Services												
Means of Egress												
7	Goddard Room	1		Means of Egress	N/A

Tactile exit sign not provided	-	Ensure tactile exit signs with raised characters and braille are provided at exit doors. Mount signs between 48"- 60" above the finished floor located on the latch side of the door.	1	232	\$232
8	Library in Goddard Room	1		Means of Egress	N/A

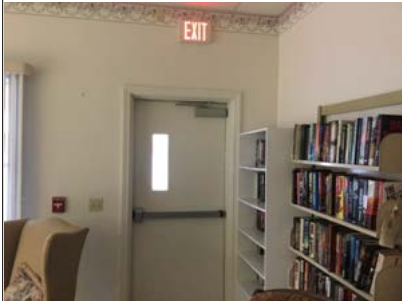
Tactile exit sign not provided	-	Ensure tactile exit signs with raised characters and braille are provided at exit doors. Mount signs between 48"- 60" above the finished floor located on the latch side of the door.	1	232	\$232

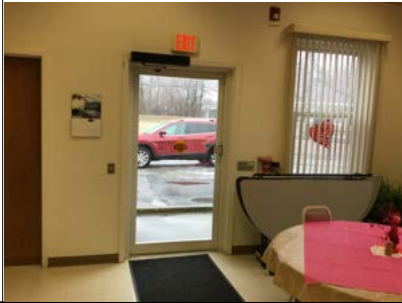
Tactile exit sign not provided	-	Ensure tactile exit signs with raised characters and braille are provided at exit doors. Mount signs between 48"- 60" above the finished floor located on the latch side of the door.	1	232	\$232
11	Dining Area	1		Means of Egress	N/A

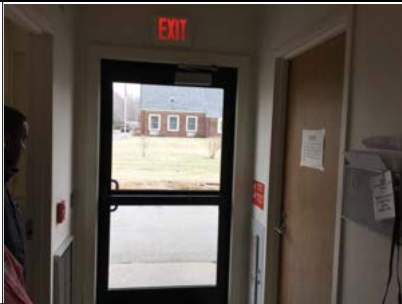
Tactile exit sign not provided	-	Ensure tactile exit signs with raised characters and braille are provided at exit doors. Mount signs between 48"- 60" above the finished floor located on the latch side of the door.	1	232	\$232

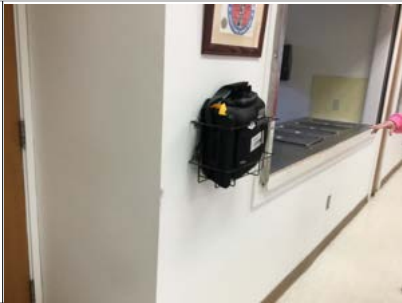
Interior Access Route												
12	Dining Area	1		Interior Access Route	N/A

Obstructed by protruding objects	-	Provide a cane-detectable barrier.	1	306	\$306
Doors, Doorways, & Gates												
13	Media Room	1		Doors, Doorways, & Gates	Circulation

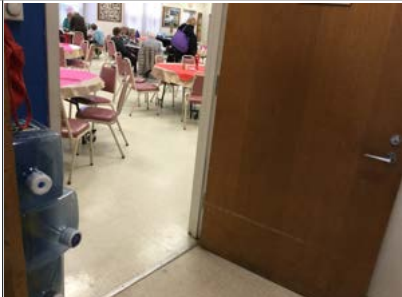
Maneuvering clearance(s) not provided	-	Remove the obstruction. (Relocate stored items to provide 18" maneuvering clearance on the pull side of the door.	1	Labor	\$0

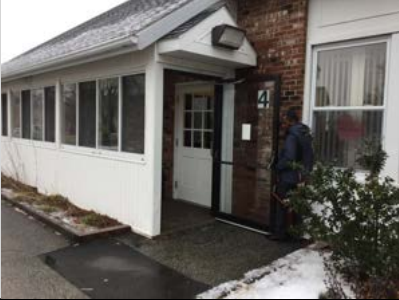
Threshold > 1/2" high	1.5"	Alter the threshold to be 1/2" high max.	1	150	\$150
15	Women's Toilet Room at Dining Area	1		Doors, Doorways, & Gates	Toilet Room

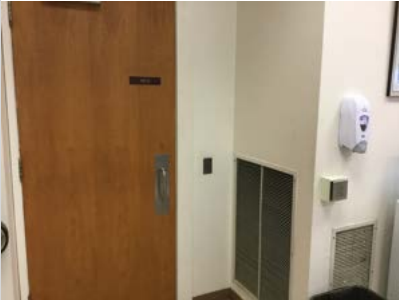
Automatic door opener not operable	-	Repair or replace the door opener at the door to the women's multi-user toilet room. (Note: The men's toilet room door is pictured, but the non operable power door opener is at the women's multi-user toilet room.)	1	3060	\$3060
Assembly Area												
16	Dining Area	1		Assembly Area	N/A

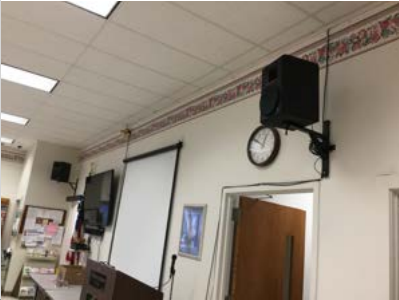
Assistive listening devices not provided	-	If audible communication is integral to the use of the space, provide an assistive listening system. (Cost based on a transmitter, receiver, ear speaker, neck loop and USB charger - Capacity: 50 or less.)	1	1214	\$1214

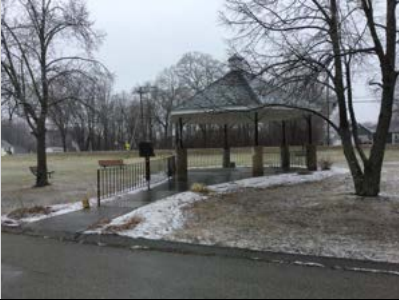
Exterior Benches												
17	Benches Surrounding Gazebo	Ext.		Exterior Benches	N/A

No accessible route to 20% of benches	-	Provide an accessible route to 20% of benches (at least one bench) in this area. (Cost based on a 48"x30 asphalt route.)	1	1200	\$1200
Toilet & Bathing Rooms

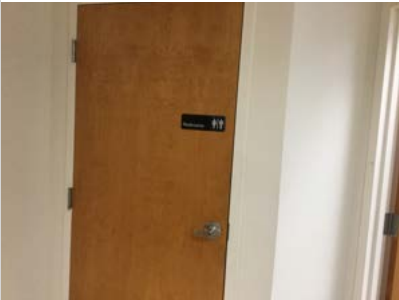
Raised characters not provided on sign Braille not provided on sign International Symbol of Acc. not provided Sign not located on the latch side of the door	-	Provide text with raised characters duplicated in braille on sign. Provide a sign with the International Symbol of Accessibility. Locate sign at permanent rooms alongside the door on the latch side.	1	232	\$232
19	Men's and Women's Toilet Room at Dining Area	1		Overall Access	Toilet Room

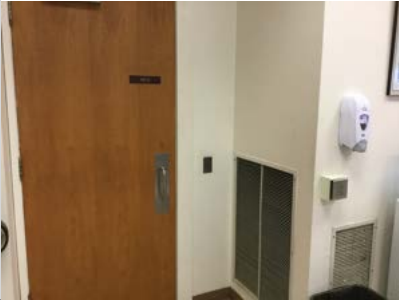
Raised characters not provided on sign Braille not provided on sign International Symbol of Acc. not provided Sign not located on the latch side of the door	- -	Provide text with raised characters duplicated in braille on sign. Provide a sign with the International Symbol of Accessibility. Locate sign at permanent rooms alongside the door on the latch side.	2	232	\$464

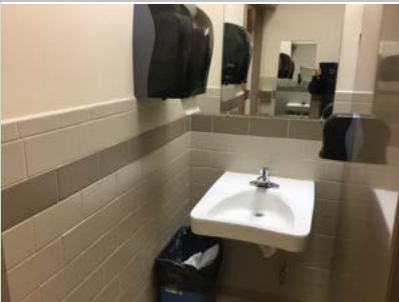
Lavatory												
20	Women's Toilet Room by Dining Area	1		Lavatory	N/A

Clear floor space not provided at lavatory	-	Provide at least one lavatory with a 30" min. by 48" min. clear floor space positioned for a forward approach. (Relocate paper towel dispenser and trash can.)	1	256	\$256
Toilet Compartment												
21	Men's Toilet Room at Dining Area	1		Toilet Compartment	Accessible Compartment

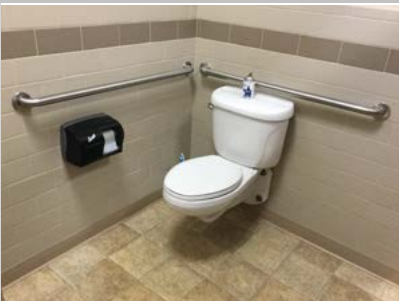
Flush control not on open side	-	Provide the flush control on the open side of the toilet (transfer side).	1	374	\$374
22	Women's Toilet Room by Dining Area	1		Toilet Compartment	Accessible Compartment

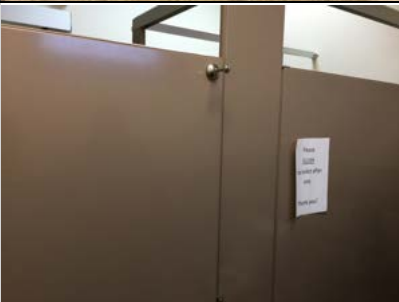
Coat hook > 48"	69"	Lower coat hook so that it is no higher than 48".	1	150	\$150

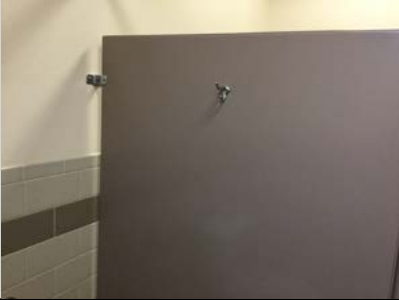
ID	Location	Floor	Room	Element	Type	Photo	Issues	Current Measure	Recommendations	Quantity	Price	Cost Estimation
23	Men's Toilet Room at Dining Area	1		Toilet Compartment	Accessible Compartment

Coat hook > 48"	64"	Lower coat hook so that it is no higher than 48".	1	150	\$150
Urinal												
24	Men's Toilet Room at Dining Area	1		Urinal	N/A

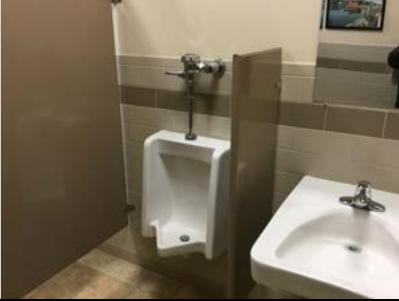
Rim > 17" high	20"	Provide at least one urinal with the rim no higher than 17" above the finished floor.	1	3248	\$3248

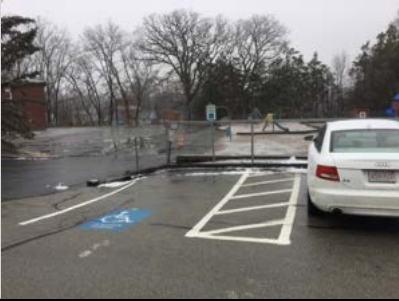
ID	Location	Floor	Room	Element	Type	Photo	Issues	Current Measure	Recommendations	Quantity	Price	Cost Estimation
Approach and Entrance												
Off-Street Parking Lot or Garage												
1	Parking Lot	Ext.		Off-Street Parking Lot or Garage	Employee

Access aisle < 60" wide at car/van space Sign bottom < 60" above finished grade	- 51.5"	Provide a marked access aisle that is at least 60" wide. Locate sign with the bottom of the sign 60" above the ground.	1	300	\$300
2	Parking Lot	Ext.		Off-Street Parking Lot or Garage	Visitor

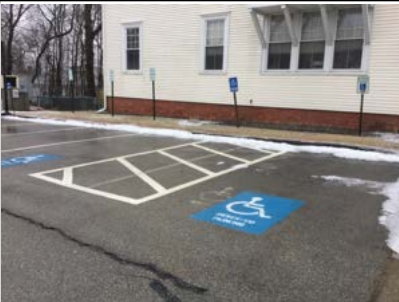
Sign bottom < 60" above finished grade	-	Locate sign with the bottom of the sign 60" min. above the ground.	2	Labor	\$0
Entrance												
3	Employee Entrance	1		Entrance

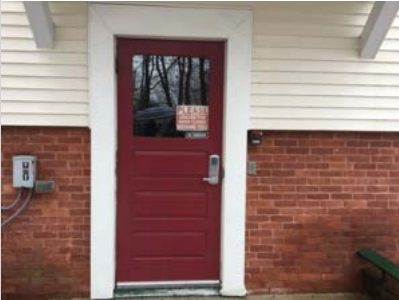
Entrance not on an accessible route Directional sign to accessible entrance not provided		Provide a directional sign indicating the location of the nearest accessible entrance.	1	346	\$346

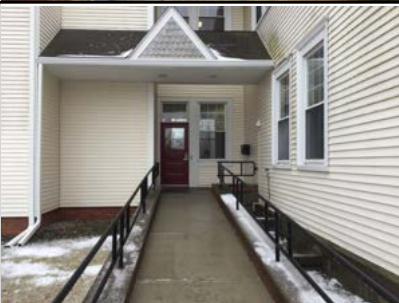
4	Accessible Entrance	1		Entrance	Secondary Entrance

International Symbol of Accessibility not provided	-	Provide the International Symbol of Accessibility.	1	346	\$346
5	Main Entrance	Ext.		Entrance	Main Entrance

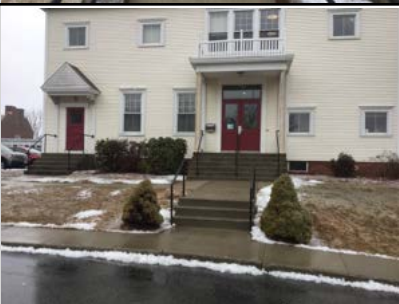
Entrance not on an accessible route Directional sign to accessible entrance not provided	- -	Provide a directional sign indicating the location of the nearest accessible entrance.	1	346	\$346

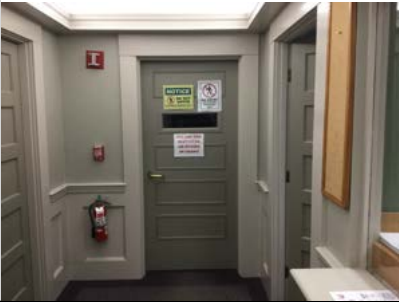
Tactile exit sign not provided	-	Ensure a tactile exit sign with raised characters and braille is provided at exit door. Mount sign between 48"- 60" above finished floor located on the latch side of the door.	1	232	\$232
8	Accessible Entrance	1		Means of Egress	N/A

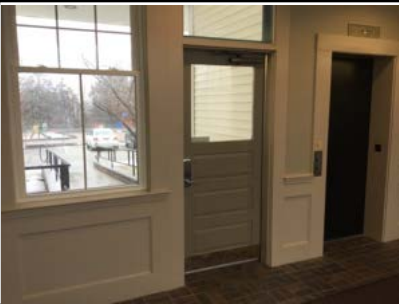
Tactile exit sign not provided Illuminated ISA symbol not provided (MAAB)	- -	Ensure a tactile exit sign with raised characters and braille is provided at exit door. Mount sign between 48"- 60" above finished floor located on the latch side of the door. Provide an illuminated International Symbol of Accessibility.	1	884	\$884

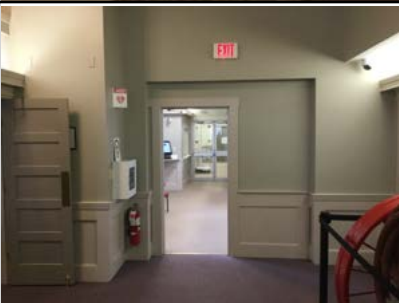
9	Exit Near Toilet Rooms	2		Means of Egress	147

Tactile exit sign not provided	- -	Ensure a tactile exit sign with raised characters and braille is provided at exit door. Mount sign between 48"- 60" above finished floor located on the latch side of the door.	1	232	\$232
Interior Access Route												
10	Lobby Near Elevator	1		Interior Access Route	N/A

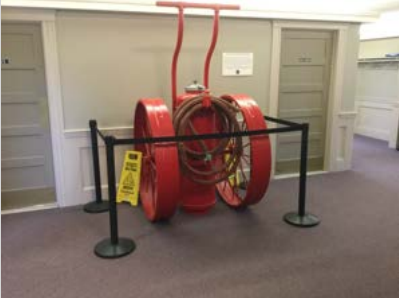
ID	Location	Floor	Room	Element	Type	Photo	Issues	Current Measure	Recommendations	Quantity	Price	Cost Estimation
11	Hallway Near Toilet Rooms	2		Interior Access Route	N/A

Obstructed by protruding objects	-	Provide a second stanchion cord at 27" cane-detectable barrier. Relocate stanchion cord to maintain the maneuvering clearance at the door	1	Labor	\$0
12	Selectmen's Meeting Room	2		Interior Access Route	N/A

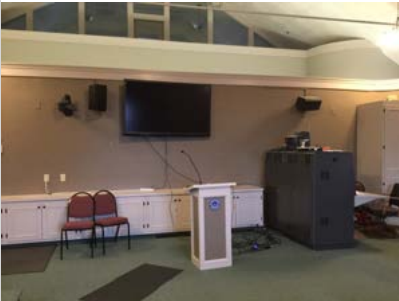
Mat not securely attached	-	Secure the mat.	1	Labor	\$0
Doors, Doorways, & Gates												
13	Women's Toilet Room	1		Doors, Doorways, & Gates	Toilet Room

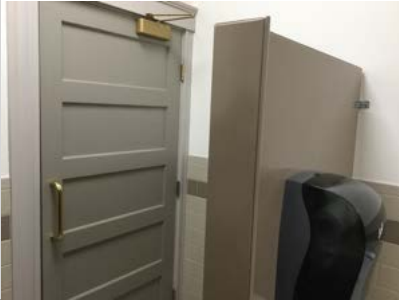
Maneuvering clearance(s) not provided	-	Relocate partition to maintain the required 54" min. maneuvering clearance at the pull side of the door.	1	256	\$256
14	Men's Toilet Room	1		Doors, Doorways, & Gates	Toilet Room

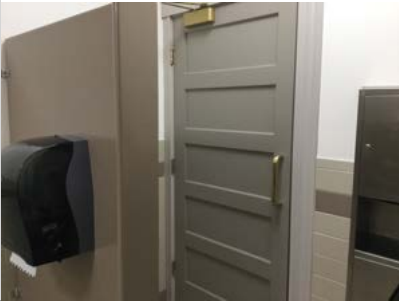
Maneuvering clearance(s) not provided Door requires > 5 lbs. of force to open	39" 9 lbs	Relocate partition to maintain the required 54" min. maneuvering clearance at the pull side of the door. Adjust closers so doors do not require more than 5 pounds of force to open.	1	256	\$256

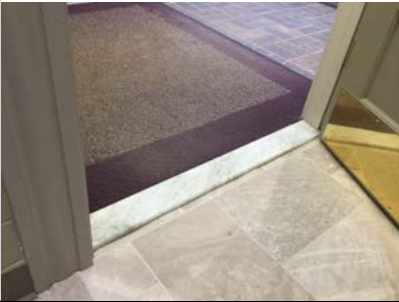
15	Women's Toilet Room & Men's Toilet Room	1		Doors, Doorways, & Gates	Toilet Room

Threshold not beveled	-	Bevel threshold.	2	150	\$300

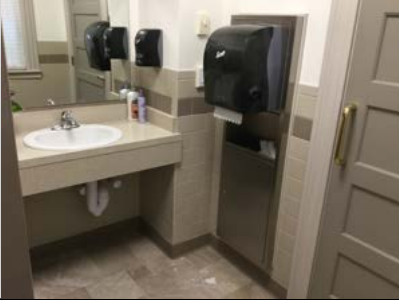
ID	Location	Floor	Room	Element	Type	Photo	Issues	Current Measure	Recommendations	Quantity	Price	Cost Estimation
16	Women's Toilet Room	2		Doors, Doorways, & Gates	Toilet Room

Maneuvering clearance(s) not provided	9.9" -	Relocate paper towel dispenser to maintain the required 18" maneuvering clearance at the door.	1	353	\$353
17	Men's Toilet Room	2		Doors, Doorways, & Gates	Circulation

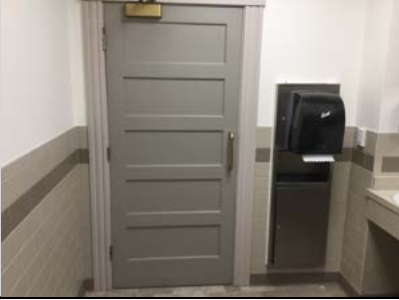
Maneuvering clearance(s) not provided	-	Relocate paper towel dispenser to maintain the required 18" maneuvering clearance at the door.	1	353	\$353
18	Planning Board	2		Doors, Doorways, & Gates	Meeting Room

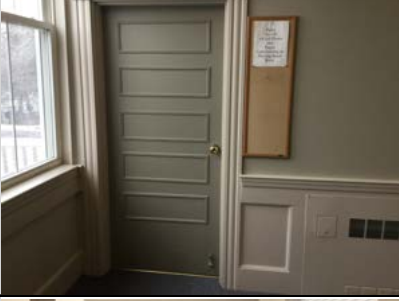
Hardware not operable with a closed fist	-	Provide hardware that can be operable with one hand and not require tight grasping, pinching, or twisting of the wrist.	1	484	\$484
19	Women's Toilet Room	2		Doors, Doorways, & Gates	Toilet Room
