Town of Auburn, Massachusetts

ADA Self-Evaluation and Transition Plan

September 2020

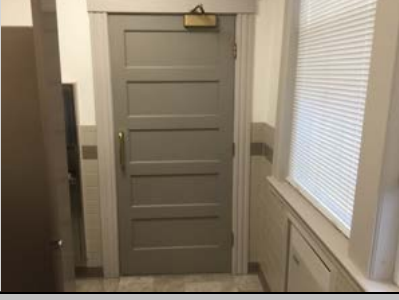
Door requires > 5 lbs. of force to open	9 lbs	Adjust closers so doors do not require more than 5 pounds of force to open.	1	Labor	\$0

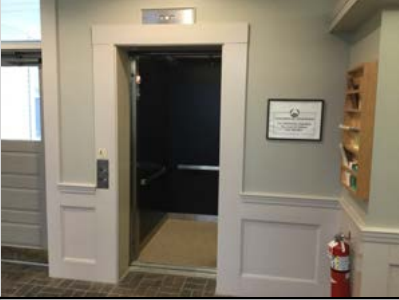
Elevator												
20	Lobby	1		Elevator	Interior

Tactile stars not provided at main entry level	-	Provide a tactile star on both sides of jambs at main floor. At other floors, provide appropriate number. Provide a tactile star at the main floor on the control panel within the car.	1	96	\$96

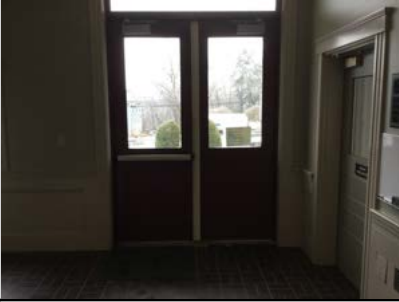
ID	Location	Floor	Room	Element	Type	Photo	Issues	Current Measure	Recommendations	Quantity	Price	Cost Estimation
Signage												
21	Main Entrance	1		Signage	Egress

Emergency exit not on an accessible route Directional sign to accessible emergency exit not provided	- -	Provide a directional sign indicating the location of the nearest accessible emergency exit.	1	232	\$232
22	Men's Toilet Room	1		Signage	Designation

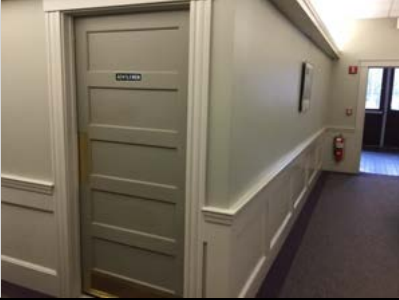
Raised characters not provided on sign Braille not provided on sign Sign not located on the latch side of the door International Symbol of Acc. not provided	- - -	Provide text with raised characters duplicated in braille on sign. Locate sign alongside the door on the latch side. Provide a sign with the International Symbol of Accessibility.	1	232	\$232
23	Women's Toilet Room	1		Signage	Designation

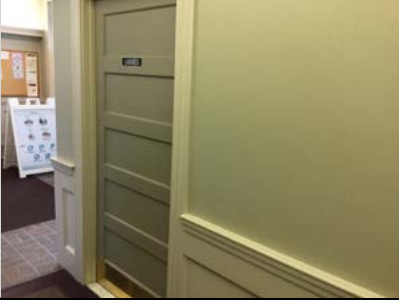
Raised characters not provided on sign Braille not provided on sign Sign not located on the latch side of the door International Symbol of Acc. not provided	- - -	Provide text with raised characters duplicated in braille on sign. Locate sign alongside the door on the latch side. Provide a sign with the International Symbol of Accessibility.	1	232	\$232

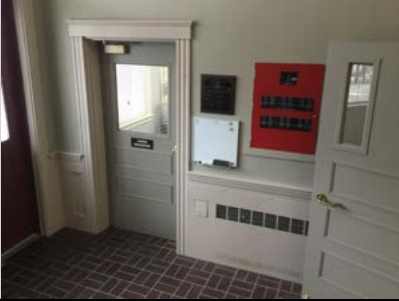
24	Human Resources	1		Signage	Designation

Raised characters not provided on sign Braille not provided on sign Sign not located on the latch side of the door	- - -	Provide text with raised characters duplicated in braille on sign. Locate sign alongside the door on the latch side.	1	232	\$232
25	Veterans Services	1		Signage	Designation

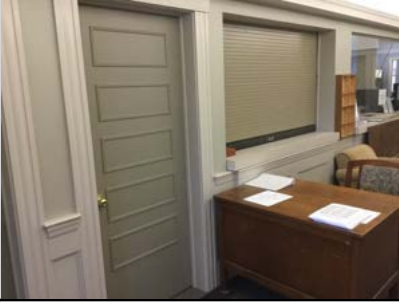
Raised characters not provided on sign Braille not provided on sign Sign not located on the latch side of the door	- - -	Provide text with raised characters duplicated in braille on sign. Locate sign alongside the door on the latch side.	1	232	\$232

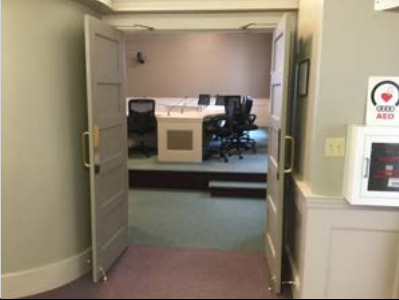
ID	Location	Floor	Room	Element	Type	Photo	Issues	Current Measure	Recommendations	Quantity	Price	Cost Estimation
26	Selectmen's Meeting Room	2		Signage	Designation

Signage is not provided	-	Locate compliant signage alongside the door on the latch side.	2	232	\$464
27	Women's Toilet Room	2		Signage	Designation

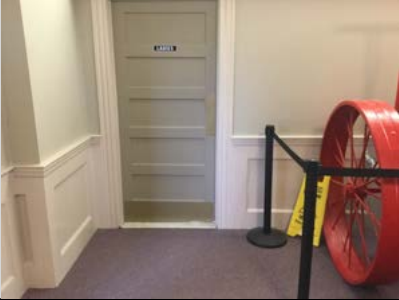
Raised characters not provided on sign Braille not provided on sign Sign not located on the latch side of the door International Symbol of Acc. not provided	<ul style="list-style-type: none">----	Provide text with raised characters duplicated in braille on sign. Locate sign alongside the door on the latch side. Provide a sign with the International Symbol of Accessibility.	1	232	
28	Men's Toilet Room	2		Signage	Designation

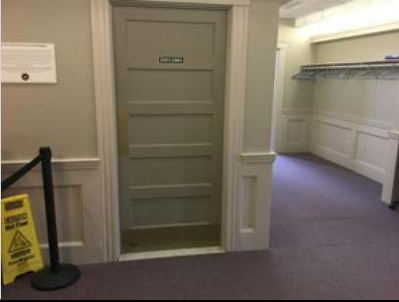
Raised characters not provided on sign Braille not provided on sign Sign not located on the latch side of the door International Symbol of Acc. not provided	<ul style="list-style-type: none">---	Provide text with raised characters duplicated in braille on sign. Locate sign alongside the door on the latch side. Provide a sign with the International Symbol of Accessibility.	1	232	\$232

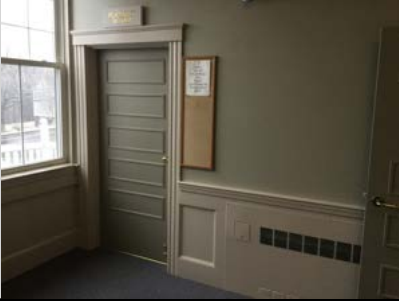
29	Planning Board	2		Signage	Designation

Raised characters not provided on sign Braille not provided on sign Sign not located on the latch side of the door	<ul style="list-style-type: none">---	Provide text with raised characters duplicated in braille on sign. Locate sign alongside the door on the latch side.	1	232	\$232
30	Hallway	2		Signage	Directional

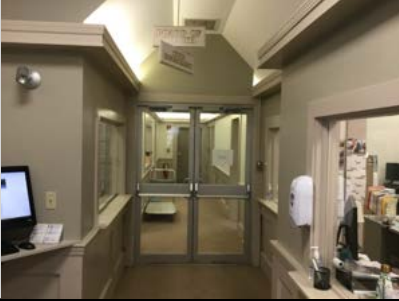
Contrast not provided on sign Text size non-compliant on sign	<ul style="list-style-type: none">--	Install a sign with characters that have a high contrast to the background. Ensure that character size on the sign complies with the Character Height Table 703.5.5 in the ADA 2010 Standards.	1	232	\$232

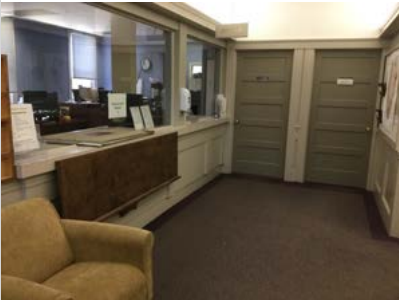
ID	Location	Floor	Room	Element	Type	Photo	Issues	Current Measure	Recommendations	Quantity	Price	Cost Estimation
Service Counter												
31	Assessor Office	1		Service Counter	N/A

Counter > 36" high	38"	Provide a counter that is 36" max. above the ground or finished floor.	1	880	\$880
32	Treasurer and Collector Office	1		Service Counter	N/A

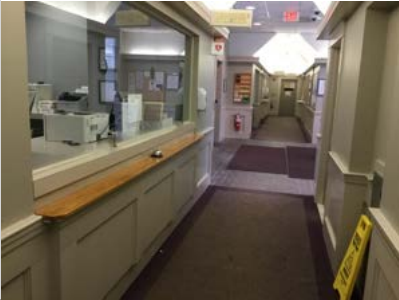
Counter > 36" high	41.7"	Provide a counter that is 36" max. above the ground or finished floor.	1	880	\$880
33	Town Clerk	1		Service Counter	N/A

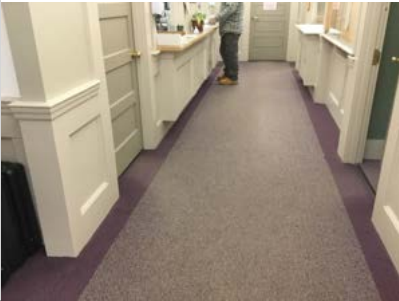
Counter > 36" high	37.5"	Provide a counter that is 36" max. above the ground or finished floor.	1	880	\$880
Operable Parts												
34	Hallway	2		Operable Parts	Clothes Rod/Hooks

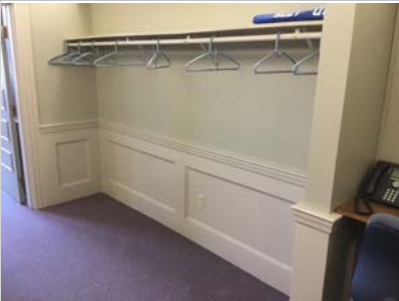
Side reach > 54"	66"	Mount clothes rod 48" above finished floor.	1	256	\$256
Dining or Work Surfaces												
35	Assessor Office	1		Dining or Work Surfaces	Work Surface

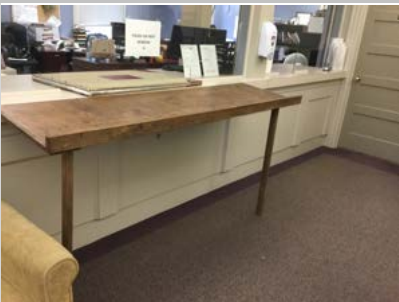
Top of dining/work surface < 28" or > 34"	38"	Provide a work surface with top between 28"-34" above the floor and 27" clear height underneath.	1	700	\$700

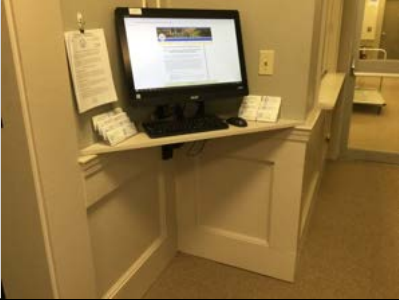
ID	Location	Floor	Room	Element	Type	Photo	Issues	Current Measure	Recommendations	Quantity	Price	Cost Estimation
36	Hallway	2		Dining or Work Surfaces	Work Surface

Top of dining/work surface < 28" or > 34"	37"	Provide a work surface with tops between 28"-34" above the floor and 27" clear height underneath.	1	700	\$700
Assembly Area												
37	Selectmen's Meeting Room	2		Assembly Area	N/A

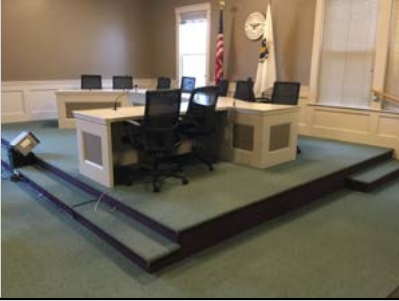
Accessible route to stage not provided Assistive listening devices not provided	- -	Provide a temporary ramp as needed to ensure an accessible route to the stage. If audible communication is integral to the use of the space, provide an assistive listening system.	1	2100	\$2100
Toilet & Bathing Rooms												
Lavatory												
38	Women's Toilet Room	1		Lavatory	419

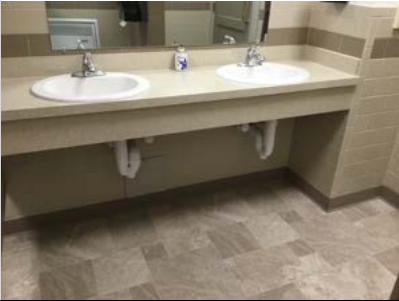
Dispensers not within reach range	49.5"	Relocate dispenser to 42" max. above the floor.	1	353	\$353
Toilet Compartment

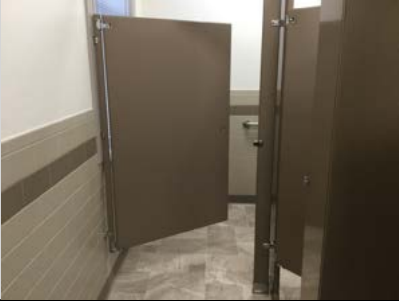
39	Women's Toilet Room	1		Toilet Compartment	Accessible Compartment

Door has malfunctioning self-closing hinge	-	Repair hinge.	1	Labor	\$0

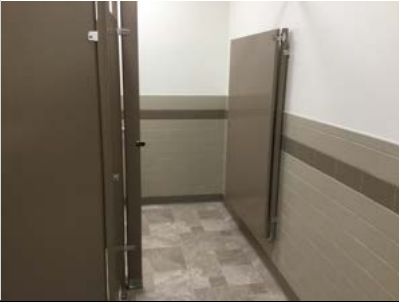
ID	Location	Floor	Room	Element	Type	Photo	Issues	Current Measure	Recommendations	Quantity	Price	Cost Estimation
40	Men's Toilet Room	1		Toilet Compartment	Accessible Compartment

Door has malfunctioning self-closing hinge Coat hook > 48"	- 55"	Repair hinge. Lower coat hook so that it is no higher than 48".	1	150	\$150
41	Women's Toilet Room	2		Toilet Compartment	Accessible Compartment

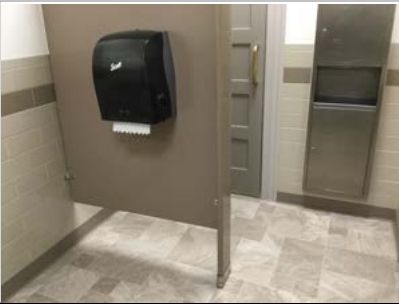
Dispensers												
44	Men's Toilet Room	1		Dispensers	Paper Towel Dispenser

Not operable with a closed fist	-	Provide a dispenser that can be operable with one hand and not require tight grasping, pinching, or twisting of the wrist.	1	200	\$200

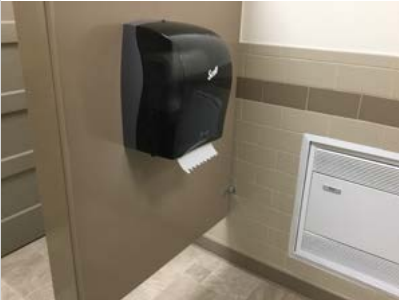
ID	Location	Floor	Room	Element	Type	Photo	Issues	Current Measure	Recommendations	Quantity	Price	Cost Estimation
45	Women's Toilet Room	1		Dispensers	Paper Towel Dispenser

Not operable with a closed fist	-	Provide a dispenser that can be operable with one hand and not require tight grasping, pinching, or twisting of the wrist.	1	200	\$200
46	Men's Toilet Room	2		Dispensers	Paper Towel Dispenser

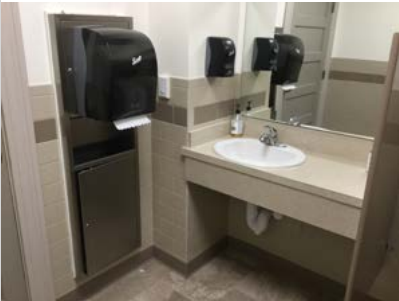
Not operable with a closed fist	-	Provide a dispenser that can be operable with one hand and not require tight grasping, pinching, or twisting of the wrist.	1	200	\$200
47	Women's Toilet Room	2		Dispensers	Paper Towel Dispenser

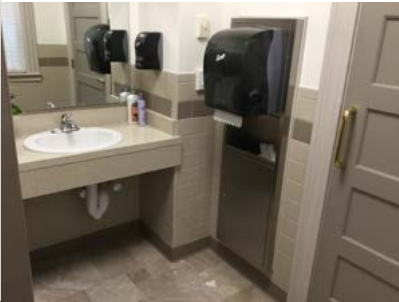
Not operable with a closed fist	-	Provide a dispenser that can be operable with one hand and not require tight grasping, pinching, or twisting of the wrist.	1	200	\$200
Best Practice												
Desk												
48	Hallway	1		Desk	N/A

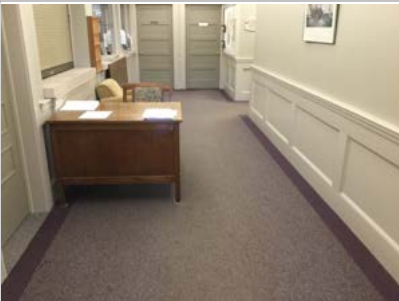
Recommend Providing a work surface with 27" min. knee and toe clearance.	1	-	\$0

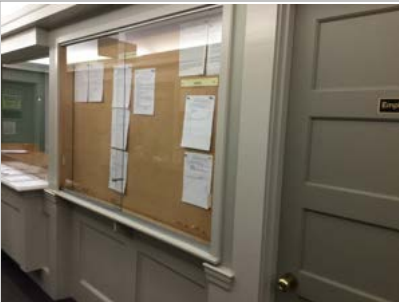
Informaiton Board												
49	Lobby Near Town Clerck	1		nformation Board	N/A

Recommend relocating the information board to avoid glare.	1	-	\$0

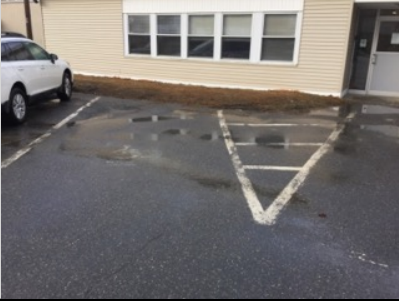
ID	Location	Floor	Room	Element	Type	Photo	Issues	Current Measure	Recommendations	Quantity	Price	Cost Estimation
Approach and Entrance												
Off-Street Parking Lot or Garage												
1	Parking Lot	Ext.		Off-Street Parking Lot or Garage	Employee

Total # of parking Total # of designated accessible parking spaces Total # of designated van accessible spaces	8 - -	Provide a van accessible space that is at least 132" wide with a marked access aisle that is at least 96" wide. Provide a sign with the bottom of the sign 60" min. above the ground and the top 96" max. Add the designation "Van Accessible" to the sign.	1	0	\$0
Emergency Exit												
2	Entrance/ Exit From Conference Room	Ext.		Emergency Exit	N/A

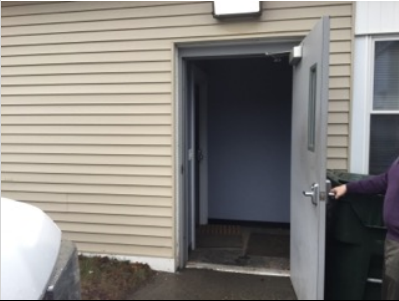
Mat not securely attached	-	Secure the mat.	1	Labor	\$0
3	Exit/Entrance From Conference Room	1		Emergency Exit	N/A

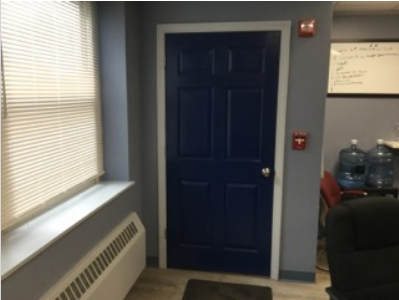
Mat not securely attached Hardware not operable with a closed fist	- -	Secure the mat. Provide hardware that can be operable with one hand and not require tight grasping, pinching, or twisting of the wrist.	1	484	\$484

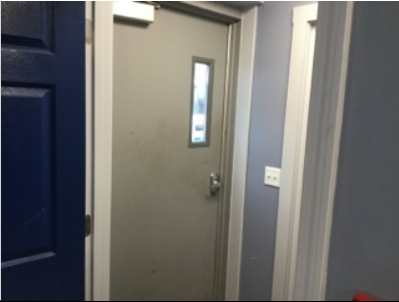
Access to Goods and Services												
Means of Egress												
4	Entrance/ Exit From Conference Room	1		Means of Egress	N/A

Tactile exit sign not provided Illuminated ISA symbol not provided (MAAB)	- -	Ensure a tactile exit sign with raised characters and braille is provided at exit door. Mount sign between 48"- 60" above the finished floor located on the latch side of the door. Provide an illuminated sign with the International Symbol of Accessibility.	1	884	\$884

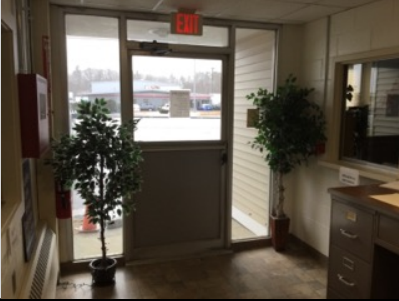
ID	Location	Floor	Room	Element	Type	Photo	Issues	Current Measure	Recommendations	Quantity	Price	Cost Estimation
5	Main Entrance	1		Means of Egress	N/A

Tactile exit sign not provided Illuminated ISA symbol not provided (MAAB)	- -	Ensure tactile exit signs with raised characters and braille are provided at exit doors. Mount signs between 48"- 60" above the finished floor located on the latch side of the door. Provide an illuminated sign with the International Symbol of Accessibility.	1	432	\$432
Doors, Doorways, & Gates												
6		1		Doors, Doorways, & Gates	Office

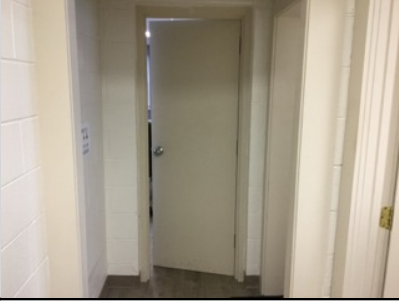
Clear width at door < 32" Hardware not operable with a closed fist	25.5" -	Widen the door so that there is 32" min. clear width. Provide hardware that can be operable with one hand and not require tight grasping, pinching, or twisting of the wrist.	1	3366	\$3366
7	Men's Toilet Room	1		Doors, Doorways, & Gates	Toilet Room

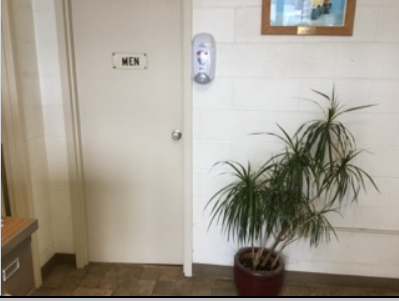
Hardware not operable with a closed fist	-	Provide hardware that can be operable with one hand and not require tight grasping, pinching, or twisting of the wrist.	1	484	\$484

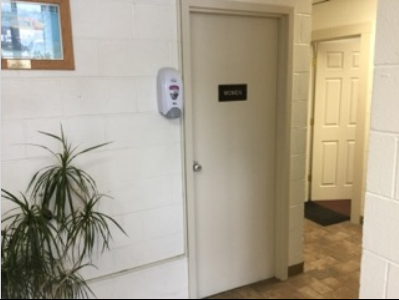
Signage												
8	Women's Toilet Room & Men's Toilet Room	1		Signage	Designation

Raised characters not provided on sign Braille not provided on sign Sign not located on the latch side of the door	- - -	Provide text with raised characters duplicated in braille on sign. Locate sign at permanent rooms alongside the door on the latch side.	2	232	\$464
Toilet & Bathing Rooms

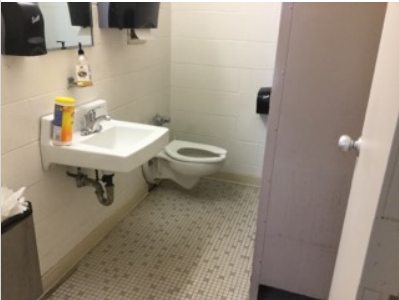
ID	Location	Floor	Room	Element	Type	Photo	Issues	Current Measure	Recommendations	Quantity	Price	Cost Estimation
Overall Access												
9	Women's Toilet Room	1		Overall Access	Toilet Room

Accessible plumbing fixtures or stalls not provided	-	Provide an accessible single-user toilet room.	1	24604	\$24604
Lavatory												
10	Men's Toilet Room	1		Lavatory	N/A

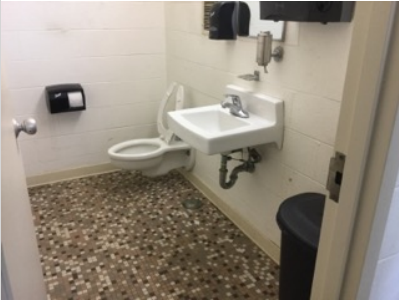
Plumbing underneath is exposed	-	Insulate or otherwise configure pipes to prevent contact for at least one lavatory.	1	92	\$92
Single-User Toilet												
11	Men's Toilet Room	1		Single-User Toilet	N/A

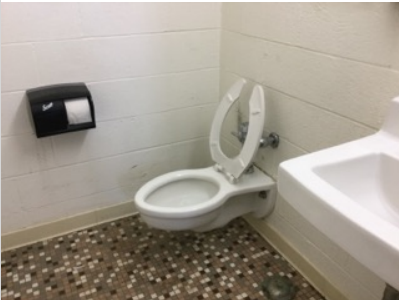
Flush control not on open side Grab bar not provided	- -	Relocate the flush control to the open side. Provide one grab bar on the side wall of the toilet and one on the rear wall.	1	2170	\$2170
Best Practice												
Window												
12	Highway Division	1		Window	N/A

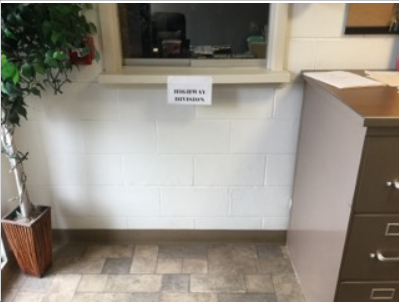
- Recommend relocating the file cabinet located near the window at the Highway Division to provide a forward and parallel clear floor space at the window.

Recommend relocating file cabinet to provide a forward and parallel clear floor space at the window.	1	-	\$0

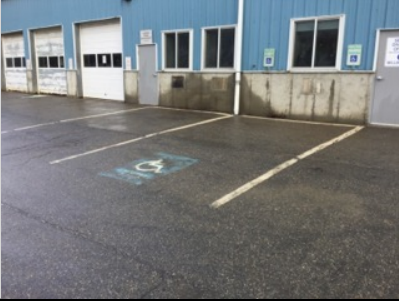
ID	Location	Floor	Room	Element	Type	Photo	Issues	Current Measure	Recommendations	Quantity	Price	Cost Estimation
Approach and Entrance												
Off-Street Parking Lot or Garage												
1	Parking Lot	Ext.		Off-Street Parking Lot or Garage	Employee

Access aisle not provided Sign bottom < 60" above finished grade	- 53"	Provide a marked access aisle that is at least 96" wide. Locate sign with the bottom of the sign 60" above the ground.	1	0	\$0
Access to Goods and Services												
Interior Access Route												
2		1		Interior Access Route	N/A

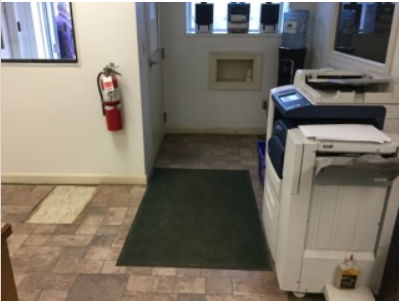
Mat not securely attached	-	Secure the mat.	1	Labor	\$0
Doors, Doorways, & Gates												
3	Women's Toilet Room	1		Doors, Doorways, & Gates	Toilet Room

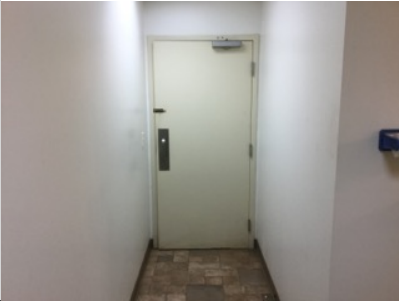
Maneuvering clearance(s) not provided	-	Provide an automatic door opener.	1	-	\$0
4	Men's Toilet Room	1		Doors, Doorways, & Gates	Toilet Room

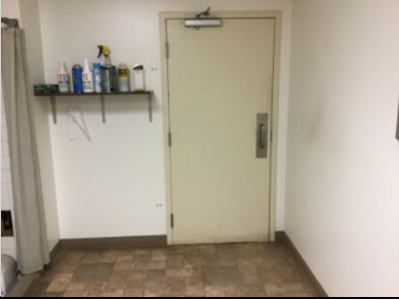
Maneuvering clearance(s) not provided Door requires > 5 lbs. of force to open Obstructed by protruding objects	- 15 lbs	Change the swing of the door to provide the required maneuvering clearance at the door. Adjust closer so door does not require more than 5 pounds of force to open. Relocate shelf to maintain the maneuvering clearance at the door.	1	-	\$0

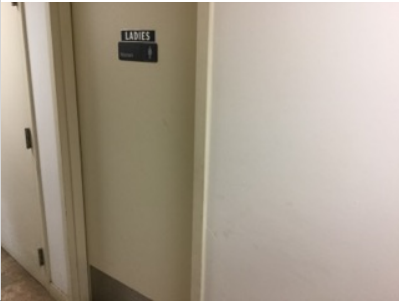
ID	Location	Floor	Room	Element	Type	Photo	Issues	Current Measure	Recommendations	Quantity	Price	Cost Estimation
Signage												
5	Women's Toilet Room	1		Signage	Designation

Raised characters not provided on sign Braille not provided on sign Sign not located on the latch side of the door	- - -	Provide text with raised characters duplicated in braille on sign. Locate sign at permanent rooms alongside the door on the latch side.	1	0	\$0
6	Men's Toilet Room	1		Signage	Designation

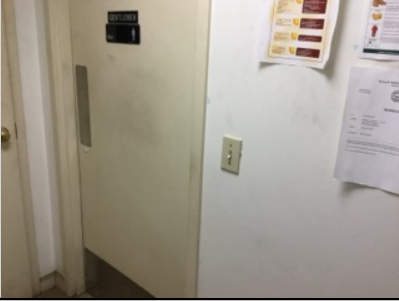
Raised characters not provided on sign Braille not provided on sign Sign not located on the latch side of the door	- - -	Provide text with raised characters duplicated in braille on sign. Locate sign at permanent rooms alongside the door on the latch side.	1	0	\$0
Dining or Work Surfaces												
7	Meeting Room	1		Dining or Work Surfaces	Work Surface

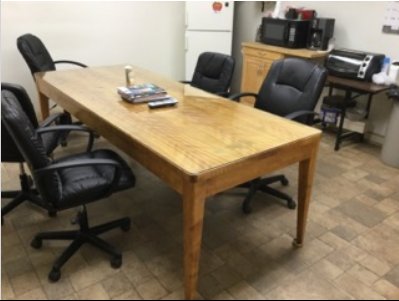
Knee or toe clearance not provided	25"	Provide at least 1 dining or work surface with 27" min. knee and toe clearance.	1	0	\$0

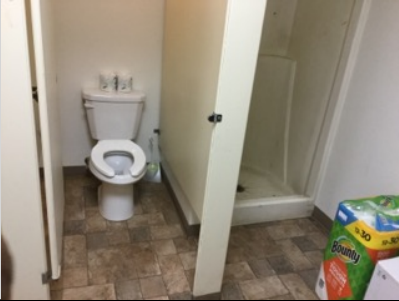
Toilet & Bathing Rooms												
Overall Access												
8	Women's Toilet Room	1		Overall Access	Toilet Room

Accessible plumbing fixtures or stalls not provided	-	Provide one accessible wheelchair compartment.	1	-	\$0

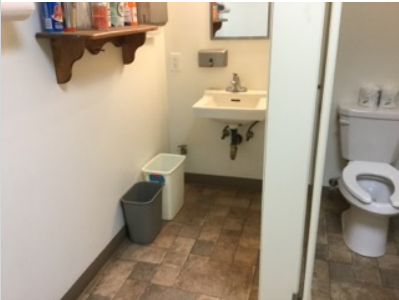
ID	Location	Floor	Room	Element	Type	Photo	Issues	Current Measure	Recommendations	Quantity	Price	Cost Estimation
Lavatory												
9	Women's Toilet Room	1		Lavatory	N/A

Plumbing underneath is exposed Mirror above lavatory w/reflective surface > 40" Obstructed by protruding objects	- 46"	Insulate or otherwise configure pipes to prevent contact at the lavatory. Lower mirror so that the bottom surface is at 40" max. above the finished floor. Relocate shelf so it does not protrude into the circulation path.	1	-	\$0
10	Men's Toilet Room	1		Lavatory	N/A

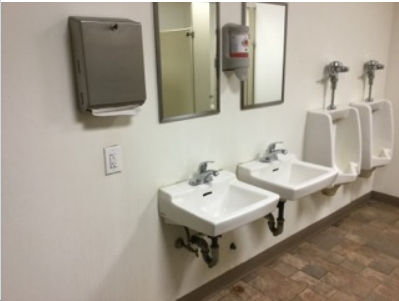
Plumbing underneath is exposed Mirror above lavatory w/reflective surface > 40" Dispensers not within reach range	- 46" 59"	Insulate or otherwise configure pipes to prevent contact for at least one lavatory. Lower mirror so that the bottom surface is at 40" max. above the finished floor. Lower dispensers to 42" max. above the floor.	1	-	\$0

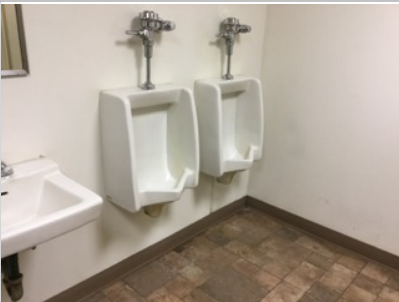
Urinal												
11	Men's Toilet Room	1		Urinal	N/A

Rim > 17" high	23.5"	Provide at least one urinal with the rim no higher than 17" above the finished floor.	1	-	\$0
Dispensers												
12	Men's Toilet Room	1		Dispensers	Paper Towel Dispenser

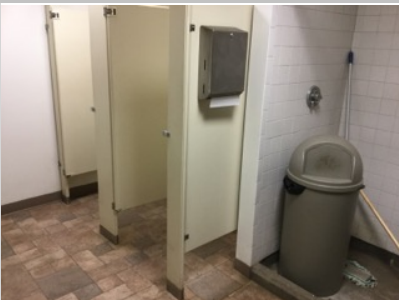
Controls > 42" high	50"	Lower paper towel dispenser so the operable part is 42" max. above the finished floor.	1	-	\$0

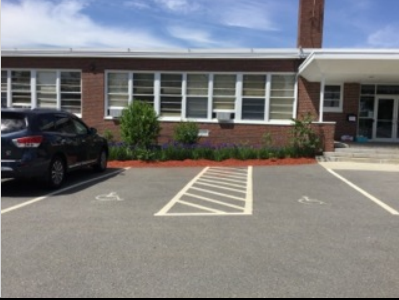
ID	Location	Floor	Room	Element	Type	Photo	Issues	Current Measure	Recommendations	Quantity	Price	Cost Estimation
Approach and Entrance												
Off-Street Parking Lot or Garage												
1	Parking	Ext.		Off-Street Parking Lot or Garage	Visitor

Total # of parking Total # of designated accessible parking spaces Total # of designated van accessible spaces Access aisle < 60" wide at car/van space Sign not provided Sign does not have the designation "Van Accessible"	19 1 1 58" - -	Provide a marked access aisle that is at least 60" wide. Provide a sign at each of the two accessible parking spaces with the International Symbol of Accessibility (ISA) sign with the bottom of the sign 60" min. above the ground and the top 96" max. above the ground. Add the designation "Van Accessible" to the sign located at the van accessible space.	1	1300	\$1300
Entrance												
2	Egress Door 2	Ext		Entrance	Secondary Entrance

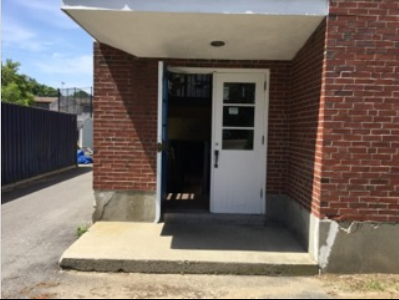
Entrance not on an accessible route Directional sign to accessible entrance not provided	- -	Provide a directional sign indicating the location of the nearest accessible entrance.	1	346	\$346

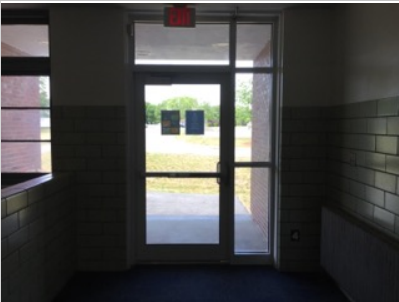
Emergency Exit												
3	Egress Door 4	1		Emergency Exit	N/A

Tactile sign not provided at exit Directional sign to accessible emergency exit not provided	-	Provide tactile exit signs with raised characters and braille at exit doors. Mount signs between 48"- 60" above the finished floor located on the latch side of the door. Provide a directional sign indicating the location of the nearest accessible emergency exit.	1	464	\$464
4	Egress Door 2	1		Emergency Exit	N/A

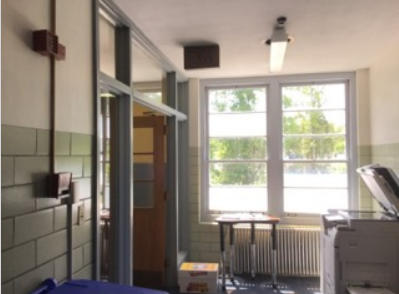
Directional sign to accessible emergency exit not provided Tactile exit sign not provided	-	Provide a directional sign indicating the location of the nearest accessible emergency exit. Ensure tactile exit signs with raised characters and braille are provided at exit doors. Mount signs between 48"- 60" above the finished floor located on the latch side of the door.	2	232	\$464

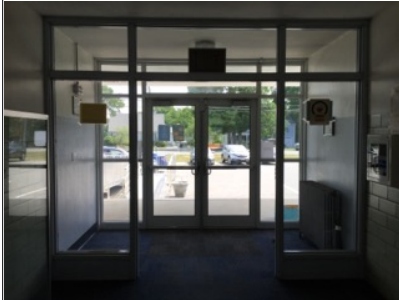
ID	Location	Floor	Room	Element	Type	Photo	Issues	Current Measure	Recommendations	Quantity	Price	Cost Estimation	
5		1		Emergency Exit	N/A

Illuminated Int. Symbol of Acc. not provided (MAAB) Door requires > 15 lbs. of force to open Tactile exit sign not provided	- 22lbs	Provide an illuminated sign with the International Symbol of Accessibility (ISA). Adjust closers of exterior doors so doors do not require more than 15 pounds of force. Note: Fire doors shall have a minimum opening force allowable by the appropriate administrative authority. Ensure tactile exit signs with raised characters and braille are provided at exit doors.	1	432	\$432	
Access to Goods and Services													
Means of Egress													
6	Main Entrance East Side	1		Means of Egress	N/A

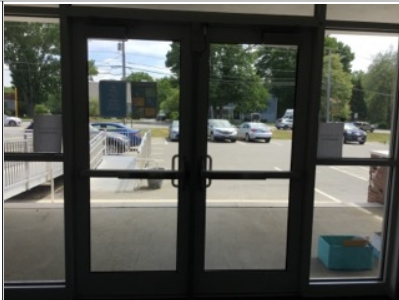
Tactile exit sign not provided Door requires > 5 lbs. of force to open	-	Ensure tactile exit signs with raised characters and braille are provided at exit doors. Mount signs between 48"- 60" above the finished floor located on the latch side of the door. Adjust closers so doors do not require more than 5 pounds of force to open.	1	232	\$232

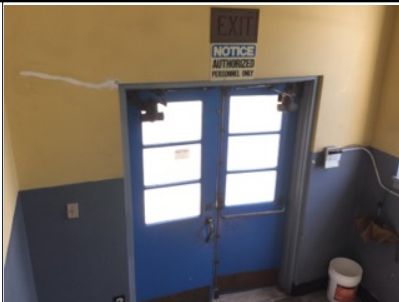
7	Egress Door 2	B		Means of Egress	N/A

Tactile exit sign not provided Door requires > 5 lbs. of force to open	-	Ensure tactile exit signs with raised characters and braille are provided at exit doors. Mount signs between 48"- 60" above the finished floor located on the latch side of the door. Adjust closers so doors do not require more than 5 pounds of force to open.	1	232		\$232
Interior Access Route													
8	Main Entrance East Side	1		Interior Access Route	N/A

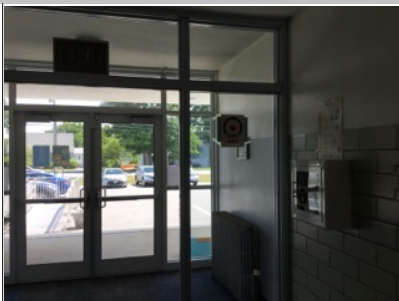
Obstructed by protruding objects	-	Provide a cane-detectable barrier 27" max. above the ground at the AED.	1	306	\$306	
9	Right Next to Entrance	1		Interior Access Route	N/A

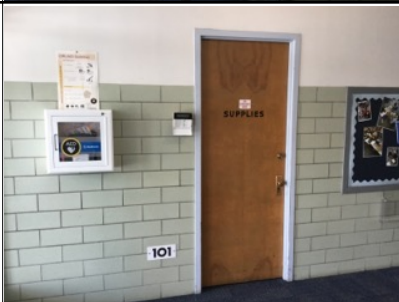
Obstructed by protruding objects	7"	Provide a cane-detectable barrier 27" max. above the ground at the AED.	1	306		\$306

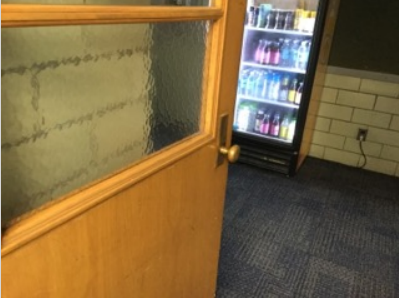
ID	Location	Floor	Room	Element	Type	Photo	Issues	Current Measure	Recommendations	Quantity	Price	Cost Estimation
Doors, Doorways, & Gates												
10	Meeting Room	1		Doors, Doorways, & Gates	Meeting Room

Hardware not operable with a closed fist	-	Provide hardware that can be operable with one hand and not require tight grasping, pinching, or twisting of the wrist.	1	484	\$484
11	Men's and Boys' Toilet Room	1		Doors, Doorways, & Gates	Toilet Room

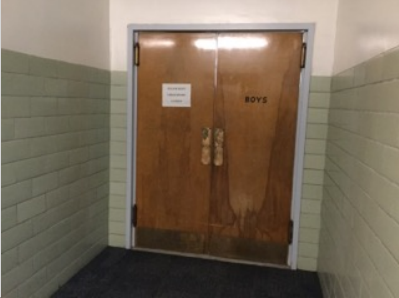
Door requires > 5 lbs. of force to open	7 lbs.	Adjust closers so doors do not require more than 5 pounds of force to open.	1	Labor	\$0
12	Women's and Girls' Toilet Room	1		Doors, Doorways, & Gates	Toilet Room

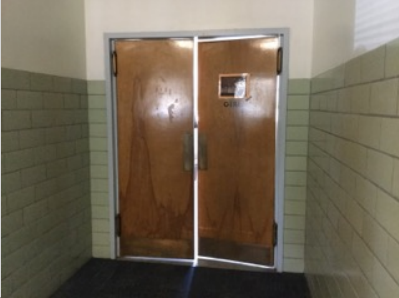
Door requires > 5 lbs. of force to open	11 lbs.	Adjust closers so doors do not require more than 5 pounds of force to open.	1	Labor	\$0
Signage												
13	Supply Rooms 101 and 113	1		Signage	Designation

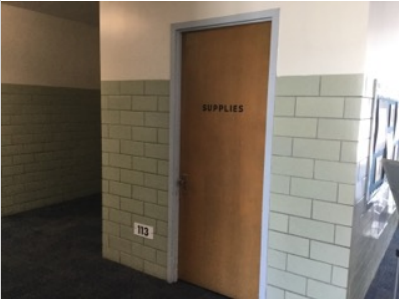
Raised characters not provided on sign Braille not provided on sign Sign not located on the latch side of the door	- - -	Provide text with raised characters duplicated in braille on sign. Locate sign at permanent rooms alongside the door on the latch side.	2	232	\$464

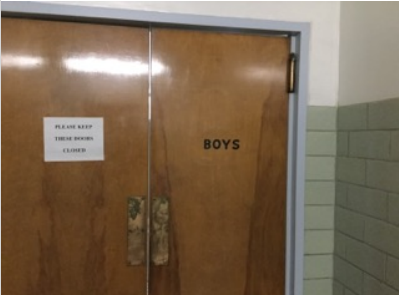
14	Men's and Boys' Toilet Room	1		Signage	Designation

Raised characters not provided on sign Braille not provided on sign Sign not located on the latch side of the door	- - -	Provide text with raised characters duplicated in braille on sign. Locate sign at permanent rooms alongside the door on the latch side.	1	232	\$232

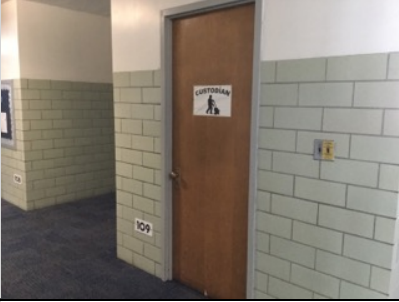
ID	Location	Floor	Room	Element	Type	Photo	Issues	Current Measure	Recommendations	Quantity	Price	Cost Estimation
15	Custodian Room 109	1		Signage	Designation

Raised characters not provided on sign Braille not provided on sign Sign not located on the latch side of the door	- - -	Provide text with raised characters duplicated in braille on sign. Locate sign at permanent rooms alongside the door on the latch side.	1	232	\$232
16	Women's and Girls' Toilet Room	1		Signage	Designation

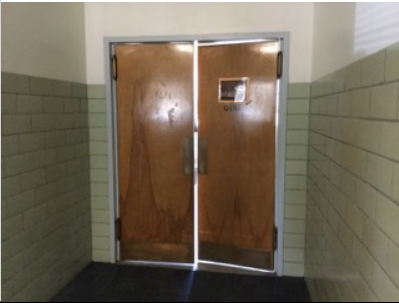
Raised characters not provided on sign Braille not provided on sign Sign not located on the latch side of the door	- - -	Provide text with raised characters duplicated in braille on sign. Locate sign at permanent rooms alongside the door on the latch side.	1	232	\$232
17	Main Office 102	1		Signage	Designation

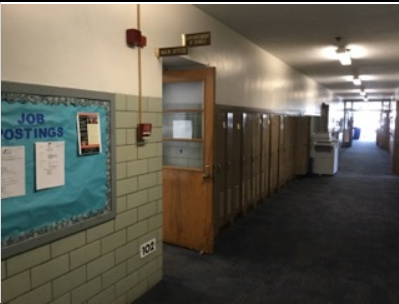
Raised characters not provided on sign Braille not provided on sign Sign not located on the latch side of the door	- - -	Provide text with raised characters duplicated in braille on sign.. Locate sign at permanent rooms alongside the door on the latch side.	1	232	\$232

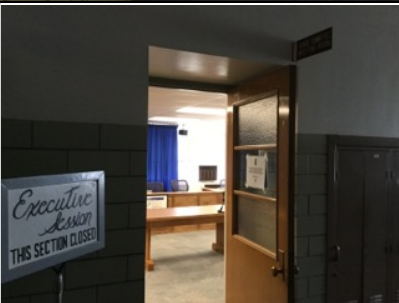
18	Meeting Room	1		Signage	Designation

Raised characters not provided on sign Braille not provided on sign Sign not located on the latch side of the door	- - -	Provide text with raised characters duplicated in braille on sign. Provide braille on sign. Locate sign at permanent rooms alongside the door on the latch side.	1	232	\$232
Service Counter												
19	Main Office	1		Service Counter	N/A

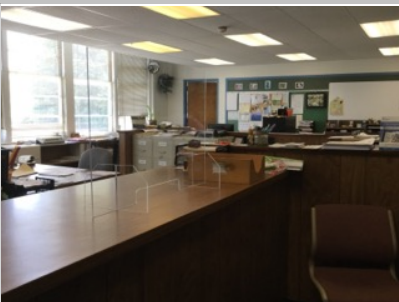
Counter > 36" high	41"	Provide a counter that is 36" max. above the ground or finished floor.	1	880	\$880

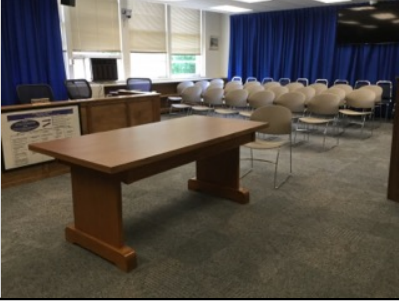
ID	Location	Floor	Room	Element	Type	Photo	Issues	Current Measure	Recommendations	Quantity	Price	Cost Estimation
Dining or Work Surfaces												
20	Meeting Room	1		Dining or Work Surfaces	Work Surface

Knee or toe clearance not provided	24"	Provide at least 1 work surface with 27" min. knee and toe clearance.	1	700	\$700
Assembly Area												
21	Meeting Room	1		Assembly Area	N/A

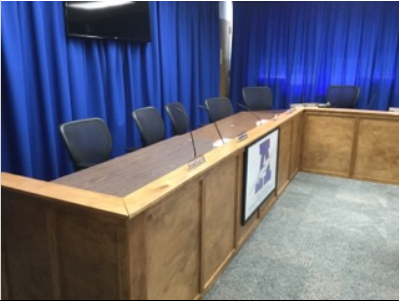
Assistive listening devices not provided	-	If audible communication is integral to the use of the space, provide an assistive listening system and a sign indicating the assistive listening system is available. (Cost based on a transmitter, receiver, ear speaker, neck loop and USB charger - Capacity: 50 or less and a sign.)	1	1446	\$1446
Toilet & Bathing Rooms												
Lavatory												
22	Men's and Boys' Toilet Room	1		Lavatory	N/A

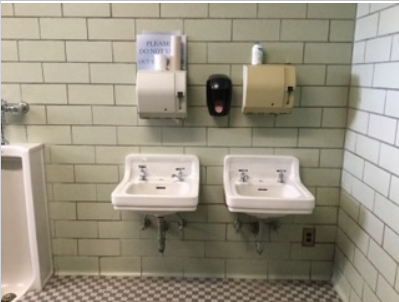
Toe or knee clearances not provided Plumbing underneath is exposed Mirror above lavatory w/reflective surface > 40" Dispensers not within reach range	23" - 48" 56"	Provide at least one lavatory with knee and toe clearance positioned for a forward approach. Insulate or otherwise configure pipes to prevent contact for at least one lavatory. Lower mirror so that the bottom surface is at 40" max. above the finished floor. Lower soap dispenser to 42" max. above the floor.	1	2387	\$2387

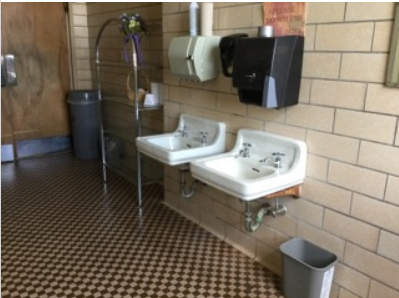
23	Women's and Girls' Toilet Room	1		Lavatory	N/A

Toe or knee clearances not provided Plumbing underneath is exposed Mirror above lavatory w/reflective surface > 40" Dispensers not within reach range	23" - 48" 54"	Provide at least one lavatory with knee and toe clearance positioned for a forward approach. Insulate or otherwise configure pipes to prevent contact for at least one lavatory. Lower mirror so that the bottom surface is at 40" max. above the finished floor. Lower soap dispenser to 42" max. above the floor.	1	2387	\$2387

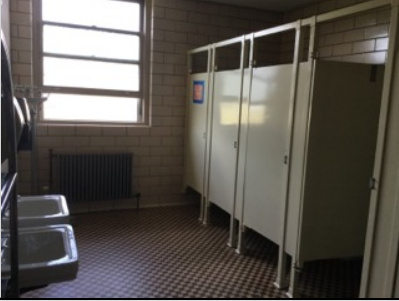
Clearance at toilet < 72" clear depth (MAAB)	-	Provide a wheelchair accessible compartment that is 60" wide and 72" deep.	1	6182	\$6182
Best Practice												
Egress Stairway												
26	Egress Door 2	1		Egress Stairway	N/A

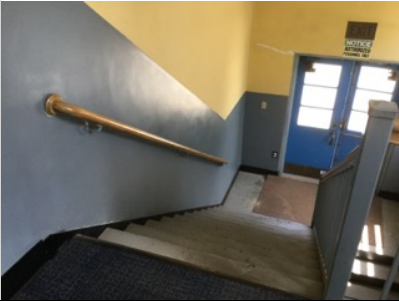
Recommend providing handrails that are 34"-38" high above the floor that extend horizontally above the landing for 12" min. beginning above the first and last riser nosing. Recommend adding contrasting strips at the edge of each step at the stairs leading to the main entrance and at the interior stairs.	1	-	\$0

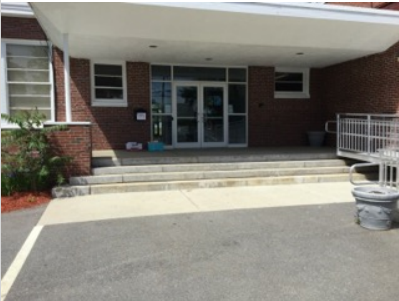
Exterior Stairs												
27	Main Entrance East Side	Ext.		Exterior Stairs	N/A

Recommend providing handrails at exterior stairs.	2	-	\$0

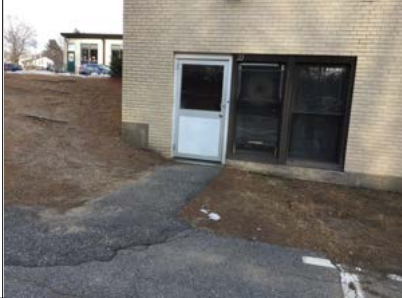
ID	Location	Floor	Room	Element	Type	Photo	Issues	Current Measure	Recommendations	Quantity	Price	Cost Estimation
Approach and Entrance												
Exterior Access Route												
1	Door #22	Ext.		Exterior Access Route	Exterior

Level changes > 1/4"	-	Alter change in level to be 1/4" high max. (Cost for a 3x3 asphalt patch.)	1	160	\$160
Off-Street Parking Lot or Garage												
2	By Ramp to Door #5	Ext.		Off-Street Parking Lot or Garage	N/A

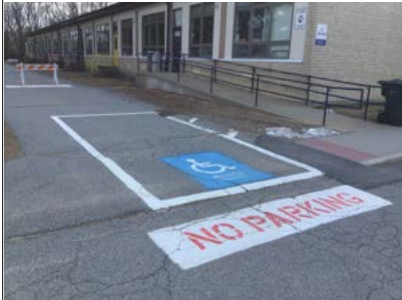
Total # of parking Total # of designated van accessible spaces Access aisle < 96" wide at van space Sign not provided Sign does not have the designation "Van Accessible"	21 1 - - -	Provide a marked access aisle that is at least 96" wide. Provide a sign with the International Symbol of Accessibility (ISA) with the bottom of the sign 60" min. above the ground and the top 96" max. above the ground. Add the designation "Van Accessible" to the sign located at the van accessible space.	1	800	\$800

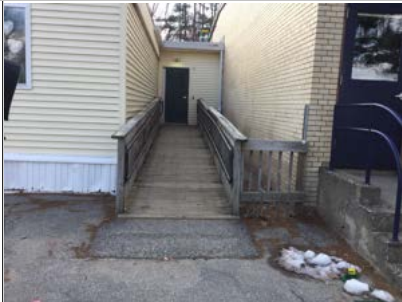
Exterior Ramp												
3	Ramp to Door #12	Ext.		Exterior Ramp	N/A

Handrails do not extend 12" past top & bottom	-	Alter handrails to extend horizontally above the landing for 12" min. beyond the bottom of ramp runs. (Cost based on welding 12" extensions on to both existing railings at the bottom of the ramp run.)	2	142	\$284
Exterior Stair												
4	Main Entrance	Ext.		Exterior Stair	N/A

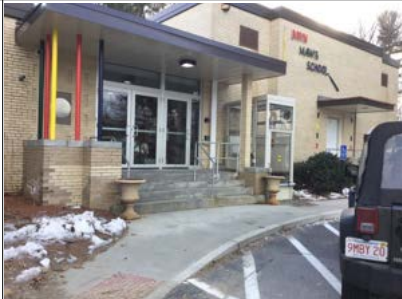
Handrails do not extend 12" from stair	-	Ensure that the sloped bottom extension extends one tread depth minimum beyond last riser nosing in same direction as stair flight. (Cost for two metal railing extensions.)	2	142	\$284

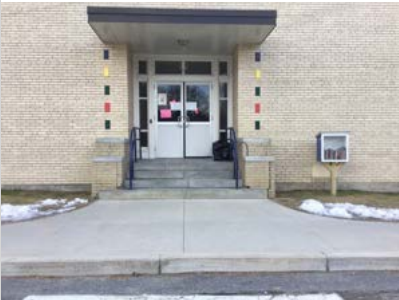
ID	Location	Floor	Room	Element	Type	Photo	Issues	Current Measure	Recommendations	Quantity	Price	Cost Estimation
Entrance												
5	Back Entrance and Book Exchange	Ext.		Entrance	Secondary Entrance

Directional sign to accessible entrance not provided	-	Provide a directional sign indicating the location of the nearest accessible entrance.	1	346	\$346
Access to Goods and Services												
Means of Egress												
6	Cafeteria	1	126	Means of Egress	N/A

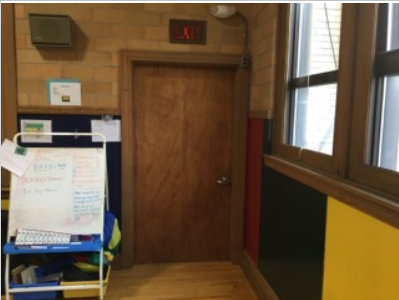
Tactile exit sign not provided	-	Ensure a tactile exit sign with raised characters and braille is provided at exit door. Mount sign between 48"- 60" above the finished floor located on the nearest adjacent wall.	1	232	\$232
7		1	126	Means of Egress	N/A

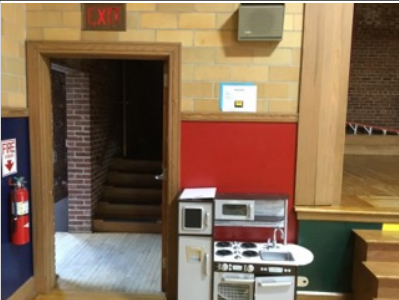
Tactile exit sign not provided	-	Ensure a tactile exit sign with raised characters and braille is provided at exit door. Mount sign between 48"- 60" above the finished floor located on the latch side of the door.	1	232	\$232

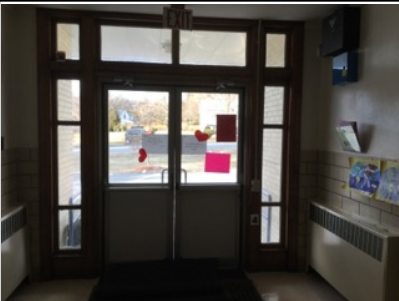
8	Exit #4	1	110	Means of Egress	N/A

Tactile exit sign not provided	-	Ensure a tactile exit sign with raised characters and braille is provided at exit door. Mount sign between 48"- 60" above the finished floor located on the latch side of the door.	1	232	\$232
9	Technology Room - Exit #8	1	112	Means of Egress	N/A

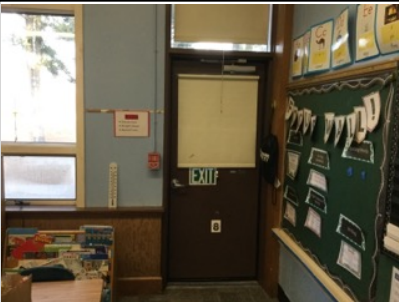
Tactile exit sign not provided	-	Ensure a tactile exit sign with raised characters and braille is provided at exit door. Mount sign between 48"- 60" above the finished floor located on the latch side of the door.	1	232	\$232

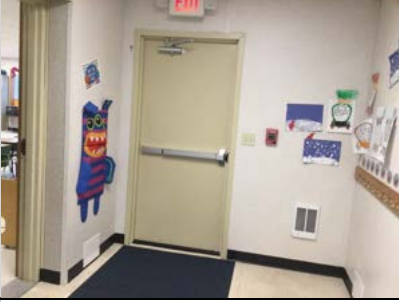
ID	Location	Floor	Room	Element	Type	Photo	Issues	Current Measure	Recommendations	Quantity	Price	Cost Estimation
10	Exit #15	1		Means of Egress	N/A

Tactile exit sign not provided	-	Ensure a tactile exit sign with raised characters and braille is provided at exit door. Mount sign between 48"- 60" above the finished floor located on the latch side of the door.	1	232	\$232
11	Classroom Near Exit #15 Egress to Stairs	1		Means of Egress	N/A

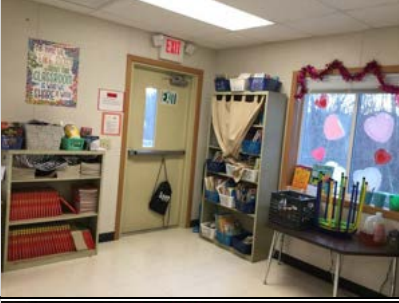
Tactile exit sign not provided	-	Ensure a tactile exit sign with raised characters and braille is provided at exit door. Mount sign between 48"- 60" above the finished floor located on the latch side of the door.	1	232	\$232
12	Exit #20	1	126	Means of Egress	N/A

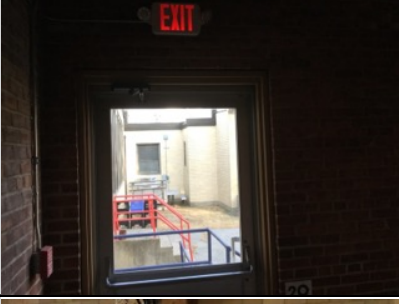
Tactile exit sign not provided Emergency exit not on an accessible route	- -	Ensure a tactile exit sign with raised characters and braille is provided at exit door. Mount sign between 48"- 60" above the finished floor located on the latch side of the door. Provide a directional sign indicating the location of the nearest accessible emergency exit.	1	232	\$232

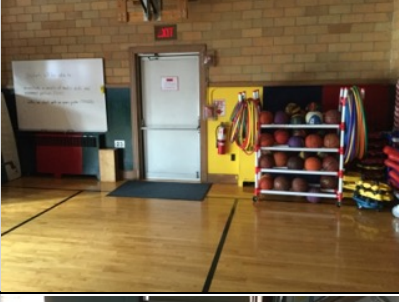
13	Gymnasium	1	126	Means of Egress	N/A

Tactile exit sign not provided Emergency exit not on an accessible route	-	Ensure a tactile exit sign with raised characters and braille is provided at exit door. Mount sign between 48"- 60" above the finished floor located on the latch side of the door. Provide a directional sign indicating the location of the nearest accessible emergency exit.	1	232	\$232
14	2nd Grade Classroom	1	107	Means of Egress	N/A

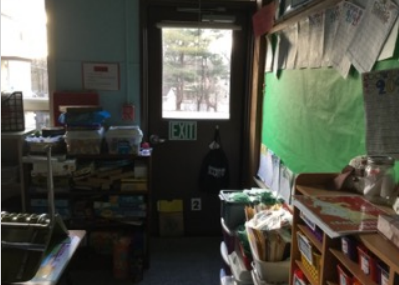
Tactile exit sign not provided Maneuvering clearance(s) not provided		Ensure a tactile exit sign with raised characters and braille is provided at exit door. Mount sign between 48"- 60" above the finished floor located on the latch side of the door. Remove stored items to maintain the maneuvering clearance at the door.	1	232	\$232

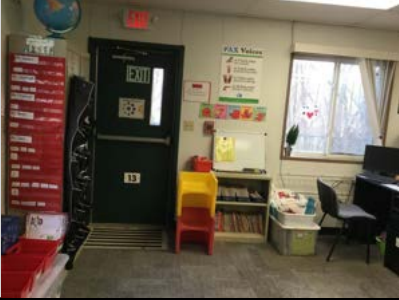
ID	Location	Floor	Room	Element	Type	Photo	Issues	Current Measure	Recommendations	Quantity	Price	Cost Estimation
15	Classroom - Exit #13	1	116	Means of Egress	N/A

Tactile exit sign not provided Maneuvering clearance(s) not provided	-	Ensure a tactile exit sign with raised characters and braille is provided at exit door. Mount sign between 48"- 60" above the finished floor located on the latch side of the door. Remove stored items to maintain the maneuvering clearance at the door.	1	232	\$232
16	Exit #14	1	117	Means of Egress	N/A

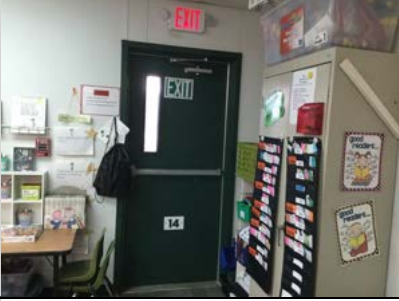
Tactile exit sign not provided Maneuvering clearance(s) not provided	-	Ensure a tactile exit sign with raised characters and braille is provided at exit door. Mount sign between 48"- 60" above the finished floor located on the latch side of the door. Remove stored items to maintain the maneuvering clearance at the door.	1	232	\$232
17	Exit #6	1	110	Means of Egress	N/A

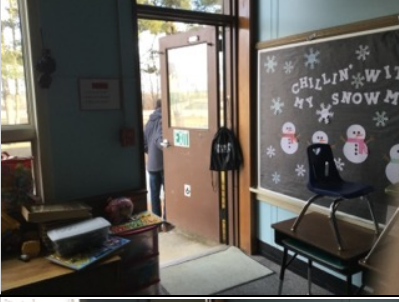
Tactile exit sign not provided Maneuvering clearance(s) not provided	-	Ensure a tactile exit sign with raised characters and braille is provided at exit door. Mount sign between 48"- 60" above the finished floor located on the latch side of the door. Remove stored items to maintain the maneuvering clearance at the door.	1	232	\$232

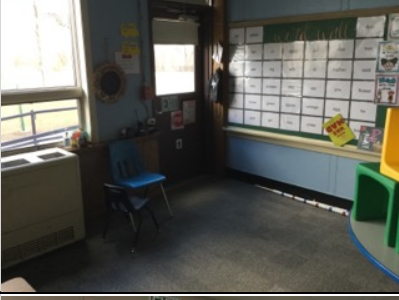
18	Exit #5	1	109	Means of Egress	N/A

Tactile exit sign not provided Illuminated ISA symbol not provided (MAAB)	- -	Ensure a tactile exit sign with raised characters and braille is provided at exit door. Mount sign between 48"- 60" above the finished floor located on the latch side of the door. Provide an illuminated sign with the International Symbol of Accessibility.	1	432	\$432
19	Exit # 12 - To Ramp	1	117	Means of Egress	N/A

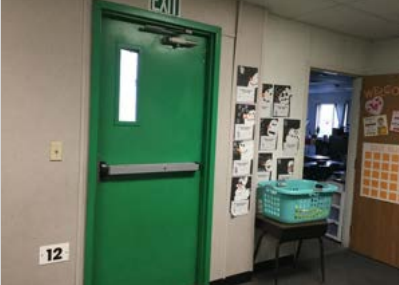
Tactile exit sign not provided Illuminated ISA symbol not provided (MAAB)	- -	Ensure a tactile exit sign with raised characters and braille is provided at exit door. Mount sign between 48"- 60" above the finished floor located on the latch side of the door. Provide an illuminated sign with the International Symbol of Accessibility.	1	432	\$432

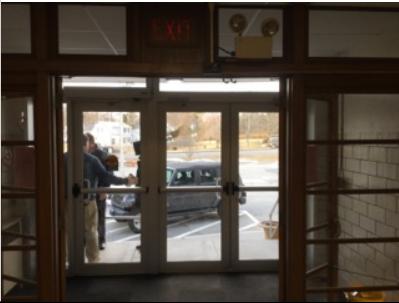
Illuminated ISA symbol not provided (MAAB)	-	Provide an illuminated sign with the International Symbol of Accessibility.	1	200	\$200
22	Exit #22	B		Means of Egress	N/A

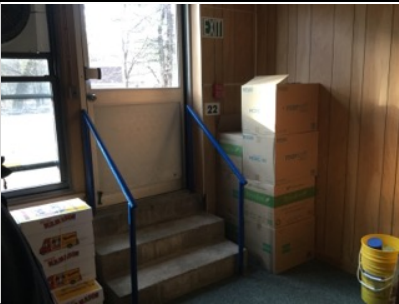
Tactile exit sign not provided Emergency exit not on an accessible route		Ensure a tactile exit sign with raised characters and braille is provided at exit door. Mount sign between 48" - 60" above the finished floor located on the latch side of the door. Provide a directional sign indicating the location of the nearest accessible emergency exit.	1	232	\$232
Interior Access Route

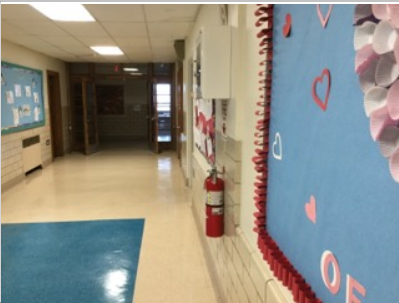
23	Hallway	1		Interior Access Route	N/A

Obstructed by protruding objects	-	Provide a cane-detectable barrier.	1	306	\$306
24	Reading Room	1	B05	Interior Access Route	N/A

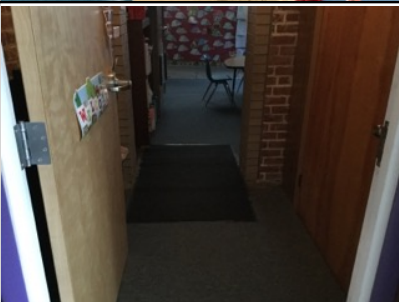
Mat not securely attached	-	Secure the mat.	1	Labor	\$0

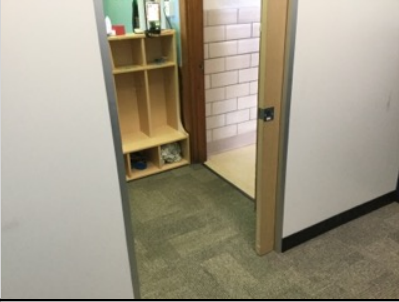
ID	Location	Floor	Room	Element	Type	Photo	Issues	Current Measure	Recommendations	Quantity	Price	Cost Estimation
Doors, Doorways, & Gates												
25	Special Needs Classroom	1	109	Doors, Doorways, & Gates	Classroom

Clear width at door < 32" Hardware not operable with a closed fist	30" -	Widen the door so that there is 32" min. clear width. Provide hardware that can be operable with one hand and not require tight grasping, pinching, or twisting of the wrist.	1	3850	\$3850
26	Special Needs Classroom	1	109	Doors, Doorways, & Gates	Classroom

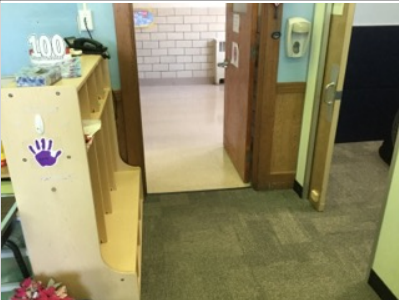
Maneuvering clearance(s) not provided	-	Remove cabinet to maintain the maneuvering clearance at the door.	1	Labor	\$0
27	Exit #2 - 2nd Grade Classroom	1	107	Doors, Doorways, & Gates	Assembly Space

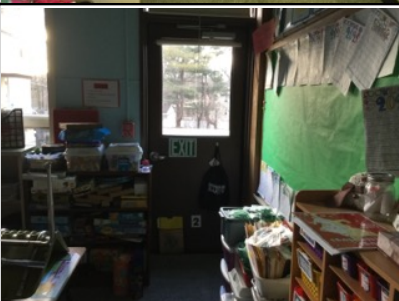
Maneuvering clearance(s) not provided	-	Remove storage to maintain the maneuvering clearance at the door.	1	Labor	\$0
28	Hallway	1	116	Doors, Doorways, & Gates	Classroom

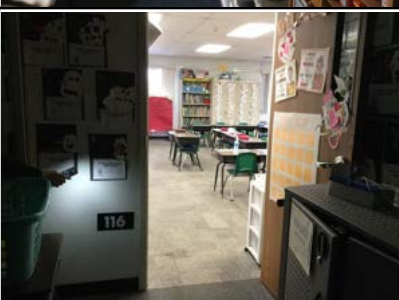
Maneuvering clearance(s) not provided	-	Remove stored items to maintain the maneuvering clearance at the door	1	Labor	\$0

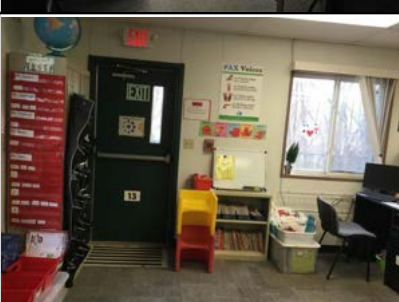
29	Classroom Exit #13	1	116	Doors, Doorways, & Gates	Emergency Egress

Maneuvering clearance(s) not provided	-	Remove stored items to maintain the maneuvering clearance at the door	1	Labor	\$0
