Town of Auburn, Massachusetts

ADA Self-Evaluation and Transition Plan

September 2020

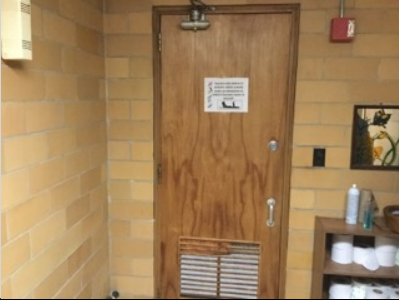
ID	Location	Floor	Room	Element	Type	Photo	Issues	Current Measure	Recommendations	Quantity	Price	Cost Estimation
30	Women's Toilet Room	1	B04	Doors, Doorways, & Gates	Toilet Room

Maneuvering clearance(s) not provided Door requires > 5 lbs. of force to open	-	Adjust closer so door does not require more than 5 pounds of force to open. Remove cabinet to maintain the maneuvering clearance at the door.	1	Labor	\$0
31	Special Needs Classroom	1	109	Doors, Doorways, & Gates	Classroom

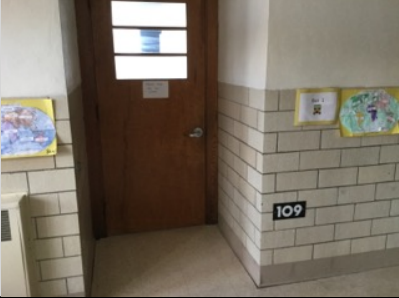
Maneuvering clearance not provided at recess > 6"	-	Install an automatic door opener or keep door open. Applies to all classrooms.	1	Labor	\$0
32	Boys' Toilet Room	1		Doors, Doorways, & Gates	Toilet Room

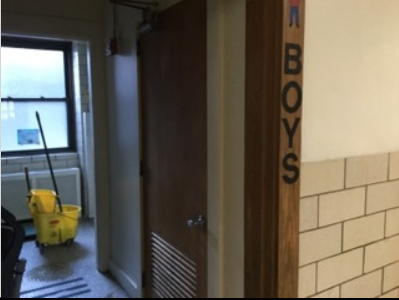
Door requires > 5 lbs. of force to open	10 lbs.	Adjust closer so door does not require more than 5 pounds of force to open.	1	Labor	\$0
Signage												
33	Gymnasium	1	126	Signage	Designation

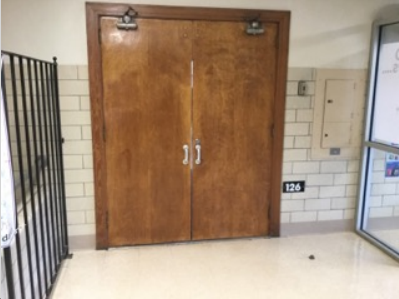
Signage is not provided	-	Locate compliant signage alongside the door on the latch side.	1	232	\$232

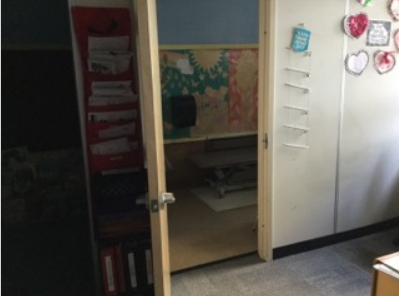
34	Toilet Room	1	109	Signage	Designation

Signage is not provided	-	Locate compliant signage alongside the door on the latch side.	1	232	\$232

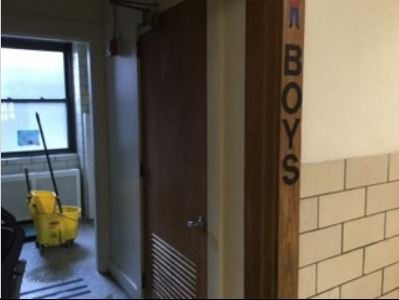
ID	Location	Floor	Room	Element	Type	Photo	Issues	Current Measure	Recommendations	Quantity	Price	Cost Estimation
35	Boys' Toilet Room	1		Signage	Designation

Signage is not provided	-	Locate compliant signage alongside the door on the latch side.	1	232	\$232
36	Boys'/Girls' Toilet Room Near Room #121	1		Signage	Designation

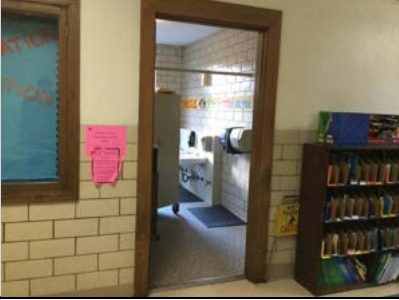
Signage is not provided	-	Locate compliant signage alongside the door on the latch side. (Provide a sign with the International Symbol of Accessibility once an accessible toilet compartment is provided.)	1	232	
37	Women's Toilet Room	1	B04	Signage	Designation

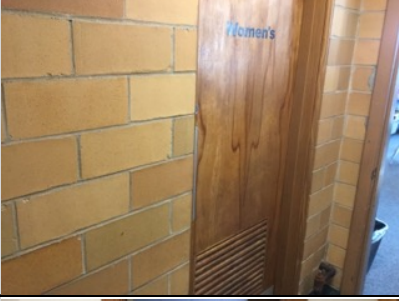
Raised characters not provided on sign Raised characters < 48" or > 60" above ground Braille not provided on sign Sign not located on the latch side of the door	<ul style="list-style-type: none">----	Provide text with raised characters duplicated in braille on sign. Mount sign so that the baseline of the lowest tactile character is 48" min. above finished floor and the baseline of the highest tactile character is 60" max. above the finished floor. Locate sign alongside the door on the latch side. After toilet room is made accessible, add the International Symbol of Accessibility (ISA).	1	232	\$232

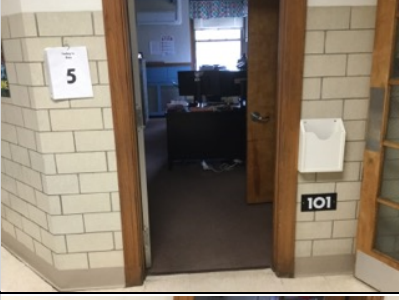
38	Administration	1	101	Signage	Designation

Raised characters not provided on sign Raised characters < 48" or > 60" above ground Braille not provided on sign	<ul style="list-style-type: none">---	Provide text with raised characters duplicated in braille on sign. Mount sign so that the baseline of the lowest tactile character is 48" min. above finished floor and the baseline of the highest tactile character is 60" max. above the finished floor.	1	232	\$232
39	Nurse's Office	1	103	Signage	Designation

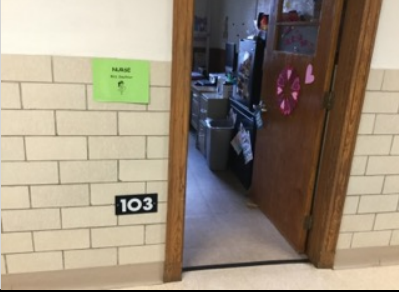
Raised characters not provided on sign Raised characters < 48" or > 60" above ground Braille not provided on sign	<ul style="list-style-type: none">---	Provide text with raised characters duplicated in braille on sign. Mount sign so that the baseline of the lowest tactile character is 48" min. above finished floor and the baseline of the highest tactile character is 60" max. above the finished floor.	1	232	\$232

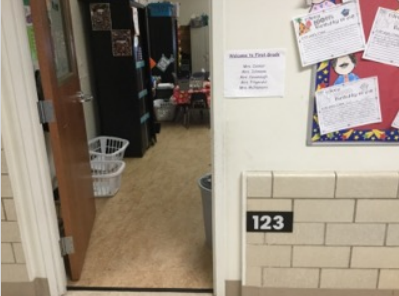
ID	Location	Floor	Room	Element	Type	Photo	Issues	Current Measure	Recommendations	Quantity	Price	Cost Estimation
40	First Grade Classroom	1	123	Signage	Designation

Raised characters not provided on sign Raised characters < 48" or > 60" above ground Braille not provided on sign	- - -	Provide text with raised characters duplicated in braille on sign. Mount sign so that the baseline of the lowest tactile character is 48" min. above finished floor and the baseline of the highest tactile character is 60" max. above the finished floor.	1	232	\$232
41	Library	1	122	Signage	Designation

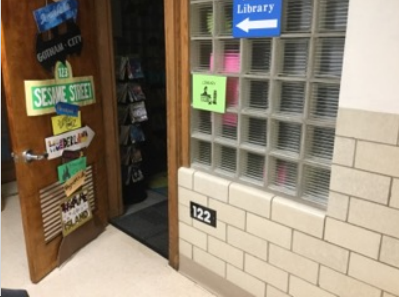
Raised characters not provided on sign Raised characters < 48" or > 60" above ground Braille not provided on sign	- - -	Provide text with raised characters duplicated in braille on sign. Mount sign so that the baseline of the lowest tactile character is 48" min. above finished floor and the baseline of the highest tactile character is 60" max. above the finished floor.	1	232	\$232

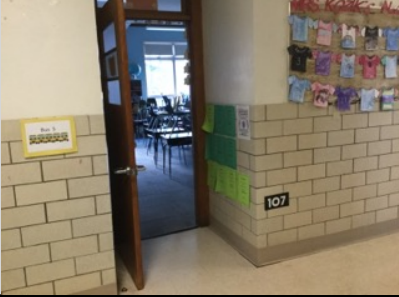
42	2nd Grade Classroom	1	107	Signage	Designation

Raised characters not provided on sign Raised characters < 48" or > 60" above ground Braille not provided on sign	- - -	Provide text with raised characters duplicated in braille on sign. Mount sign so that the baseline of the lowest tactile character is 48" min. above finished floor and the baseline of the highest tactile character is 60" max. above the finished floor.	1	232	\$232
43	Technology Room	1	112	Signage	Designation

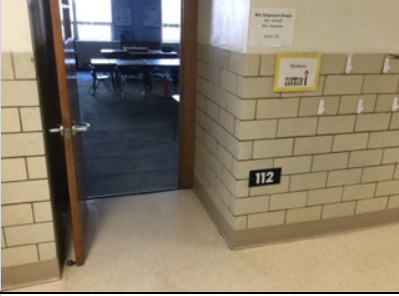
Raised characters not provided on sign Raised characters < 48" or > 60" above ground Braille not provided on sign	- - -	Provide text with raised characters duplicated in braille on sign. Mount sign so that the baseline of the lowest tactile character is 48" min. above finished floor and the baseline of the highest tactile character is 60" max. above the finished floor.	1	232	\$232
44	Classroom	1	116	Signage	Designation

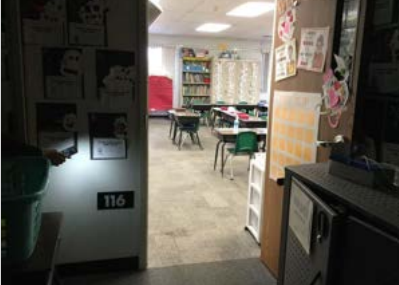
Raised characters not provided on sign Raised characters < 48" or > 60" above ground Braille not provided on sign	- - -	Provide text with raised characters duplicated in braille on sign. Mount signs so that the baseline of the lowest tactile character is 48" min. above finished floor and the baseline of the highest tactile character is 60" max. above the finished floor.	1	232	\$232

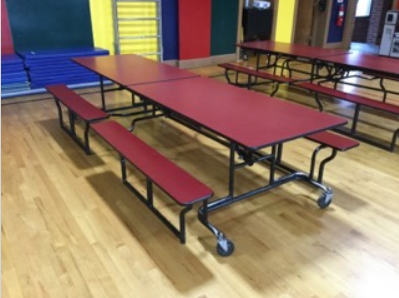
ID	Location	Floor	Room	Element	Type	Photo	Issues	Current Measure	Recommendations	Quantity	Price	Cost Estimation
Dining or Work Surfaces												
45	Cafeteria	1	126	Dining or Work Surfaces	Dining Surface

At least one or 5% accessible tables not provided Top of dining/work surface < 28" or > 34"	- 26"	Ensure that at least one dining surface is accessible. Provide at least one dining surface with top between 28"- 34" above the floor and 27" clear height underneath.	1	700	\$700
46	Reading Room	1	B05	Dining or Work Surfaces	Work Surface

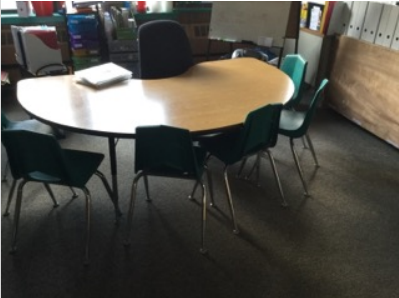
Knee or toe clearance not provided	-	Adjust work surface to ensure a 24" min. knee clearance is provided.	1	Labor	\$0
47	Reading Room	1	B05	Dining or Work Surfaces	Work Surface

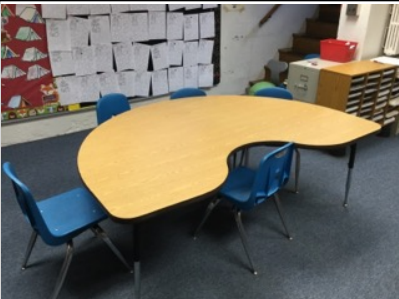
Knee or toe clearance not provided	-	Adjust work surface to ensure a 24" min. knee clearance is provided.	1	Labor	\$0
48	Library	1	122	Dining or Work Surfaces	Work Surface

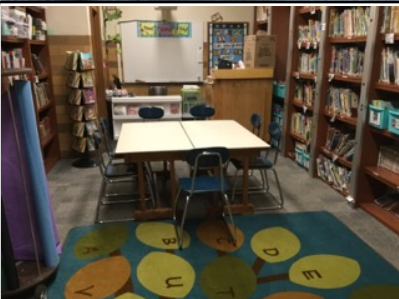
Knee or toe clearance not provided	22"	Provide at least work surface with 24" min. knee and toe clearance.	1	700	\$700

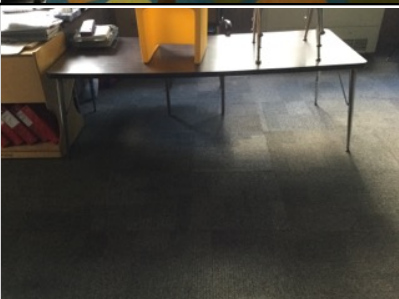
49		1	109	Dining or Work Surfaces	Work Surface

Knee or toe clearance not provided	22"	Adjust work surface to ensure a 24" min. knee clearance is provided.	1	Labor	\$0

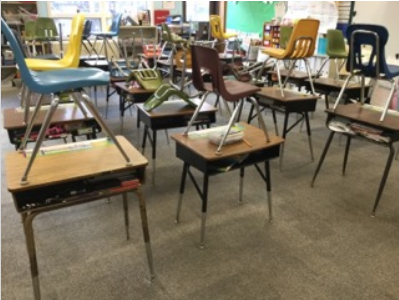
ID	Location	Floor	Room	Element	Type	Photo	Issues	Current Measure	Recommendations	Quantity	Price	Cost Estimation
50	2nd Grade Classroom	1	107	Dining or Work Surfaces	Work Surface

Knee or toe clearance not provided	20"	Adjust work surface to ensure a 24" min. knee clearance is provided.	1	Labor	\$0
51	Technology Room	1	112	Dining or Work Surfaces	Work Surface

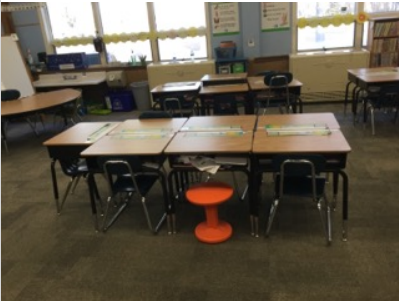
Knee or toe clearance not provided	-	Adjust work surface to ensure a 24" min. knee clearance is provided.	1	Labor	\$0
52	Council Room	B	B05	Dining or Work Surfaces	Work Surface

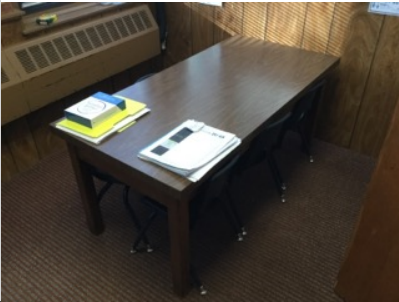
Top of dining/work surface < 28" or > 34"	22.5"	Provide a work surface with tops between 28"-34" above the floor and 27" clear height underneath.	1	700	\$700
Assembly Area												
53	Cafeteria	1	126	Assembly Area

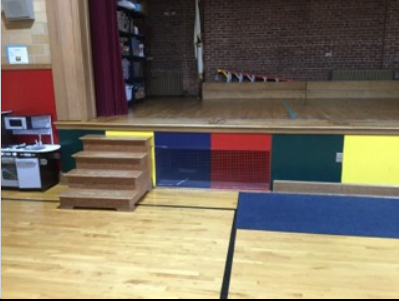
Accessible route to stage not provided	-	Provide an accessible route to the stage. (Cost estimate for a 30' long wood ramp.)	1	12000	\$12000

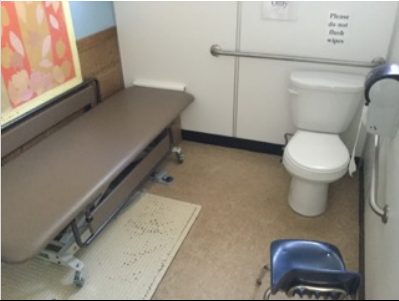
Toilet & Bathing Rooms												
Overall Access												
54	Toilet Room	1	109	Overall Access

Turning space not provided Toilet paper dispenser is not compliant		Remove examination table to maintain the required maneuvering clearance at the toilet. Relocate toilet paper so that it is 24" min. high, located under the grab bar, and between 7" and 9" from the front of the toilet. (Cost to relocate the toilet paper dispenser.)	1	256	\$256

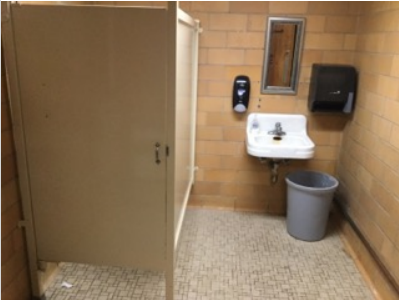
Accessible plumbing fixtures or stalls not provided	-	Provide one accessible wheelchair compartment.	1	6182	\$6182
56	Boys' Toilet Room	1		Overall Access	Toilet Room

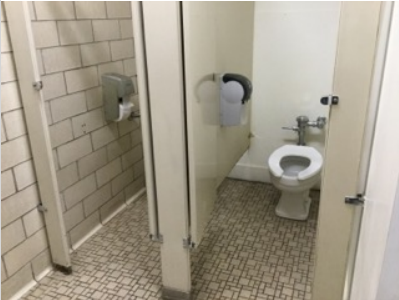
Accessible plumbing fixtures or stalls not provided	-	Provide one accessible wheelchair compartment.	1	6182	\$6182
Lavatory												
57	Toilet Room	1	109	Lavatory	N/A

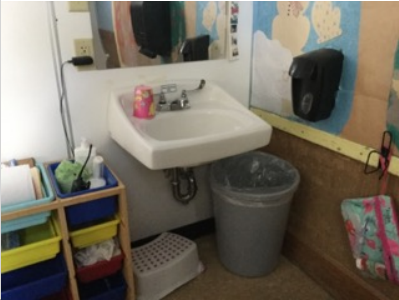
Clear floor space not provided at lavatory Plumbing underneath is exposed	- -	Remove storage to maintain the required 30" min. by 48" min. clear floor space positioned for a forward approach at the lavatory. Insulate or otherwise configure pipes to prevent contact at lavatory.	1	92	\$92
Dispensers												
58	Boys'/Girls' Toilet Room Near Room #121	1	Mmm	Dispensers	Paper Towel Dispenser

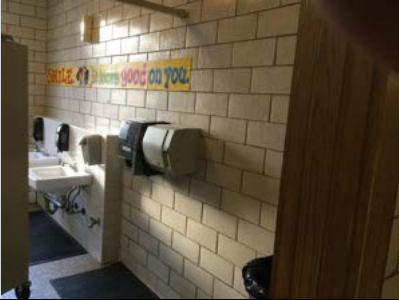
Dispenser acts as a protruding object	-	Relocate paper towel dispenser out of the circulation path.	2	353	\$706

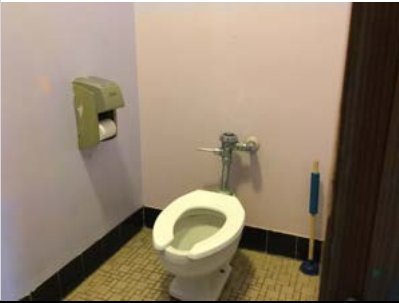
Clearance at toilet < 72" clear deep	-	Provide a new accessible single-user toilet room with a toilet that has clear floor space at the toilet that is 72" deep min.	1	24604	\$24604
60	Boys' Toilet Room	1	106	Single-User Toilet (Children)	N/A

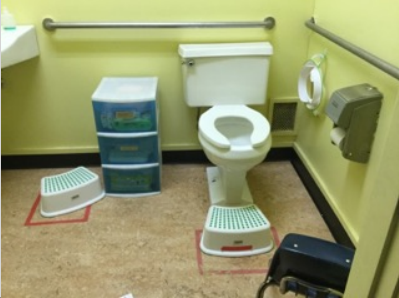
Clearance at toilet < 72" clear deep Clearance at toilet < 60" clear wide	- -	Remove items to maintain the required 60" min. by 72" min. maneuvering clearance at the toilet.	1	Labor	\$0
Toilet Compartment (Children)												
61	Boys'/Girls' Toilet Room Near Room #121	1		Toilet Compartment (Children)	Ambulatory Compartment

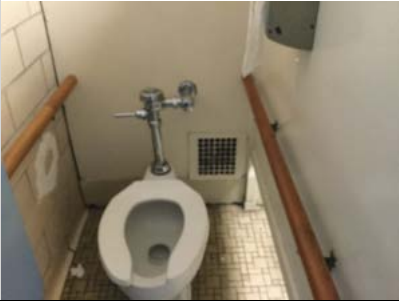
Clearance at toilet < 60" clear width		Provide a wheelchair accessible compartment that is 60" wide min. and 72" deep min.	1	6182	\$6182

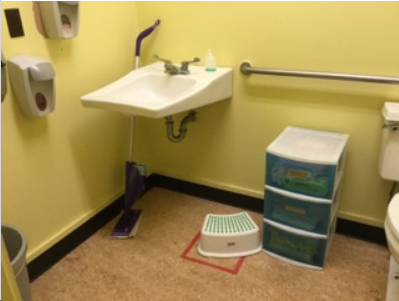
Lavatory (Children)												
62	Boys' Toilet Room	1	106	Lavatory (Children)	N/A

Lavatory rim or counter > 30" Exposed plumbing underneath	33" -	Relocate lavatory with the front of the rim or counter no higher than 30" above the finished floor. Insulate or otherwise configure pipes to prevent contact at lavatory.	1	348	\$348
63	Boys' Toilet Room	1		Lavatory (Children)	N/A

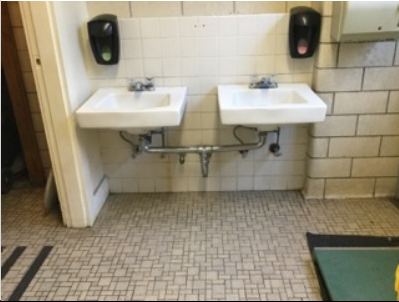
Faucet not operable with a closed fist Exposed plumbing underneath	- -	Provide a faucet that can be operable with one hand and not require tight grasping, pinching, or twisting of the wrist for at least one lavatory. Insulate or otherwise configure pipes to prevent contact, for at least one lavatory.	1	1078	\$1078

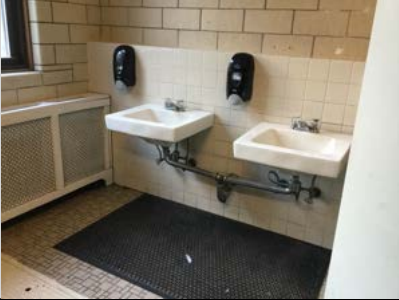
Faucet not operable with a closed fist Exposed plumbing underneath	- -	Provide a faucet that can be operable with one hand and not require tight grasping, pinching or twisting of the wrist for at least one lavatory. Insulate or otherwise configure pipes to prevent contact, for at least one lavatory.	1	1078	\$1078
Additional Access												
Drinking Fountains												
65	Hallway - Near Room #106	1		Drinking Fountains	Low

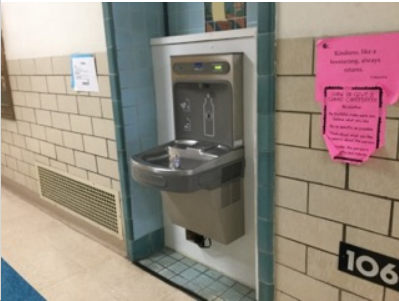
No drinking fountain provided for standing users	-	Provide an additional drinking fountain for standing users.	1	4028	\$4028
66	Hallway	1		Drinking Fountains	Low

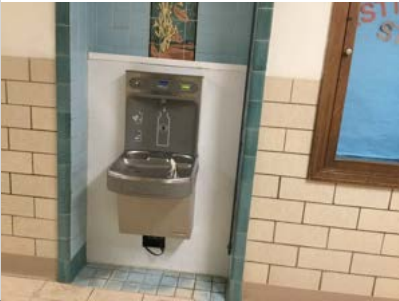
No drinking fountain provided for standing users	-	Provide an additional drinking fountain for standing users or install a Hi-Lo drinking fountain.	1	4028	\$4028

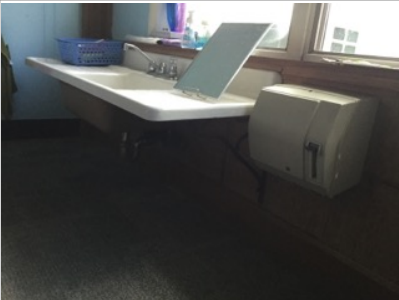
Sinks for Children's Use												
67	Classroom	1	110	Sinks for Children's Use	Classroom

Knee or toe clearance not provided	15"	Provide at least one sink with 25" high knee and toe clearance positioned for a forward approach.	1	1686	\$1686
Play and Sport Areas

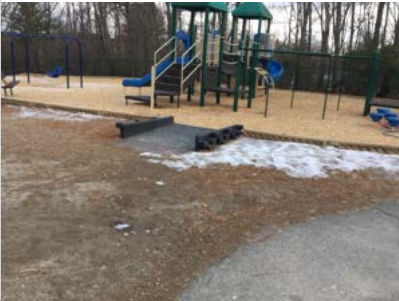
Accessible route not provided to playground Accessible route not provided around playground Accessible route not provided to play components	- - -	Install an accessible route to and around the playground. (Cost estimate for 100'x48" min. of stone dust path, \$3,200.) Provide a compliant impact-attenuating surface to and around the play components. (Cost estimate for 2,000 sq. ft. of poured in place rubber surface, \$28,000.)	1	31200	\$31200
Best Practice												
Parking												
69	Parking North Side of School	Ext.		Parking	N/A

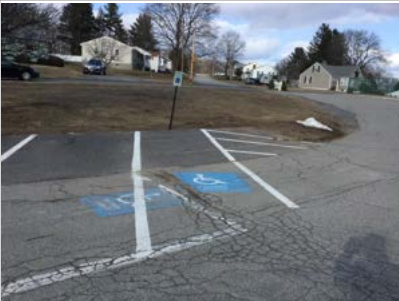
Recommend providing a 60" wide min. marked access aisle at the parking space.	1	-	\$0
Stairs												
70	Exits	Ext.		Stairs	N/A

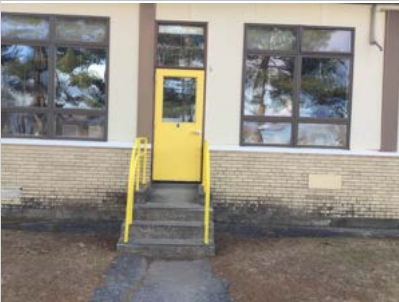
Recommend providing extension at all the exterior stairs.	22	-	\$0

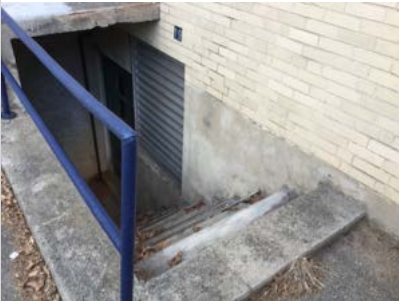
71	Door #19	Ext.		Stairs	N/A

Recommend providing a gate or some kind of barrier for safety.	1	-	\$0

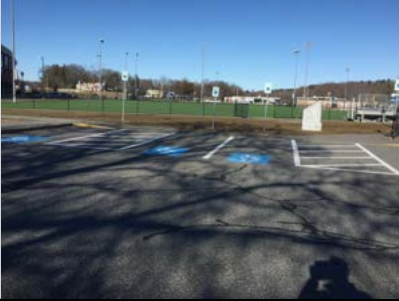
Total # of designated accessible parking spaces Total # of designated van accessible spaces Sign does not have the designation "Van Accessible"	3 1 -	Add the designation "Van Accessible" to the sign located at the van accessible space.	1	500	\$500
2	Parking by Door #8	Ext.		Off-Street Parking Lot or Garage	N/A

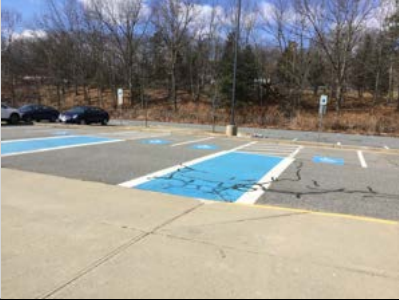
Total # of designated accessible parking spaces Sign not provided Sign does not have the designation "Van Accessible"	3 1 - -	Provide a sign with the International Symbol of Accessibility (ISA) at one car accessible space. Mount the bottom of the sign 60" min. above the ground and the top 96" max. above the ground. Add the designation "Van Accessible" to the sign located at the van accessible space.	1	500	\$500

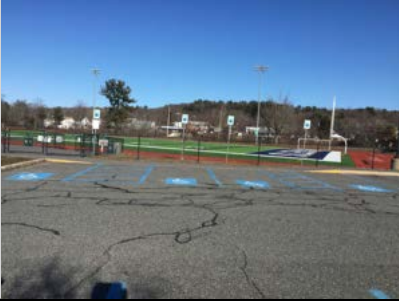
3	Accessible Parking by Football Field			Off-Street Parking Lot or Garage	N/A

Sign does not have the designation "Van Accessible" Total # of designated accessible parking spaces	3 1 -	Add the designation "Van Accessible" to the sign located at the van accessible space.	1	500	\$500
Passenger Loading Zones												
4	Drop-off Area by Door #1	Ext.		Passenger Loading Zones	N/A

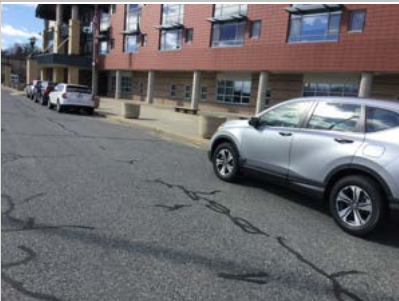
Access aisle not provided Sign with ISA not provided (MAAB)	- -	Provide a marked access aisle that is at least 60" wide and that extends the full length of the vehicle. Provide a sign that includes the International Symbol of Accessibility (ISA) at the head of the space. Locate the sign so that the bottom is 60" min. above the ground and the top is 96" max. above the ground.	1	800	\$800
5	Crosswalk at Rear Drop-Off Area	Ext.		Passenger Loading Zones	N/A

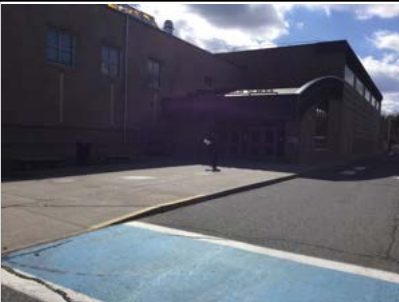
Access aisle not provided Sign with ISA not provided (MAAB)	- -	Provide a marked access aisle that is at least 60" wide and that extends the full length of the vehicle. Provide a sign that includes the International Symbol of Accessibility (ISA) at the head of the space. Locate the sign so that the bottom is 60" min. above the ground and the top is 96" max. above the ground.	1	800	\$800

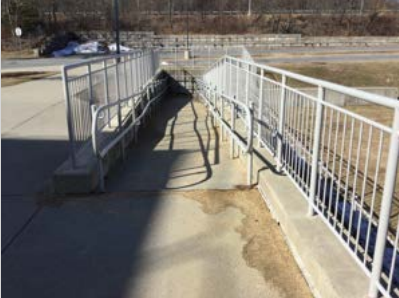
Not maintained in operable working condition	1"	Beveled the change in level at the top ramp landing to ensure is 1/2" max. (Cost based on a 4'x4' concrete patch.)	1	256	\$256
Access to Goods and Services												
Means of Egress												
7	Media Center	3		Means of Egress	N/A

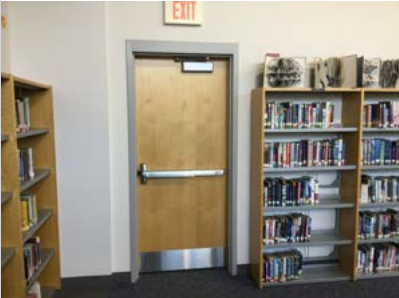
Tactile exit sign not provided	-	Ensure a tactile exit sign with raised characters and braille is provided at exit door. Mount sign between 48"- 60" above the finished floor located on the latch side of the door.	1	232	\$232
8	Exit #5	1		Means of Egress	N/A

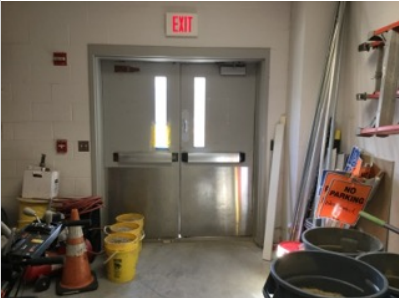
Tactile exit sign not provided Illuminated ISA symbol not provided (MAAB)	- -	Ensure a tactile exit sign with raised characters and braille is provided at exit door. Mount sign between 48"- 60" above the finished floor located on the latch side of the door. Provide an illuminated sign with the International Symbol of Accessibility.	1	432	\$432

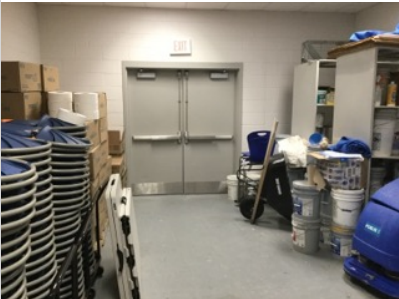
9	Exit #4	1	1032	Means of Egress	N/A

Tactile exit sign not provided Illuminated ISA symbol not provided (MAAB)	- -	Ensure a tactile exit sign with raised characters and braille is provided at exit door. Mount sign between 48"- 60" above the finished floor located on the latch side of the door. Provide an illuminated sign with the International Symbol of Accessibility.	1	432	\$432
10	Towards Parking Area	1		Means of Egress	N/A

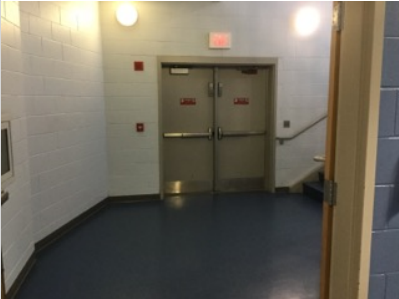
Tactile exit sign not provided Illuminated ISA symbol not provided (MAAB)	- -	Ensure a tactile exit sign with raised characters and braille is provided at exit door. Mount sign between 48"- 60" above the finished floor located on the latch side of the door. Provide an illuminated sign with the International Symbol of Accessibility.	1	432	\$432

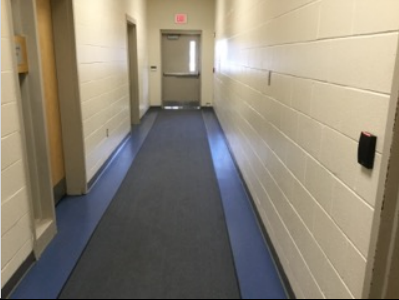
Tactile exit sign not provided Illuminated ISA symbol not provided (MAAB)	- -	Ensure a tactile exit sign with raised characters and braille is provided at exit door. Mount sign between 48"- 60" above the finished floor located on the latch side of the door. Provide an illuminated sign with the International Symbol of Accessibility.	1	432	\$432
12	Exit #10	1		Means of Egress	N/A

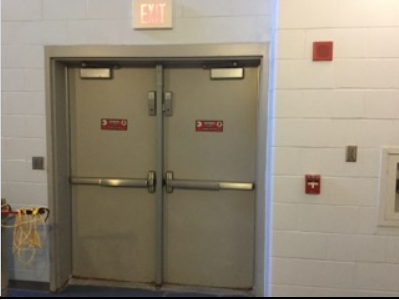
Tactile exit sign not provided Illuminated ISA symbol not provided (MAAB)	- -	Ensure a tactile exit sign with raised characters and braille is provided at exit door. Mount sign between 48"- 60" above the finished floor located on the latch side of the door. Provide an illuminated sign with the International Symbol of Accessibility.	1	432	\$432

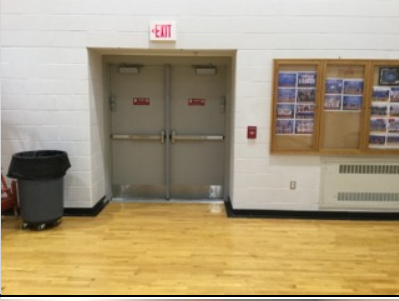
13	Gymnasium	2		Means of Egress	N/A

Tactile exit sign not provided Illuminated ISA symbol not provided (MAAB)	- -	Ensure tactile exit signs with raised characters and braille are provided at exit doors. Mount signs between 48"- 60" above the finished floor located on the latch side of the door. Provide an illuminated sign with the International Symbol of Accessibility.	2	432	\$864
14	Stair #2	2		Means of Egress	N/A

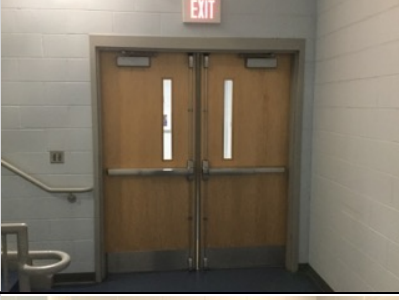
Floor level designation not provided	-	Provide a sign on the interior of the stairway enclosure indicating the floor level.	1	232	\$232
15	Stair #3	2		Means of Egress	N/A

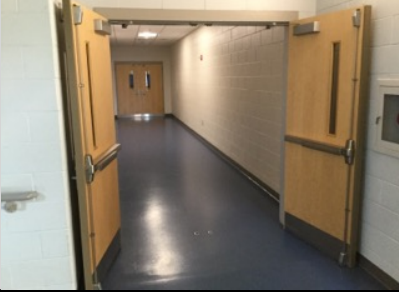
Floor level designation not provided	-	Provide a sign on the interior of the stairway enclosure indicating the floor level.	1	232	\$232

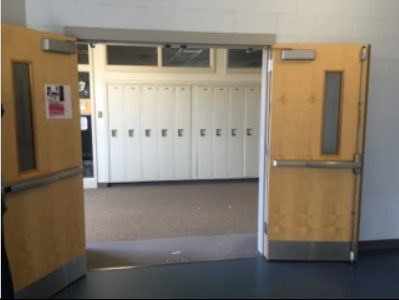
Floor level designation not provided	-	Provide a sign on the interior of the stairway enclosure indicating the floor level.	1	232	\$232
17	Stair #2	3		Means of Egress	N/A

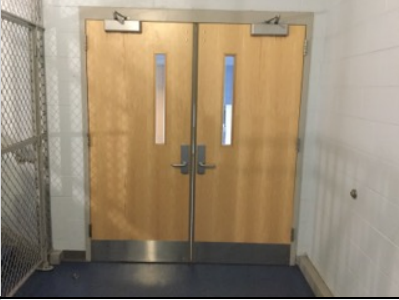
Floor level designation not provided	-	Provide a sign on the interior of the stairway enclosure indicating the floor level.	1	232	\$232
18	Main Entrance	1		Means of Egress	N/A

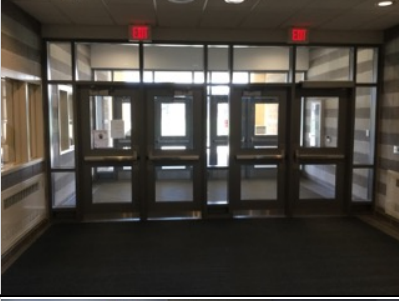
Illuminated ISA symbol not provided (MAAB)	-	Provide an illuminated sign with the International Symbol of Accessibility.	1	200	\$200
19	Secondary Entrance	2		Means of Egress	N/A

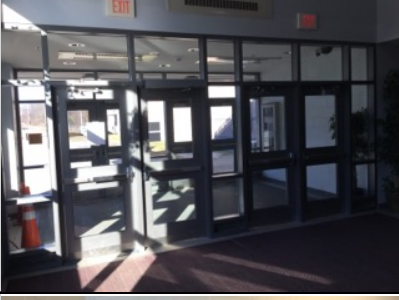
Illuminated ISA symbol not provided (MAAB)	-	Provide an illuminated sign with the International Symbol of Accessibility.	1	200	\$200
20	Stair #1	2 A		Means of Egress	N/A

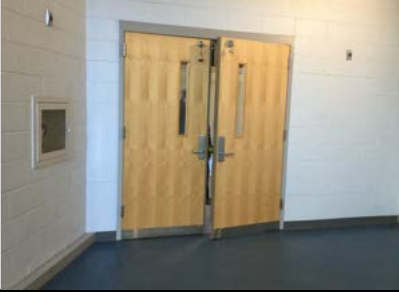
Floor level designation not provided	-	Provide a sign on the interior of the stairway enclosure indicating the floor level.	1	232	\$232

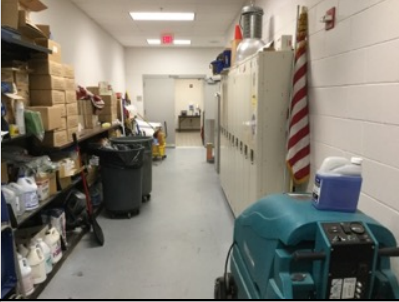
Route < 36" wide	-	Ensure that a clear width of 36" min. is maintained at the accessible route at all time.	1	Labor	\$0
22	Hallway Near Room 1083	1		Interior Access Route	N/A

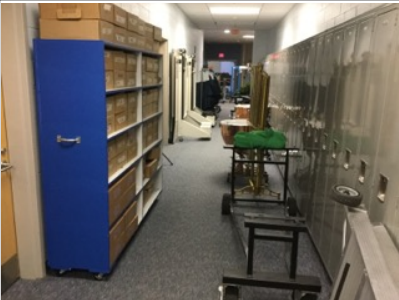
Route < 36" wide	-	Remove furniture to ensure that a clear width of 36" min. is maintained at the accessible route.	1	Labor	\$0
23	Dressing Room A	1	1077	Interior Access Route	N/A

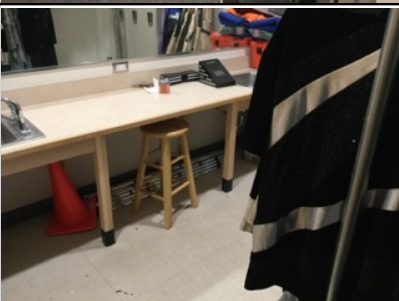
Route < 36" wide	-	Ensure that a clear width of 36" min. is maintained at the accessible route.	1	Labor	\$0
24	Nurse Suite	1	1106	Interior Access Route	N/A

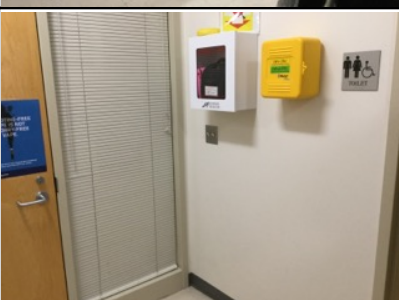
Obstructed by protruding objects	-	Relocate cabinet so it does not protrude into the circulation path.	1	256	\$256
25	Near Stair #2	2		Interior Access Route	N/A

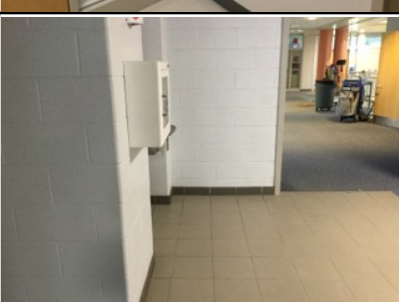
Obstructed by protruding objects	7"	Relocate cabinet so it does not protrude into the circulation path.	1	256	\$256

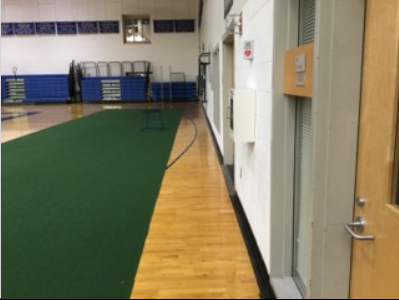
Obstructed by protruding objects	-	Relocate cabinet so it does not protrude into the circulation path.	1	256	\$256
27	Hallway - Near Room 3038	3		Interior Access Route	N/A

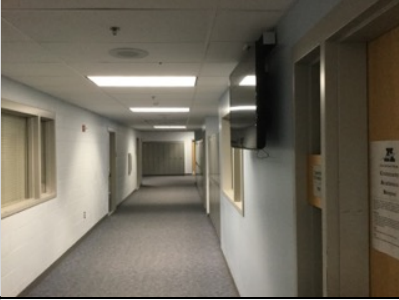
Obstructed by protruding objects	6"	Provide a cane-detectable barrier.	1	306	\$306
28	Near Media Center	3		Interior Access Route	N/A

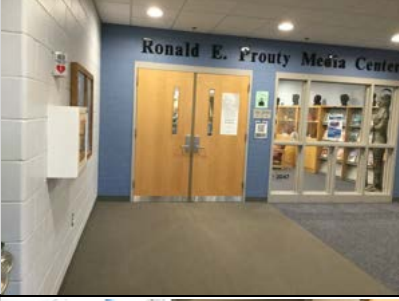
Obstructed by protruding objects	42"	Relocate AED so it does not protrude into the circulation path.	1	256	\$256
29	By Exit Towards Parking Area	1		Interior Access Route

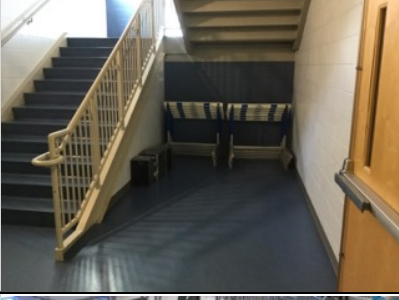
Vertical clearance < 80" above finished floor		Provide a cane-detectable barrier underneath stair.	1	960	\$960
30	Classroom	2	2012	Interior Access Route	N/A

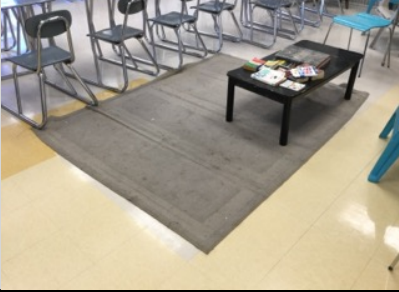
Mat not securely attached	-	Secure the mat.	1	Labor	\$0

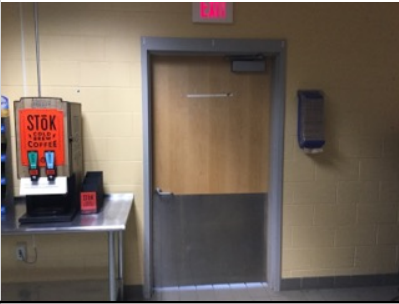
Maneuvering clearance(s) not provided	-	Relocate table to maintain the maneuvering clearance at the door.	1	Labor	\$0
32	Guidance Office	1	1132	Doors, Doorways, & Gates	Office

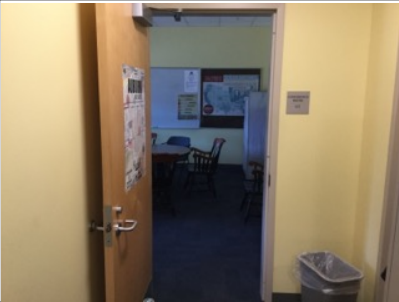
Maneuvering clearance(s) not provided	-	Relocate trash can to maintain the maneuvering clearance at the door.	1	Labor	\$0
33	Dressing Room A	1	1077	Doors, Doorways, & Gates	Other

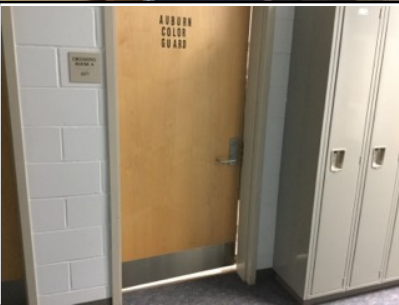
Maneuvering clearance(s) not provided	7.5"	Relocate cabinet to maintain the maneuvering clearance at the door.	1	Labor	\$0
34	Dressing Room B	1	1078	Doors, Doorways, & Gates	Other

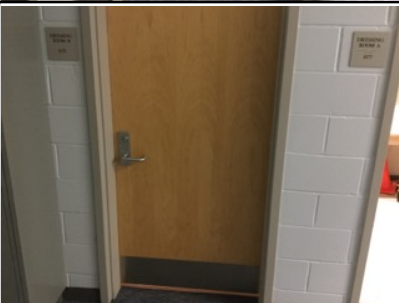
Maneuvering clearance(s) not provided	10.5"	Relocate cabinet to maintain the maneuvering clearance at the door.	1	Labor	\$0
35	Preschool	1	1105	Doors, Doorways, & Gates	Classroom

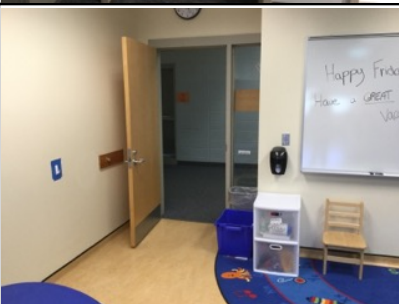
Maneuvering clearance(s) not provided	-	Remove storage bin to maintain the maneuvering clearance at the door.	1	Labor	\$0

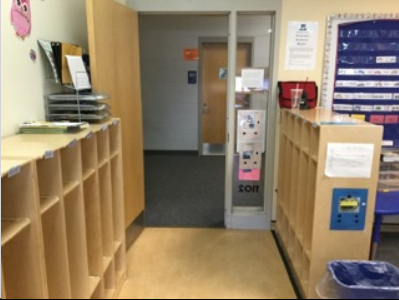
Maneuvering clearance(s) not provided	-	Remove shelving to maintain the require maneuvering clearance at the door.	1	Labor	\$0
37	Preschool Room	1	1096	Doors, Doorways, & Gates	Classroom

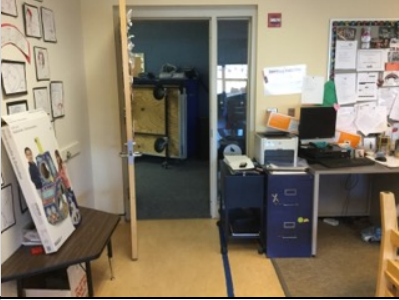
Maneuvering clearance(s) not provided	-	Relocate cabinet to maintain the maneuvering clearance at the door.	1	Labor	\$0
38	Science Classroom	3	3060	Doors, Doorways, & Gates	Classroom

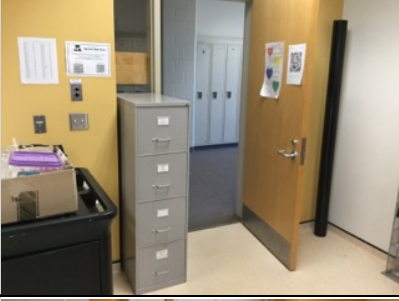
Maneuvering clearance(s) not provided	-	Relocate cabinet to maintain the maneuvering clearance at the door.	1	Labor	\$0
39	Science Classroom	3	3059	Doors, Doorways, & Gates	Classroom

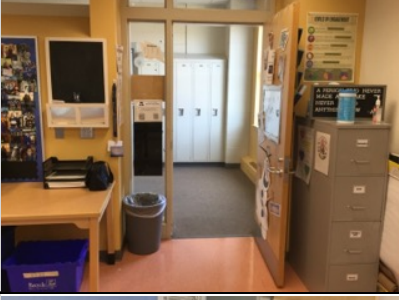
Maneuvering clearance(s) not provided	-	Relocate trash can to maintain the maneuvering clearance at the door.	1	Labor	\$0
40	Classroom	3	3040	Doors, Doorways, & Gates	Classroom

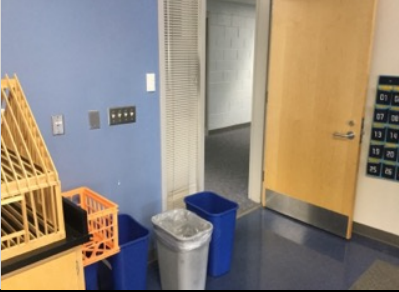
Maneuvering clearance(s) not provided	-	Relocate trash can to maintain the maneuvering clearance at the door.	1	Labor	\$0

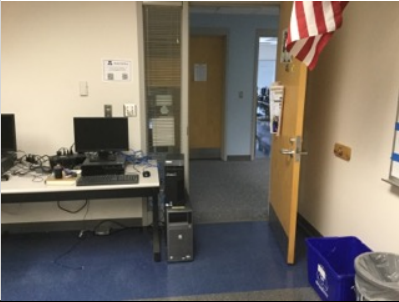
Maneuvering clearance(s) not provided	-	Relocate computers to maintain the maneuvering clearance at the door.	1	Labor	\$0
42	Classroom	3	3009	Doors, Doorways, & Gates	Classroom

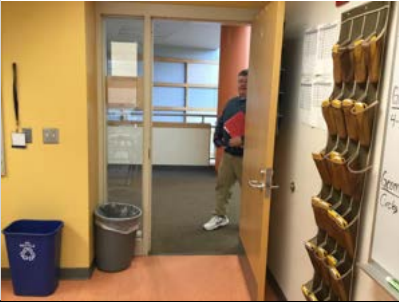
Maneuvering clearance(s) not provided	2"	Relocate trash to maintain the maneuvering clearance at the door.	1	Labor	\$0
43	Classroom	3	3004	Doors, Doorways, & Gates	Classroom

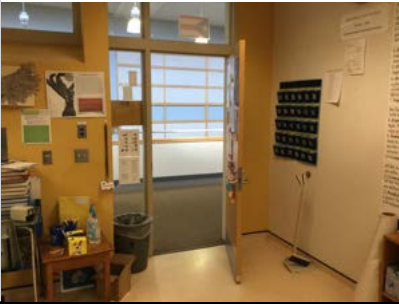
Maneuvering clearance(s) not provided	-	Relocate trash to maintain the maneuvering clearance at the door.	1	Labor	\$0
44	Press Box	Ext.		Doors, Doorways, & Gates	Other

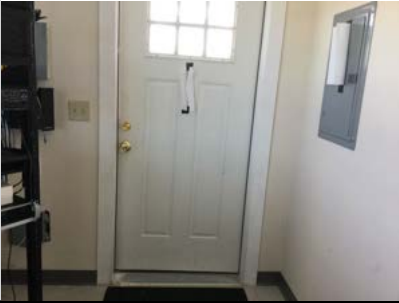
Hardware not operable with a closed fist	-	Provide hardware that can be operable with one hand and not require tight grasping, pinching, or twisting of the wrist.	2	484	\$968
45	Men's Toilet Room	1		Doors, Doorways, & Gates	Toilet Room

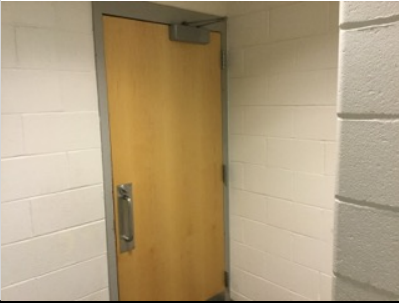
Door requires > 5 lbs. of force to open	14 lbs	Adjust closer so door does not require more than 5 pounds of force to open.	1	Labor	\$0

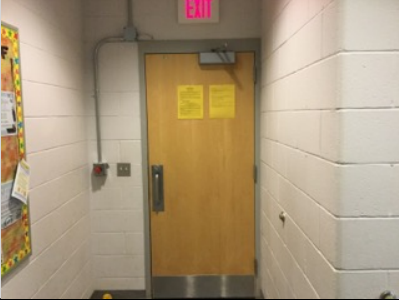
Door requires > 5 lbs. of force to open	10 lbs	Adjust closer so door does not require more than 5 pounds of force to open.	1	Labor	\$0
47	Boys' Locker Room	1		Doors, Doorways, & Gates	Toilet Room

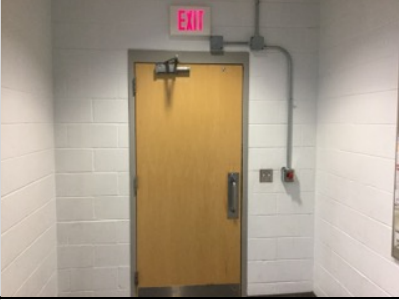
Door requires > 5 lbs. of force to open	14 lbs.	Adjust closer so door does not require more than 5 pounds of force to open.	1	Labor	\$0
48	Team Locker Room	1		Doors, Doorways, & Gates	Other

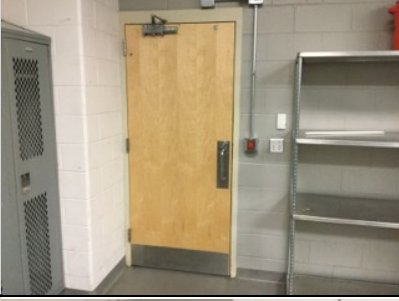
Door requires > 5 lbs. of force to open	11 lbs	Adjust closer so door does not require more than 5 pounds of force to open.	1	Labor	\$0
49	All Gender Toilet Room	1		Doors, Doorways, & Gates	Toilet Room

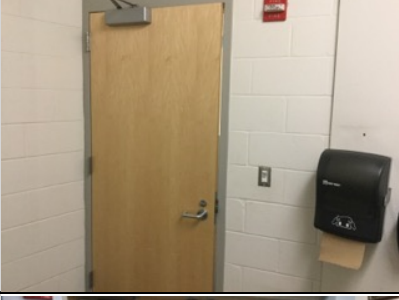
Door requires > 5 lbs. of force to open	15 lbs	Adjust closer so door does not require more than 5 pounds of force to open.	1	Labor	\$0

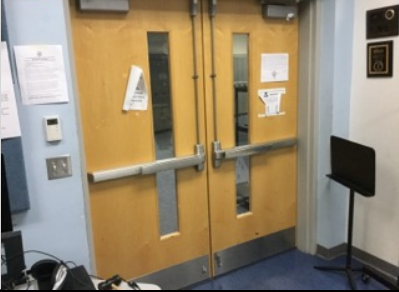
50	Band Room	1	1191	Doors, Doorways, & Gates	Classroom

Door requires > 5 lbs. of force to open	11 lbs	Adjust closers so doors do not require more than 5 pounds of force to open.	1	Labor	\$0

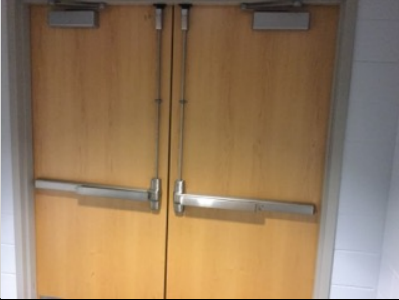
. Door requires > 5 lbs. of force to open	14 lbs	Adjust closers so doors do not require more than 5 pounds of force to open.	1	Labor	\$0
52	Boys' Toilet Room	2		Doors, Doorways, & Gates	Toilet Room

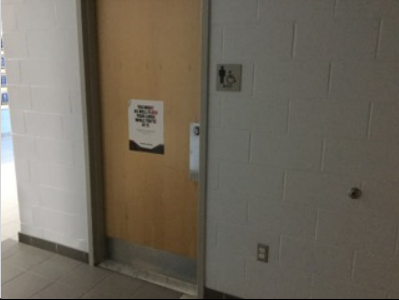
. Door requires > 5 lbs. of force to open	13 lbs.	Adjust closer so door does not require more than 5 pounds of force to open.	1	Labor	\$0
53	Team Locker Room	2		Doors, Doorways, & Gates	Other

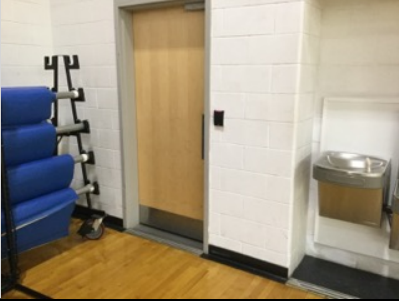
. Door requires > 5 lbs. of force to open	14 lbs.	Adjust closer so door does not require more than 5 pounds of force to open.	1	Labor	\$0
54	Women's Toilet Room	3		Doors, Doorways, & Gates	Toilet Room

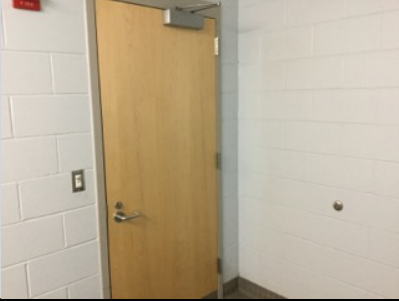
. Door requires > 5 lbs. of force to open	15 lbs	Adjust closer so door does not require more than 5 pounds of force to open.	1	Labor	\$0

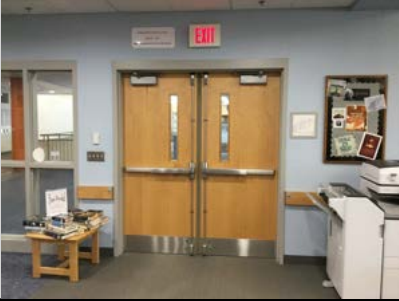
55	Media Center	3		Doors, Doorways, & Gates	Other

. Door requires > 5 lbs. of force to open	11 lbs.	Adjust closer so door does not require more than 5 pounds of force to open.	1	Labor	\$0

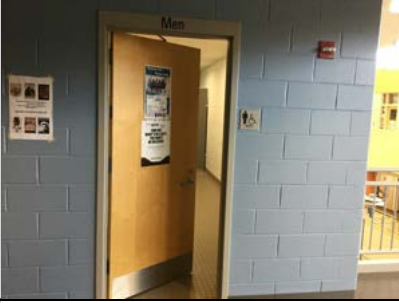
Door requires > 5 lbs. of force to open	15 lbs.	Adjust closer so door does not require more than 5 pounds of force to open.	1	Labor	\$0
57	Girls' Toilet Room by Elevator	3		Doors, Doorways, & Gates	Toilet Room

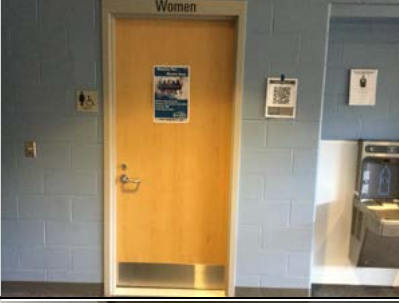
Door requires > 5 lbs. of force to open	15 lbs.	Adjust closer so door does not require more than 5 pounds of force to open.	1	Labor	\$0
58	Men's Single-User Toilet Room by Room 3039	3		Doors, Doorways, & Gates	Toilet Room

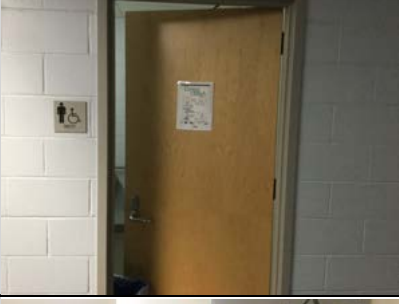
Door requires > 5 lbs. of force to open	13 lbs.	Adjust closer so door does not require more than 5 pounds of force to open.	1	Labor	\$0
59	Women's Single-User Toilet Room by Room 2071	2 A		Doors, Doorways, & Gates	Toilet Room

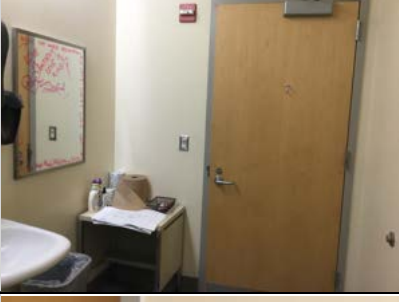
Maneuvering clearance(s) not provided	-	Remove stored items to provide 18" min. maneuvering clearance on pull-side of door.	1	Labor	\$0

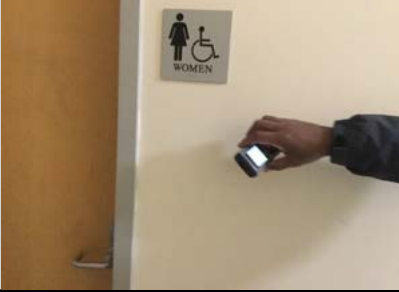
60	Women's Single-User Toilet Room	2 A		Doors, Doorways, & Gates	Toilet Room

Door requires > 5 lbs. of force to open	16 lbs.	Adjust closer so door does not require more than 5 pounds of force to open.	1	Labor	\$0

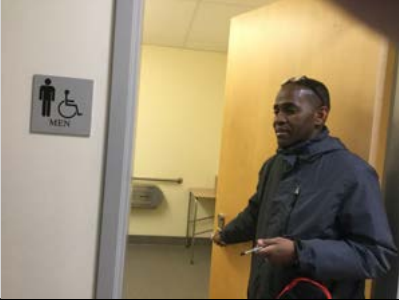
ID	Location	Floor	Room	Element	Type	Photo	Issues	Current Measure	Recommendations	Quantity	Price	Cost Estimation
61	Men's Single-User Toilet Room	2 A		Doors, Doorways, & Gates	Toilet Room

Door requires > 5 lbs. of force to open	19 lbs.	Adjust closer so door does not require more than 5 pounds of force to open.	1	Labor	\$0
Signage												
62	Teacher Break Room	1	1004	Signage	Designation

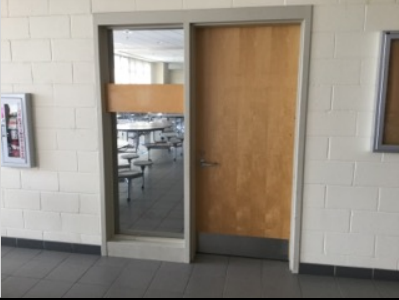
Signage is not provided	-	Locate compliant signage alongside the door on the latch side.	1	232	\$232
63	Team Locker Room	1		Signage	Designation

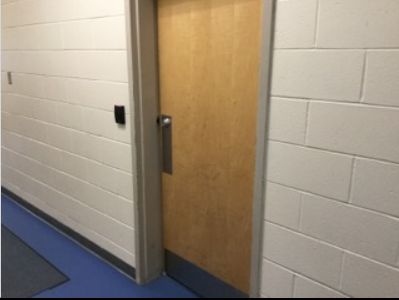
Signage is not provided	-	Locate compliant signage alongside the door on the latch side.	1	232	\$232
64	Presentation Room	1	1059	Signage	Designation

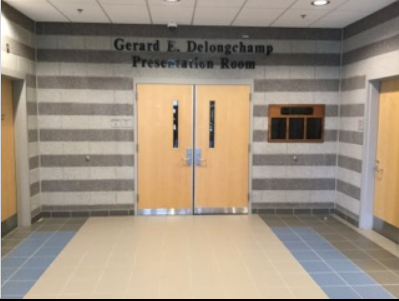
Signage is not provided	-	Locate compliant signage alongside the door on the latch side.	1	232	\$232
65	Team Locker Room	2		Signage	Designation

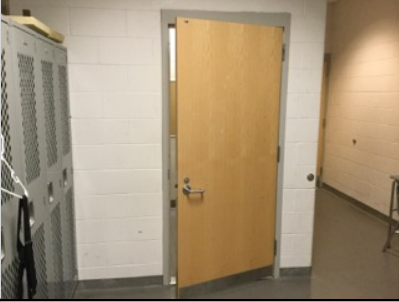
Signage is not provided	-	Locate compliant signage alongside the door on the latch side.	1	232	\$232

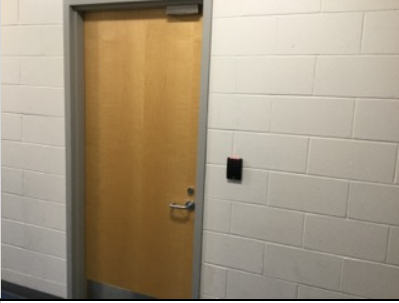
ID	Location	Floor	Room	Element	Type	Photo	Issues	Current Measure	Recommendations	Quantity	Price	Cost Estimation
66	Referees	2		Signage	Designation

Signage is not provided	-	Locate compliant signage alongside the door on the latch side.	1	232	\$232
67	Gymnasium	2	2029	Signage	Designation

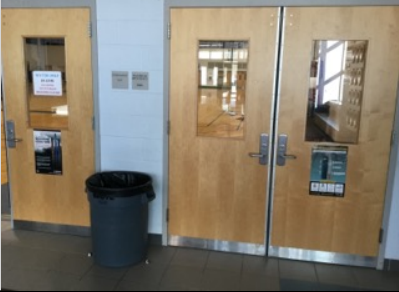
Clear floor space is not provided	-	Relocate trash can to ensure that a 18" min. clear floor space is provided at the designation sign.	1	Labor	\$0
68	Men's Toilet Room	1		Signage	Designation

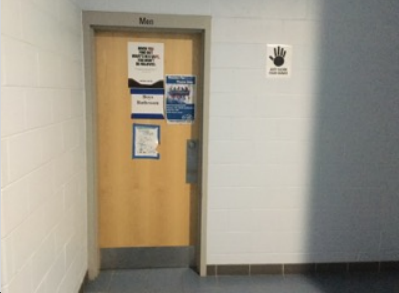
Raised characters not provided on sign Raised characters < 48" or > 60" above ground Braille not provided on sign Sign not located on the latch side of the door	- - - -	Provide text with raised characters duplicated in braille on sign. Mount sign so that the baseline of the lowest tactile character is 48" min. above finished floor and the baseline of the highest tactile character is 60" max. above the finished floor. Locate sign alongside the door on the latch side.	1	232	\$232

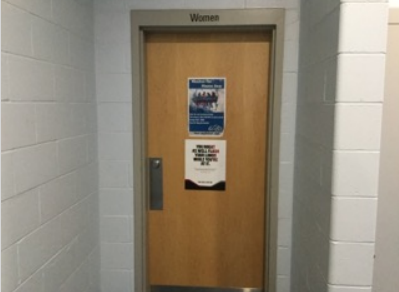
69	Women's Toilet Room	1		Signage	Designation

Raised characters not provided on sign Raised characters < 48" or > 60" above ground Braille not provided on sign Sign not located on the latch side of the door	- - - -	Provide text with raised characters duplicated in braille on sign. Mount sign so that the baseline of the lowest tactile character is 48" min. above finished floor and the baseline of the highest tactile character is 60" max. above the finished floor. Locate sign alongside the door on the latch side.	1	232	\$232
70	Girls' Locker Room	1		Signage	Designation

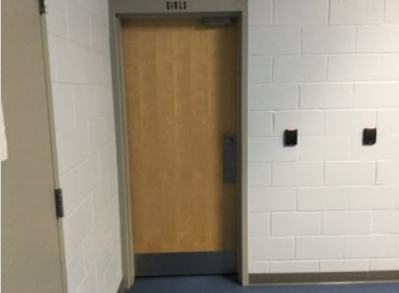
Raised characters not provided on sign Raised characters < 48" or > 60" above ground Braille not provided on sign Sign not located on the latch side of the door	- - - -	Provide text with raised characters duplicated in braille on sign. Mount sign so that the baseline of the lowest tactile character is 48" min. above finished floor and the baseline of the highest tactile character is 60" max. above the finished floor. Locate sign alongside the door on the latch side.	1	232	\$232

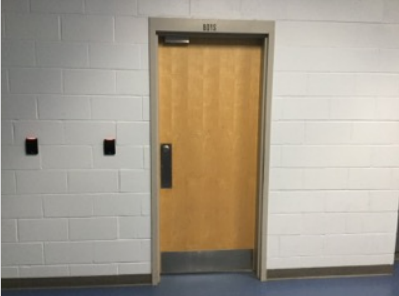
ID	Location	Floor	Room	Element	Type	Photo	Issues	Current Measure	Recommendations	Quantity	Price	Cost Estimation
71	Boys' Locker Room	1		Signage	Designation

Raised characters not provided on sign Raised characters < 48" or > 60" above ground Braille not provided on sign Sign not located on the latch side of the door	- - - -	Provide text with raised characters duplicated in braille on sign. Mount sign so that the baseline of the lowest tactile character is 48" min. above finished floor and the baseline of the highest tactile character is 60" max. above the finished floor. Locate sign alongside the door on the latch side.	1	232	\$232
72	Serving Area	1	1002	Signage	Designation

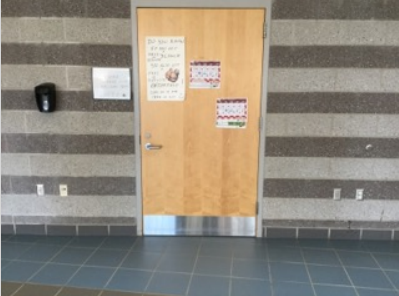
Raised characters not provided on sign Braille not provided on sign	- -	Provide text with raised characters duplicated in braille on sign.	1	232	\$232
73	Serving Area	1	1002	Signage	Designation

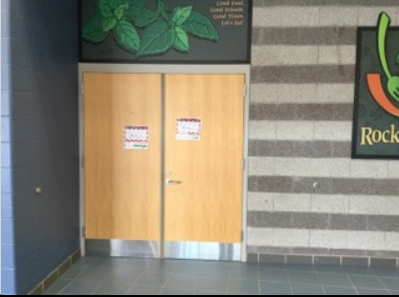
Raised characters not provided on sign Braille not provided on sign	- -	Provide text with raised characters duplicated in braille on sign.	1	232	\$232

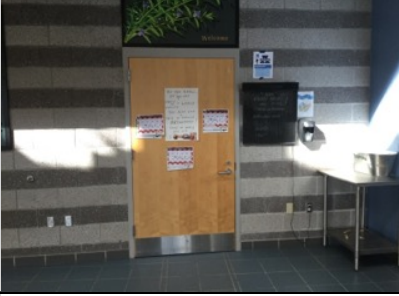
74	Serving Area	1	1002	Signage	Designation

Raised characters not provided on sign Braille not provided on sign	- -	Provide text with raised characters duplicated in braille on sign.	1	232	\$232
75	History Classroom	2	2006	Signage	Designation

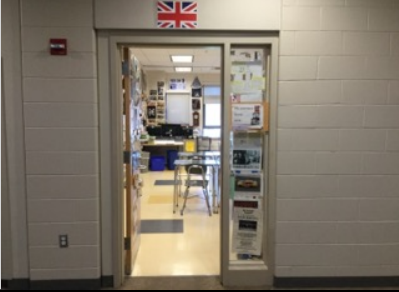
Raised characters not provided on sign Braille not provided on sign	- -	Provide text with raised characters duplicated in braille on sign.	1	232	\$232

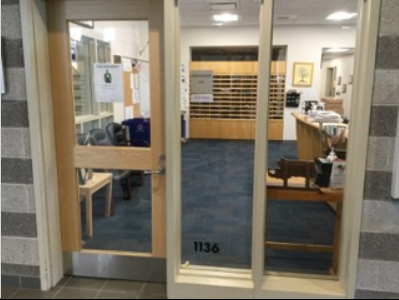
ID	Location	Floor	Room	Element	Type	Photo	Issues	Current Measure	Recommendations	Quantity	Price	Cost Estimation
76	Administratio n Office	1	1136	Signage	Designation

Braille not provided on sign	-	Provide braille on sign.	1	232	\$232
77	All Gender Toilet Room	1		Signage	Designation
