Town of Auburn, Massachusetts

ADA Self-Evaluation and Transition Plan

September 2020

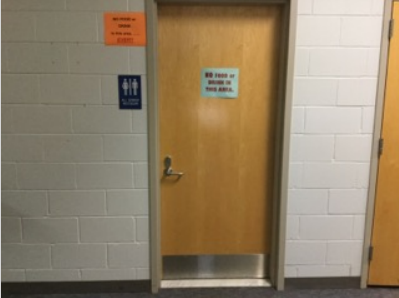
International Symbol of Acc. not provided	-	Provide a sign with the International Symbol of Accessibility.	1	232	\$232
78	Chorus	1	1079	Signage	Designation

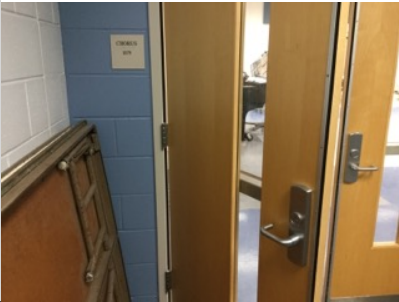
Sign not located on the latch side of the door	-	Locate sign at permanent rooms alongside the door on the latch side.	1	Labor	\$0
79	Dressing Room A	1	1077	Signage	Designation

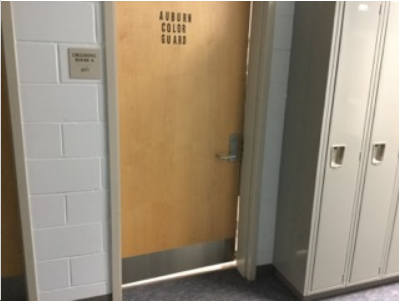
Sign not located on the latch side of the door	-	Locate sign at permanent rooms alongside the door on the latch side.	1	Labor	\$0
Service Counter												
80	Lobby	1		Service Counter	N/A

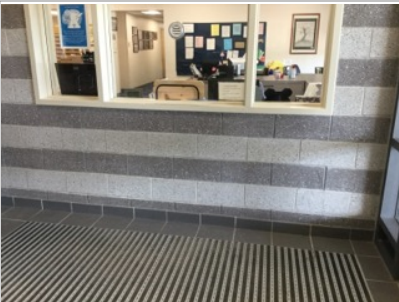
Counter > 36" high	41"	Provide a counter that is 36" max. above the ground or finished floor.	1	880	\$880

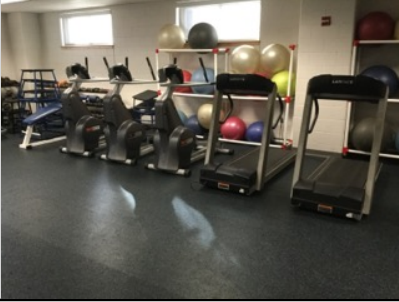
ID	Location	Floor	Room	Element	Type	Photo	Issues	Current Measure	Recommendations	Quantity	Price	Cost Estimation
Exercise Machines												
81	Fitness Room	1	2018	Exercise Machines	N/A

Clear floor space is not provided		Ensure a 30" min. by 48" min. clear floor space is provided at each type of machine.	1	Labor	\$0
Operable Parts												
82	Serving Area	1	1002	Operable Parts	Other

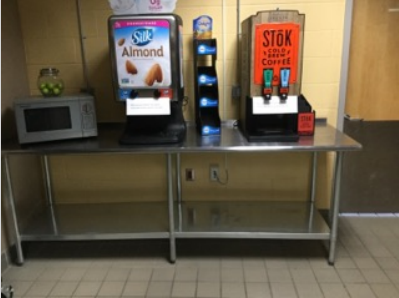
Reach < 15" or > 48"(forward/side approach)	-	Relocate dispensing machine to ensure that operable parts are 48" max. above the finished floor.	1	Labor	\$0
83	Hallway	1		Operable Parts	Other

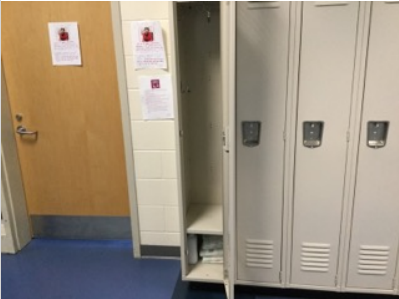
Reach < 15" or > 48"(forward/side approach)	-	Ensure hook is mounted 48" max. above the finished floor.	1	Labor	\$0
84	Nurse Suite	1	1106	Operable Parts	Other

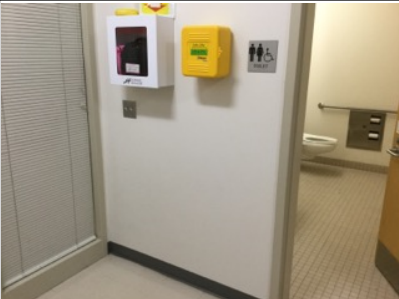
Reach < 15" or > 48"(forward/side approach)	60"	Relocate cabinet so that control is 48" max. above the finished floor. See ID #24 for cost.	1	-	\$0

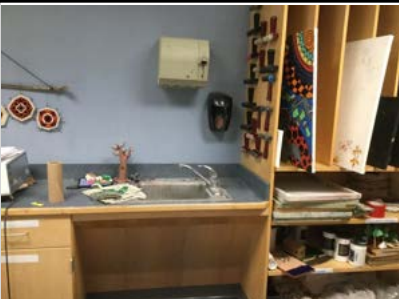
85	Art Room	2 A		Operable Parts	Other

Side reach > 54"	64"	Relocate paper towel dispenser so that control is 48" above the finished floor.	1	256	\$256

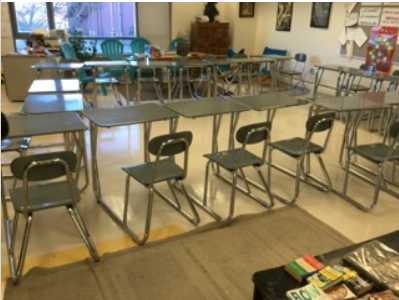
ID	Location	Floor	Room	Element	Type	Photo	Issues	Current Measure	Recommendations	Quantity	Price	Cost Estimation
Dining or Work Surfaces												
86	Classroom	2	2012	Dining or Work Surfaces	Work Surface

At least one or 5% accessible tables not provided	-	Ensure that at least one work surface is accessible.	1	700	\$700
87	Spanish Classroom	2	2012	Dining or Work Surfaces	Work Surface

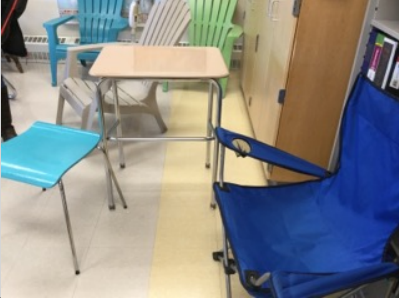
At least one or 5% accessible tables not provided	-	Ensure that at least one work surface is accessible.	1	700	\$700
88	History Classroom	2	2006	Dining or Work Surfaces	Work Surface

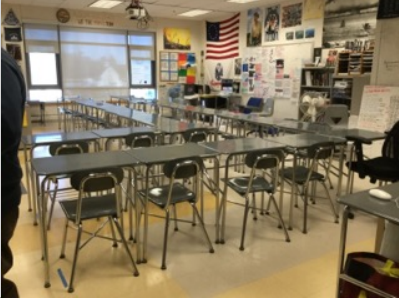
At least one or 5% accessible tables not provided	-	Ensure that at least one work surface is accessible.	1	700	\$700
89	Classroom	3	3064	Dining or Work Surfaces	Work Surface

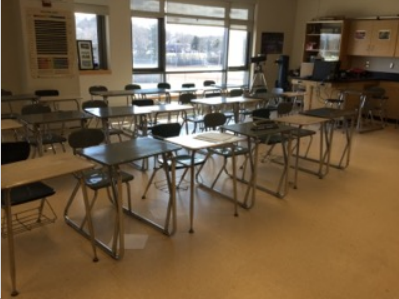
At least one or 5% accessible tables not provided	-	Ensure that at least one work surface is accessible.	1	700	\$700
90	Media Lab	3		Dining or Work Surfaces	Work Surface

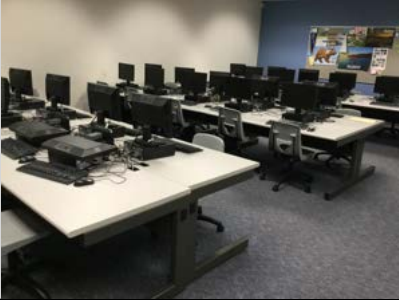
At least one or 5% accessible tables not provided	26"	Ensure that at least one work surface is accessible with 27" min. knee clearance. (Adjust table footing to increase knee clearance.)	1	Labor	\$0

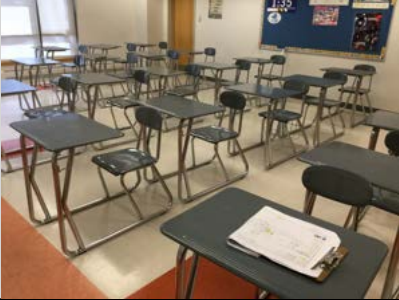
ID	Location	Floor	Room	Element	Type	Photo	Issues	Current Measure	Recommendations	Quantity	Price	Cost Estimation
91	Classroom	3	3009	Dining or Work Surfaces	Work Surface

At least one or 5% accessible tables not provided	-	Ensure that at least one work surface is accessible with knee and toe clearance.	1	700	\$700
92	Wood Tech	1	1032	Dining or Work Surfaces	Work Surface

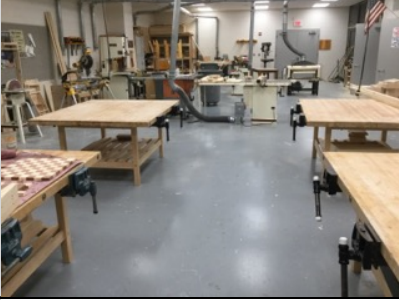
Knee or toe clearance not provided	-	Provide at least one work surface with 27" min. knee and toe clearance positioned for a forward approach.	1	700	\$700
93	Science Classroom	3	3059	Dining or Work Surfaces	Work Surface

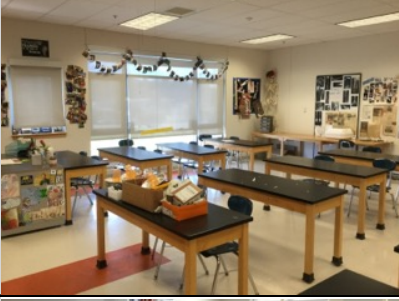
Knee or toe clearance not provided	24"	Provide at least 1 dining or work surface with 27" min. knee and toe clearance.	1	700	\$700
94	Computer Room	3		Dining or Work Surfaces	Work Surface

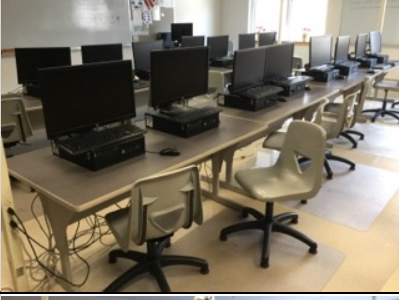
Knee or toe clearance not provided	25.5"	Provide at least one work surface with 27" min. knee and toe clearance.	1	700	\$700

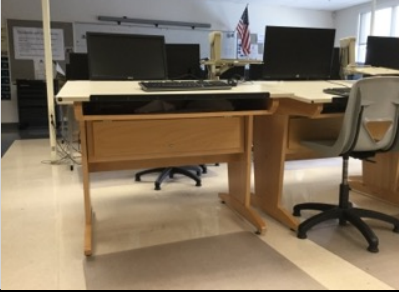
95	Classroom	3		Dining or Work Surfaces	Work Surface

Knee or toe clearance not provided	26"	Provide at least one work surface with 27" min. knee and toe clearance.	1	700	\$700

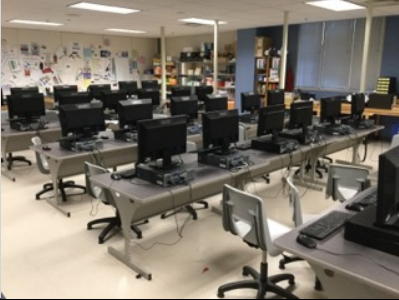
ID	Location	Floor	Room	Element	Type	Photo	Issues	Current Measure	Recommendations	Quantity	Price	Cost Estimation
96	Computer Room	3	3040	Dining or Work Surfaces	Work Surface

Knee or toe clearance not provided	25.5"	Provide at least one work surface with 27" min. knee and toe clearance.	1	700	\$700
97	Computer Room	3	3036	Dining or Work Surfaces	Work Surface

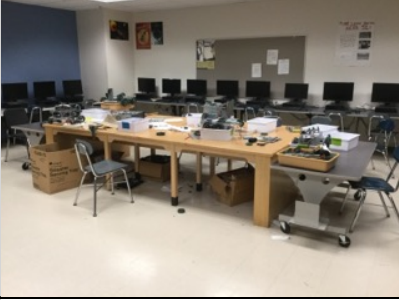
Knee or toe clearance not provided	26"	Provide at least one work surface with 27" min. knee and toe clearance.	1	700	\$700
98		1	1105	Dining or Work Surfaces	Work Surface

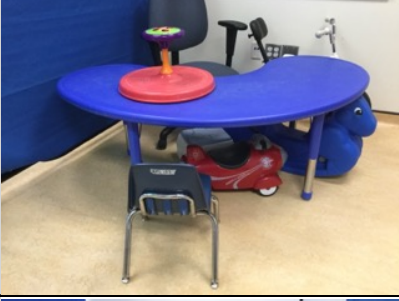
Top of dining/work surface < 26" or > 30"	22"	Ensure that at least one work surface is between 26"- 30" above the floor.	1	Labor	\$0
99		1	1105	Dining or Work Surfaces	Work Surface

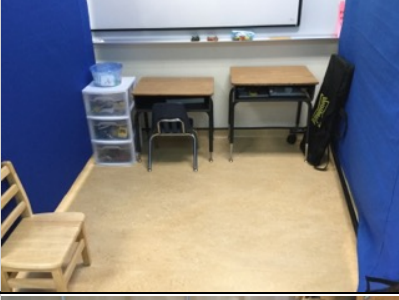
Top of dining/work surface < 26" or > 30"	-	Ensure at least one work surface has a top between 26"*30" above the finished floor.	1	Labor	\$0
100	Preschool	1	1102	Dining or Work Surfaces	Work Surface

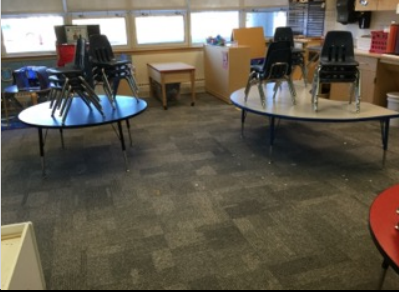
Top of dining/work surface < 26" or > 30"		Ensure that at least one work surface is between 26"- 30" above the floor.	1	Labor	\$0

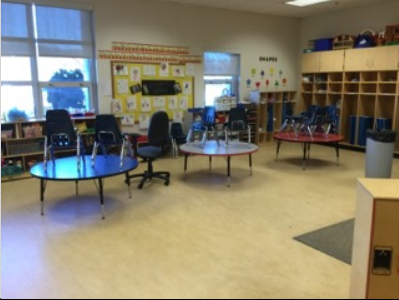
ID	Location	Floor	Room	Element	Type	Photo	Issues	Current Measure	Recommendations	Quantity	Price	Cost Estimation
101	Preschool Room	1	1101	Dining or Work Surfaces	Work Surface

Top of dining/work surface < 28" or > 34"	-	Ensure that at least one work surface is between 26"- 30" above the floor.	1	Labor	\$0
Assembly Area												
102	Auditorium	1	1069	Assembly Area	N/A

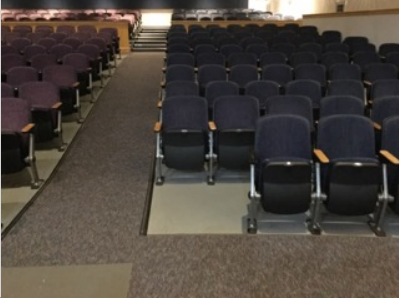
Number of seats Number of designated wheelchair spaces Designated aisle seats < 1% (MAAB)	491 6 -	At least 1% of the total number of aisle seats provided must be identified by a sign or marker and have folding or retractable armrests.	5	900	\$4500
103	Gymnasium	2		Assembly Area	N/A

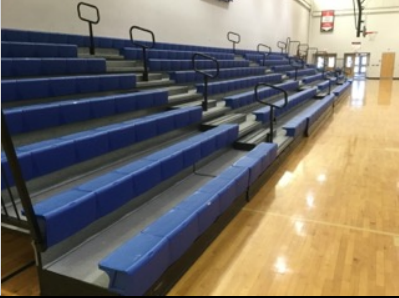
Minimum # wheelchair spaces not provided	-	Ensure the required number of wheelchair spaces are provided.	1	-	\$0
Locker Room												
104	Girls' Locker Room	1		Locker Room	Women's

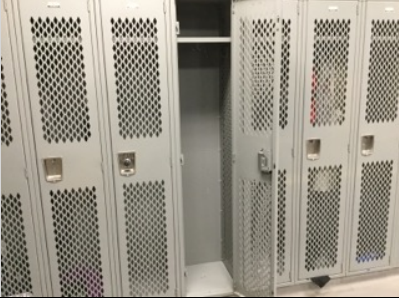
2% of lockers are not accessible	-	Provide at least 1 accessible locker. Ensure shelf and hook are mounted 48" max. above the finished floor.	1	Labor	\$0

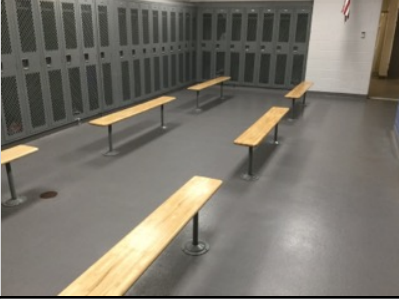
105	Girls' Locker Room	1		Locker Room	Women's

Back support not provided at bench Bench < 24" deep	- 9.5"	Provide at least one bench with back support or that is affixed to a wall with room on the side to transfer. Provide a bench that is 24" deep.	1	456	\$456

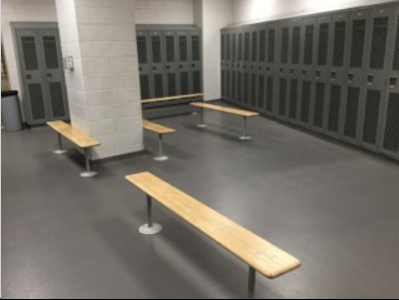
ID	Location	Floor	Room	Element	Type	Photo	Issues	Current Measure	Recommendations	Quantity	Price	Cost Estimation
106	Boys' Locker Room	1		Locker Room	Men's

Back support not provided at bench Bench < 24" deep	- 9.5"	Provide at least one bench with back support or that is affixed to a wall with room on the side to transfer. Provide a bench that is 24" deep.	1	456	\$456
107	Team Locker Room	1		Locker Room	Men's

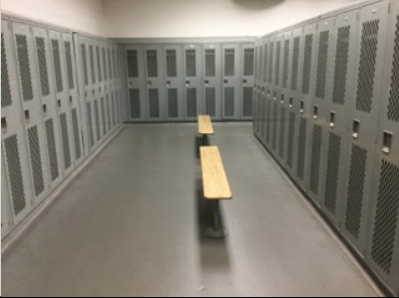
Back support not provided at bench Bench < 24" deep	- 9.5"	Provide at least one bench with back support or that is affixed to a wall with room on the side to transfer. Provide a bench that is 24" deep.	1	456	\$456
108	Team Locker Room	2		Locker Room	N/A

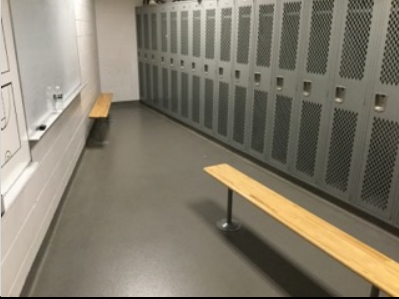
Bench < 24" deep	9.5"	Provide a bench that is 24" deep.	1	200	\$200
109	Hallway Lockers	2 A		Locker Room	N/A

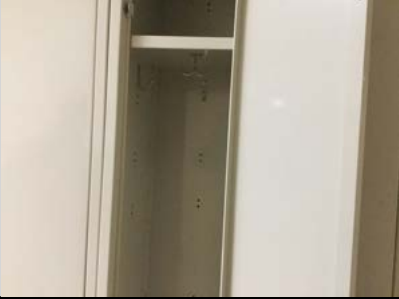
Storage > 48" high Hook > 48" high	62" 59"	Ensure that at least 5% of lockers are accessible, and no higher than 48 inches above the floor. Locate hook and storage shelf no higher than 48" above the finished floor.	1	Labor	\$0

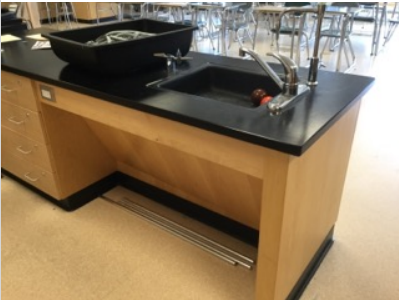
Laboratory												
110	Science Lab	3	3064	Laboratory	Other

Non-compliant faucets	-	Install faucets that do not require tight grasping, pinching, or twisting of the wrist.	1	986	\$986

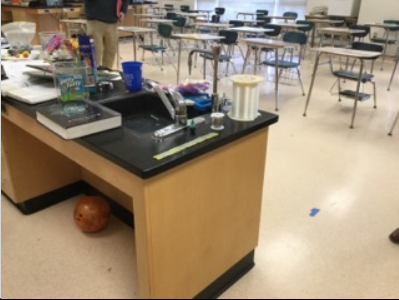
ID	Location	Floor	Room	Element	Type	Photo	Issues	Current Measure	Recommendations	Quantity	Price	Cost Estimation
111	Lab	3	3060	Laboratory	Other

Non-compliant faucets	-	Install faucets that do not require tight grasping, pinching, or twisting of the wrist.	1	986	\$986
112	Science Lab	3	3064	Laboratory	Other

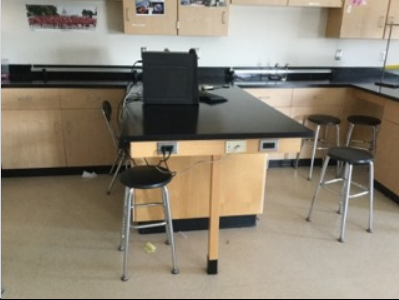
Top of dining/work surface < 28" or > 34"	36"	Provide a work surface with tops between 28" - 34" above the floor and 27" clear height underneath.	1	700	\$700
113	Lab	3	3060	Laboratory	Other

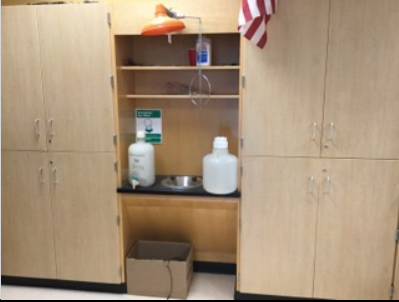
Emergency shower out of reach range	-	Lower the shower pull to 48" max.	1	Labor	\$0
114	Science Lab	3	3064	Laboratory	Other

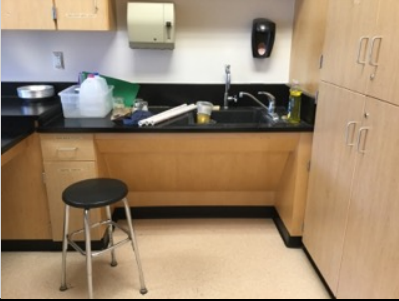
Accessories > 48"	55.5"	Lower paper towel dispenser so the operable part is mounted 44" max. above the finished floor.	1	256	\$256
115	Science Lab	3	3064	Laboratory	Other

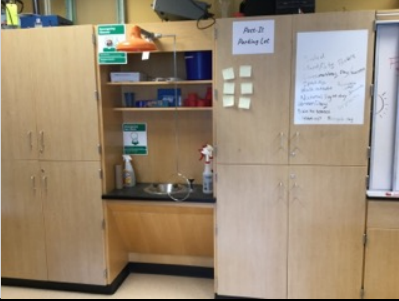
Accessible route obstructed by protruding object	-	Relocate emergency shower pull to maintain the accessible route to the sink.	1	Labor	\$0

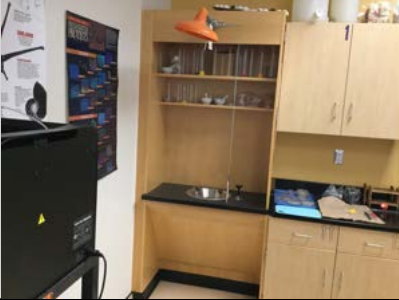
ID	Location	Floor	Room	Element	Type	Photo	Issues	Current Measure	Recommendations	Quantity	Price	Cost Estimation
116	Lab	3	3004	Laboratory	Chemistry

Accessible route obstructed by protruding object	-	Relocate emergency shower pull to maintain the accessible route to the sink.	1	Labor	\$0
Picnic Tables												
117	Near Door #1	Ext.		Picnic Tables

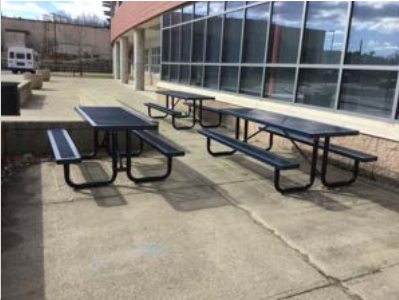
Toe or knee clearance at tables not provided	-	Provide at least 1 dining surface (or ensure that 5% of dining surfaces) have toe and knee clearance.	1	1400	\$1400
Exterior Benches												
118	Playground	Ext.		Exterior Benches

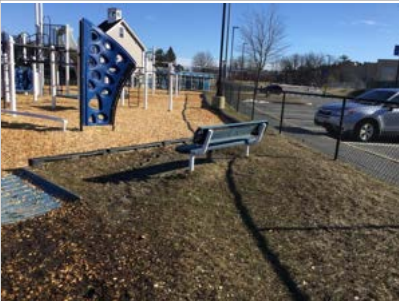
Accessible route not provided to at least one bench		Provide an accessible route to at least one bench in this area. (Cost based on a 4' wide min. x 6' long asphalt path to bench.)	1	240	\$240
Kitchens and Kitchenettes												
119	Teaching Preparation Classroom	1	1008	Kitchens and Kitchenettes	Classrooms

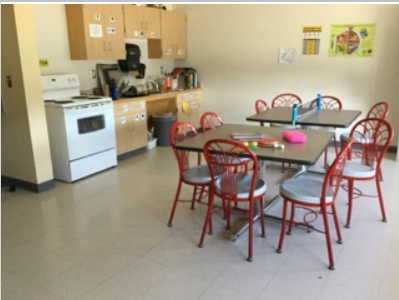
Knee/toe clearance not provided at cooktop Control panels at cooktop not at front	- -	Provide a cooktop with knee and toe clearance positioned for a forward approach. Provide a cooktop with controls that do not require reaching across burners.	1	1000	\$1000

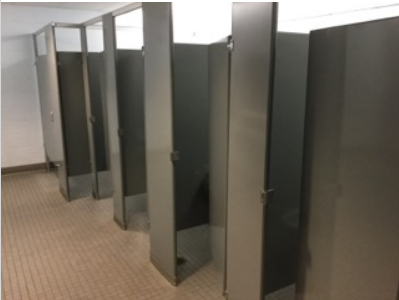
ID	Location	Floor	Room	Element	Type	Photo	Issues	Current Measure	Recommendations	Quantity	Price	Cost Estimation
Overall Access												
120	Girls' Toilet Room	2		Overall Access	Toilet Room

6 fixtures, but no ambulatory compartment provided	-	Provide one ambulatory accessible compartment.	1	3012	\$3012
121	Men's and Women's Toilet Room by Football Field	Ext.		Overall Access	Toilet Room

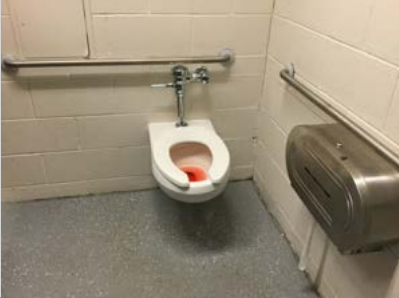
Audible and visible alarms not provided	-	When fire system is updated, ensure that a visible and audible fire alarm is installed.	2	-	\$0
122	Men's and Women's Toilet Room by Football Field	Ext.		Overall Access	Toilet Room

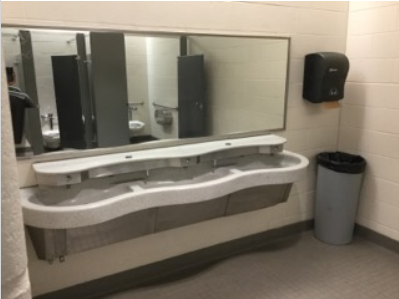
Toe or knee clearances not provided	-	Remove panel to ensure the required 27" min. knee clearance positioned for a forward approach is provided.	1	Labor	\$0

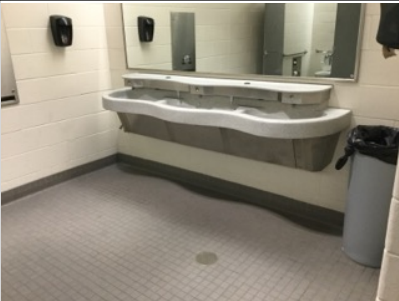
124	Women's Toilet Room	1		Lavatory	N/A

Toe or knee clearances not provided	-	Remove panel to ensure the required 27" min. knee clearance positioned for a forward approach is provided.	1	Labor	\$0

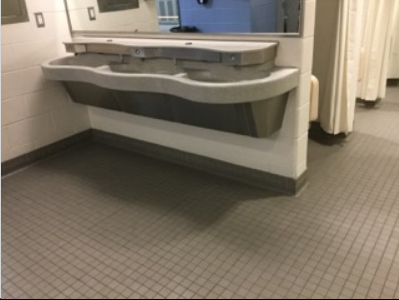
ID	Location	Floor	Room	Element	Type	Photo	Issues	Current Measure	Recommendations	Quantity	Price	Cost Estimation
125	Girls' Locker Room	1		Lavatory	N/A

Toe or knee clearances not provided	-	Remove panel to ensure the required 27" min. knee clearance positioned for a forward approach is provided.	1	Labor	\$0
126	Boys' Locker Room	1		Lavatory	N/A

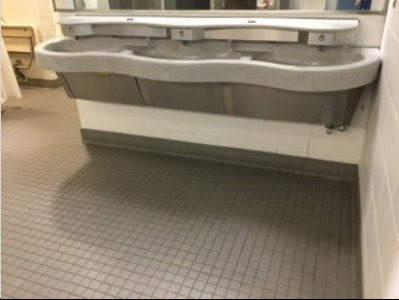
Toe or knee clearances not provided	-	Remove panel to ensure the required 27" min. knee clearance positioned for a forward approach is provided.	1	Labor	\$0
127	Women's Toilet Room by Football Field	Ext.		Lavatory	N/A

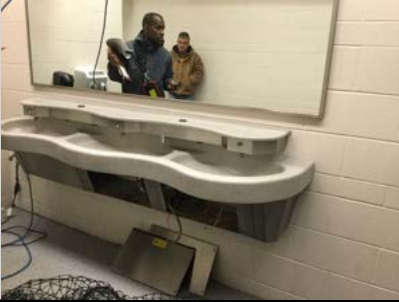
Toe or knee clearances not provided Mirror above lavatory w/reflective surface > 40"	- 43"	Remove panel to ensure the required 27" min. knee clearance positioned for a forward approach is provided. Lower mirror so that the bottom surface is at 40" max. above the finished floor.	1	256	\$256
128	Men's Toilet Room by Football Field	Ext.		Lavatory	N/A

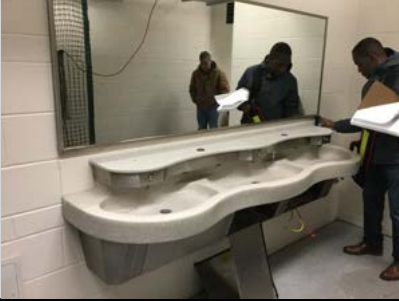
Toe or knee clearances not provided Mirror above lavatory w/reflective surface > 40"	- 41.5"	Remove panel to ensure the required 27" min. knee clearance positioned for a forward approach is provided. Lower mirror so that the bottom surface is at 40" max. above the finished floor.	1	256	\$256

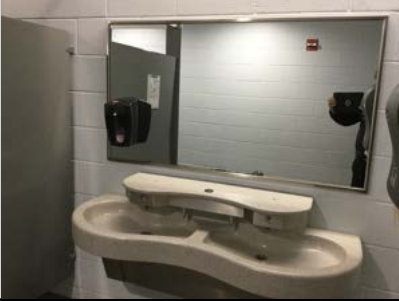
129	Girls' Toilet Room by Elevator	3		Lavatory	N/A

Toe or knee clearances not provided Dispensers not within reach range	- 54"	Remove panel to ensure the required 27" min. knee clearance positioned for a forward approach is provided. Lower dispensers to 42" max. above the floor.	1	256	\$256

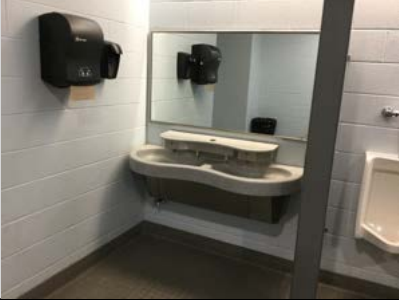
ID	Location	Floor	Room	Element	Type	Photo	Issues	Current Measure	Recommendations	Quantity	Price	Cost Estimation
130	Boys' Toilet Room	3		Lavatory	481

Toe or knee clearances not provided Dispensers not within reach range Dispenser acts as a protruding object	- 63" 10"	Remove panel to ensure the required 27" min. knee clearance positioned for a forward approach is provided. Relocate so the operable part of the paper towel and soap dispensers are 42" max. above the finished floor. Ensure paper towel dispenser does not protrude into the circulation path.	2	256	\$512
131	Nurse Suite - Toilet Room	1	1106	Lavatory	N/A

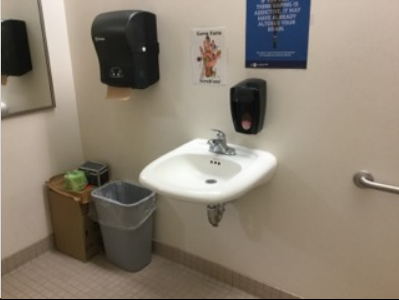
Plumbing underneath is exposed Dispensers not within reach range	- -	Insulate or otherwise configure pipes to prevent contact at lavatory. Lower paper towel dispensers to 42" max. above the floor.	1	348	\$348
132	Referees - Single-User Toilet Room	2		Lavatory	N/A

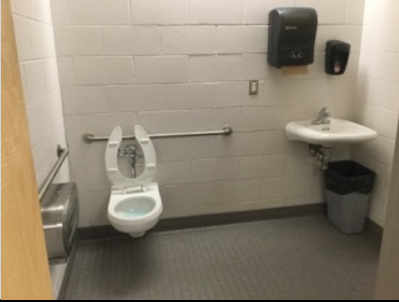
Plumbing underneath is exposed Dispensers not within reach range	- -	Insulate or otherwise configure pipes to prevent contact at lavatory. Lower paper towel dispenser so the operable part is 42" max. above the finished floor.	1	348	\$348

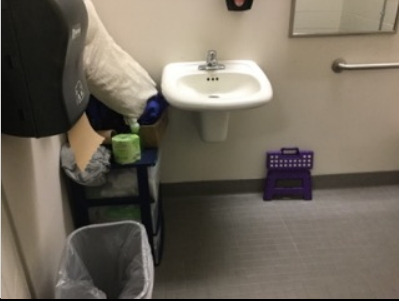
133	All Gender Toilet Room	1		Lavatory	N/A

Not maintain in operable working condition		Remove all storage from toilet room to ensure the toilet room is maintain in operable working condition.	1	Labor	\$0
134	Men's Single-User Toilet Room	2 A		Lavatory	N/A

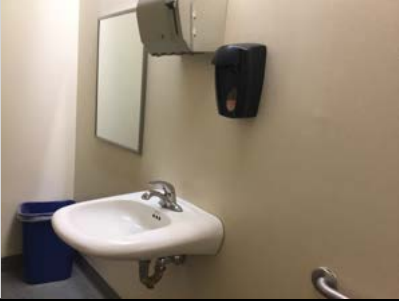
Plumbing underneath is exposed	-	Insulate or otherwise configure pipes to prevent contact at lavatory.	1	92	\$92

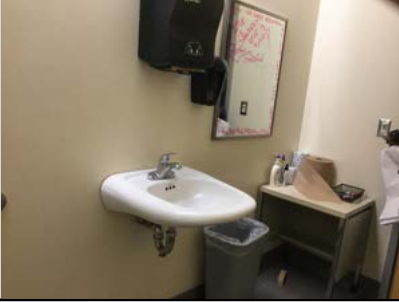
ID	Location	Floor	Room	Element	Type	Photo	Issues	Current Measure	Recommendations	Quantity	Price	Cost Estimation
135	Women's Single-User Toilet Room by Room 2071	2 A		Lavatory	N/A

Plumbing underneath is exposed Dispensers not within reach range	- -	Insulate or otherwise configure pipes to prevent contact at lavatory. Lower paper towel dispenser to 42" max. above the floor.	1	348	\$348
Single-User Toilet												
136	All Gender Toilet Room	1		Single-User Toilet	N/A

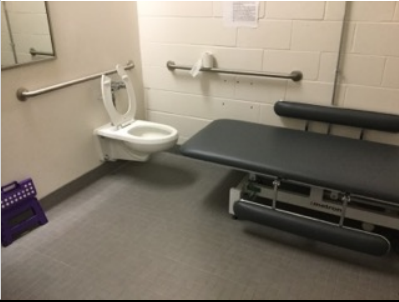
Clearance at toilet < 72" clear depth	-	Ensure the 72" deep min. clear floor space is maintain at the toilet.	1	Labor	\$0
Toilet Compartment												
137	Men's Toilet Room	1		Toilet Compartment	Accessible Compartment

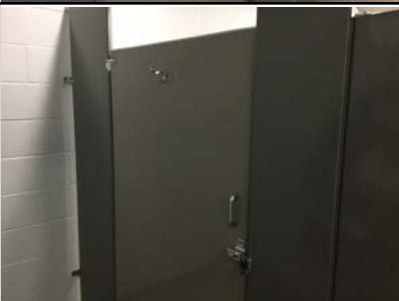
139	Boys' Toilet Room	3		Toilet Compartment	Accessible Compartment

Door has malfunctioning self-closing hinge Coat hook > 48"	- 65.5"	Repair hinge. Lower coat hook so that it is no higher than 48".	1	150	\$150

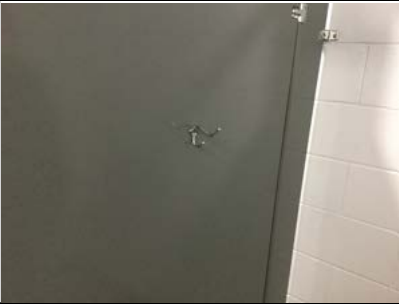
ID	Location	Floor	Room	Element	Type	Photo	Issues	Current Measure	Recommendations	Quantity	Price	Cost Estimation
140	Girls' Toilet Room by Elevator	3		Toilet Compartment	Accessible Compartment

Coat hook > 48"	55.5"	Lower coat hook so that it is no higher than 48".	1	150	\$150
Dispensers												
141	Women's Toilet Room	1		Dispensers	Paper Towel Dispenser

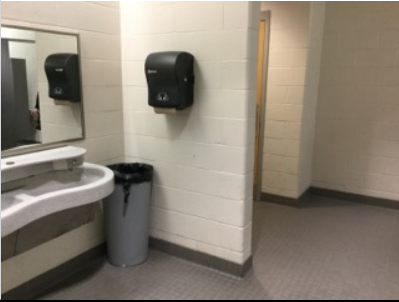
Controls > 42" high	51"	Relocate paper towel dispenser so the operable part is 42" max. above the finished floor.	1	256	\$256
142	Team Locker Room - Single-User Toilet Room	2		Dispensers	Paper Towel Dispenser

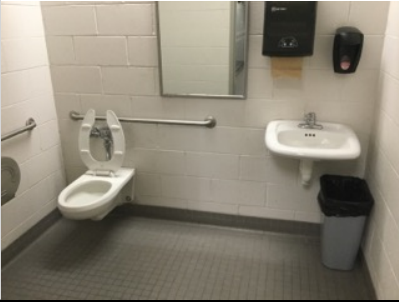
Controls > 42" high	52"	Lower paper towel dispenser so the operable part is 42" max. above the finished floor.	1	256	\$256
143	Men's Single-User Toilet Room by Room 3039	3		Dispensers	Soap Dispenser

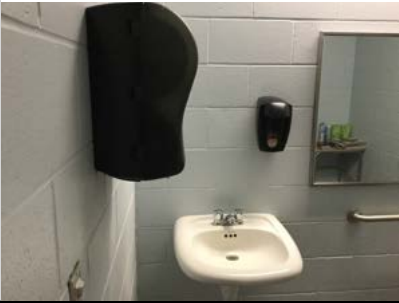
Controls > 42" high	56"	Lower paper towel and soap dispensers so the operable parts are 42" max. above the finished floor. Ensure paper towel dispenser does not protrude into the circulation path.	2	256	\$512

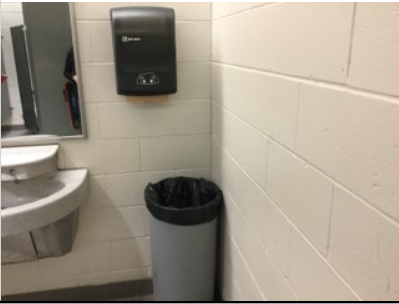
144	Men's Toilet Room	1		Dispensers	Paper Towel Dispenser

Controls > 42" high Clear floor space not provided at accessory	50" -	Relocate paper toilet dispenser so the operable part is 42" max. above the finished floor. Relocate trash can to maintain the required 30" min. by 48" min. clear floor space at the paper towel dispenser.	1	256	\$256

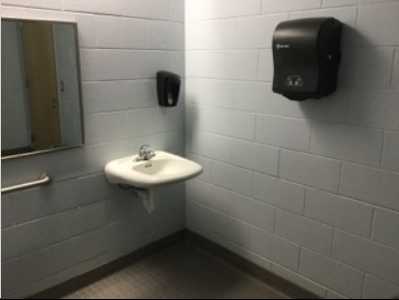
ID	Location	Floor	Room	Element	Type	Photo	Issues	Current Measure	Recommendations	Quantity	Price	Cost Estimation
145	Women's Toilet Room	3		Dispensers	Paper Towel Dispenser

Controls > 42" high Dispenser acts as a protruding object	54" 8"	Relocate paper toilet dispenser so the operable part is 42" max. above the finished floor. Ensure paper towel dispenser does not protrude into the circulation path.	1	256	\$256
Shower Compartment												
146	Referees - Shower Area	2		Shower Compartment	Transfer Type

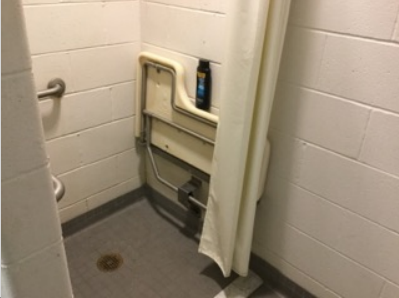
Clear space at transfer shower > 48" x 36"	-	Locate shower seat on the opposite wall to ensure a 12" clear floor space is provided beyond the seat. Ensure controls are located opposite the seat. (See Sketch.)	1	6072	\$6072
147	Boys' Locker Room	1		Shower Compartment	Roll-In Type

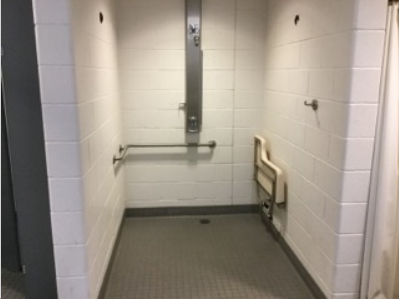
Controls not adjacent to seat (roll-in type) Fixed shower head > 48"	29.7" -	Locate controls on the back wall adjacent to the seat wall located 27" max. from the seat wall. Provide a fixed shower head mounted 48" max. above the finished floor.	1	2719	\$2719

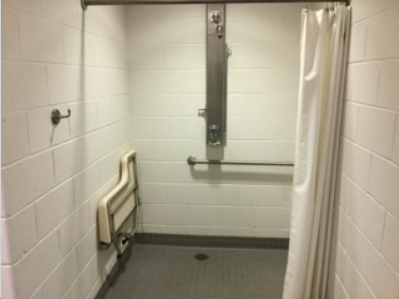
148	Girls' Locker Room	1		Shower Compartment	Roll-In Type

Controls not adjacent to seat (roll-in type) Fixed shower head > 48"	29.7" -	Locate controls on the back wall adjacent to the seat wall located 27" max. from the seat wall. Provide a fixed shower head mounted 48" max. above the finished floor.	1	2719	\$2719
Additional Access												
Drinking Fountains												
149	Near Elevator	3		Drinking Fountains	Low

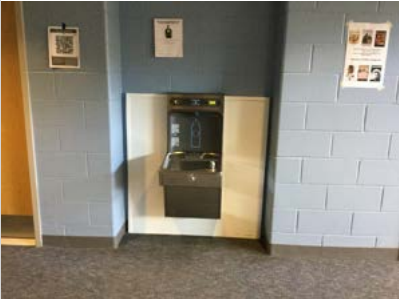
No drinking fountain provided for standing users Knee or toe clearance not provided	- 24"	Provide an additional drinking fountain for standing users or install a Hi-Lo drinking fountain. Ensure a 27" knee clearance, is provided at the drinking fountain for seated users. (Cost based on a new Hi-Lo drinking fountain.)	1	4216	\$4216

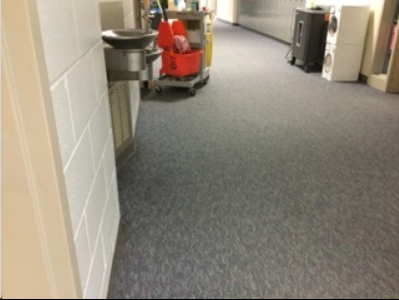
ID	Location	Floor	Room	Element	Type	Photo	Issues	Current Measure	Recommendations	Quantity	Price	Cost Estimation
150	Hallway - Near Room 1105	1		Drinking Fountains	High

Standing height fountain does not have cane protection	-	Provide a cane-detectable barrier skirt under the high unit.	1	890	\$890
151	Hallway	3		Drinking Fountains	High

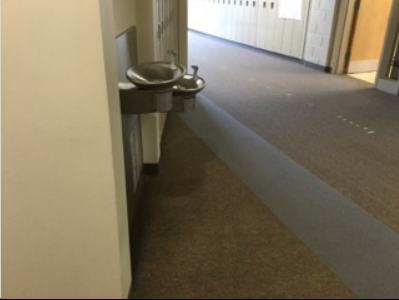
Standing height fountain does not have cane protection	-	Provide a cane-detectable barrier skirt under the high unit.	1	890	\$890
152	Hallway	3		Drinking Fountains	Low

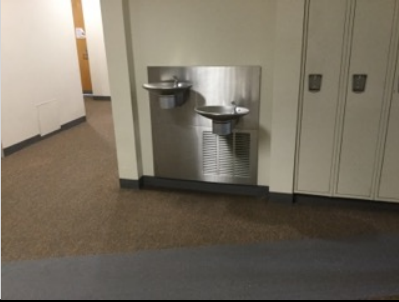
Knee or toe clearance not provided	26"	Provide knee and toe clearance, 27" min. high at drinking fountain for seated users.	1	2028	\$2028
Sink												
153	Teaching Preparation Classroom	1	1008	Sink	Classroom

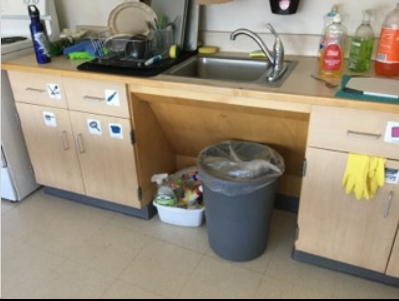
Clear floor space not provided at sink	-	Relocate trash can to ensure the 30" by 48" clear floor space positioned for a forward approach is maintained at the sink.	1	Labor	\$0

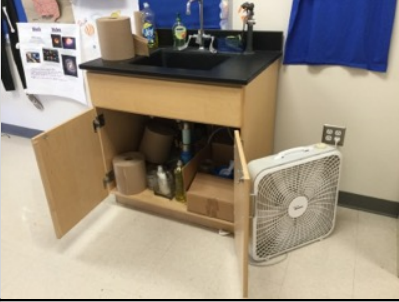
154	Science Classroom	3	3059	Sink	Classroom

Toe and knee clearances not provided Rim or counter > 34"	- 36"	Ensure there is a 27" knee clearance positioned for a forward approach. Relocate sink with the front of the rim or counter no higher than 34".	1	3094	\$3094

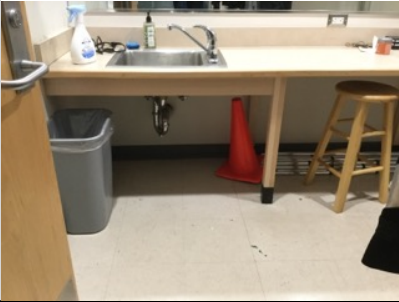
ID	Location	Floor	Room	Element	Type	Photo	Issues	Current Measure	Recommendations	Quantity	Price	Cost Estimation
155	Dressing Room A	1	1077	Sink	Other

Toe and knee clearances not provided Exposed plumbing underneath sink	24" -	Ensure there is a 27" knee clearance positioned for a forward approach. Insulate or otherwise configure pipes at sink.	1	1686	\$1686
Play and Sport Areas												
Play Areas												
156	Playground Accessible Entrance	Ext.		Play Areas	N/A

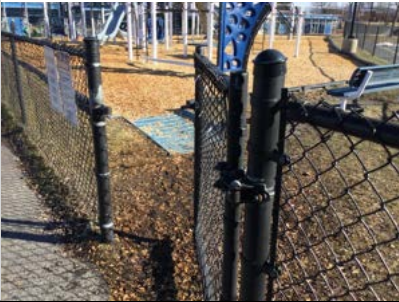
Clear width at gate < 32"	19"	Repair the playground entry gate so that there is 32" min. clear width.	1	Labor	\$0
157	Playground	Ext.		Play Areas

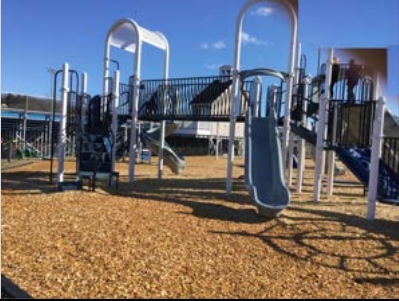
Accessible route not provided to play components	-	Provide a compliant impact-attenuating surface to and around the play components. (Cost estimate for 60 sq. ft. of poured in place rubber surface.)	1	5040	\$5040
Field												
158	Soccer Field Bleachers	Ext.		Field	Soccer

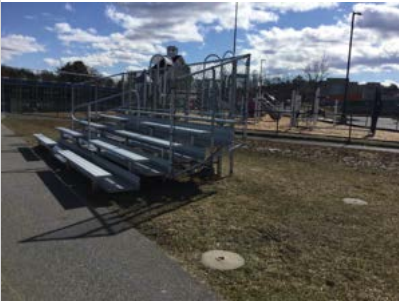
Accessible spaces not provided at sidelines seating	-	Provide a 36" x 48" clear floor space at sidelines seating. (Cost based on an asphalt patch by bleachers.)	1	120	\$120

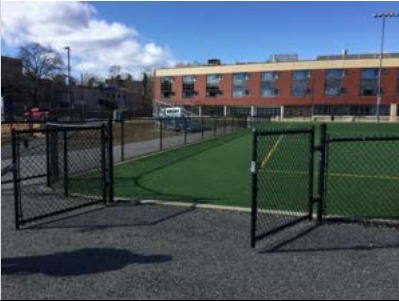
159	Soccer Field Entrance by Playground	Ext.		Field	Soccer

Field not connected to an accessible route	2"	Ensure change in level at the accessible route is no greater than ½"	1	Labor	\$0

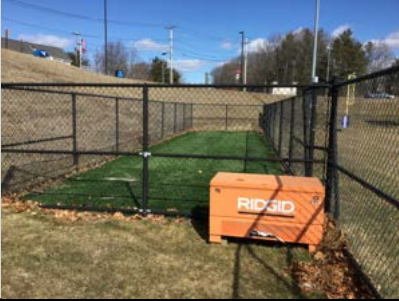
ID	Location	Floor	Room	Element	Type	Photo	Issues	Current Measure	Recommendations	Quantity	Price	Cost Estimation
160	Softball Bullpen 3rd and First Base Base Sides	Ext.		Field	Softball

Practice areas are not on an accessible route	-	Provide an accessible route to practice areas and entrance to third and first base bullpens. (Cost estimate for a 4'x60' asphalt path to the third base bullpen entrance and a 4'x30' asphalt path to the first base bullpen entrance.)	1	3600	\$3600
161	First Base Bullpen	Ext.		Field	Baseball

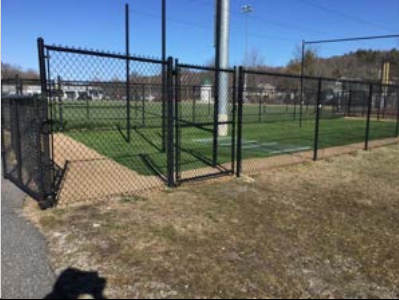
No accessible route to all areas of sport activity	-	Provide an accessible route between all areas of sport activity. Provide an accessible route to the first base bullpen. (Cost estimate for a 48" wide min. x 15' asphalt route to bullpen.)	1	240	\$240
Court												
162	Shot-Put			Court	Shot-put

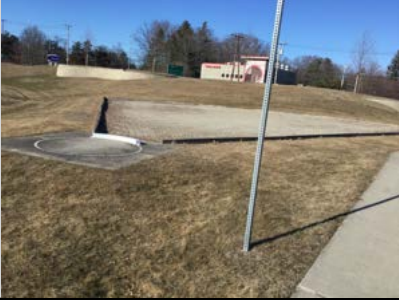
No accessible route between all areas of sport activity	-	Provide an accessible route between all areas of sport activity. (Cost estimate for a 4' wide min. by 15' asphalt route to edge of sport activity at shot-put.)	1	600	\$600

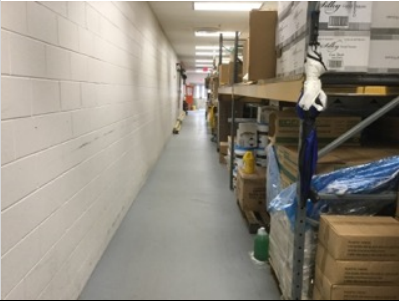
Best Practice												
Interior Access Route												
163	Near Room 1032	1		Interior Access Route	N/A

Even though the min. clear width is more than 36", recommend having the hallway clear at all time.	1	-	\$0

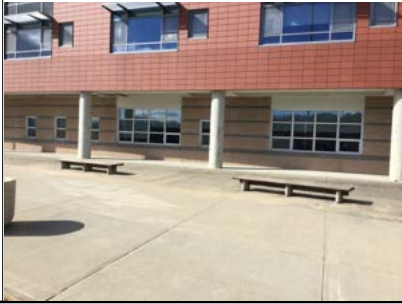
ID	Location	Floor	Room	Element	Type	Photo	Issues	Current Measure	Recommendations	Quantity	Price	Cost Estimation
Benches												
164	Main Entrance	Ext.		Benches	N/A

Recommend providing some benches with arms and backrests.	1	-	\$0
Crosswalk												
165	Front Towards Door #2	Ext.		Crosswalk	N/A

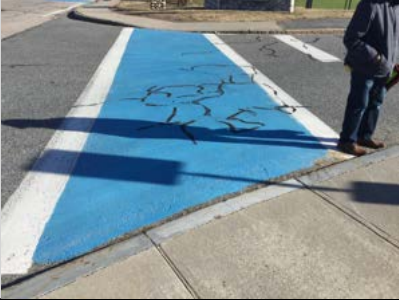
ID	Location	Floor	Room	Element	Type	Photo	Issues	Current Measure	Recommendations	Quantity	Price	Cost Estimation
169	Auburn Street Entrance by McDonald's			Crosswalk	N/A

Recommend providing detectable warnings on both sides of crosswalk.	1	-	\$0
Examination Table												
170	Nurse Suite	1	1106	Examination Table	N/A

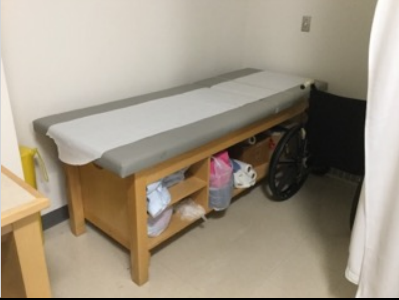
Recommend providing an adjustable examination table.	1	-	\$0
Exterior Access Route to Edge of Sport Activity												
171	Soccer Field Entrance by Baseball Field	Ext.		Exterior Access Route to Edge of Sport Activity	N/A

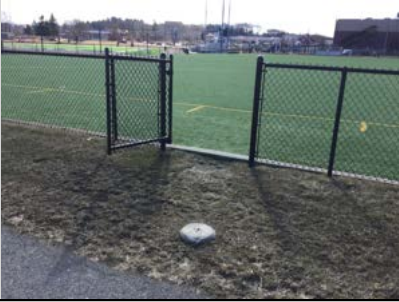
Recommend providing a 4' wide min. stable, firm and slip resistant surface and reducing 2" lip to gate at edge of sport activity.	1	-	\$0
Shower Compartment												
172	Girls' Locker Room and Boys' Locker Room	1		Shower Compartment	N/A

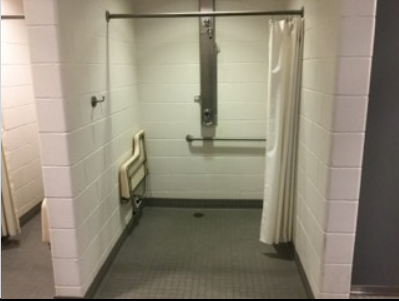
Recommend having a second shower curtain to provide more privacy.	2	-	\$0

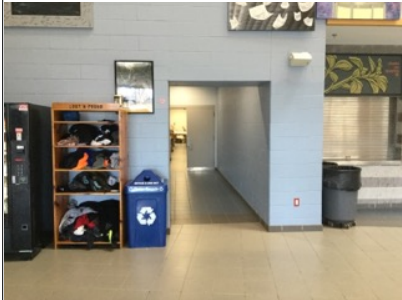
ID	Location	Floor	Room	Element	Type	Photo	Issues	Current Measure	Recommendations	Quantity	Price	Cost Estimation
Signage												
173	Towards Toilet Rooms	1		Signage	N/A

Recommend providing a directional wayfinding sign here.	1	-	\$0
Signage												
174	Serving Area	1	1002	Signage	N/A

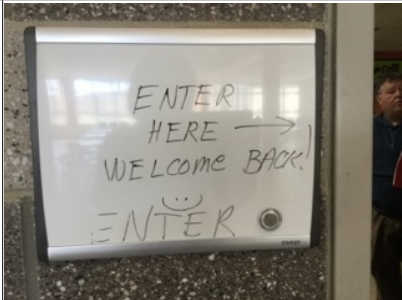
Recommend relocating board so as to avoid glare.	1	-	\$0
175	Guidance Suite	1	1122	Signage	N/A

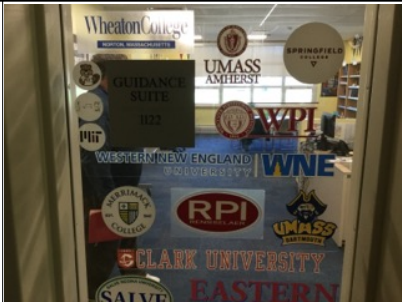
Remove all stickers to ensure the designation sign is visible.	1	-	\$0
176	Nurse Suite	1	1106	Signage	N/A

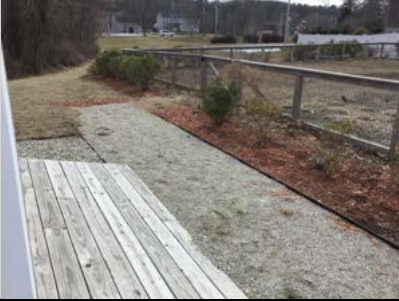
ID	Location	Floor	Room	Element	Type	Photo	Issues	Current Measure	Recommendations	Quantity	Price	Cost Estimation
Approach and Entrance												
Exterior Access Route												
1	Garden Entrance	Ext.		Exterior Access Route	Exterior

Accessible route not provided	-	Ensure an accessible route is provided from the existing walkway to the garden entrance. (Cost based on a 4' wide min. x 6' min. stone dust path connecting to the existing path.)	1	192	\$192
Off-Street Parking Lot or Garage												
2	Parking	Ext.		Off-Street Parking Lot or Garage	N/A

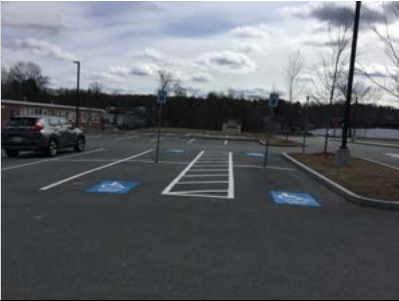
Total # of designated accessible parking spaces Access aisle < 60" wide at car/van space	4 56"	Provide a marked access aisle that is at least 60" wide.	1	300	\$300
Entrance												
3	Garden Shed	Ext.		Entrance	N/A

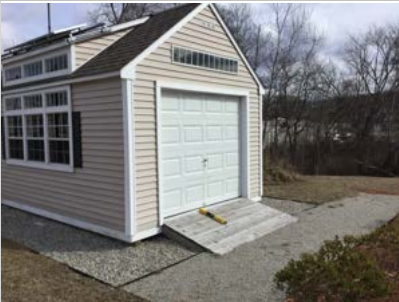
Entrance not on an accessible route	24.8%	Provide an accessible route into the garden shed. (Cost based on a portable ramp to provide access with a maximum running slope of 8.33%.)	1	500	\$500

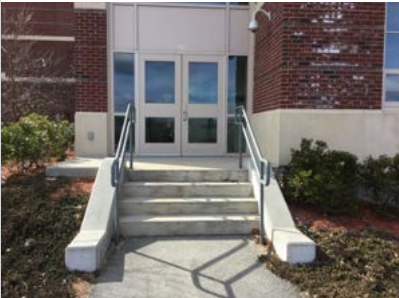
4	Exit #21	Ext.		Entrance	Other

Directional sign to accessible entrance not provided	-	Provide a directional sign indicating the location of the nearest accessible entrance.	1	346	\$346

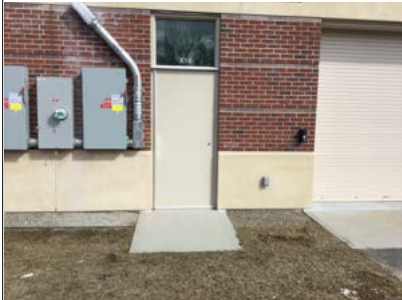
ID	Location	Floor	Room	Element	Type	Photo	Issues	Current Measure	Recommendations	Quantity	Price	Cost Estimation
Emergency Exit												
5	Exit #14	Ext.		Emergency Exit	N/A

Emergency exit not on an accessible route	-	Provide an asphalt walkway connecting the door landing to the existing walkway that is 4' wide min. by 6' min. (Cost based on an asphalt walkway.)	1	240	\$240
Access to Goods and Services												
Means of Egress												
6	Music Room	1	109	Means of Egress	N/A

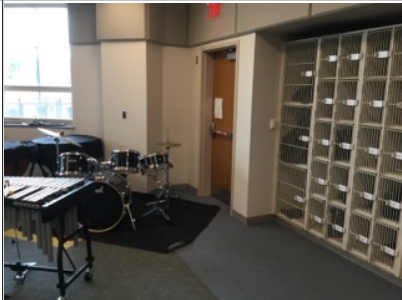
Route < 36" wide	-	Ensure that a clear width of 36" min. is maintained at the accessible route by the emergency door.	1	Labor	\$0
7	Exit From Gymnasium To Parking	1	101	Means of Egress	N/A

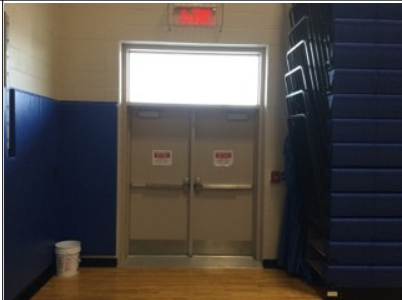
Tactile exit sign not provided	-	Ensure a tactile exit sign with raised characters and braille is provided at exit doors. Mount sign between 48"- 60" above the finished floor located on the latch side of the door.	1	232	\$232

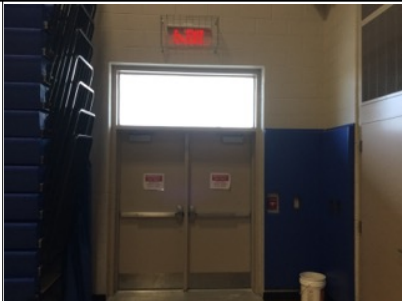
8	Gymnasium	1	101	Means of Egress	N/A

Tactile exit sign not provided	-	Ensure a tactile exit sign with raised characters and braille is provided at exit doors. Mount sign between 48"- 60" above the finished floor located on the latch side of the door.	1	232	\$232
9	Gymnasium	1	101	Means of Egress	N/A

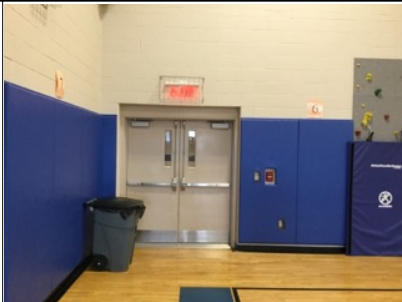
Tactile exit sign not provided	-	Ensure a tactile exit sign with raised characters and braille is provided at exit doors. Mount sign between 48"- 60" above the finished floor located on the latch side of the door.	1	232	\$232

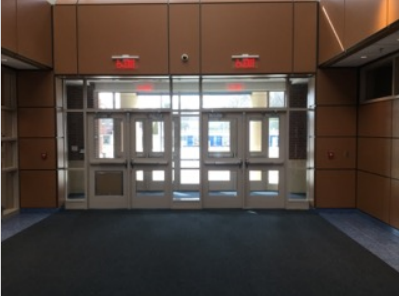
Tactile exit sign not provided	-	Ensure a tactile exit sign with raised characters and braille is provided at exit doors. Mount sign between 48"- 60" above the finished floor located on the latch side of the door.	1	232	\$232
11	Corridor	1	109	Means of Egress	N/A

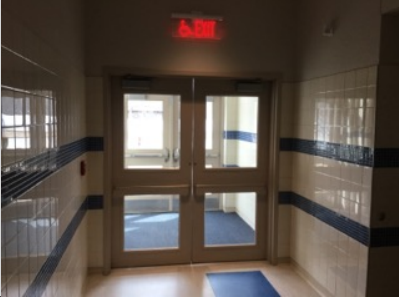
Tactile exit sign not provided	-	Ensure a tactile exit sign with raised characters and braille is provided at exit doors. Mount sign between 48"- 60" above the finished floor located on the latch side of the door.	1	232	\$232
12	Library/Media Lab	2		Means of Egress	N/A

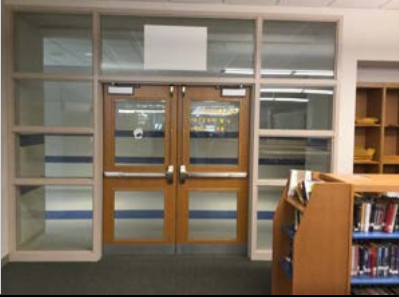
Tactile exit sign not provided	-	Ensure a tactile exit sign with raised characters and braille is provided at exit doors. Mount sign between 48"- 60" above the finished floor located on the latch side of the door.	1	232	\$232

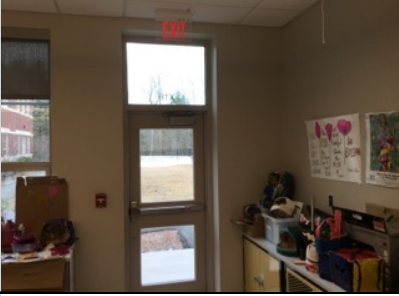
13	Classroom	1	124	Means of Egress	N/A

Tactile exit sign not provided Illuminated ISA symbol not provided (MAAB)	- -	Ensure a tactile exit sign with raised characters and braille is provided at exit door. Mount sign between 48"- 60" above the finished floor located on the latch side of the door. Provide an illuminated sign with the International Symbol of Accessibility.	1	432	\$432
14	Girls' Locker Room	1	101	Means of Egress	N/A

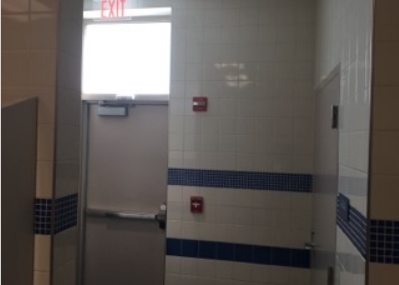
Illuminated ISA symbol not provided (MAAB)	-	Provide an illuminated sign with the International Symbol of Accessibility.	1	200	\$200

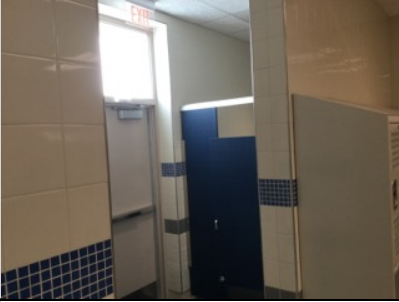
Illuminated ISA symbol not provided (MAAB)	-	Provide an illuminated sign with the International Symbol of Accessibility (ISA).	1	200	\$200
16	Band Room	1	102	Means of Egress	N/A

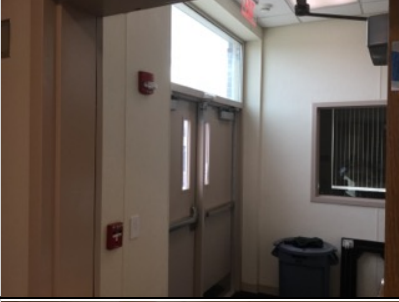
Illuminated ISA symbol not provided (MAAB)	-	Provide an illuminated sign with the International Symbol of Accessibility.	1	200	\$200
17	Science Classroom	1	125	Means of Egress	N/A

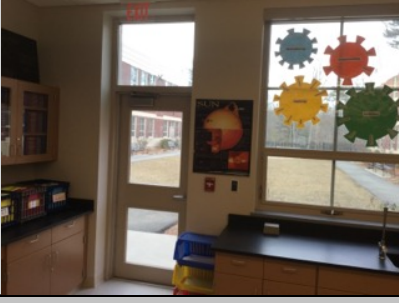
Illuminated ISA symbol not provided (MAAB)	-	Provide an illuminated sign with the International Symbol of Accessibility.	1	200	\$200
Interior Access Route												
18	Serving Area	1	109	Interior Access Route	N/A

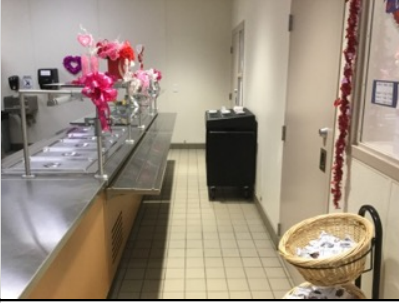
Route < 36" wide	-	Ensure that a clear width of 36" min. is maintained at the accessible route.	1	Labor	\$0
19	Music Room	1	109	Interior Access Route	N/A

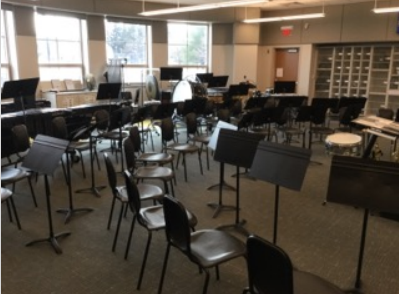
Route < 36" wide	-	Rearrange furniture to maintain the required 36" min. width at the accessible route.	1	Labor	\$0

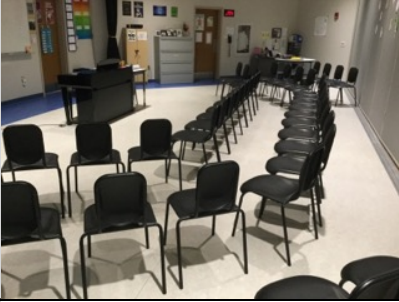
Route < 36" wide	-	Rearrange furniture to maintain the required 36" min. width at the accessible route.	1	Labor	\$0
21	Main Hallway	1	101	Interior Access Route	N/A

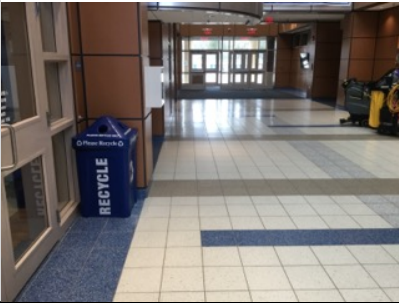
Obstructed by protruding objects	-	Relocate AED cabinet so it does not protrude into the circulation path	1	256	\$256
22	Serving Area	1	109	Interior Access Route	N/A

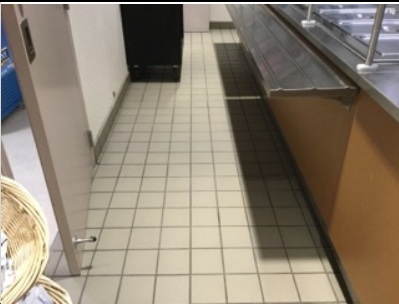
Obstructed by protruding objects	-	Provide a cane-detectable barrier.	1	306	\$306
Doors, Doorways, & Gates												
23	Nurse	1	13	Doors, Doorways, & Gates	Toilet Room

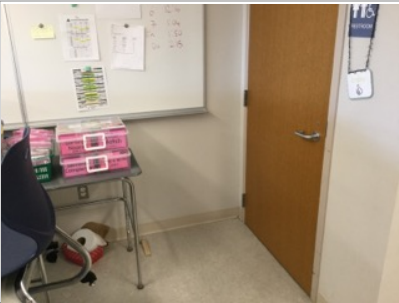
Maneuvering clearance(s) not provided	-	Remove the desk and chair to maintain the required maneuvering clearance at the door.	1	Labor	\$0
24	Girls' Locker Room	1	101	Doors, Doorways, & Gates	Toilet Room

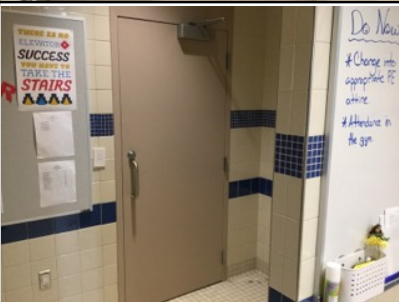
Door requires > 5 lbs. of force to open	10 lbs	Adjust closer so door does not require more than 5 pounds of force to open.	1	Labor	\$0

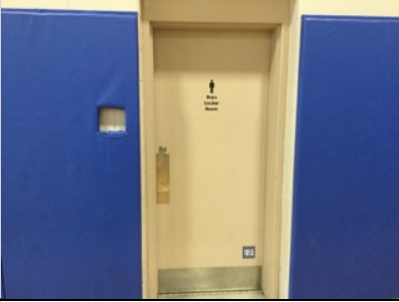
Door requires > 5 lbs. of force to open	14 lbs	Adjust closer so door does not require more than 5 pounds of force to open.	1	Labor	\$0
26	Guidance Office	1	110	Doors, Doorways, & Gates	Classroom

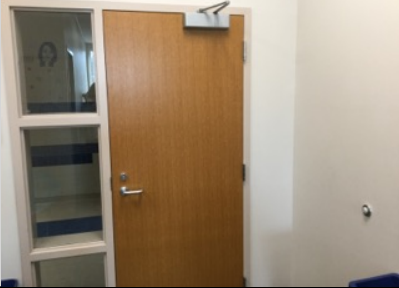
Door requires > 5 lbs. of force to open	16 lbs	Adjust closer so door does not require more than 5 pounds of force to open.	1	Labor	\$0
27	Nurse Office	1	111	Doors, Doorways, & Gates	Other

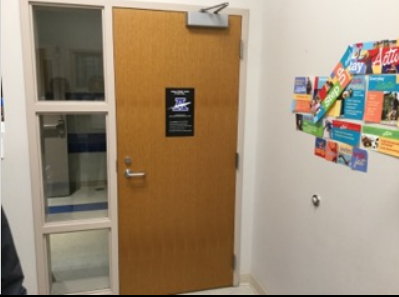
Door requires > 5 lbs. of force to open	10 lbs	Adjust closer so door does not require more than 5 pounds of force to open.	1	Labor	\$0
Signage												
28	Gymnasium	1	101	Signage	Designation
