Town of Auburn, Massachusetts

ADA Self-Evaluation and Transition Plan

September 2020

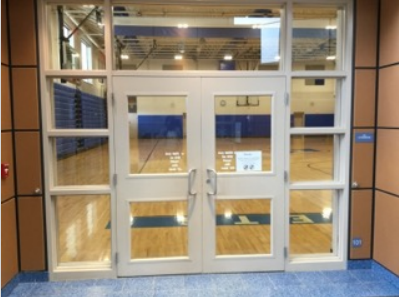
Clear floor space is not provided	-	Ensure a 18" min. clear floor space centered on the tactile characters is provided at the designation sign.	1	Labor	\$0

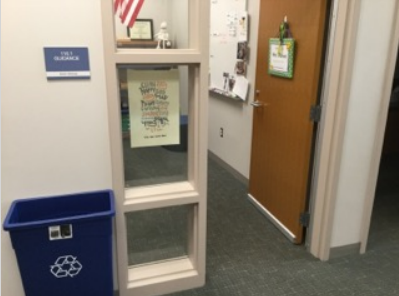
29	Classroom	1	110.1	Signage	Designation

Clear floor space is not provided	-	Ensure a 18" min. clear floor space centered on the tactile characters is provided at the designation sign.	1	Labor	\$0

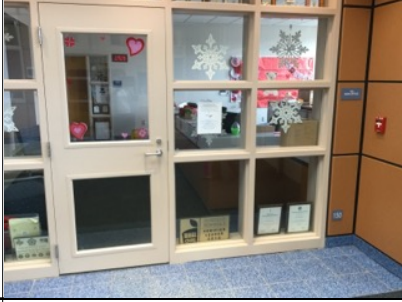
Clear floor space is not provided	-	Ensure a 18" min. clear floor space centered on the tactile characters is provided at the designation sign.	1	Labor	\$0
31	Girls' Locker Room	1	101	Signage	Designation

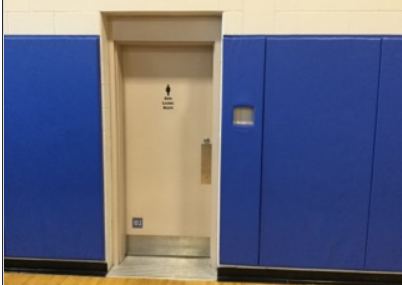
Raised characters not provided on sign Braille not provided on sign Sign not located on the latch side of the door	- - -	Provide text with raised characters duplicated in braille on sign. Locate sign at permanent rooms alongside the door on the latch side.	1	232	\$232
32	Nurse	1	111	Signage	Designation

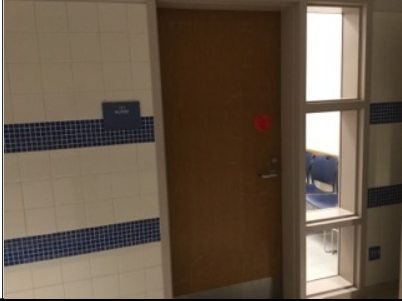
Sign not located on the latch side of the door	-	Locate sign alongside the door on the latch side.	1	Labor	\$0
33	Art Classroom	1	124	Signage	Designation

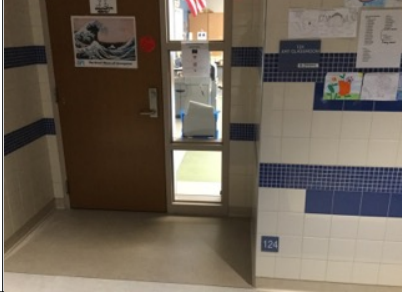
Sign not located on the latch side of the door	-	Locate sign alongside the door on the latch side.	1	Labor	\$0

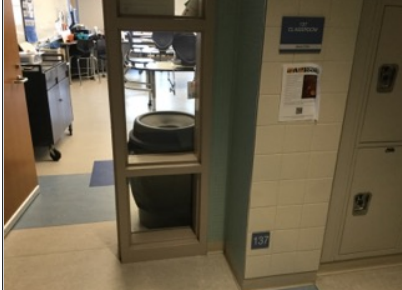
34	Classroom	1	137	Signage	Designation

Sign not located on the latch side of the door	-	Locate sign alongside the door on the latch side.	1	Labor	\$0

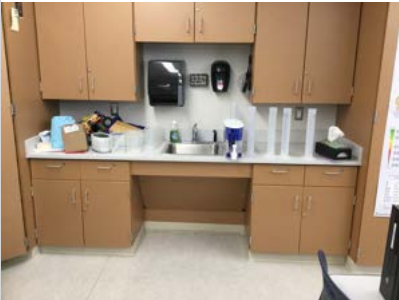
Side reach > 54"	59"	Relocate soap dispenser so that control is 48" above the finished floor.	1	256	\$256
Dining or Work Surfaces												
36	Science	1	125	Dining or Work Surfaces	Work Surface

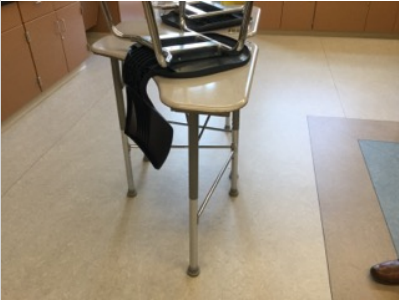
Knee or toe clearance not provided	-	Provide at least 1 work surface with 27" min. knee and toe clearance.	1	700	\$700
37	Library Computer Station	2		Dining or Work Surfaces	Work Surface

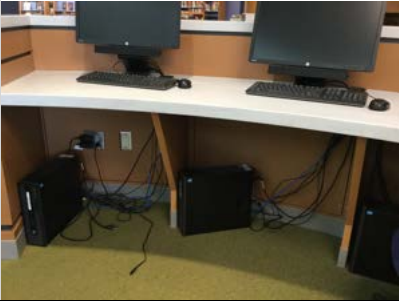
Knee or toe clearance not provided	-	Relocate at least one computer tower from underneath work station to provide clear space under the desk.	1	Labor	\$0
38	Classroom #236	2		Dining or Work Surfaces	Work Surface

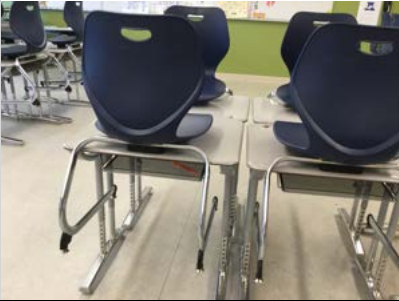
Knee or toe clearance not provided	24"	Adjust at least one work surface to provide 27" min. knee and toe clearance.	1	Labor	\$0

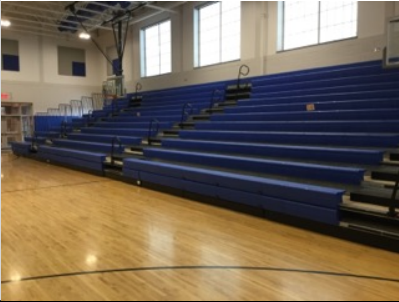
Assembly Area												
39	Gym	1	101	Assembly Area	N/A

Minimum # wheelchair spaces not provided	-	Provide the required number of wheelchair accessible spaces based on the seating count.	1	-	\$0

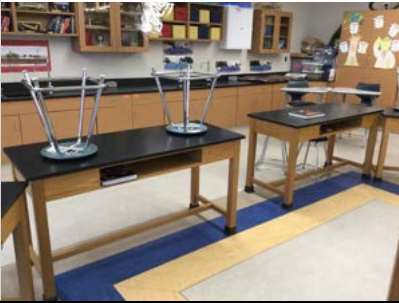
Knee or toe clearance not provided	26"	Provide at least work surface with 27" min. knee and toe clearance.	1	700	\$700
41	Science	1	125	Laboratory	Other

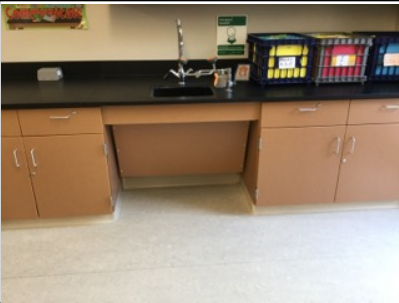
Emergency eyewash out of reach range	-	Provide one emergency eyewash within reach range.	1	560	\$560
42	Science	1	125	Laboratory	Other

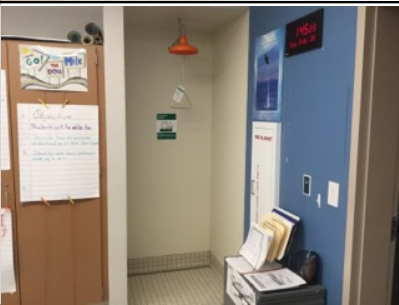
Emergency shower out of reach range	66.5"	Lower the shower pull to 48" max.	1	Labor	\$0
43	Chemistry Lab	2		Laboratory	Chemistry

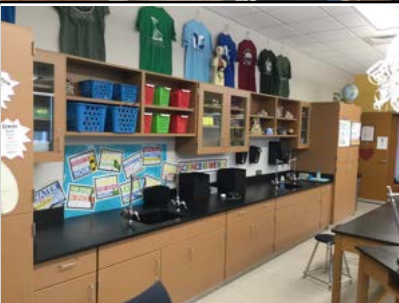
High storage above 48"	-	Relocate storage to ensure that 50% of storage is accessible.	1	Labor	\$0
44	Lab	1	124	Laboratory	Biology

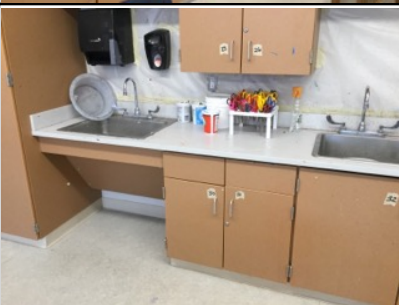
Accessories > 48"	59"	Lower controls and operable parts to 48" max. above the floor.	1	256	\$256
Toilet & Bathing Rooms

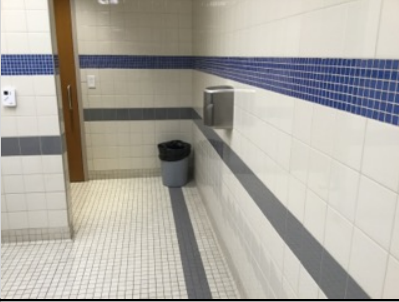
Obstructed by protruding objects	7"	Relocate hand dryer out of the circulation path.	1	353	\$353
46	Women's Toilet Room	1		Overall Access	Toilet Room

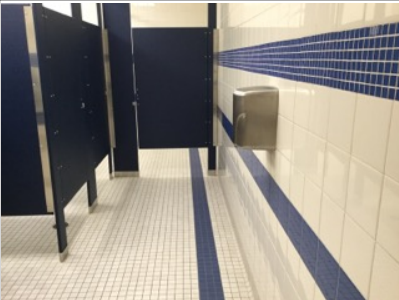
Obstructed by protruding objects	7"	Relocate hand dryer out of circulation path.	1	353	\$353
Lavatory												
47	Nurse Office	1		Lavatory	N/A

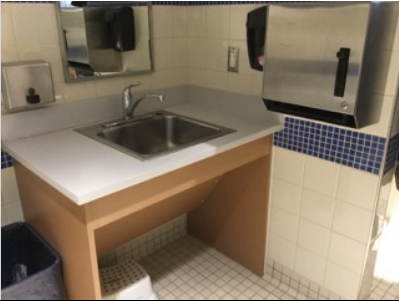
Clear floor space not provided at lavatory	-	Relocate paper towel dispenser to maintain the required clear floor space at the lavatory.	1	353	\$353
48	Girls' Locker Room	1	101	Lavatory	N/A

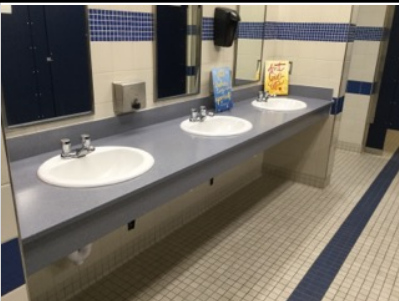
Dispensers not within reach range	58"	Lower soap dispenser to 42" max. above the floor.	1	353	\$353
49	Boys' Locker Room	1	101.5	Lavatory	N/A

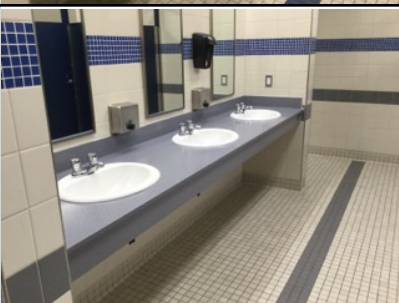
Dispensers not within reach range	58"	Lower dispensers to 42" max. above the floor.	1	353	\$353

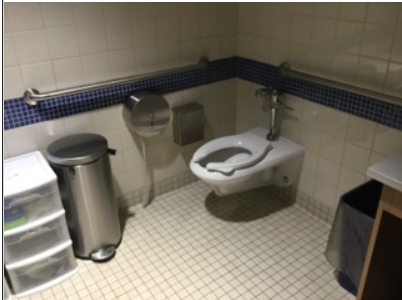
ID	Location	Floor	Room	Element	Type	Photo	Issues	Current Measure	Recommendations	Quantity	Price	Cost Estimation
Single-User Toilet												
50	Nurse Office	1		Single-User Toilet	N/A

Clearance at toilet < 60" clear width	-	Remove furniture and other items to maintain the required 60" min. by 72" min. clear floor space at the toilet.	1	Labor	\$0
Toilet Compartment												
51	Boys' Locker Room	1	101.5	Toilet Compartment	Accessible Compartment

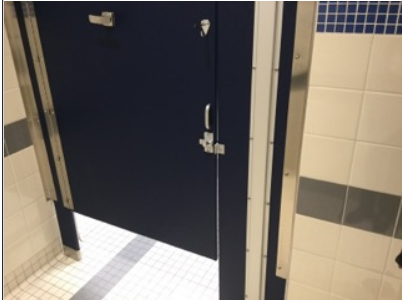
Door has malfunctioning self-closing hinge	-	Repair hinge.	1	Labor	\$0
52	Girls' Toilet Room	2		Toilet Compartment	Accessible Compartment

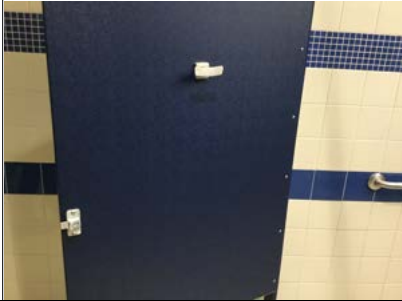
Door has malfunctioning self-closing hinge	-	Repair hinge.	1	Labor	\$0
53	Boys' Locker Room	1	101.5	Toilet Compartment	Accessible Compartment

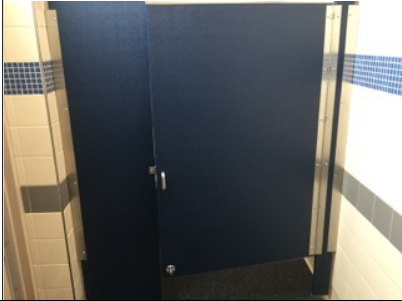
Door has malfunctioning self-closing hinge	-	Repair hinge.	1	Labor	\$0
Dispensers												
54	Men's Toilet Room	1		Dispensers	Soap Dispenser

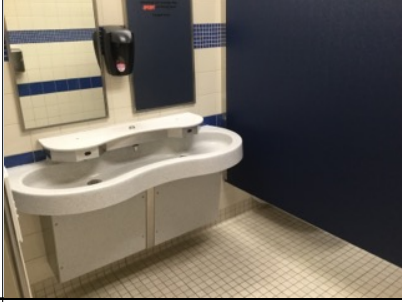
ID	Location	Floor	Room	Element	Type	Photo	Issues	Current Measure	Recommendations	Quantity	Price	Cost Estimation
55	Women's Toilet Room	1		Dispensers	Soap Dispenser

Controls > 42" high	56"	Relocate soap dispenser so that it 42" max. above the finished floor.	1	353	\$353
56	Boys' Toilet Room by Lab #219	2		Dispensers	Soap Dispenser

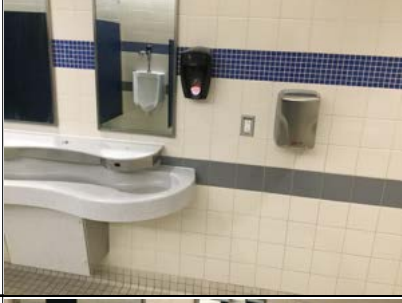
Controls > 42" high	57"	Relocate soap dispenser so that it 42" max. above the finished floor.	1	353	\$353
57	Girls' Toilet Room	2		Dispensers	Soap Dispenser

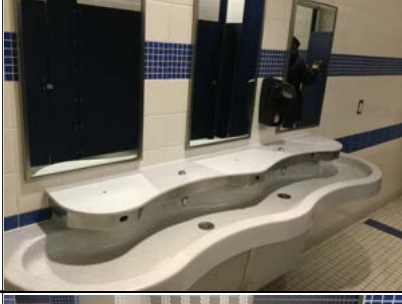
Controls > 42" high	52"	Relocate soap dispenser so that it 42" max. above the finished floor.	1	353	\$353
58	Girls' Locker Room	1	101.2	Dispensers	Hand Dryer

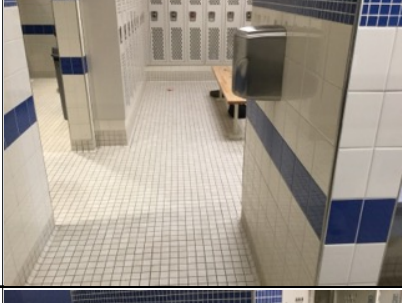
Dispenser acts as a protruding object	7"	Relocate dispenser out of the circulation path.	1	353	\$353
59	Boys' Locker Room	1	101.5	Dispensers	Hand Dryer

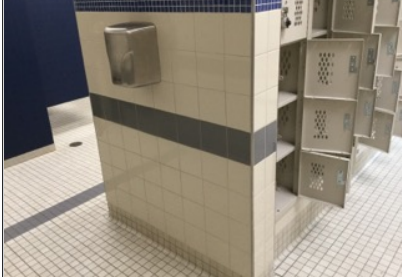
Dispenser acts as a protruding object	7"	Relocate dispenser out of the circulation path.	1	353	\$353

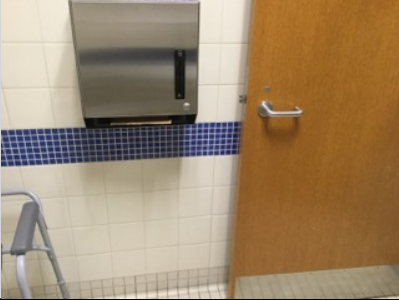
ID	Location	Floor	Room	Element	Type	Photo	Issues	Current Measure	Recommendations	Quantity	Price	Cost Estimation
60	Nurse Office	1	111.1	Dispensers	Hand Dryer

Dispenser acts as a protruding object	-	Relocate hand dryer dispenser out of the circulation path.	1	353	\$353
61	Boys' Toilet Room by Lab #219	2		Dispensers	Hand Dryer

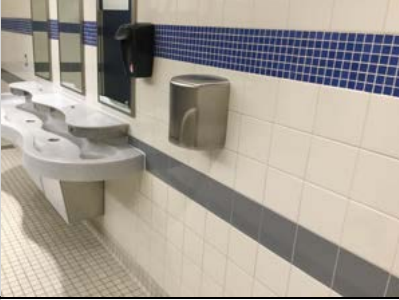
Dispenser acts as a protruding object	6"	Relocate hand dryer dispenser out of the circulation path.	1	353	\$353
62	Girls' Toilet Room	2		Dispensers	Hand Dryer

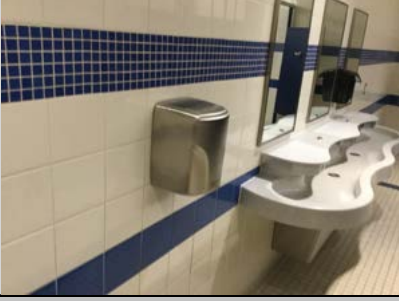
Dispenser acts as a protruding object	6"	Relocate hand dryer dispenser out of the circulation path.	1	353	\$353
Shower Compartment												
63	Nurse Office	1		Shower Compartment	Transfer Type

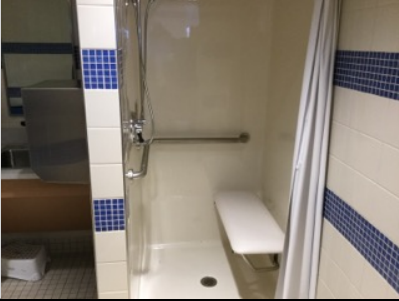
Clear space at transfer shower > 48" x 36"	-	Locate seat and grab bars opposite side to provide the required 48" parallel to the seat to transfer. Locate the shower head and controls on the opposite side.	1	6072	\$6072

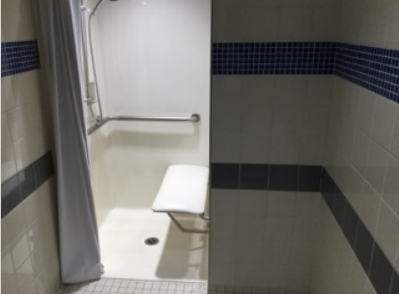
64	Boys' Locker Room	1	101.5	Shower Compartment	Transfer Type

Grab bar non compliant	-	Grab bar at transfer shower is not compliant but it is usable.	1	-	\$0

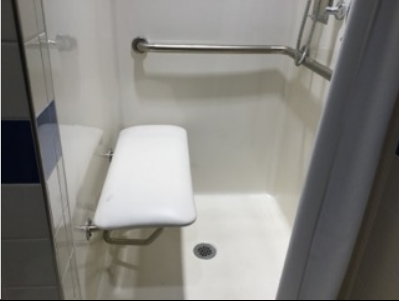
ID	Location	Floor	Room	Element	Type	Photo	Issues	Current Measure	Recommendations	Quantity	Price	Cost Estimation
65	Girls' Locker Room	1	101	Shower Compartment	Transfer Type

Grab bar non compliant	-	Grab bar at transfer shower is not compliant but it is usable.	1	-	\$0
Changing Rooms												
66	Girls' Locker Room	1	101	Changing Rooms	Women's

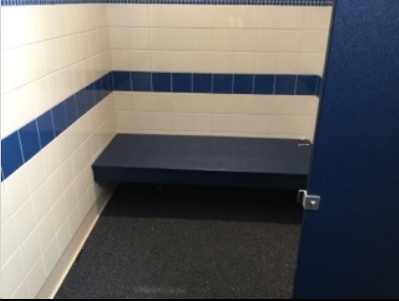
Room is < 78" x 72" 30" clear not provided alongside bench Bench is not 17"-19" high Hook > 48" high	72"X60" - 10.5" 54"	Provide an accessible changing room that is 78" by 72" minimum. Provide a 30" min. by 48" min. clear space along the side of the bench so that wheelchair users can transfer. Install a bench with the top of the seat between 17"- 19" above the finished floor. Locate hook no higher than 48" above the finished floor.	1	6216	\$6216
67	Boys' Locker Room	1	101.5	Changing Rooms	Men's

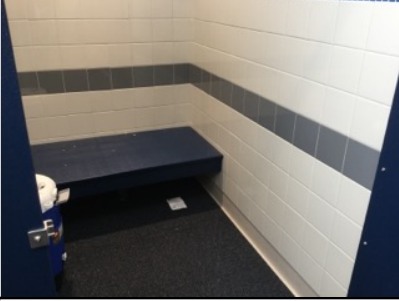
Room is < 78" x 72" 30" clear not provided alongside bench Bench is not 17"-19" high Hook > 48" high	72"X60" - 10.5" 54"	Provide an accessible changing room that is 78" by 72" minimum. Provide a 30" min. by 48" min. clear space along the side of the bench so that wheelchair users can transfer. Install a bench with the top of the seat between 17"- 19" above the finished floor. Locate hook no higher than 48" above the finished floor.	1	6216	\$6216

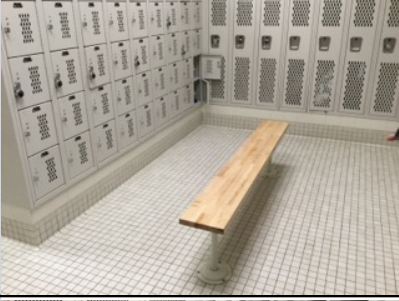
68	Girls' Locker Room	1	101	Changing Rooms	Women's

Back support not provided at bench Bench < 24" deep	- 9.5"	Provide at least one bench with back support or that is affixed to a wall with room on the side to transfer. Provide a bench that is 24" deep.	1	400	\$400
69	Boys' Locker Room	1	101.5	Changing Rooms	Men's

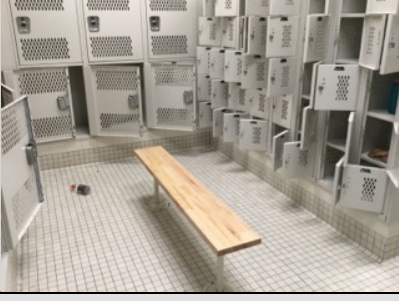
Back support not provided at bench Bench < 24" deep	- 9.5"	Provide at least one bench with back support or that is affixed to a wall with room on the side to transfer. Provide a bench that is 24" deep.	1	400	\$400
Best Practice

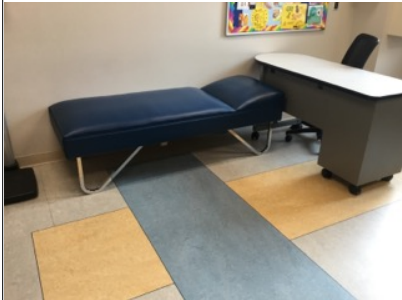
ID	Location	Floor	Room	Element	Type	Photo	Issues	Current Measure	Recommendations	Quantity	Price	Cost Estimation
Examination Table												
70	Nurse Office	1	111.1	Examination Table	N/A

-	Recommend providing an adjustable examination table.	1	-	\$0
Podium												
71	Cafeteria	1	109	Podium	N/A

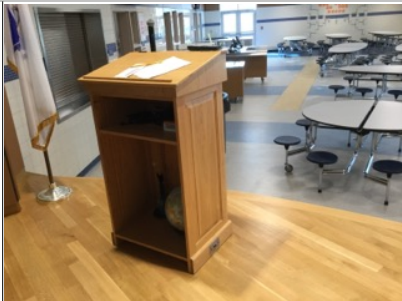
Recommend providing an adjustable podium with knee and toe clearance.	1	-	\$0

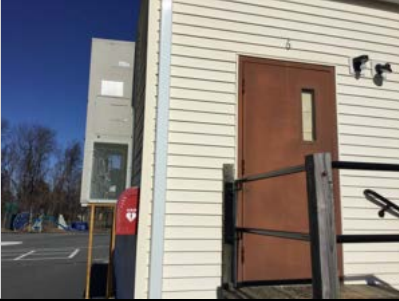
ID	Location	Floor	Room	Element	Type	Photo	Issues	Current Measure	Recommendations	Quantity	Price	Cost Estimation
Approach and Entrance												
Exterior Access Route												
1	By Exit #6	Ext.		Exterior Access Route	Exterior

Obstructed by protruding objects	-	Provide a cane-detectable barrier 27" max. above the ground under the AED.	1	306	\$306
Off-Street Parking Lot or Garage												
2	Exit #6	Ext.		Off-Street Parking Lot or Garage	N/A

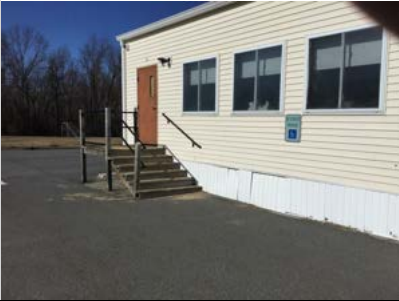
Total # of parking Total # of designated accessible parking spaces Total # of designated van accessible spaces Access aisle < 60" wide at car/van space Access aisle < 96" wide at van space Sign not provided Sign does not have the designation "Van Accessible"	37 - - - - -	Provide 1 compliant van accessible parking space with a marked access aisle and 1 compliant car accessible parking space with a marked access aisle. Provide a sign with the International Symbol of Accessibility (ISA) 60" max. to the bottom of the sign Add the designation "Van Accessible" to the sign at the van accessible space. Locate spaces on shortest route to the door 2 drop-off area.	1	1850	\$1850

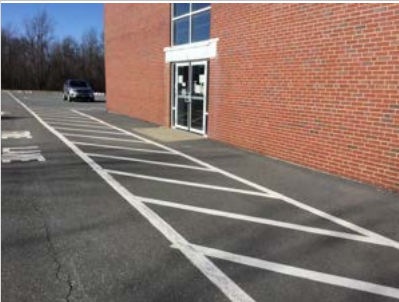
Passenger Loading Zones												
3	Exit #2 Drop-Off	Ext.		Passenger Loading Zones	N/A

Vehicle pull-up space < 96" wide Sign with ISA not provided (MAAB)	77" -	Provide a vehicle pull-up space that is at least 96" wide. Provide a sign that includes the International Symbol of Accessibility (ISA) at the head of the drop-off area. Locate the sign so that the bottom is 60" min. above the ground and the top is 96" max. above the ground.	1	800	\$800
Entrance												
4	Exit #11	Ext.		Entrance	Other

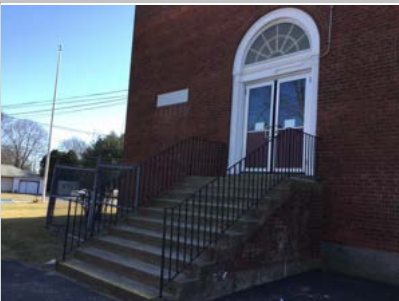
Directional sign to accessible entrance not provided	-	Provide a directional sign indicating the location of the nearest accessible entrance.	1	346	\$346
Access to Goods and Services

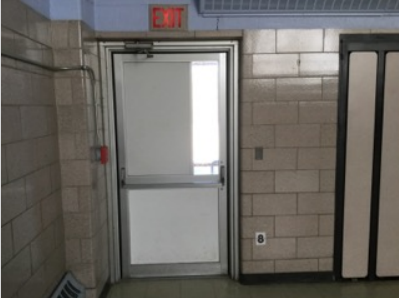
ID	Location	Floor	Room	Element	Type	Photo	Issues	Current Measure	Recommendations	Quantity	Price	Cost Estimation
Means of Egress												
5	Exit #8	1		Means of Egress	N/A

Tactile exit sign not provided	-	Ensure a tactile exit sign with raised characters and braille is provided at exit door. Mount sign between 48"- 60" above the finished floor located on the latch side of the door.	1	232	\$232
6	Exit #6	1	113	Means of Egress	N/A

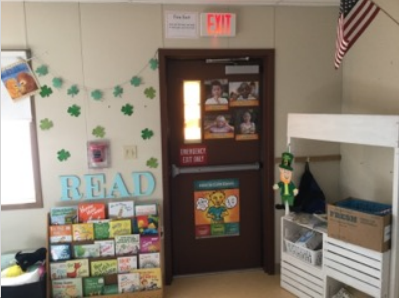
Tactile exit sign not provided	-	Ensure tactile exit signs with raised characters and braille are provided at exit doors. Mount signs between 48"- 60" above the finished floor located on the latch side of the door.	1	232	\$232
7	Exit by Room #122	1		Means of Egress	N/A

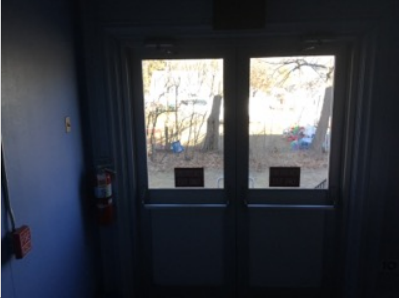
Tactile exit sign not provided	-	Ensure tactile exit signs with raised characters and braille are provided at exit doors. Mount signs between 48"- 60" above the finished floor located on the latch side of the door.	1	232	\$232

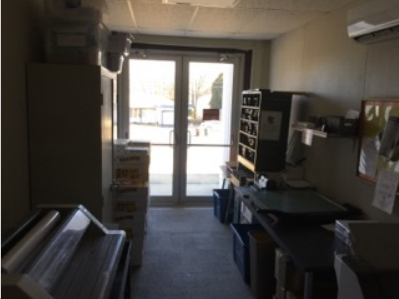
8	Exit By Room #119	1	119	Means of Egress	N/A

Tactile exit sign not provided Maneuvering clearance(s) not provided	-	Provide a sign on the interior of the stairway enclosure indicating the floor level. Remove stored items to maintain the required maneuvering clearance at the door. Remove the obstruction.	1	232	\$232
9	Exit #2	1		Means of Egress	N/A

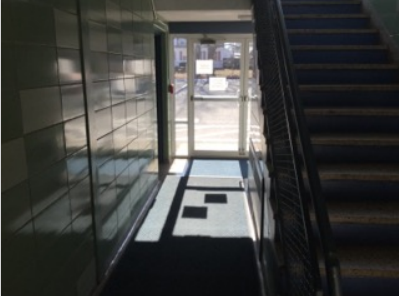
Tactile exit sign not provided Illuminated ISA symbol not provided (MAAB)	- -	Ensure a tactile exit sign with raised characters and braille is provided at exit door. Mount sign between 48"- 60" above the finished floor located on the latch side of the door. Provide an illuminated sign with the International Symbol of Accessibility.	1	432	\$432

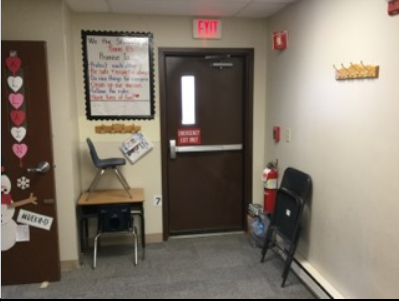
ID	Location	Floor	Room	Element	Type	Photo	Issues	Current Measure	Recommendations	Quantity	Price	Cost Estimation
10	Exit #7	1		Means of Egress	N/A

Floor level designation not provided Maneuvering clearance(s) not provided	- -	Provide a sign on the interior of the stairway enclosure indicating the floor level. Remove stored items to maintain the required maneuvering clearance at the door. Remove the obstruction.	1	232	\$232
11	Main Entrance	1		Means of Egress	N/A

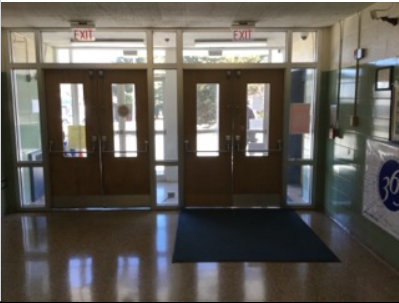
Illuminated ISA symbol not provided (MAAB)	-	Provide an illuminated sign with the International Symbol of Accessibility.	1	200	\$200
12	Entrance/Exit	1	103	Means of Egress	N/A

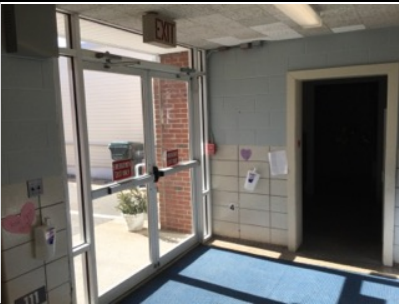
Illuminated ISA symbol not provided (MAAB)	-	Provide an illuminated sign with the International Symbol of Accessibility.	1	200	\$200
Doors, Doorways, & Gates												
13	Girls' Toilet Room	2	209	Doors, Doorways, & Gates	Toilet Room

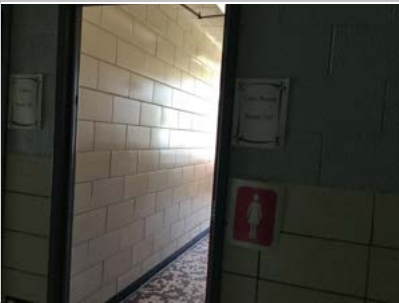
Clear width at door < 32"	30"	Widen the door so that there is 32" min. clear width.	1	5292	\$5292

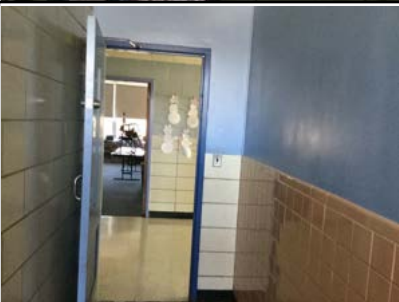
14	Boys' Toilet Room	2	208	Doors, Doorways, & Gates	Toilet Room

Clear width at door < 32" Maneuvering clearance(s) not provided	29" 14"	Widen the door so that there is 32" min. clear width. Provide 18" min. maneuvering clearance on the pull side of the door or provide an automatic door opener.	1	3060	\$3060

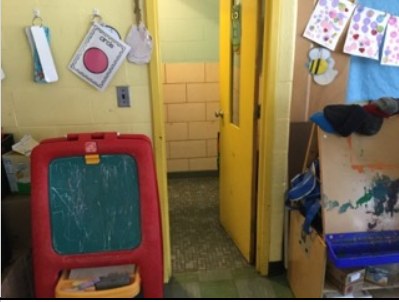
ID	Location	Floor	Room	Element	Type	Photo	Issues	Current Measure	Recommendations	Quantity	Price	Cost Estimation
15	Classroom	1	105	Doors, Doorways, & Gates	Classroom

Clear width at door < 32" Hardware not operable with a closed fist	21" -	Widen the door so that there is 32" min. clear width. Provide hardware that can be operable with one hand and not require tight grasping, pinching, or twisting of the wrist. (See ID #52 for cost.)	1	-	\$0
16	Library	B	105	Doors, Doorways, & Gates	Other

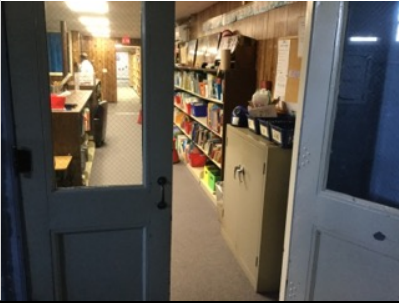
If double-leaf door, neither compliant	28"	Ensure that at least one of the active leaves is at least 32" min. wide.	1	3366	\$3366
17	Nurse's Office	1	109	Doors, Doorways, & Gates	Other

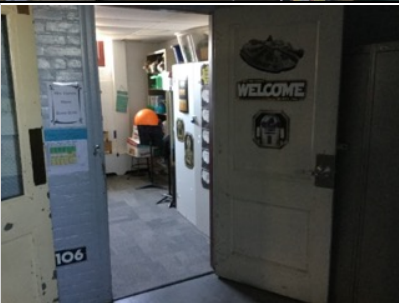
Maneuvering clearance(s) not provided		Change the swing of the door to ensure the min. maneuvering clearance is provided.	1	1884	\$1884
18	Music Room	B	106	Doors, Doorways, & Gates	Classroom

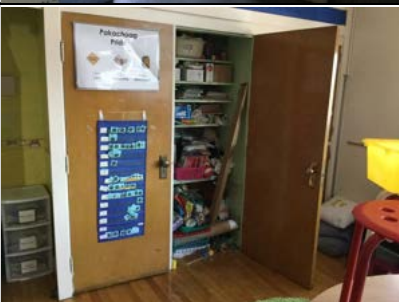
19	Classroom	2	225	Doors, Doorways, & Gates	Other

Hardware not operable with a closed fist	-	Provide hardware that can be operable with one hand and not require tight grasping, pinching, or twisting of the wrist.	1	484	\$484

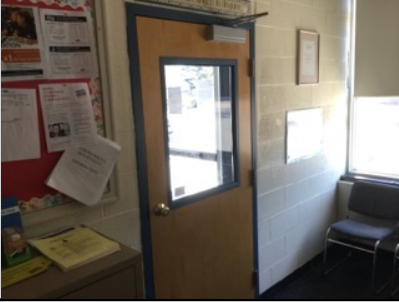
ID	Location	Floor	Room	Element	Type	Photo	Issues	Current Measure	Recommendations	Quantity	Price	Cost Estimation
20	Office	1	101	Doors, Doorways, & Gates	Office

Hardware not operable with a closed fist Door requires > 5 lbs. of force to open	- 11 lbs.	Provide hardware that can be operable with one hand and not require tight grasping, pinching, or twisting of the wrist. Adjust closer so door does not require more than 5 pounds of force to open.	1	484	\$484
Signage												
21	Single-User Toilet Room	1	129	Signage	Designation

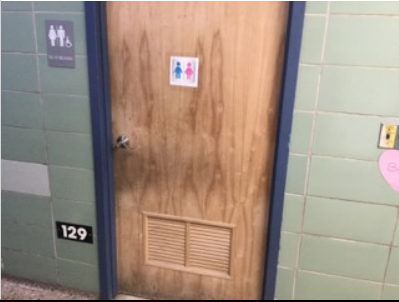
This toilet room is labeled as accessible but is not really accessible.	1	-	\$0
22	Nurse's Room - Toilet Room	1	109	Signage	Designation

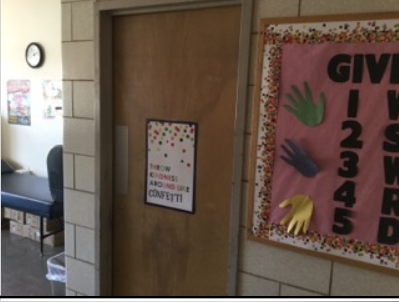
Signage is not provided		Locate compliant signage alongside the door on the latch side.	1	232	\$232
23	Gymnasium	1		Signage	Designation

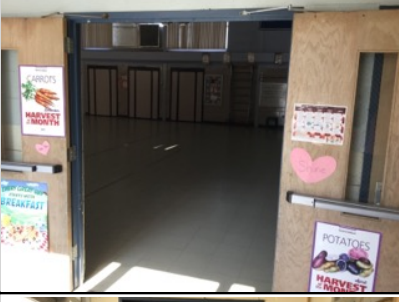
Signage is not provided		Locate compliant signage alongside the door on the latch side.	1	232	\$232

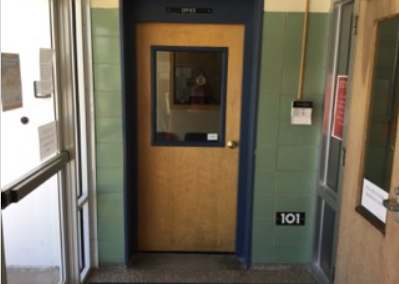
24	Office	1	101	Signage	Designation

Raised characters not provided on sign Raised characters < 48" or > 60" above ground Braille not provided on sign	- - -	Provide text with raised characters duplicated in braille on sign. Mount sign so that the baseline of the lowest tactile character is 48" min. above finished floor and the baseline of the highest tactile character is 60" max. above the finished floor.	1	232	\$232

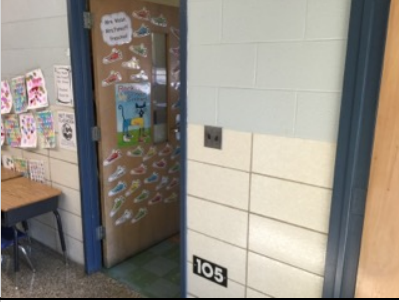
ID	Location	Floor	Room	Element	Type	Photo	Issues	Current Measure	Recommendations	Quantity	Price	Cost Estimation
25	Classroom	1	105/106	Signage	Designation

Raised characters not provided on sign Raised characters < 48" or > 60" above ground Braille not provided on sign	- - -	Provide text with raised characters duplicated in braille on sign. Mount signs so that the baseline of the lowest tactile character is 48" min. above finish floor and the baseline of the highest tactile character is 60" max. above the finished floor.	2	232	\$464
26	Classroom	1	107/108	Signage	Designation

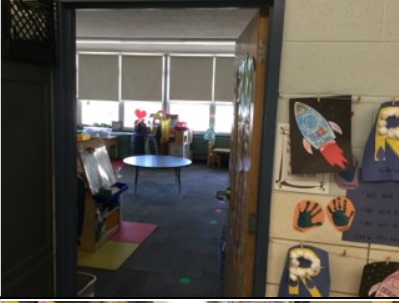
Raised characters not provided on sign Raised characters < 48" or > 60" above ground Braille not provided on sign	- - -	Provide text with raised characters duplicated in braille on sign. Mount signs so that the baseline of the lowest tactile character is 48" min. above finished floor and the baseline of the highest tactile character is 60" max. above the finished floor.	2	232	\$464

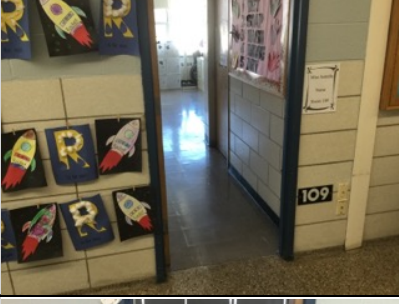
27	Nurse's Room	1	109	Signage	Designation

Raised characters not provided on sign Raised characters < 48" or > 60" above ground Braille not provided on sign		Provide text with raised characters duplicated in braille on sign. Mount sign so that the baseline of the lowest tactile character is 48" min. above finished floor and the baseline of the highest tactile character is 60" max. above the finished floor.	1	232	\$232
28	Art Room	1	104	Signage	Designation

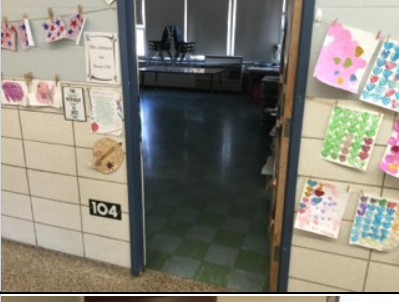
Raised characters not provided on sign Raised characters < 48" or > 60" above ground Braille not provided on sign	- - -	Provide text with raised characters duplicated in braille on sign. Mount sign so that the baseline of the lowest tactile character is 48" min. above finished floor and the baseline of the highest tactile character is 60" max. above the finished floor. Provide braille on sign.	1	232	\$232
29	Classroom	1	112/113	Signage

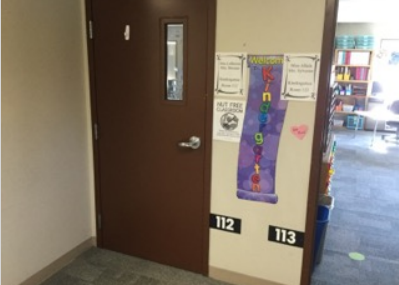
Raised characters not provided on sign Raised characters < 48" or > 60" above ground Braille not provided on sign		Provide text with raised characters duplicated in braille on sign. Mount signs so that the baseline of the lowest tactile character is 48" min. above finished floor and the baseline of the highest tactile character is 60" max. above the finished floor.	2	232	\$464

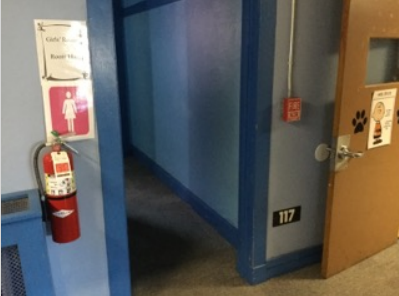
ID	Location	Floor	Room	Element	Type	Photo	Issues	Current Measure	Recommendations	Quantity	Price	Cost Estimation
30	Girls' Toilet Room	1	117	Signage	Designation

Raised characters not provided on sign Raised characters < 48" or > 60" above ground Braille not provided on sign	- - -	Provide text with raised characters duplicated in braille on sign. Mount sign so that the baseline of the lowest tactile character is 48" min. above finished floor and the baseline of the highest tactile character is 60" max. above the finished floor.	1	232	\$232
31	Special Needs Classroom	1	119	Signage	Designation

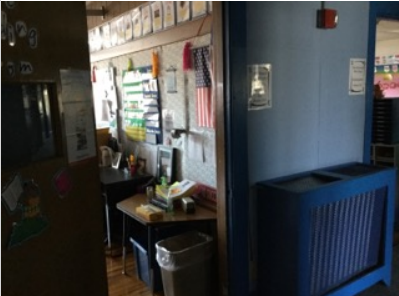
Raised characters not provided on sign Raised characters < 48" or > 60" above ground Braille not provided on sign	- - -	Provide text with raised characters duplicated in braille on sign. Mount sign so that the baseline of the lowest tactile character is 48" min. above finished floor and the baseline of the highest tactile character is 60" max. above the finished floor.	1	232	\$232

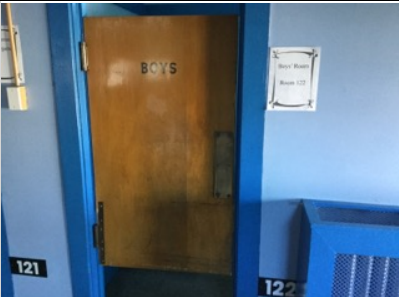
32	Boys' Toilet Room	1	122	Signage	Designation

Raised characters not provided on sign Raised characters < 48" or > 60" above ground Braille not provided on sign Sign not located on the latch side of the door	- - - -	Provide text with raised characters duplicated in braille on sign. Mount sign so that the baseline of the lowest tactile character is 48" min. above finished floor and the baseline of the highest tactile character is 60" max. above the finished floor. Locate sign alongside the door on the latch side.	1	232	\$232
33	Music Room	B	106	Signage	Designation

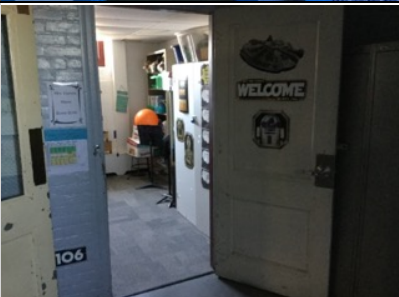
Raised characters not provided on sign Raised characters < 48" or > 60" above ground Braille not provided on sign	- - -	Provide text with raised characters duplicated in braille on sign. Mount sign so that the baseline of the lowest tactile character is 48" min. above finished floor and the baseline of the highest tactile character is 60" max. above the finished floor.	1	232	\$232

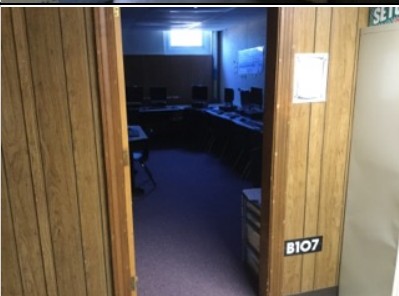
34	Technology Room	B	107	Signage	Designation

Raised characters not provided on sign Raised characters < 48" or > 60" above ground Braille not provided on sign		Provide text with raised characters duplicated in braille on sign. Mount sign so that the baseline of the lowest tactile character is 48" min. above finished floor and the baseline of the highest tactile character is 60" max. above the finished floor.	1	232	\$232

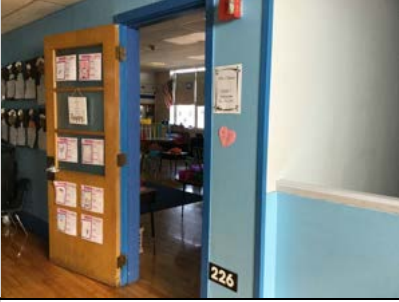
ID	Location	Floor	Room	Element	Type	Photo	Issues	Current Measure	Recommendations	Quantity	Price	Cost Estimation
35	Classroom	2	226	Signage	Designation

Raised characters not provided on sign Braille not provided on sign	- -	Provide text with raised characters duplicated in braille on sign.	1	232	\$232
36	First Grade Classroom	2	216	Signage	Designation

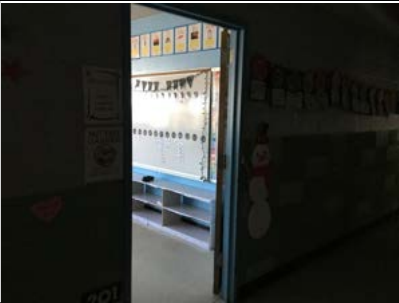
Raised characters not provided on sign Braille not provided on sign	- -	Provide text with raised characters duplicated in braille on sign.	1	232	\$232
38	Girls' Toilet Room	2	215	Signage	Designation

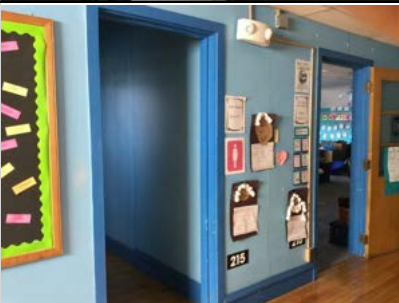
Raised characters not provided on sign Braille not provided on sign International Symbol of Acc. not provided	- -	Provide text with raised characters duplicated in braille on sign. Provide a sign with the International Symbol of Accessibility once an accessible compartment is provided.	1	232	\$232

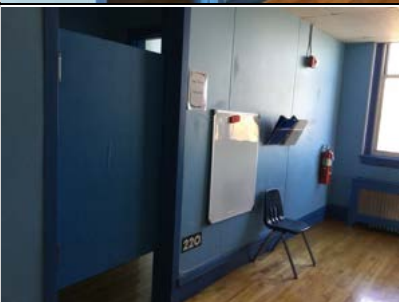
39	Boys' Toilet Room	2	220	Signage	Designation

Raised characters not provided on sign Braille not provided on sign International Symbol of Acc. not provided	- -	Provide text with raised characters duplicated in braille on sign. Provide a sign with the International Symbol of Accessibility.	1	232	\$232

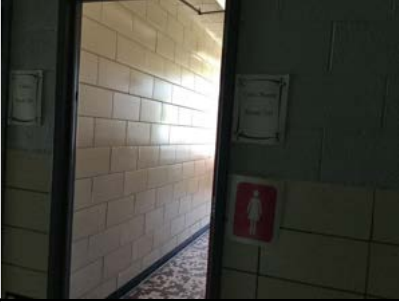
ID	Location	Floor	Room	Element	Type	Photo	Issues	Current Measure	Recommendations	Quantity	Price	Cost Estimation
40	Girls' Toilet Room	2	209	Signage	Designation

Raised characters not provided on sign Braille not provided on sign International Symbol of Acc. not provided	- -	Provide text with raised characters duplicated in braille on sign. Provide a sign with the International Symbol of Accessibility once an accessible compartment is provided.	1	232	\$232
41	Boys' Toilet Room	2	208	Signage	Designation

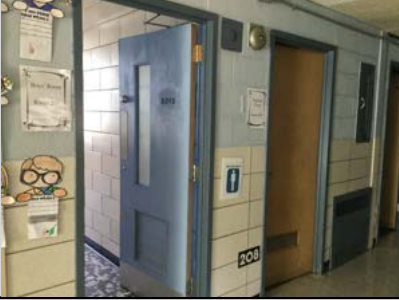
Raised characters not provided on sign Braille not provided on sign International Symbol of Acc. not provided	- -	Provide text with raised characters duplicated in braille on sign. Provide a sign with the International Symbol of Accessibility once an accessible compartment is provided.	1	232	\$232
Dining or Work Surfaces												
42	Classroom	1	105	Dining or Work Surfaces	Work Surface

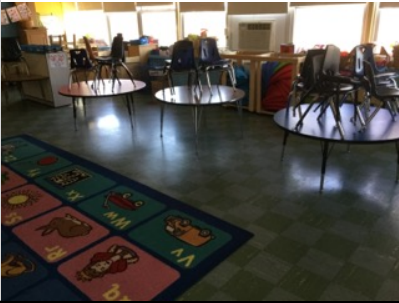
Knee or toe clearance not provided	-	Adjust work surface to ensure a 26" min. knee clearance is provided.	1	Labor	\$0

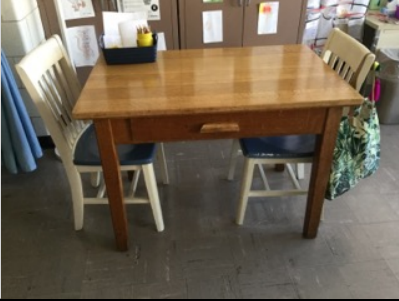
43	Nurse's Room	1	109	Dining or Work Surfaces	Work Surface

Knee or toe clearance not provided	23.5"	Provide a work surface with 26" min. knee and toe clearance.	1	700	\$700
44	Art Room	1	104	Dining or Work Surfaces	Work Surface

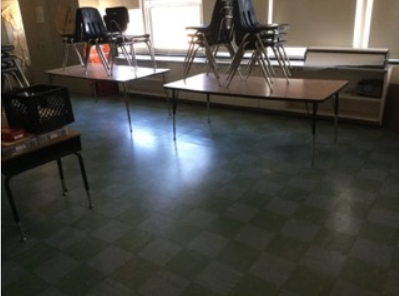
Knee or toe clearance not provided	26"	Adjust work surface to ensure a 26" min. knee clearance is provided.	1	Labor	\$0

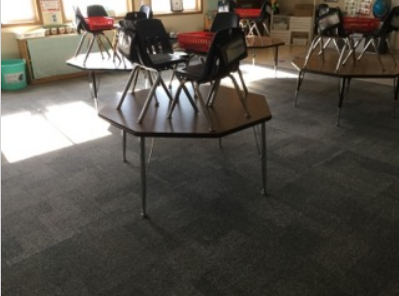
ID	Location	Floor	Room	Element	Type	Photo	Issues	Current Measure	Recommendations	Quantity	Price	Cost Estimation
45	Classroom	1	112	Dining or Work Surfaces	Work Surface

Knee or toe clearance not provided	21.5"	Adjust work surface to ensure a 26" min. knee clearance is provided.	1	Labor	\$0
46	Library	B	105	Dining or Work Surfaces	Work Surface

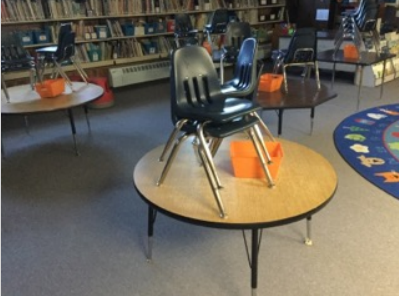
Knee or toe clearance not provided	21"	Adjust work surface to ensure a 26" min. knee clearance is provided.	1	Labor	\$0
47	Technology Room	B	107	Dining or Work Surfaces	Work Surface

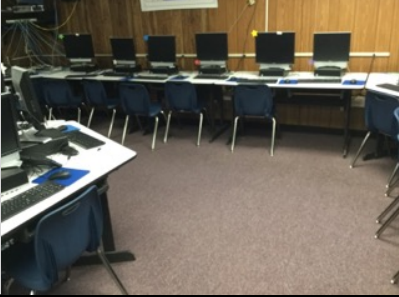
Knee or toe clearance not provided	25"	Provide at least 1 work surface with 26" min. knee and toe clearance.	1	700	\$700
Assembly Area												
48	Assembly Area	1		Assembly Area

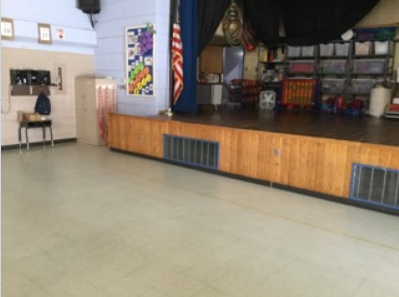
Accessible route to stage not provided		Provide a ramp to ensure an accessible route to the stage. (Cost estimate for a 30' long wood ramp.)	1	12067	\$12067
49	Classroom	2	216	Assembly Area	N/A

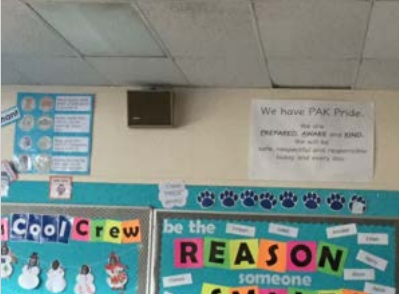
Assistive listening devices not provided	-	If audible communication is integral to the use of the space, provide an assistive listening system. (A portable system could also be used in the room with the stage if necessary.) (Cost for a transmitter, receiver, ear speaker, neck loop and USB charger - Capacity: 50 or less.)	1	1214	\$1214

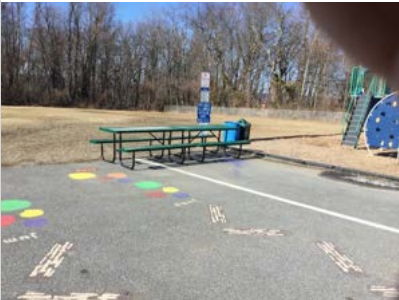
ID	Location	Floor	Room	Element	Type	Photo	Issues	Current Measure	Recommendations	Quantity	Price	Cost Estimation
Picnic Tables												
50	Playground	Ext.		Picnic Tables	N/A

Toe or knee clearance at tables not provided	-	Provide at least picnic table with toe and knee clearance.	1	1400	\$1400
Toilet & Bathing Rooms												
Overall Access												
51	Nurse	1	109	Overall Access	Toilet Room

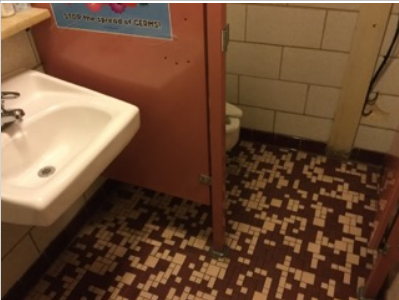
Turning space not provided	-	Provide an accessible single-user toilet room.	1	24604	\$24604
52	Toilet Room	1	105	Overall Access	Toilet Room

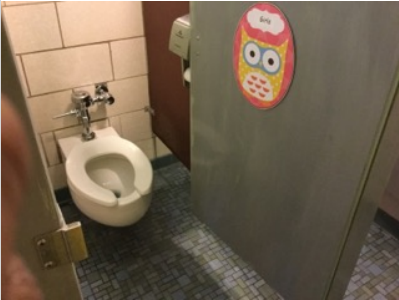
Accessible plumbing fixtures or stalls not provided	-	Provide an accessible single-user toilet room.	1	24604	\$24604
53	Girls' Toilet Room	1	117	Overall Access	Toilet Room

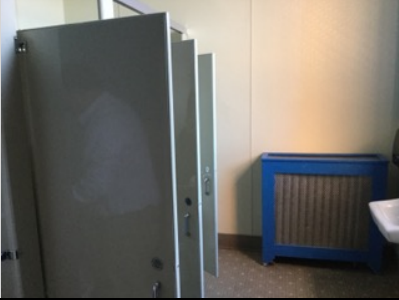
Accessible plumbing fixtures or stalls not provided	-	Provide one accessible wheelchair compartment.	1	6182	\$6182
54	Boys' Toilet Room	1	122	Overall Access	Toilet Room

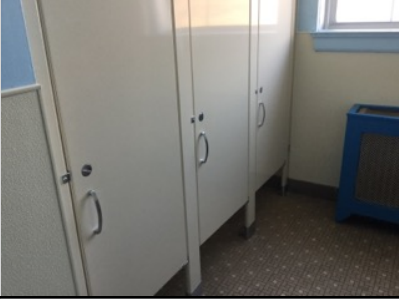
Accessible plumbing fixtures or stalls not provided	-	Provide one accessible wheelchair compartment.	1	6182	\$6182

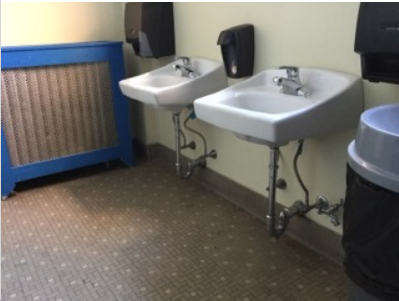
ID	Location	Floor	Room	Element	Type	Photo	Issues	Current Measure	Recommendations	Quantity	Price	Cost Estimation
Lavatory												
55	Girls' Toilet Room	1	117	Lavatory	N/A

Toe or knee clearances not provided Plumbing underneath is exposed	- -	Provide at least one lavatory with knee and toe clearance positioned for a forward approach. Insulate or otherwise configure pipes to prevent contact, for at least one lavatory.	1	1778	\$1778
56	Boys' Toilet Room	1	122	Lavatory	N/A

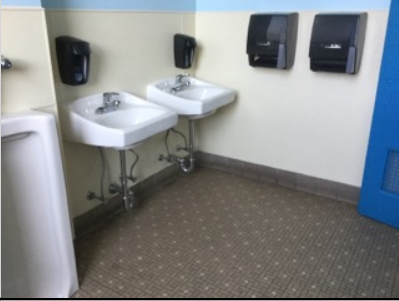
Toe or knee clearances not provided Plumbing underneath is exposed	- -	Provide at least one lavatory with knee and toe clearance positioned for a forward approach. Insulate or otherwise configure pipes to prevent contact, for at least one lavatory.	1	1778	\$1778
57	Single-User Toilet Room	1	129	Lavatory	N/A

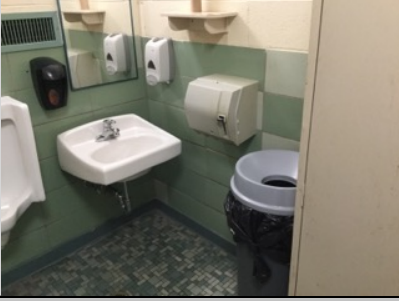
Plumbing underneath is exposed	-	Insulate or otherwise configure pipes to prevent contact, for at least one lavatory.	1	92	\$92

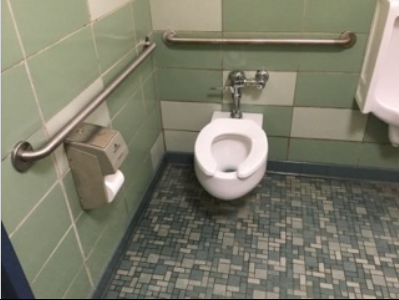
Single-User Toilet												
58	Single-User Toilet Room	1	129	Single-User Toilet	N/A

Flush control not on open side Centerline < or > 18" (MAAB) Toilet paper dispenser is not compliant	- 19" -	Relocate the flush control to the open side. Relocate toilet so that the centerline is 18" from the side wall. Relocate toilet paper so that it is 24" min. high, located under the grab bar, and between 7" and 9" from the front of the toilet.	1	3458	\$3458
Toilet Rooms for Children

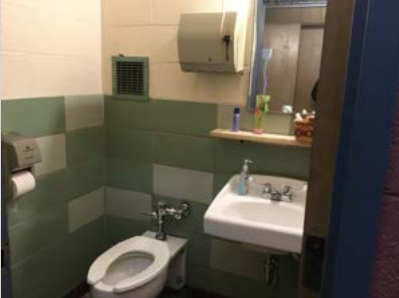
ID	Location	Floor	Room	Element	Type	Photo	Issues	Current Measure	Recommendations	Quantity	Price	Cost Estimation
Single-User Toilet (Children)												
59	Single-User Toilet in Speech Classroom	2	213	Single-User Toilet (Children)	N/A

Clearance at toilet < 60" clear wide	-	Provide a new accessible single-user toilet room with a toilet that has clear floor space at the toilet that is 60" wide min.	1	24604	\$24604
Toilet Compartment (Children)												
60	Girls' Toilet Room	2	215	Toilet Compartment (Children)	Accessible Compartment

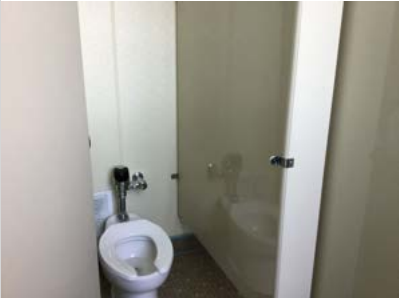
Clearance at toilet < 60" clear width	-	Provide a wheelchair accessible compartment that is 60" wide min. and 72" deep min.	1	6182	\$6182
61	Boys' Toilet Room	2	220	Toilet Compartment (Children)	Accessible Compartment

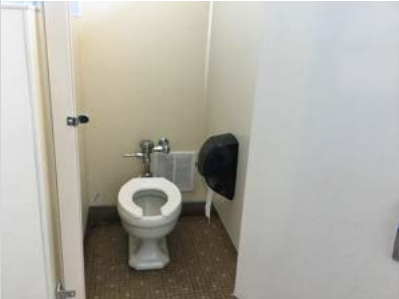
Clearance at toilet < 60" clear width	-	Provide a wheelchair accessible compartment that is 60" wide min. and 72" deep min.	1	6182	\$6182

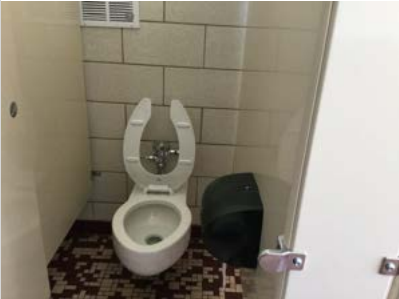
62	Girls' Toilet Room	2	209	Toilet Compartment (Children)	Accessible Compartment

Clearance at toilet < 60" clear width	-	Provide a wheelchair accessible compartment that is 60" wide min. and 72" deep min.	1	6182	\$6182
63	Boys' Toilet Room	2	208	Toilet Compartment (Children)	Accessible Compartment

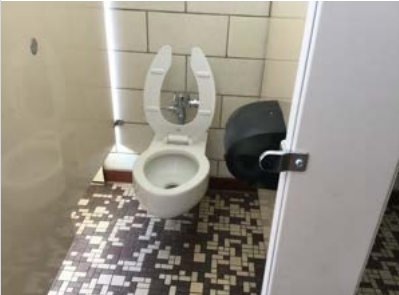
Clearance at toilet < 60" clear width	-	Provide a wheelchair accessible compartment that is 60" wide min. and 72" deep min.	1	6182	\$6182

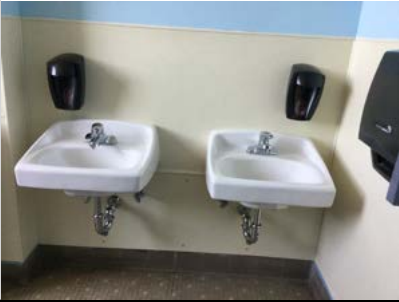
Exposed plumbing underneath	-	Insulate or otherwise configure pipes to prevent contact, for at least one lavatory.	1	92	\$92
66	Girls' Toilet Room	2	215	Lavatory (Children)	N/A

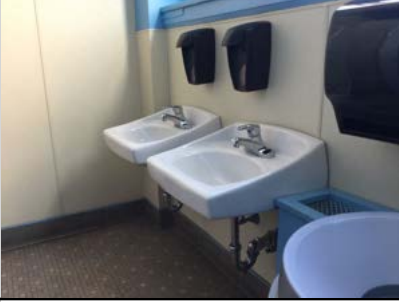
Exposed plumbing underneath	-	Insulate or otherwise configure pipes to prevent contact, for at least one lavatory.	1	92	\$92
67	Girls' Toilet Room	2	209	Lavatory (Children)	N/A

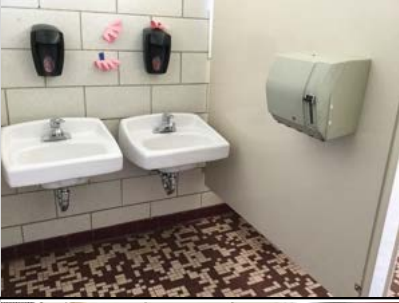
Exposed plumbing underneath	-	Insulate or otherwise configure pipes to prevent contact, for at least one lavatory.	1	92	\$92

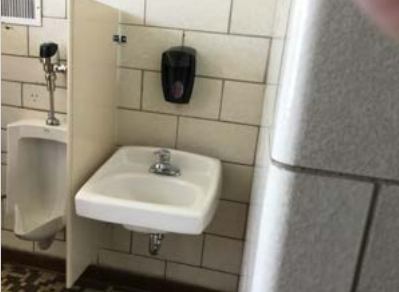
68	Boys' Toilet Room	2	208	Lavatory (Children)	N/A

Exposed plumbing underneath	-	Insulate or otherwise configure pipes to prevent contact, for at least one lavatory.	1	92	\$92

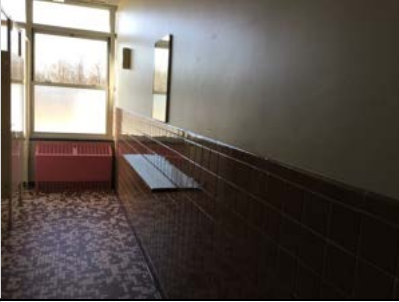
ID	Location	Floor	Room	Element	Type	Photo	Issues	Current Measure	Recommendations	Quantity	Price	Cost Estimation
69	Girls' Toilet Room	2	209	Lavatory (Children)	N/A

Mirror above lavatory w/reflective surface > 31"	49"	Lower mirror so that the bottom surface is at 31" above finished floor.	1	256	\$256
70	Boys' Toilet Room	2	208	Lavatory (Children)	N/A

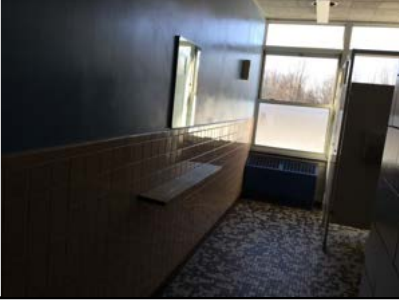
Mirror above lavatory w/reflective surface > 31"	49"	Lower mirror so that the bottom surface is at 31" above finished floor.	1	256	\$256
Dispensers (Children)												
71	Boys' Toilet Room	2	220	Dispensers (Children)	Paper Towel Dispenser

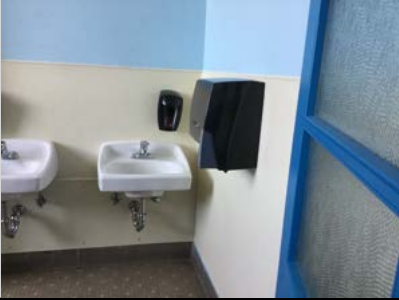
Dispenser is a protruding object	-	Relocate dispenser out of the circulation path.	1	256	\$256
72	Boys' Toilet Room	2	208	Dispensers (Children)	Paper Towel Dispenser

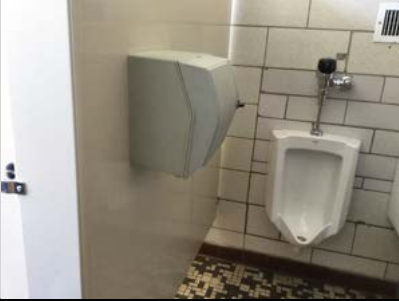
Dispenser is a protruding object	-	Relocate dispenser out of the circulation path.	1	256	\$256
Urinal (Children)

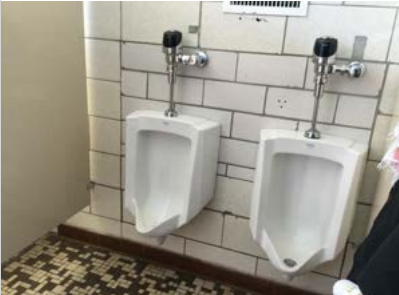
73	Boys' Toilet Room	2	208	Urinal (Children)	N/A

Rim > 15" high (MAAB)	16.5"	Provide at least one urinal with the rim no higher than 15" above the finished floor.	1	3248	\$3248

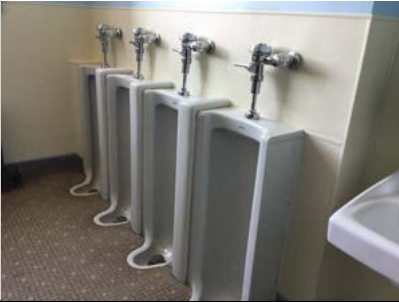
ID	Location	Floor	Room	Element	Type	Photo	Issues	Current Measure	Recommendations	Quantity	Price	Cost Estimation
74	Boys' Toilet Room	2	220	Urinal (Children)	N/A

Flush control is > 44" high or not properly located	47"	Mount flush control at 44" max. above the finished floor.	1	374	\$374
Additional Access												
Drinking Fountains												
75	Hallway	1	101	Drinking Fountains	Low

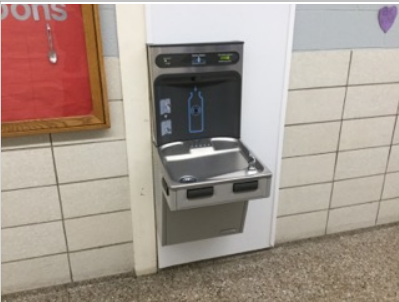
No drinking fountain provided for standing users	-	Provide an additional drinking fountain for standing users or install a Hi-Lo drinking fountain.	1	4028	\$4028
76	Hallway	1	103	Drinking Fountains	Low

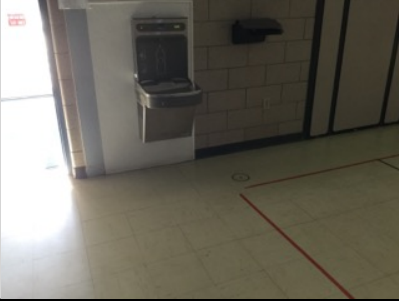
No drinking fountain provided for standing users		Provide an additional drinking fountain for standing users or install a Hi-Lo drinking fountain.	1	4028	\$4028
77	Hallway by Room #225	2		Drinking Fountains	Low
