Town of Auburn, Massachusetts

ADA Self-Evaluation and Transition Plan

September 2020

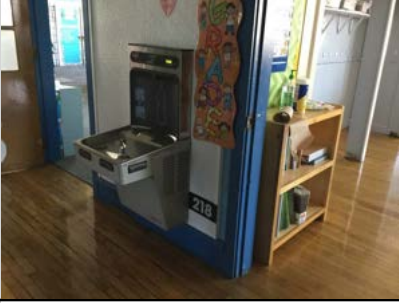
No drinking fountain provided for standing users	-	Provide an additional drinking fountain for standing users or install a Hi-Lo drinking fountain.	1	4208	\$4208

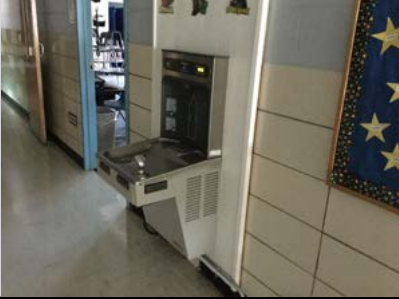
78	Hallway by Room #213	2		Drinking Fountains	Low

No drinking fountain provided for standing users	-	Provide an additional drinking fountain for standing users or install a Hi-Lo drinking fountain.	1	4208	\$4208

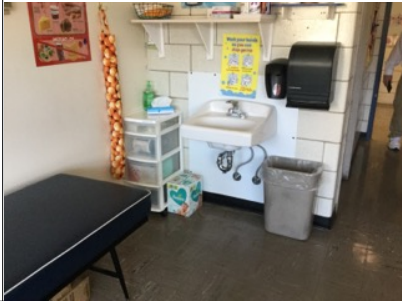
ID	Location	Floor	Room	Element	Type	Photo	Issues	Current Measure	Recommendations	Quantity	Price	Cost Estimation
Sink												
79	Nurse's Room	1	109	Sink	Other

Clear floor space not provided at sink Exposed plumbing underneath sink		Remove stored items to maintain the required 30" min. by 48" min. clear floor space positioned for a forward approach at the sink. Insulate or otherwise configure pipes at sink.	1	92	\$92
Sinks for Children's Use												
80	Classroom	1	105	Sinks for Children's Use	Classroom

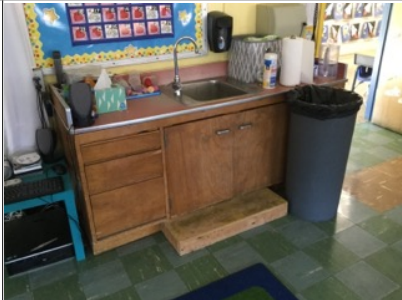
Knee or toe clearance not provided	-	Provide a sink with 25" high knee and toe clearance positioned for a forward approach.	1	1686	\$1686
81	Classroom Grade 1	2	201	Sinks for Children's Use	Classroom

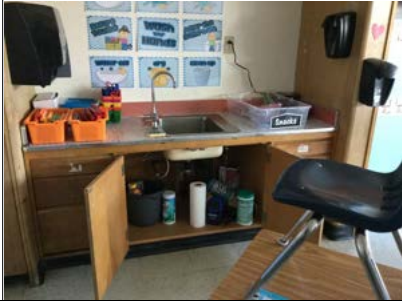
Knee or toe clearance not provided	-	Provide a sink with 25" high knee and toe clearance positioned for a forward approach.	1	1686	\$1686
Play and Sport Areas												
Play Areas

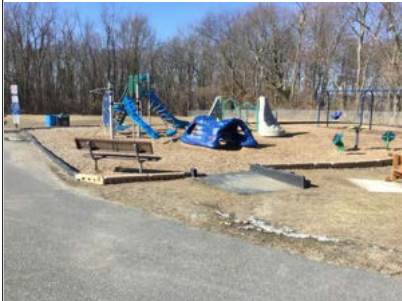
82	Playground	Ext.		Play Areas	N/A

Accessible route not provided to playground Accessible route not provided around playground Accessible route not provided to play components	<ul style="list-style-type: none">---	Install an accessible route to and around the playground. (Cost estimate for 48" wide min. x 300' stone dust path, \$9,600) Provide a compliant impact-attenuating surface to and around the play components. (Cost estimate for 2800 sq. ft. of poured in place rubber surface, \$39,200.)	1	48800	\$48800

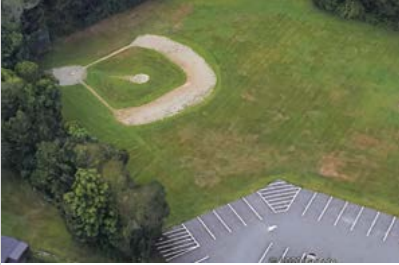
ID	Location	Floor	Room	Element	Type	Photo	Issues	Current Measure	Recommendations	Quantity	Price	Cost Estimation
Field												
83	Baseball Field	Ext.		Field	Baseball

No accessible route to all areas of sport activity	-	Install an accessible route between all areas of sport activity. (Cost estimate for a 48" wide min. x 120' long stone dust path from parking lot along tree line on first base side towards home plate, the edge of sport activity.)	1	3840	\$3840
Best Practice												
84	By Exit #11	Ext.

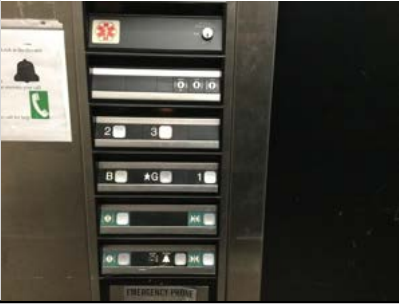
Recommend indicating which room the elevator opens in when the 1, 2 and 3 call buttons are used, and duplicating the information in braille at each call button.	1	-	\$0
Examination Table												
86	Nurse's Room	1	109	Examination Table	N/A

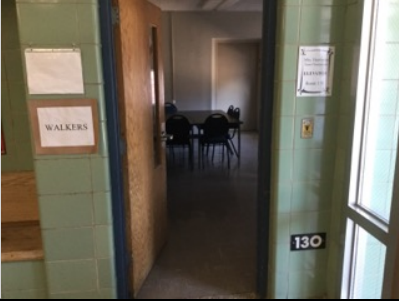
ID	Location	Floor	Room	Element	Type	Photo	Issues	Current Measure	Recommendations	Quantity	Price	Cost Estimation
Signage												
87		1	130	Signage	N/A

Recommend providing a sign indicating the direction to the elevator.	1	-	\$0
Stair												
88	Exit #12	Ext.		Stair

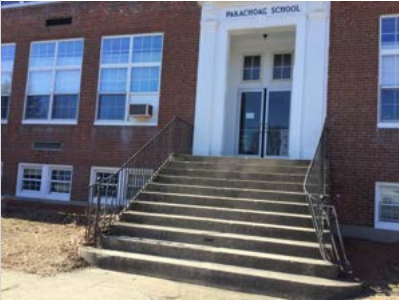
Recommend providing two 12" metal rail extensions at the bottom of the staircase.	1	-	\$0
89	Exit #11	Ext.		Stair	N/A

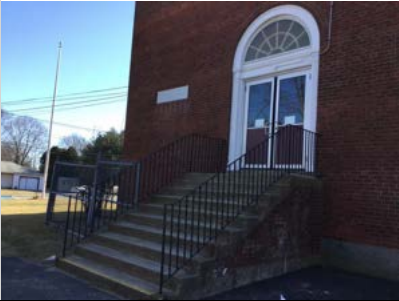
Recommend providing two 12" metal rail extensions at the bottom of the staircase.	1	-	\$0
Stairs												
90		1	129	Stairs	N/A

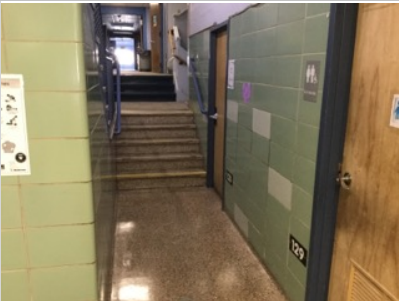
Recommend adding contrasting strips at the edge of each step at stairs.	1	-	\$0
91	Exit #7	Ext.		Stairs	N/A

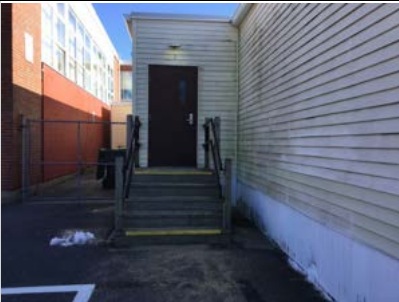
Recommend providing two 12" metal rail extensions at the bottom of the staircase.	2	-	\$0

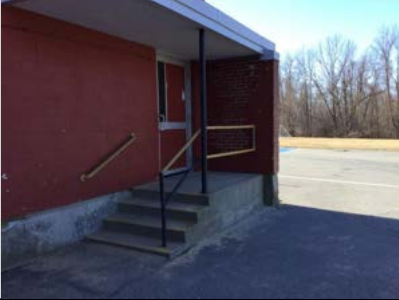
ID	Location	Floor	Room	Element	Type	Photo	Issues	Current Measure	Recommendations	Quantity	Price	Cost Estimation
92	Exit #8	Ext.		Stairs	N/A

Recommend providing two 12" metal rail extensions at the bottom of the staircase.	2	-	\$0
93	Exit #10	Ext.		Stairs

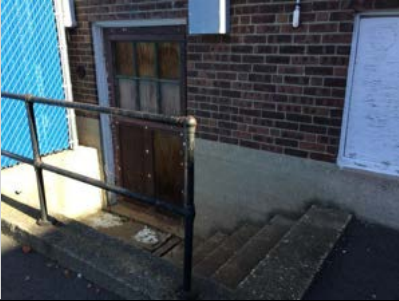
Recommend providing a gate at the top of stairs to provide a measure of safety for children outside of the school.	1	-	\$0

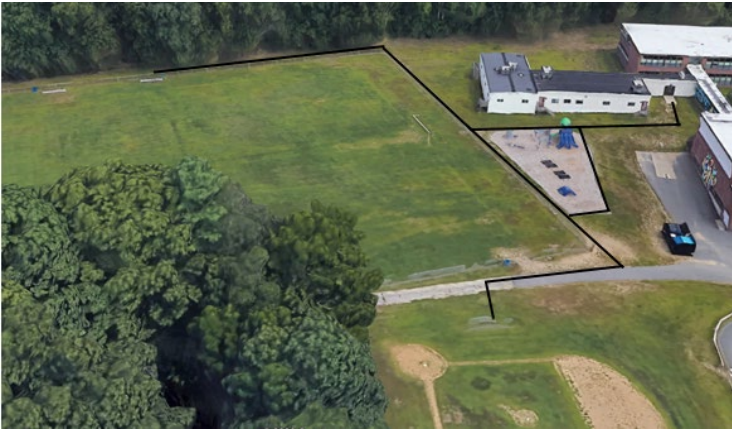
Figure 1: Possible accessible asphalt route from door 9 to and around the playground, and to the team seating and the edge of sport activity at the baseball and soccer fields. (Based on 4’ wide min. x 825’ long asphalt route with a max. running slope of 1:20 (5.00%) and a max. cross slope of 1:50 (2.00%)).

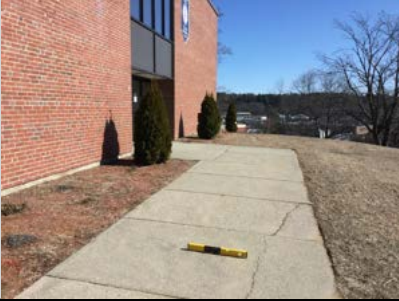
ID	Location	Floor	Room	Element	Type	Photo	Issues	Current Measure	Recommendations	Quantity	Price	Cost Estimation
Approach and Entrance												
Exterior Access Route												
1	Path to Exit #14	Ext.		Exterior Access Route	Exterior

Cross slope > 1:50 (2.00%) Route not maintained in operable working condition	3.4% -	Reduce cross slope to be no steeper than 1:50 (2.00%). Ensure the accessible route is maintained at walkway in operable working condition.	1	400	\$400
2	Route to Baseball	Ext.		Exterior Access Route	Exterior

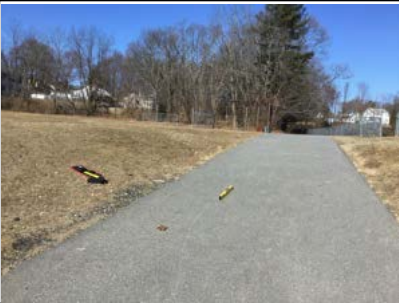
Running slope > 1:20 (5%)	12%	Reduce running slope to be no steeper than 1:20 (5.00%). (Cost of accessible route provided in ID #90.)	1	-	\$0
Off-Street Parking Lot or Garage												
3	By Ball Field	Ext.		Off-Street Parking Lot or Garage	N/A

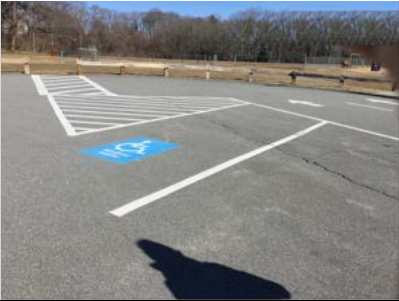
Total # of designated van accessible spaces Sign not provided Sign does not have the designation "Van Accessible"	1 - -	Provide a sign with the International Symbol of Accessibility with the bottom of the sign 60" min. above the ground and the top 96" max. above the ground. Add the designation "Van Accessible" to the sign located at the van accessible space.	1	500	\$500

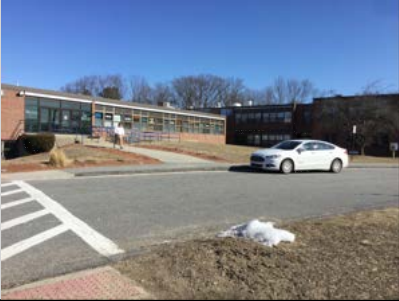
Passenger Loading Zones												
4	Loading Zone	Ext.		Passenger Loading Zones	N/A

Access aisle not provided Sign with ISA not provided (MAAB)	- -	Provide a marked access aisle that is at least 60" wide and that extends the full length of the vehicle. Provide a sign that includes the International Symbol of Accessibility (ISA) at the head of the space. Locate the sign so that the bottom is 60" min. above the ground and the top is 96" max. above the ground.	1	800	\$800

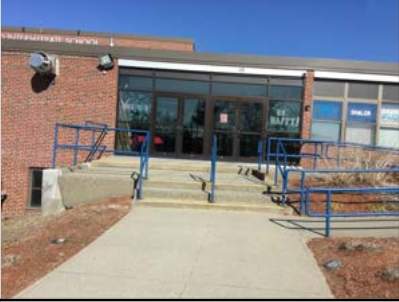
ID	Location	Floor	Room	Element	Type	Photo	Issues	Current Measure	Recommendations	Quantity	Price	Cost Estimation
Exterior Stair												
5	Main Entrance	Ext.		Exterior Stair	N/A

Handrails do not extend 12" from stair	-	Top: Ensure handrails extend horizontally above the landing for 12" min. beginning above the first riser nosing. Bottom: Ensure that the sloped bottom extension extends one tread depth minimum beyond last riser nosing in same direction as stair flight. (Cost based on welding three metal extensions on to existing metal railings. Note that one top railing does not need an extension.)	3	142	\$426
6	Exit #16	Ext.		Exterior Stair	N/A

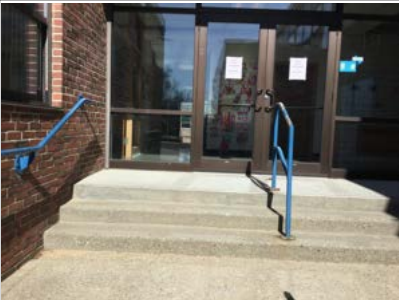
Handrails do not extend 12" from stair	-	Top: Ensure handrails extend horizontally above the landing for 12" min. at the middle railing.	1	142	\$142
7	Exit #16	Ext.		Exterior Stair	N/A

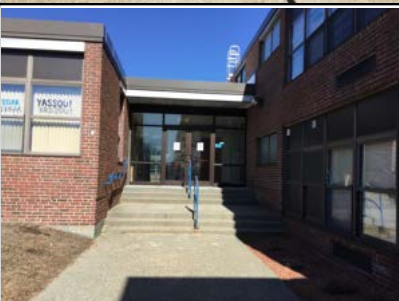
Handrails do not extend 12" from stair Handrail not provided on both sides	- -	Bottom: Ensure that the sloped bottom extension extends one tread depth minimum beyond last riser nosing in same direction as stair flight. Provide a handrail on one side.	1	2362	\$2362

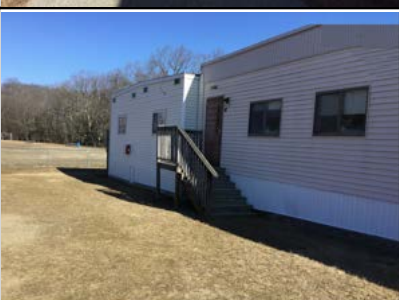
8	Exit #11	Ext.		Exterior Stair	N/A

Cross section of handrail is not compliant Handrail not provided on both sides	- -	Provide handrails with 1 1/4" - 2" circular cross sections or 4"- 6 1/4" non-circular cross sections. Provide a handrail on one side (Cost based on 2 15 foot wood handrails.)	2	660	\$1320
9	Exit #12	Ext.		Exterior Stair	N/A

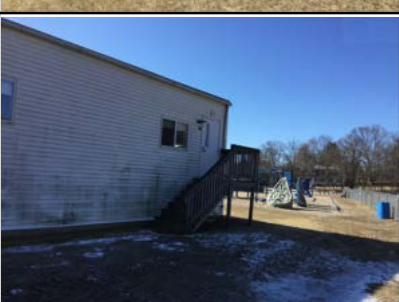
Cross section of handrail is not compliant Handrail not provided on both sides	- -	Provide handrails with 1 1/4" - 2" circular cross sections or 4"- 6 1/4" non-circular cross sections. Provide a handrail on one side. (Cost based on two 20 foot wood handrails.)	2	880	\$1760

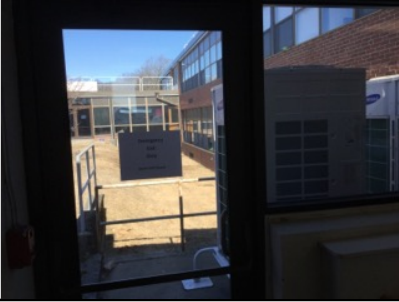
ID	Location	Floor	Room	Element	Type	Photo	Issues	Current Measure	Recommendations	Quantity	Price	Cost Estimation
Entrance												
10	Classroom	1	109	Entrance	Other

International Symbol of Accessibility not provided	-	Provide a sign with the International Symbol of Accessibility (ISA).	1	346	\$346
Emergency Exit												
11	Exit #9	Ext.		Emergency Exit	N/A

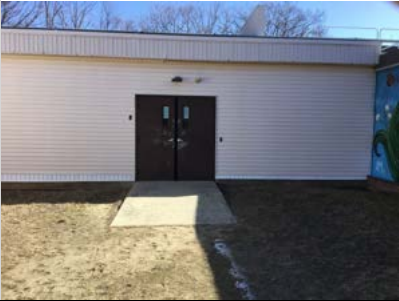
Emergency exit not on an accessible route	-	Provide an accessible route to emergency exit. (Cost of accessible route provided in ID #90.)	1	-	\$0
Access to Goods and Services												
Means of Egress												
12	Main Entrance	1		Means of Egress	N/A

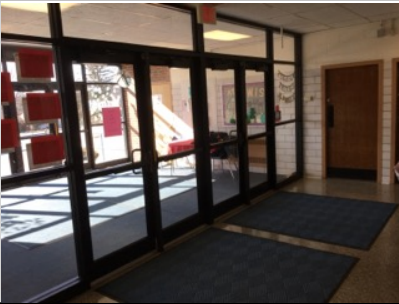
Tactile exit sign not provided	-	Ensure tactile exit signs with raised characters and braille are provided at exit doors. Mount signs between 48"- 60" above the finished floor located on the latch side of the door.	1	232	\$232
13	Exit #2 Next to Main Entrance	2	203	Means of Egress	N/A

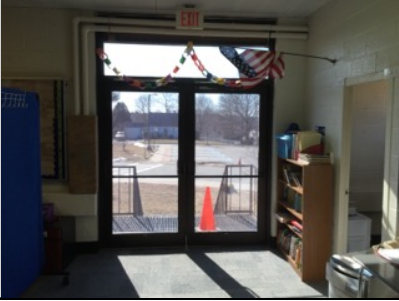
Tactile exit sign not provided	-	Ensure tactile exit signs with raised characters and braille are provided at exit doors. Mount signs between 48"- 60" above the finished floor located on the latch side of the door.	1	232	\$232

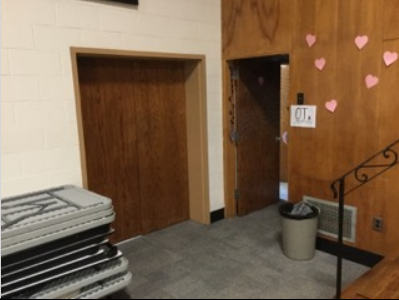
ID	Location	Floor	Room	Element	Type	Photo	Issues	Current Measure	Recommendations	Quantity	Price	Cost Estimation
14	Auditorium	2		Means of Egress	N/A

Tactile exit sign not provided	-	Ensure tactile exit signs with raised characters and braille are provided at exit doors. Mount signs between 48"- 60" above the finished floor located on the latch side of the door.	1	232	\$232
15	Gym	B		Means of Egress	N/A

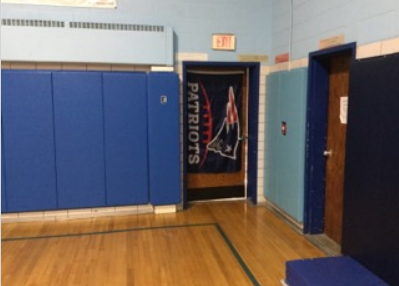
Tactile exit sign not provided	-	Ensure tactile exit signs with raised characters and braille are provided at exit doors. Mount signs between 48"- 60" above the finished floor located on the latch side of the door.	1	232	\$232
16	Close to Room #208	2		Means of Egress	N/A

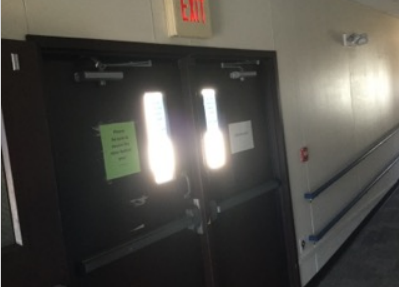
Tactile exit sign not provided	-	Ensure tactile exit signs with raised characters and braille are provided at exit doors. Mount signs between 48"- 60" above the finished floor located on the latch side of the door.	1	232	\$232

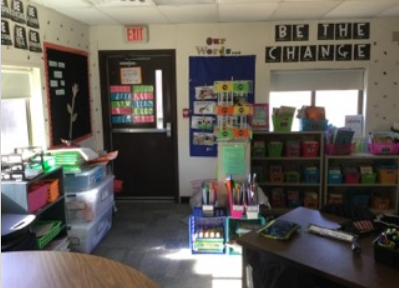
17	4th Grade	2	208	Means of Egress	N/A

Tactile exit sign not provided	-	Ensure tactile exit signs with raised characters and braille are provided at exit doors. Mount signs between 48"- 60" above the finished floor located on the latch side of the door.	1	232	\$232
18	Music Room	2	210	Means of Egress	N/A

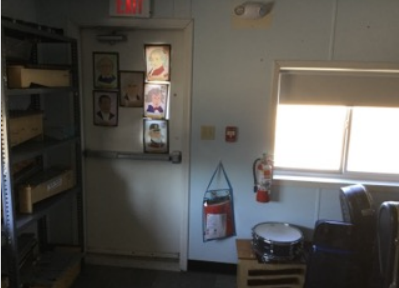
Tactile exit sign not provided	-	Ensure tactile exit signs with raised characters and braille are provided at exit doors. Mount signs between 48"- 60" above the finished floor located on the latch side of the door.	1	232	\$232

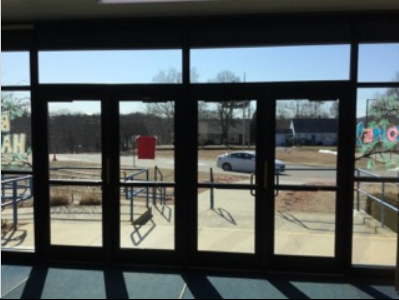
ID	Location	Floor	Room	Element	Type	Photo	Issues	Current Measure	Recommendations	Quantity	Price	Cost Estimation
19	Main Entrance	1		Means of Egress	N/A

Tactile exit sign not provided Illuminated ISA symbol not provided (MAAB)	- -	Ensure tactile exit signs with raised characters and braille are provided at exit doors. Mount signs between 48"- 60" above the finished floor located on the latch side of the door. Provide an illuminated exit sign with an illuminated sign with the International Symbol of Accessibility (ISA).	1	1116	\$1116
20	Exit Near Room #103	1		Means of Egress	N/A

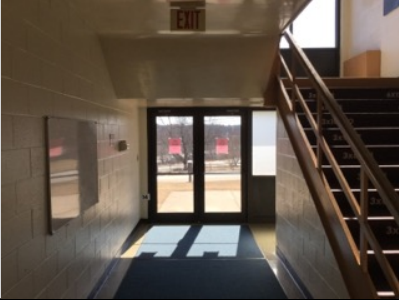
Tactile exit sign not provided Illuminated ISA symbol not provided (MAAB)	- -	Ensure tactile exit signs with raised characters and braille are provided at exit doors. Mount signs between 48"- 60" above the finished floor located on the latch side of the door. Provide an illuminated sign with the International Symbol of Accessibility (ISA).	1	432	\$432

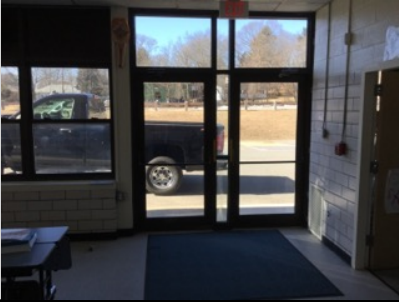
21	Cafeteria	B		Means of Egress	N/A

Illuminated ISA symbol not provided (MAAB) Tactile exit sign not provided	- -	Ensure tactile exit signs with raised characters and braille are provided at exit doors. Mount signs between 48"- 60" above the finished floor located on the latch side of the door. Provide an illuminated sign with the International Symbol of Accessibility (ISA).	1	432	\$432
Doors, Doorways, & Gates												
22	Classroom	B	114	Doors, Doorways, & Gates	Other

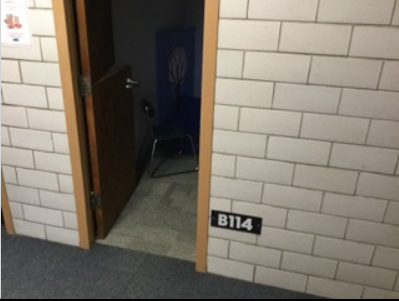
Clear width at door < 32"	27"	Widen the door so that there is 32" min. clear width.	1	3366	\$3366
23	Classroom	2	203	Doors, Doorways, & Gates	Classroom

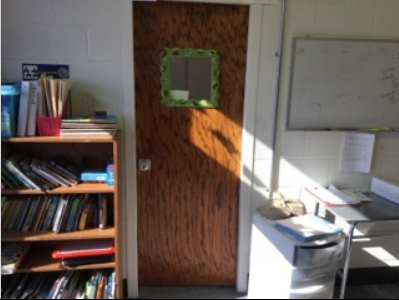
Clear width at door < 32" Hardware not operable with a closed fist	28" -	Widen the door so that there is 32" min. clear width. Provide hardware that can be operable with one hand and not require tight grasping, pinching, or twisting of the wrist.	1	3850	\$3850

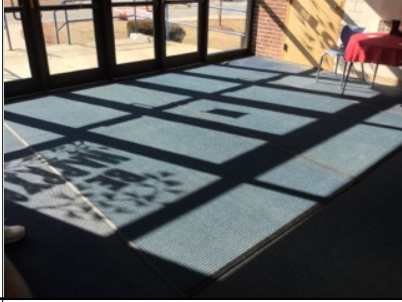
ID	Location	Floor	Room	Element	Type	Photo	Issues	Current Measure	Recommendations	Quantity	Price	Cost Estimation
24	Doorway	2		Doors, Doorways, & Gates	Circulation

Maneuvering clearance(s) not provided	-	Relocate chairs and table to maintain the maneuvering clearance at the door.	1	Labor	\$0
25	Hallway Next to Room #203	2	203	Doors, Doorways, & Gates	Circulation

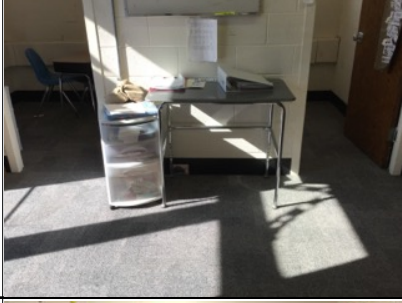
Maneuvering clearance(s) not provided	-	Relocate chairs and table to maintain the maneuvering clearance at the door.	1	Labor	\$0
26	Classroom	2	328	Doors, Doorways, & Gates	Classroom

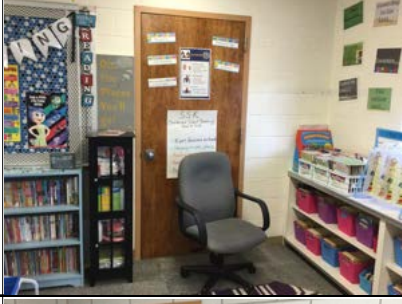
Maneuvering clearance(s) not provided Hardware not operable with a closed fist	- -	Remove furniture to maintain maneuvering clearance at the door. Provide hardware that can be operable with one hand and not require tight grasping, pinching, or twisting of the wrist.	1	484	\$484
27	Toilet Room	2		Doors, Doorways, & Gates	Toilet Room

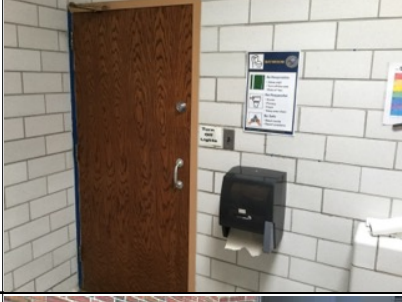
Maneuvering clearance(s) not provided Hardware not operable with a closed fist Door requires > 5 lbs. of force to open	12" - 10 lbs	Relocate the paper towel dispenser out of the pull-side maneuvering clearance at the door. Provide hardware that can be operable with one hand and not require tight grasping, pinching, or twisting of the wrist. Adjust closers so doors do not require more than 5 pounds of force to open.	1	837	\$837

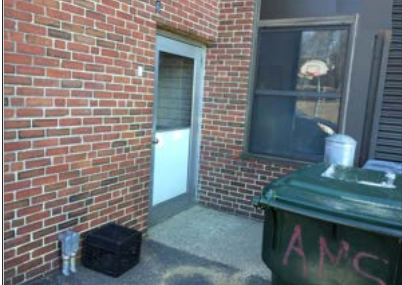
28	Exit #6	Ext.		Doors, Doorways, & Gates	Other

Hardware not operable with a closed fist	-	Provide hardware that can be operable with one hand and not require tight grasping, pinching, or twisting of the wrist.	1	484	\$484

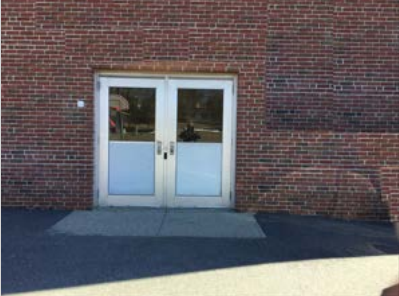
ID	Location	Floor	Room	Element	Type	Photo	Issues	Current Measure	Recommendations	Quantity	Price	Cost Estimation
29	Exit #7	Ext.		Doors, Doorways, & Gates	Emergency Egress

Hardware not operable with a closed fist	-	Provide hardware that can be operable with one hand and not require tight grasping, pinching, or twisting of the wrist.	2	484	\$968
30	Relaxation Room	2		Doors, Doorways, & Gates	Other

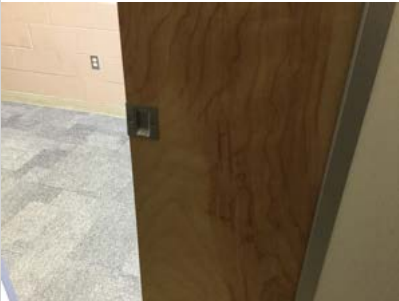
Hardware not operable with a closed fist	-	Provide hardware that can be operable with one hand and not require tight grasping, pinching, or twisting of the wrist.	1	484	
31	Staff Toilet	2		Doors, Doorways, & Gates	Toilet Room

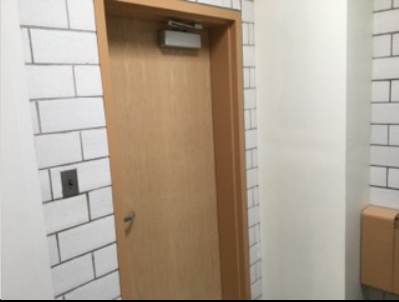
Door requires > 5 lbs. of force to open	10 lbs	Adjust closers so doors do not require more than 5 pounds of force to open.	1	Labor	\$0
Ramps												
32	Ramp	1	109	Ramps	Interior

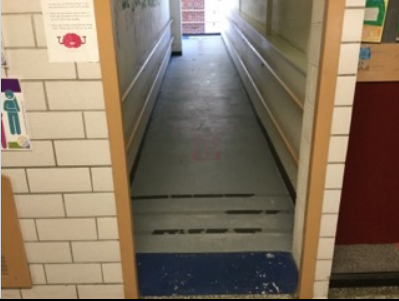
No top or bottom landing provided	-	Provide landing at top and bottom of ramp. (It may be technically infeasible to renovate the landings. Cost not provided.)	1	-	\$0

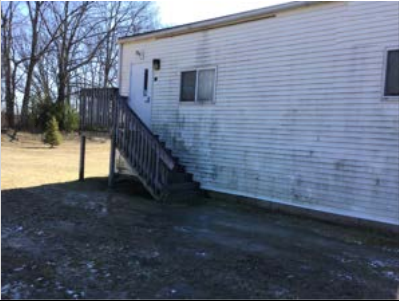
Stairways												
33	Exit #13	Ext.		Stairways	Egress

Handrail not provided on both sides Handrails have non-compliant cross section	- 5"	Provide handrail on one side. Provide handrails with 1 1/4" - 2" circular cross sections. (Cost based on two 15 foot wood handrails.)	2	660	\$1320

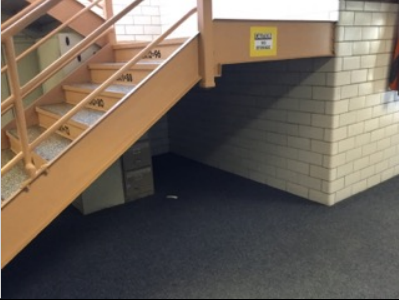
ID	Location	Floor	Room	Element	Type	Photo	Issues	Current Measure	Recommendations	Quantity	Price	Cost Estimation
34	Hallway Next to B114	B	B114	Stairways	Other

Vertical clearance < 80" above finished floor	-	Provide a cane-detectable barrier underneath stair.	1	960	\$960
Platform Lift or LULA Elevator												
35	Lift	2		Platform Lift or LULA Elevator	Interior

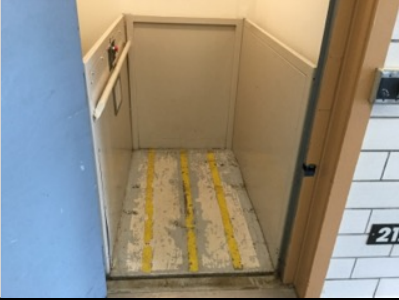
36" x 54" clear floor space not provided Clearance between platform and landing > 1 1/2"	- -	Providing a 36" by 54" clear floor space might be technically infeasible. Apply new sill plate where possible.	1	21660	\$21660
Elevator												
36	Lift	2		Elevator	Interior

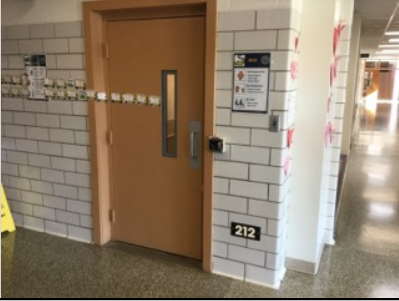
Hoistway signs not on both jambs	-	Provide hoistway signs on both sides of jambs.	1	96	\$96
Signage												
37	Special Needs Toilet for Room #203	2		Signage	Designation

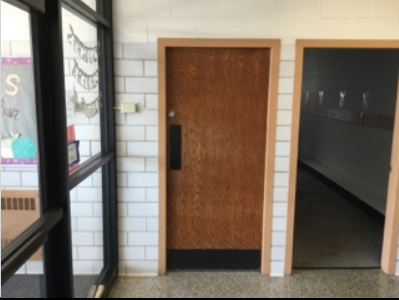
Signage is not provided	-	Locate compliant signage alongside the door on the latch side.	1	232	\$232

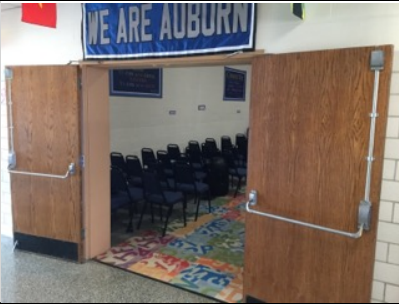
38	Auditorium	2		Signage	Designation

Signage is not provided	-	Locate compliant signage alongside the door on the latch side.	1	232	\$232

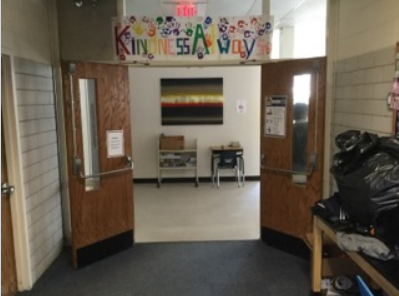
ID	Location	Floor	Room	Element	Type	Photo	Issues	Current Measure	Recommendations	Quantity	Price	Cost Estimation
39	Hallway	B		Signage	Designation

Signage is not provided	-	Locate compliant signage alongside the door on the latch side.	1	232	\$232
40	Classroom	B		Signage	Designation

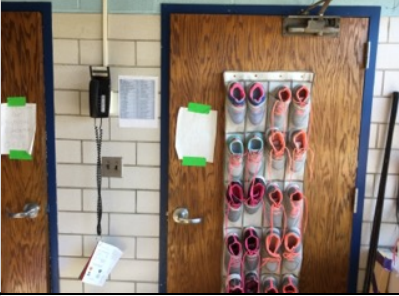
Signage is not provided	-	Locate compliant signage alongside the door on the latch side. (Cost of classrooms signage provided in ID #47.)	1	-	\$0
41	Classroom	1	109	Signage	Designation

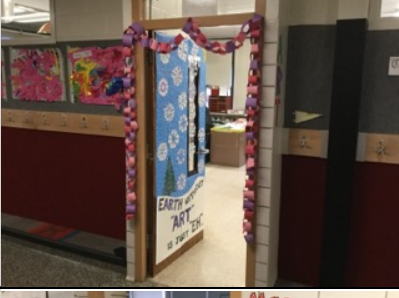
Signage is not provided	-	Locate compliant signage alongside the door on the latch side. (Cost of classrooms signage provided in ID #47.)	1	-	\$0
42	Classroom	1	110	Signage	Designation

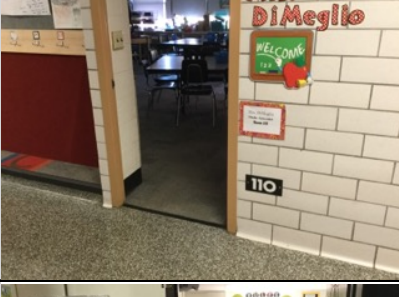
Raised characters not provided on sign Raised characters < 48" or > 60" above ground Braille not provided on sign Sign not located on the latch side of the door	- - - -	Provide text with raised characters duplicated in braille on sign. Mount signs so that the baseline of the lowest tactile character is 48" min. above finished floor and the baseline of the highest tactile character is 60" max. above the finished floor. Locate sign at permanent rooms alongside the door on the latch side. (Cost of classrooms signage provided in ID #47.)	1	-	\$0

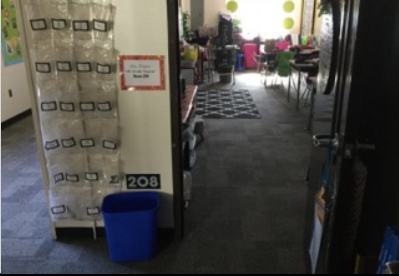
43	4th Grade	2	208	Signage	Designation

Raised characters not provided on sign Braille not provided on sign	- -	Provide text with raised characters duplicated in braille on sign. (Cost of classrooms signage provided in ID #47.)	1	-	\$0

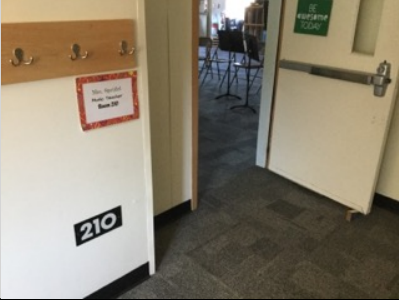
ID	Location	Floor	Room	Element	Type	Photo	Issues	Current Measure	Recommendations	Quantity	Price	Cost Estimation
44	Music Room	2	210	Signage	Designation

Raised characters not provided on sign Braille not provided on sign	- -	Provide text with raised characters duplicated in braille on sign for Rooms #210 and #211. (Cost of classrooms signage provided in ID #47.)	2	-	\$0
45	Reading Room	1	105	Signage	Designation

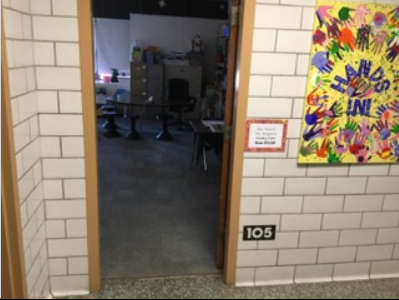
Raised characters not provided on sign Braille not provided on sign	- -	Provide text with raised characters duplicated in braille on sign. (Cost of classrooms signage provided in ID #47.)	2	-	\$0
46	Third Grade	1	103	Signage	Designation

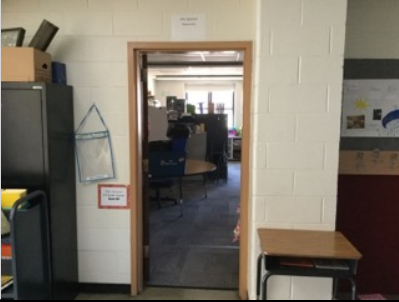
Raised characters not provided on sign Braille not provided on sign	- -	Provide text with raised characters duplicated in braille on sign. (Cost of classrooms signage provided in ID #47.)	1	-	\$0
47	Classroom	2	328	Signage	Directional

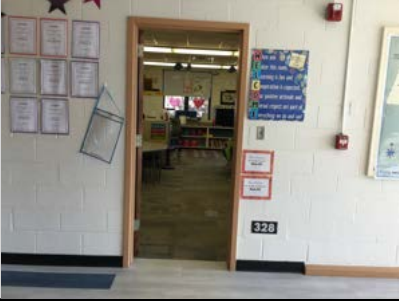
Raised characters not provided on sign Braille not provided on sign	- -	Provide text with raised characters duplicated in braille on sign to all classrooms. (Cost based on accessible signs for 43 classrooms.)	45	232	\$10440

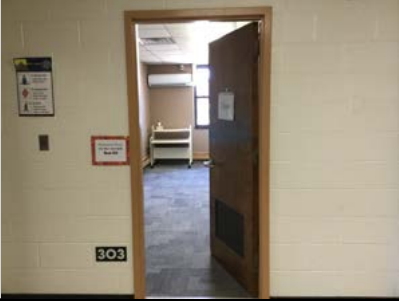
48	Relaxation Room	2	303	Signage	Designation

Raised characters not provided on sign Braille not provided on sign	- -	Provide text with raised characters duplicated in braille on sign. (Cost of classrooms signage provided in ID #47.)	1	-	\$0

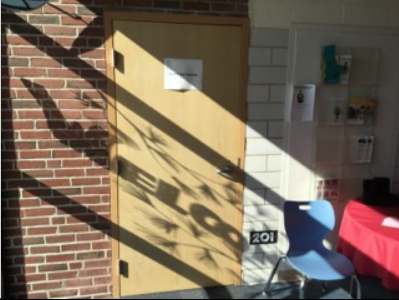
ID	Location	Floor	Room	Element	Type	Photo	Issues	Current Measure	Recommendations	Quantity	Price	Cost Estimation
49	Staff Toilet	2	201	Signage	Designation

Raised characters not provided on sign Braille not provided on sign Sign not located on the latch side of the door	- - -	Provide text with raised characters duplicated in braille on sign. Locate sign alongside the door on the latch side.	1	232	\$232
50	Classroom	2	203	Signage	Designation

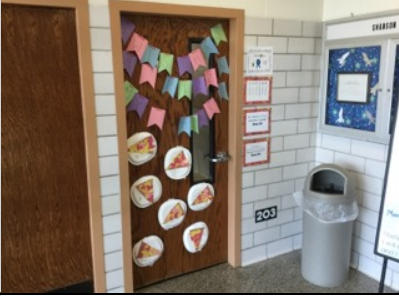
Raised characters not provided on sign Braille not provided on sign Sign not located on the latch side of the door	- - -	Provide text with raised characters duplicated in braille on sign. Locate sign alongside the door on the latch side. (Cost of classrooms signage provided in ID #47.)	1	-	\$0
51	Boys' Toilet Room	B		Signage	Designation

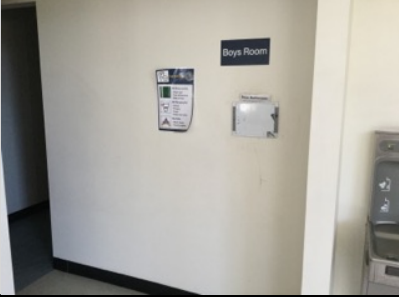
Raised characters not provided on sign Braille not provided on sign Sign not located on the latch side of the door	- - -	Provide text with raised characters duplicated in braille on sign.. Locate sign at permanent rooms alongside the door on the latch side.	1	232	\$232

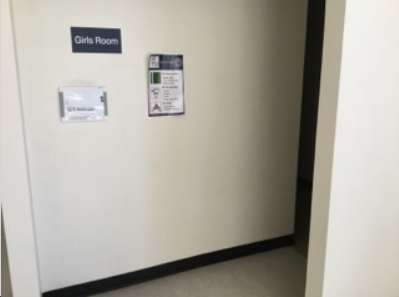
52	Girls' Toilet Room	B		Signage	Designation

Raised characters not provided on sign Braille not provided on sign Sign not located on the latch side of the door	- - -	Provide text with raised characters duplicated in braille on sign.. Locate sign at permanent rooms alongside the door on the latch side.	1	232	\$232
53	Hallway Leading to Rooms #208 -211	2		Signage	Directional

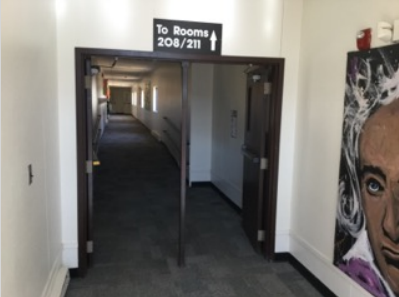
Raised characters not provided on sign Braille not provided on sign Sign not located on the latch side of the door	- - -	Provide text with raised characters duplicated in braille on sign. Locate sign alongside the door on the latch side.	1	232	\$232

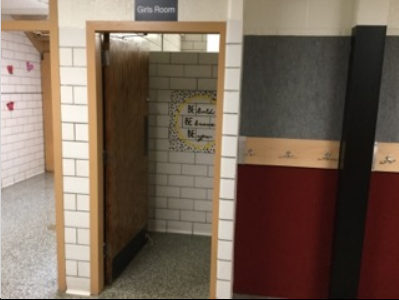
ID	Location	Floor	Room	Element	Type	Photo	Issues	Current Measure	Recommendations	Quantity	Price	Cost Estimation
54	Girls' Toilet Room	1	107	Signage	Designation

Raised characters not provided on sign Braille not provided on sign Sign not located on the latch side of the door	- - -	Provide text with raised characters duplicated in braille on sign. Locate sign alongside the door on the latch side.	1	232	\$232
55	Boys' Toilet Room	1	106	Signage	Designation

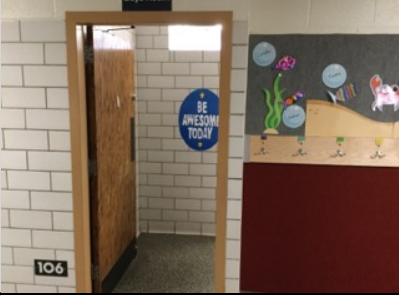
Raised characters not provided on sign Braille not provided on sign Sign not located on the latch side of the door	- - -	Provide text with raised characters duplicated in braille on sign. Locate sign alongside the door on the latch side.	1	232	\$232
56	Girls' Toilet Room	2	307	Signage	Designation

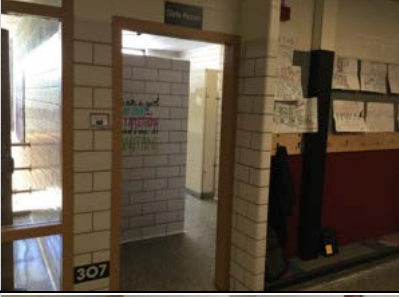
Raised characters not provided on sign Braille not provided on sign Sign not located on the latch side of the door	- - -	Provide text with raised characters duplicated in braille on sign. Locate sign alongside the door on the latch side.	1	232	\$232

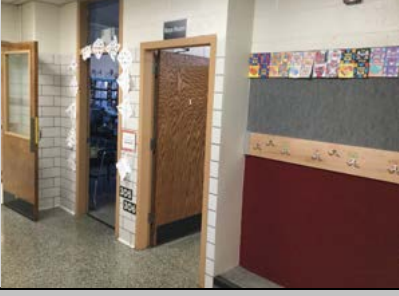
57	Boys' Toilet Room	2	306	Signage	Designation

Raised characters not provided on sign Braille not provided on sign Sign not located on the latch side of the door	- - -	Provide text with raised characters duplicated in braille on sign. Locate sign alongside the door on the latch side.	1	232	\$232
Dining or Work Surfaces												
58	Classroom	1	109	Dining or Work Surfaces	Work Surface

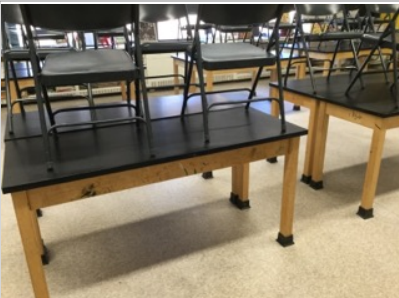
Knee or toe clearance not provided	24"	Provide at least 1 work surface with 27" min. knee and toe clearance.	1	700	\$700

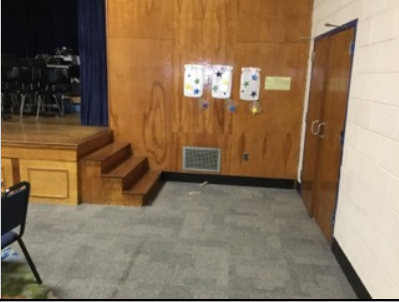
ID	Location	Floor	Room	Element	Type	Photo	Issues	Current Measure	Recommendations	Quantity	Price	Cost Estimation
Assembly Area												
59	Auditorium	2		Assembly Area	N/A

Accessible route to stage not provided	-	Provide a ramp. (Cost estimate for a 30' long wood ramp).	1	12067	\$12067
60	Auditorium	2		Assembly Area	N/A

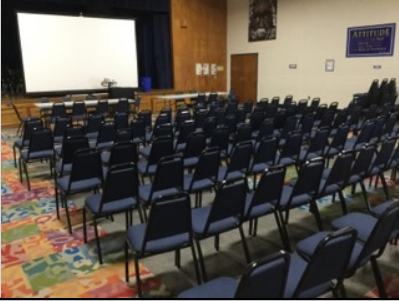
Assistive listening devices not provided	-	If audible communication is integral to the use of the space, provide an assistive listening system. If an ssistive listening system is provided, a sign indicating its availability is also required.	1	1214	\$1214
Exterior Benches												
61	Playground	Ext.		Exterior Benches	N/A

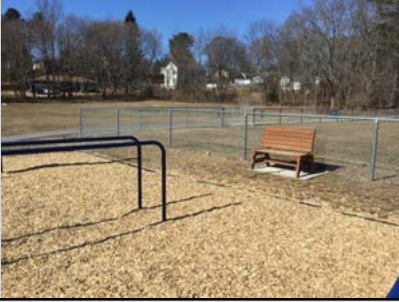
No accessible route to 20% of benches	-	Provide an accessible route to the bench near the playground. (Cost of accessible route provided in ID #90.)	1	-	\$0
Toilet & Bathing Rooms												
Overall Access												
62	Staff Toilet	2		Overall Access	Toilet Room

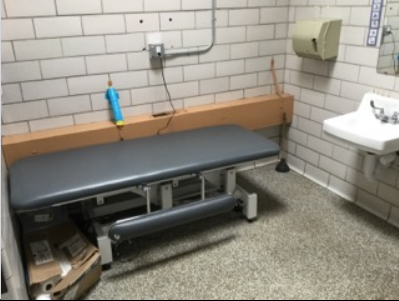
Turning space not provided	-	Remove bed to provide turning space.	1	Labor	\$0

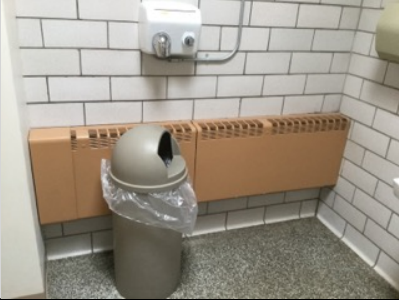
ID	Location	Floor	Room	Element	Type	Photo	Issues	Current Measure	Recommendations	Quantity	Price	Cost Estimation
63	Staff Toilet	2		Overall Access	Toilet Room

Dispensers not within reach range	51"	Lower dispensers to 42" max. above the floor.	1	353	\$353
64	Boys' Toilet Room	2	306	Overall Access	Toilet Room

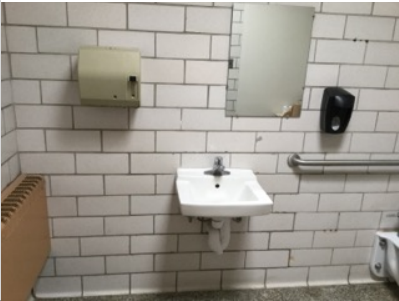
Mirror above lavatory w/reflective surface > 40" Dispensers not within reach range	46.5" 63.5"	Lower mirror so that the bottom surface is at 40" max. above the finished floor. Lower soap and paper towel dispensers to 42" max. above the floor.	1	962	\$962
66	Staff Toilet	2		Lavatory	N/A

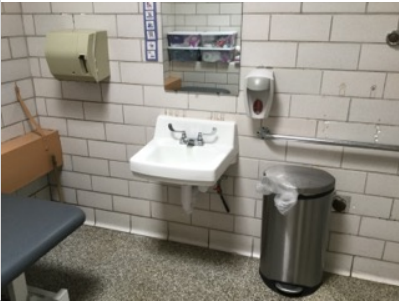
Mirror above lavatory w/reflective surface > 40" Dispensers not within reach range	42" 50"	Lower mirror so that the bottom surface is at 40" max. above the finished floor. Lower soap and paper towel dispenser to 42" max. above the floor.	1	962	\$962

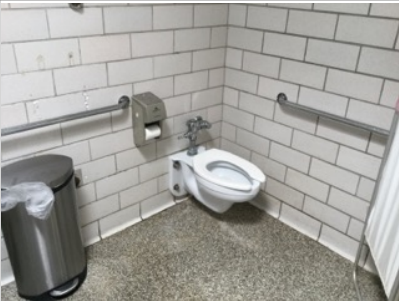
Single-User Toilet												
67	Staff Toilet	2		Single-User Toilet	N/A

Side grab bar < 54" from back wall Rear grab bar < 24" from toilet centerline	- -	Provide a side wall grab bar that is 42" long min. located 12" max. from the rear wall. Relocate rear grab bar to extend 24" min. from the centerline of the toilet.	2	396	\$792

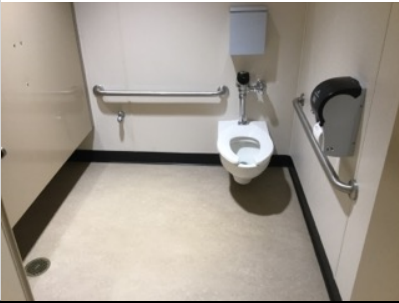
ID	Location	Floor	Room	Element	Type	Photo	Issues	Current Measure	Recommendations	Quantity	Price	Cost Estimation
Toilet Compartment												
68	Girls' Toilet Room	B		Toilet Compartment	Accessible Compartment

Dispensers not within reach range Side or rear grab bar < 33" or >36" high Non-compliant toilet paper dispenser	- 24.5" -	Locate trash dispenser within reach range below the grab bar. Locate grab bar between 33"- 36" above the floor. Relocate toilet paper dispenser so that it is between 14"- 19" above the floor and between 7"- 9" in front of the toilet. Ensure toilet paper dispenser and other devices are not mounted above grab bars.	4	256	\$1024
69	Boys' Toilet Room	B		Toilet Compartment	Accessible Compartment

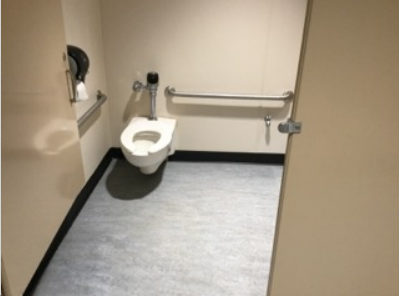
Rear grab bar < 24" from toilet centerline	36"	Relocate rear grab bar to extend 24" from the centerline of the toilet. Relocate side grab bar to extend 12" from the rear wall.	2	256	\$512

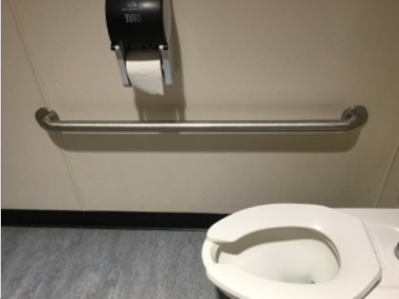
70	Boys' Toilet Room	B		Toilet Compartment	Accessible Compartment

Non-compliant toilet paper dispenser	-	Relocate toilet paper so that it is 24" min. high, located under the grab bar, and between 7" and 9" from the front of the toilet.	1	256	\$256
71	Staff Toilet	2		Toilet Compartment	Accessible Compartment

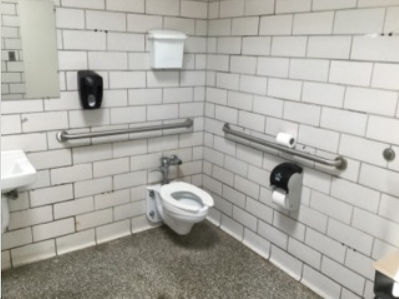
Non-compliant toilet paper dispenser Dispenser located above grab bar	-	Relocate toilet paper so that it is 24" min. high, located under the grab bar, and between 7" and 9" from the front of the toilet./Replace dispenser as it does not allow continuous paper flow. Relocate soap dispensers and trash receptacle from above the grab bar but not in the clear floor space.	3	353	\$1059
Toilet Rooms for Children												
Toilet Compartment (Children)												
72	Girls' Toilet Room	2	307	Toilet Compartment (Children)	Accessible Compartment

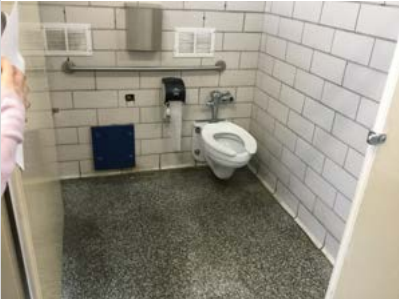
Dispenser located above grab bar Side or rear grab bar not provided Centerline < 15" or > 18" (Ages 9 - 12)	- - 14"	Relocate trash dispenser 1.5" minimum underneath the grab bar. Provide one grab bar on the side wall of the water closet. Relocate toilet so that the centerline is between 15" and 18" from the side wall.	1	4977	\$4977

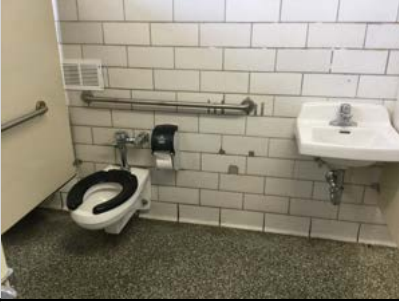
ID	Location	Floor	Room	Element	Type	Photo	Issues	Current Measure	Recommendations	Quantity	Price	Cost Estimation
73	Boys' Toilet Room	2		Toilet Compartment (Children)	Accessible Compartment

Exposed plumbing underneath Door with malfunctioning self-closing hinge Side or rear grab bar < 25" or > 27" high (Ages 9 - 12) Flush control not on open side Non-compliant toilet paper dispenser	- 34" - -	Insulate or otherwise configure pipes to prevent contact, for at least one lavatory. Repair self-closing hinge. Relocate grab bar to 25"- 27" above the floor. Provide the flush control on the open side of the toilet (transfer side), no higher than 44". Relocate toilet paper dispenser so that it is between 14"- 19" above the floor and between 7"- 9" in front of the toilet, and not mounted above the grab bar.	1	954	\$954
74	Girls' Toilet Room	1	107	Toilet Compartment (Children)	Accessible Compartment

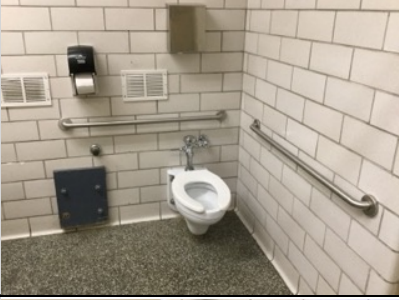
Dispensers not within reach range Non-compliant toilet paper dispenser	- -	Lower trash dispenser to be mounted under the grab bar, but not in the clear floor space. Relocate toilet paper dispenser so that it is between 14"- 19" above the floor and between 7"- 9" in front of the toilet. Ensure dispensers and other devices are not mounted above grab bars.	2	353	\$706

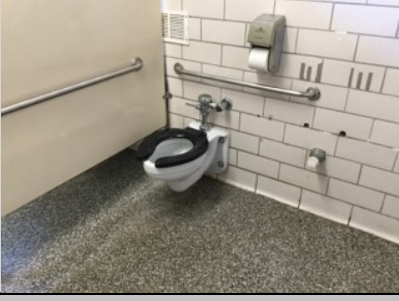
75	Boys' Toilet Room	1	106	Toilet Compartment (Children)	Accessible Compartment

Side or rear grab bar < 42" long Flush control not on open side Non-compliant toilet paper dispenser	36" - -	Provide a side/rear wall grab bar that is 42" long located 6" max. from the interior corner. Relocate toilet paper dispenser so that it is between 14"- 19" above the floor and between 7"- 9" in front of the toilet. Ensure dispensers and other devices are not mounted above grab bars. Provide the flush control on the open side of the toilet (transfer side), no higher than 44".	1	1625	\$1625
Lavatory (Children)												
76	Boys' Toilet Room	1	106	Lavatory (Children)	N/A

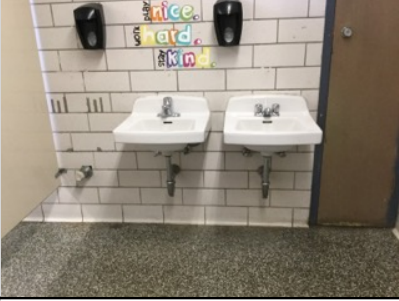
Dispenser controls > 42" high Exposed plumbing underneath	55.5" -	Relocate so the operable part of the soap dispenser at the accessible lavatory is 42" max. above the finished floor. Insulate or otherwise configure pipes to prevent contact, for at least one lavatory.	1	445	\$445

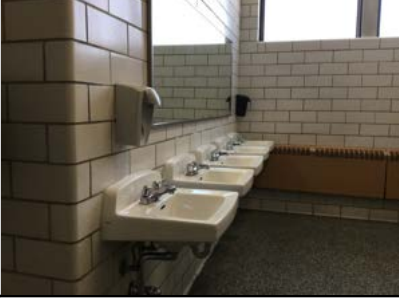
77	Girls' Toilet Room	2	307	Lavatory (Children)	N/A

Lavatory rim or counter > 30" Dispensers not within reach range Mirror above lavatory w/reflective surface > 31"	34" 51" 45"	Relocate lavatory with the front of the rim or counter no higher than 30" above the finished floor. Lower dispensers to 42" max. above the finished floor. Lower mirror so that the bottom surface is at 31" above the finished floor.	1	1059	\$1059

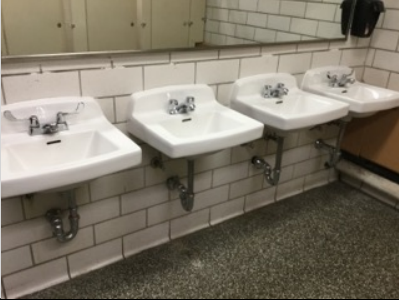
ID	Location	Floor	Room	Element	Type	Photo	Issues	Current Measure	Recommendations	Quantity	Price	Cost Estimation
78	Girls' Toilet Room	1	107	Lavatory (Children)	N/A

Lavatory rim or counter > 30" Exposed plumbing underneath Dispensers not within reach range Mirror above lavatory w/reflective surface > 31"	34.5" - 52" 45"	Lower dispensers to 42" max. above the floor. Relocate lavatory with the front of the rim or counter no higher than 30" above the finished floor. Insulate or otherwise configure pipes to prevent contact, for at least one lavatory. Lower mirror so that the bottom surface is at 31" above finished floor.	1	957	\$957
79	Boys' Toilet Room	2		Lavatory (Children)	N/A

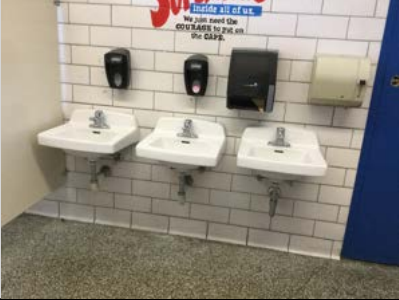
Exposed plumbing underneath Dispensers not within reach range	- -	Insulate or otherwise configure pipes to prevent contact, for at least one lavatory. Lower soap and paper towel dispensers to 42" max. above finished floor.	1	798	\$798

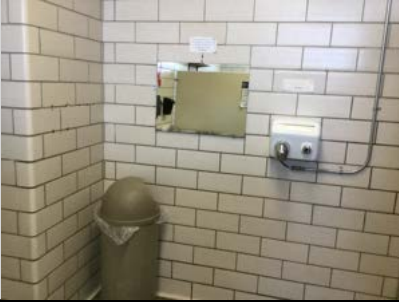
80	Boys' Toilet Room	2		Lavatory (Children)	N/A

Mirror above lavatory w/reflective surface > 31"	48"	Lower mirror so that the bottom surface is at 31" above finished floor.	1	256	\$256
Dispensers (Children)												
81	Girls' Toilet Room	1	107	Dispensers (Children)	Hand Dryer

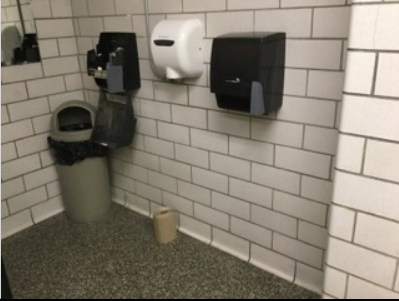
Dispenser controls > 42" high	45"	Relocate paper towel dispensers and hand dryer is 42" max. above the finished floor.	2	353	\$706
82	Boys' Toilet Room	1	106	Dispensers (Children)	Paper Towel Dispenser

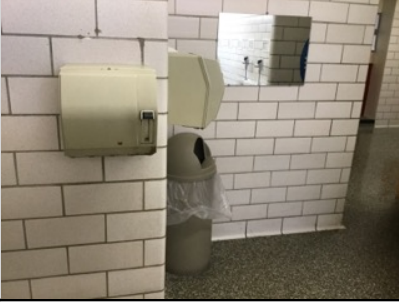
Dispenser controls > 42" high Dispenser is a protruding object	51" 10"	Relocate so the operable part of the paper towel dispenser is 42" max. above the finished floor. Relocate dispenser out of the circulation path.	2	353	\$706

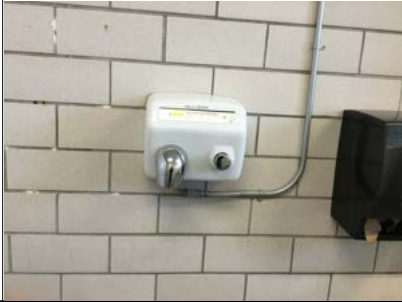
ID	Location	Floor	Room	Element	Type	Photo	Issues	Current Measure	Recommendations	Quantity	Price	Cost Estimation
83	Girls' Toilet Room	2	307	Dispensers (Children)	Hand Dryer

Dispenser is a protruding object	10"	Provide a cane-detectable barrier under the hand dryer 27" max. above finished floor.	1	353	\$353
Additional Access												
Drinking Fountains												
84	Hallway	2		Drinking Fountains	Low

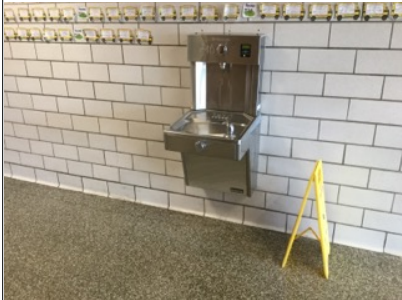
No drinking fountain provided for standing users	-	Provide an additional drinking fountain for standing users.	1	4028	\$4028
85	Hallway	B		Drinking Fountains	Low

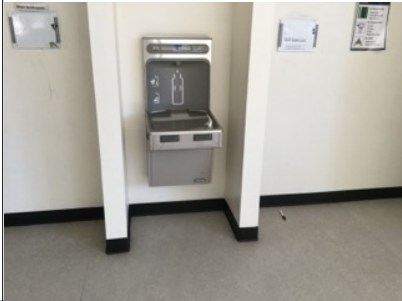
No drinking fountain provided for standing users	-	Provide an additional drinking fountain for standing users.	1	4028	\$4028
86	Hallway	B		Drinking Fountains	Low

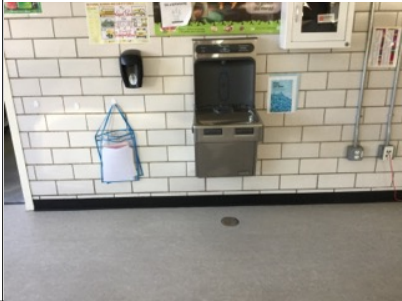
No drinking fountain provided for standing users	-	Provide an additional drinking fountain for standing users.	1	4028	\$4028
87	Hallway Near Room #207	2		Drinking Fountains	Low

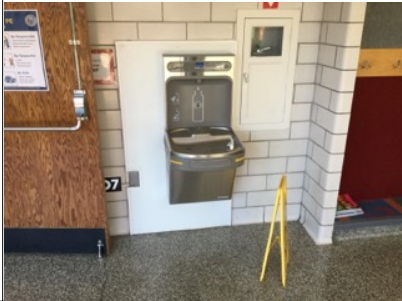
No drinking fountain provided for standing users	-	Provide an additional drinking fountain for standing users.	1	4028	\$4028

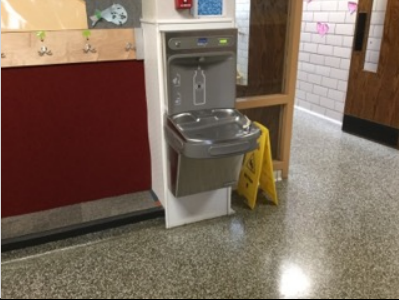
ID	Location	Floor	Room	Element	Type	Photo	Issues	Current Measure	Recommendations	Quantity	Price	Cost Estimation
88	Hallway	1	107	Drinking Fountains	Low

No drinking fountain provided for standing users	-	Provide an additional drinking fountain for standing users.	1	4028	\$4028
89	Hallway	2		Drinking Fountains	Low

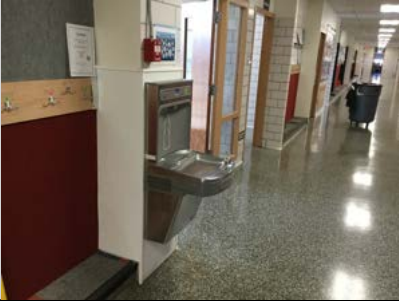
No drinking fountain provided for standing users	-	Provide an additional drinking fountain for standing users.	1	4028	\$4028
Play and Sport Areas												
Play Areas												
90	Exit #9 Landing	Ext.		Play Areas	N/A

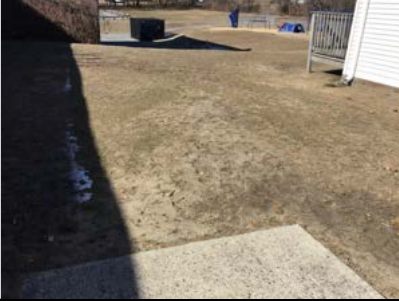
Accessible route not provided to playground	-	Install an accessible route to and around the playground and to sports fields. (See Figure 1 in the report narrative). Cost based on 4' wide min. x 825' long asphalt route with a max. running slope of 1:20 (5.00%) and a max. cross slope of 1:50 (2.00%).	1	33000	\$33000
91	Playground Towards Baseball	Ext.		Play Areas	N/A

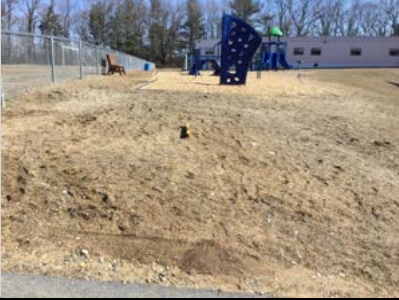
Accessible route not provided to playground Running slope > 1:20 (5%)	- -	Install an accessible route 48" wide min. to and around the playground with a max. running slope of 1:20 (5.00%) and a max. cross slope of 1:50 (2.00%). (Cost of accessible route provided in ID #90.)	1	-	\$0

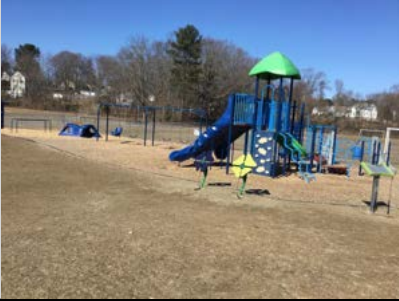
92	Playground	Ext.		Play Areas	N/A

Accessible route not provided to playground Surface not stable, firm, and slip-resistant	- -	Install an accessible route to and around the play components in the playground. (Cost estimate for 1,500 sq. ft. of poured-in-place rubber surface.)	1	21000	\$21000

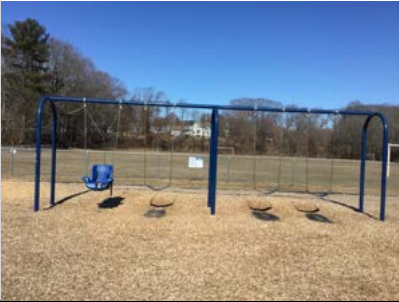
ID	Location	Floor	Room	Element	Type	Photo	Issues	Current Measure	Recommendations	Quantity	Price	Cost Estimation
93	Playground	Ext.		Play Areas	N/A

Accessible route not provided to play components	-	Provide a compliant impact-attenuating surface to and around the play components. (Cost of compliant playground surface provided in ID #92.)	1	-	\$0
Field												
94	Soccer Team Seating	Ext.		Field	Soccer
