Town of Auburn, Massachusetts

ADA Self-Evaluation and Transition Plan

September 2020

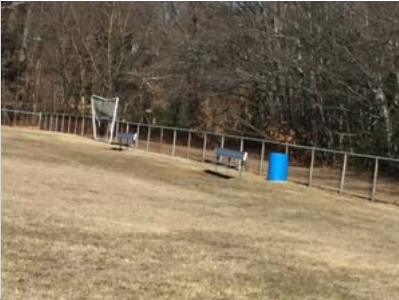
Accessible spaces not provided at team seating Accessible route not provided	- -	Provide a 36" x 48" clear floor space at team seating. Ensure an accessible route is provided to bench at team seating. (Cost of accessible route provided in ID #90.)	1	-	\$0
95	Baseball Team Seating	Ext.		Field	Baseball

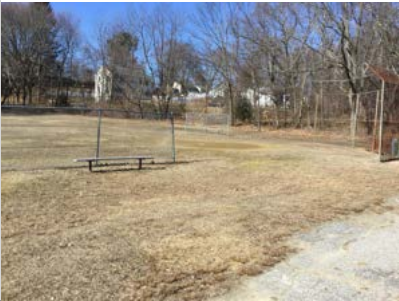
No accessible route to 20% of benches Field not connected to an accessible route	- -	Provide an accessible route to bench in this area. Provide an accessible route to the field/ edge of sport activity. (Cost of accessible route provided in ID #90.)	1	-	\$0

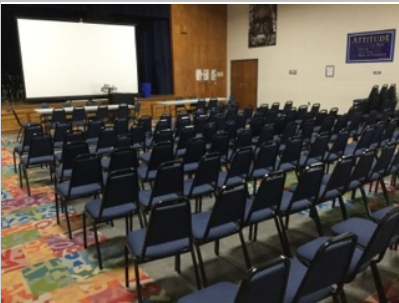
-	Recommend removing a few chairs to provide wheelchair accessible spaces in the auditorium.	1	-	\$0
97	Relaxation Room	2	303		N/A

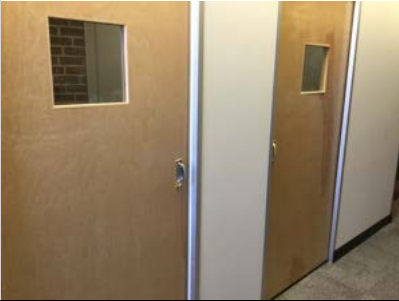
-	Recommend providing padded walls.	1	-	\$0

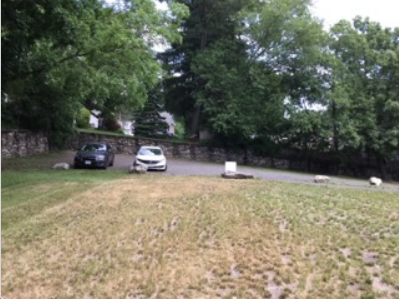
ID	Location	Floor	Room	Element	Type	Photo	Issues	Current Measure	Recommendations	Quantity	Price	Cost Estimation
Approach and Entrance												
Off-Street Parking Lot or Garage												
1	Parking Lot	Ext.		Off-Street Parking Lot or Garage	Visitor

Total # of parking Total # of designated accessible parking spaces Access aisle not provided Sign not provided	4 - - -	Provide a van accessible parking space at least 96" wide with a marked access aisle at least 96" wide.(An 11' wide min. space with a 5' wide min. marked access aisle is also permitted.) Provide a sign with the International Symbol of Accessibility (ISA) and the designation "Van Accessible" with the bottom of the sign 60" min. and the top 96" max. above the ground.	1	1850	\$1850
Access to Goods and Services												
Picnic Tables												
2	Playground Picnic Area North Side	Ext.		Picnic Tables	N/A

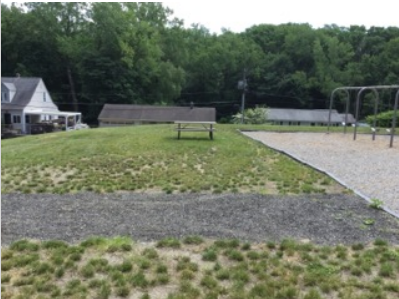
Toe or knee clearance at table not provided Picnic table not on an accessible route	- -	Provide at least one picnic table with top between 28"- 34" above the ground and 27" clear height underneath. Ensure that the dining surface is connected to an accessible route. (Cost based on an accessible picnic table connected to a 48" wide min. x 15' long stone dust path accessible route.)	1	1880	\$1880

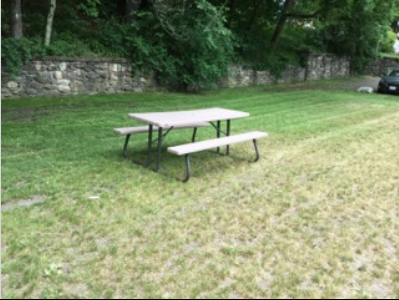
3	Playground Picnic Area North Side	Ext.		Picnic Tables	N/A

Picnic table not on an accessible route	-	Ensure that the picnic table is connected to an accessible route. (Relocate picnic table to an accessible route.)	1	Labor	\$0
Play and Sport Areas												
Play Areas												
4	Playground	Ext.		Play Areas	N/A

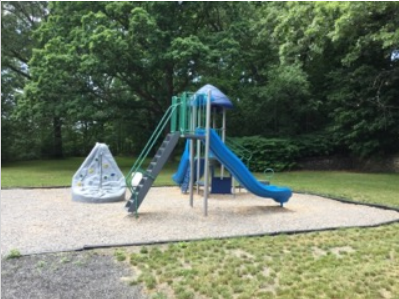
Accessible route not provided around playground	-	Install an accessible route around the playground. (Cost estimate for a 48" wide min. 240' long stone dust path around the perimeter of the playground.)	1	7680	\$7680

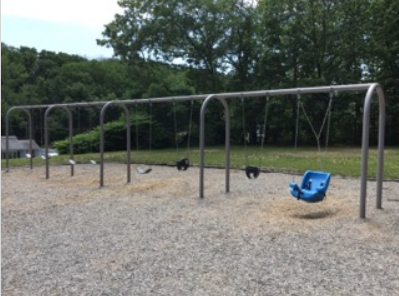
ID	Location	Floor	Room	Element	Type	Photo	Issues	Current Measure	Recommendations	Quantity	Price	Cost Estimation
5	Playground	Ext.		Play Areas	N/A

Accessible route not provided at play components	-	Provide a compliant impact-attenuating surface under and around the play components. (Cost estimate for 350 sq. ft. of poured in place rubber surface from the 60" wide min. to an under the swing set, climbing apparatus and all other play components.)	1	4900	\$4900
6	Playground	Ext.		Play Areas	N/A

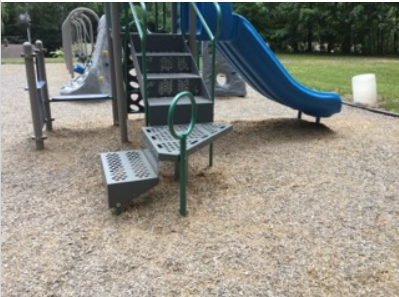
No compliant transfer system	23"	Adjust transfer platform to a height of between 11 and 18 inches.	1	Labor	\$0
7	Playground Picnic Area North Side	Ext.		Play Areas	N/A

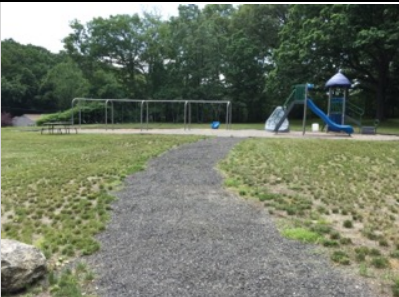
Not connected to an accessible route Surface not stable, firm, and slip-resistant	- -	Provide an accessible route to play areas. Repair surface and ensure that surface is firm, stable and slip-resistant. (Cost based on a resurfaced 48" wide min. x 30' long stone dust path from the parking lot to the playground entry with a max. running slope of 1:20 (5.00%) and a max. cross slope of 1:50 (2.00%)).	1	960	\$960

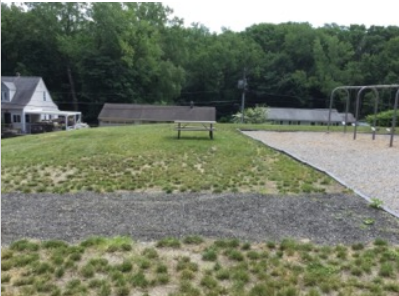
Best Practice												
Picnic Table												
8	Playground Picnic Area North Side	Ext.		Picnic Table	N/A

Recommend providing a 48" wide min. stable, firm and slip resistant surface under and around an accessible picnic table once it is placed in this area connected to an accessible route.	1	-	\$0

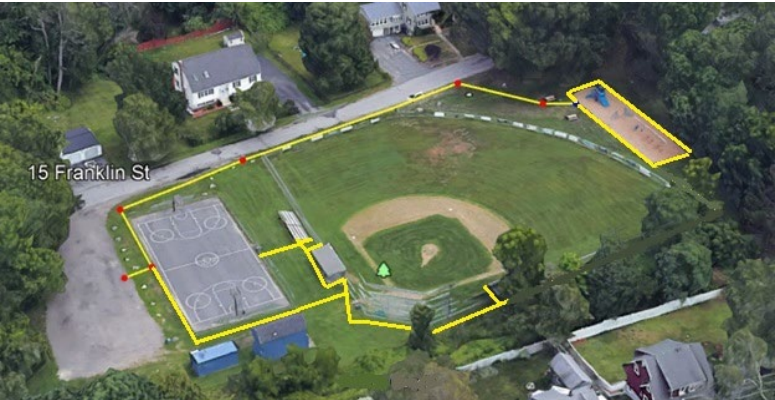
Figure 1: The yellow line shows the approximate location of the suggested accessible route connecting park amenities including the parking area to and around the playground, the edge of sport activity at the basketball court and baseball field, the first and third base dugouts, the bleachers, the concession stand, the bike rack and a picnic table.

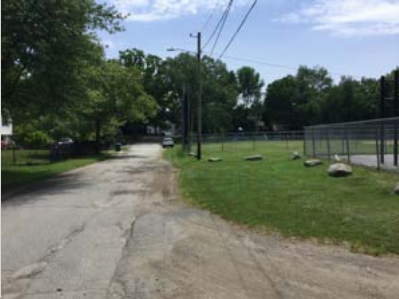
ID	Location	Floor	Room	Element	Type	Photo	Issues	Current Measure	Recommendations	Quantity	Price	Cost Estimation
Approach and Entrance												
Exterior Access Route												
1	North End of Park From Parking Lot Towards Playground	Ext		Exterior Access Route	Walkway

Not provided from all site arrival points	-	Provide a walkway 48" wide min. with a max. running slope of 1:20 (5.00%) and max. cross slope of 1:50 (2.00%) from the parking lot parallel to the road and connecting to the playground, picnic tables, basketball court, concession stand, seating and all other park amenities. See Figure 1 in report narrative. (Cost for an accessible route connecting ALL park amenities.)	1	32640	\$32640
2	Concession Stand	Ext		Exterior Access Route	Exterior

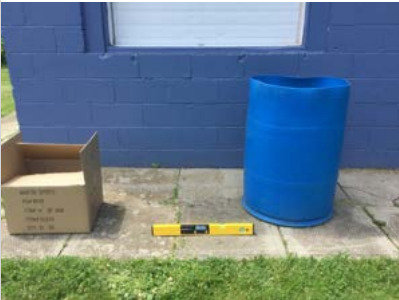
Cross slope > 1:50 (2.00%)	3.2%	Reduce cross slope to be no steeper than 1:50 (2.00%). (Cost based on a concrete patch.)	1	240	\$240
3	Route to Concession Stand and Baseball Field	Ext		Exterior Access Route	Exterior

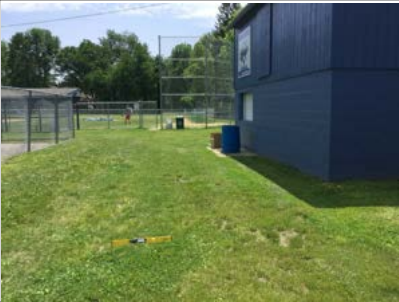
Accessible route not provided	-	Ensure an accessible route is provided.Provide a 48" wide min. walkway from the parking lot to the concession stand. See Figure 1 in report narrative. (Cost for accessible route included in ID #1.)	1	-	\$0

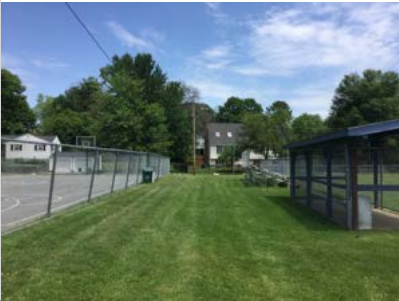
4	Route From Concession Stand to Baseball Field Player and Fan Seating	Ext		Exterior Access Route	Exterior

Accessible route not provided	-	Ensure an accessible route is provided. Provide a 48" wide min. walkway from the concession stand to the team seating dugouts and fan seating bleacher at the baseball field. See Figure 1 in report narrative. (Cost for accessible route included in ID #1.)	1	-	\$0
Off-Street Parking Lot or Garage												
5	Parking Lot by Basketball Court	Ext		Off-Street Parking Lot or Garage	N/A

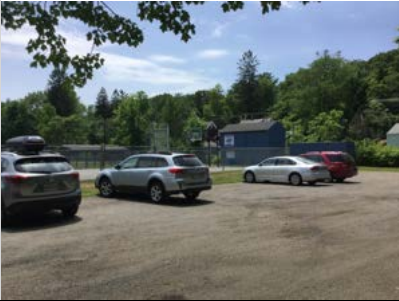
Total # of parking Total # of designated accessible parking spaces Total # of designated van accessible spaces Access aisle not provided Sign not provided	12 - - - -	Provide a van accessible parking space 96" wide min. with a marked access aisle that is at least 96" wide. (An 11' wide min. space with a 5' wide min. access aisle are also permitted.) Provide a sign the International Symbol of Accessibility (ISA) and the designation "Van Accessible" with the bottom of the sign 60" min. above the ground and the top 96" max. above the ground.	1	1850	\$1850

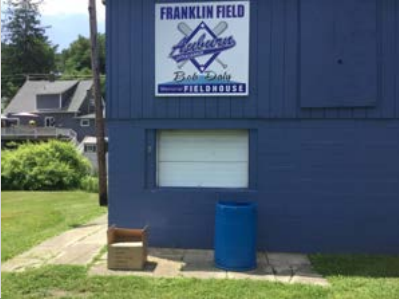
ID	Location	Floor	Room	Element	Type	Photo	Issues	Current Measure	Recommendations	Quantity	Price	Cost Estimation
Access to Goods and Services												
Service Counter												
6	Concessions Stand	Ext		Service Counter	N/A

Counter > 36" high	39"	Provide a counter that is 36" max. above the ground.	1	880	\$880
Picnic Tables												
7	By Playground	Ext		Picnic Tables	N/A

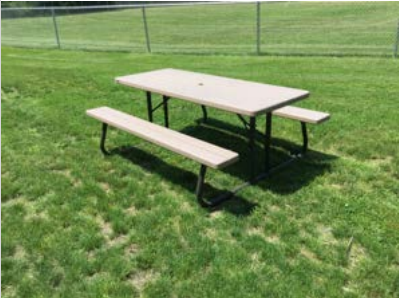
Toe or knee clearance at table not provided Picnic table not on an accessible route	26" -	Provide at least one picnic table with top between 28"- 34" above the ground and 27" clear height underneath. Ensure that the picnic table is connected to an accessible route. See Figure 1 showing the accessible route to an accessible picnic table in this area once an accessible picnic table is provided. (Shown cost is for the accessible picnic table. Accessible route cost in ID #1.)	1	1400	\$1400
Bike Racks												
8	By Playground	Ext		Bike Racks	N/A

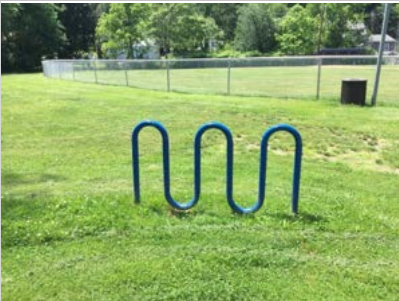
Not connected to an accessible route	-	Ensure bike racks are connected to an accessible route. Reposition bike rack to an accessible route if necessary. See Figure 1 in report narrative. (Cost for accessible route included in ID #1.)	1	Labor	\$0

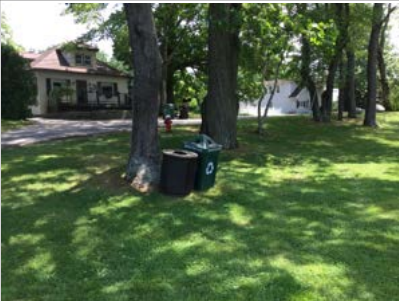
Trash / Recycling												
9	East of Playground	Ext		Trash / Recycling	N/A

Trash container not connected to an accessible route	-	Ensure trash container is located on an accessible route. Reposition trash containers to an accessible route. (Cost for accessible route included in ID #1.)	1	Labor	\$0
Play and Sport Areas

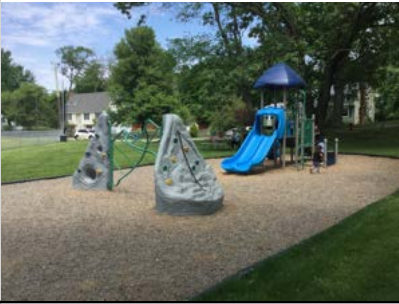
ID	Location	Floor	Room	Element	Type	Photo	Issues	Current Measure	Recommendations	Quantity	Price	Cost Estimation
Play Areas												
10	Playground	Ext		Play Areas	N/A

Accessible route not provided at play components	-	Provide a compliant impact-attenuating surface under and around the play components. (Cost estimate for 200 sq. ft. of poured in place rubber surface.)	1	22400	\$22400
11	Playground	Ext		Play Areas	N/A

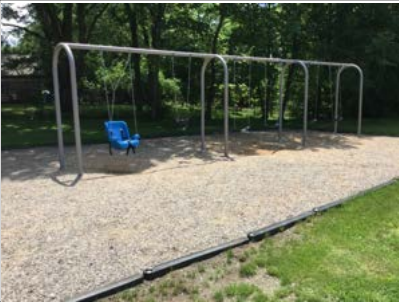
Not connected to an accessible route	3"	Provide an accessible route to play areas.(When accessible route connects to play ground, lower a 48" wide min. section of the playground border to 1/2" max.) (Cost for accessible route included in ID #1.)	1	Labor	\$0
Field												
12	Baseball Field Dugout by 3rd Base	Ext		Field	Baseball

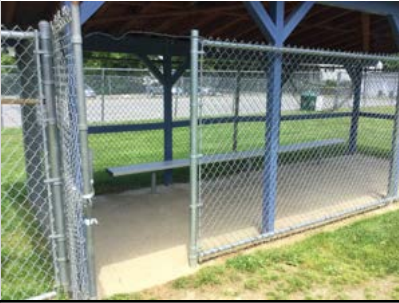
Accessible spaces are not provided at team seating	28'	Provide a 36" x 48" clear floor space at team seating on at least one end of bench. (Reposition bench.)	1	Labor	\$0

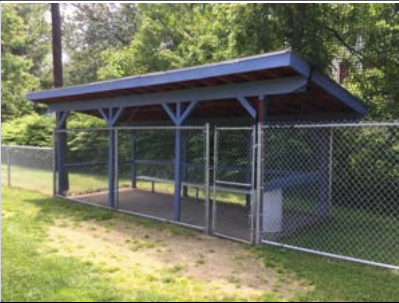
13	Baseball Field Dugout by 1st Base	Ext		Field	Baseball

Accessible spaces are not provided at team seating	33"	Provide a 36" x 48" clear floor space at team seating on at least one end of bench. (Reposition bench.)	1	Labor	\$0
14	Baseball Bleachers	Ext		Field	Baseball

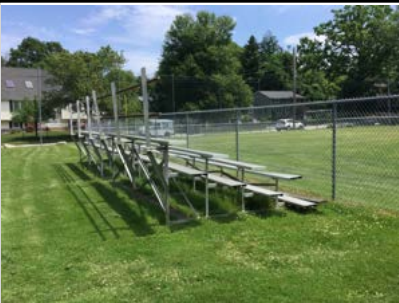
Accessible spaces not provided at sidelines seating	-	Provide a 36" x 48" clear floor space at sidelines fan seating (bleacher). See Figure 1 in report narrative. (Cost for stone dust surface alongside bleachers is included in the accessible route cost shown in ID #1.)	1	-	\$0

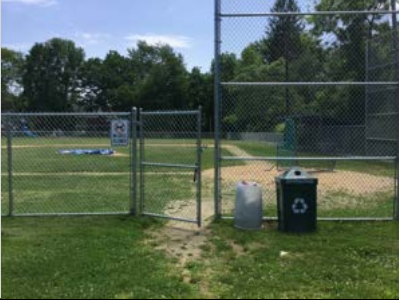
ID	Location	Floor	Room	Element	Type	Photo	Issues	Current Measure	Recommendations	Quantity	Price	Cost Estimation
15	Baseball Field Entrance by Home Plate	Ext		Field	Baseball

Not connected to an accessible-route	-	Provide an accessible route to the baseball field entrance/boundary of sport activity. See Figure 1 in report narrative. (Cost for accessible route included in ID #1.)	1	-	\$0
Court												
16	Basketball Court Entrance - South Side	Ext		Court	Basketball

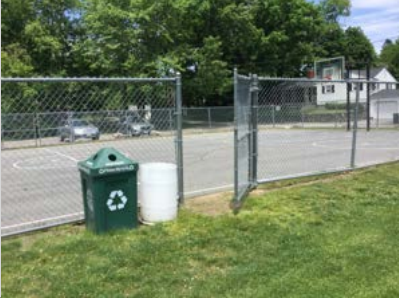
Not connected to accessible route	-	Provide an accessible route to the south side entrance to the basketball court. See Figure 1 in report narrative. (Cost for accessible route included in ID #1.)	1	-	\$0
17	Basketball Court Entrance - North Side	Ext		Court	Basketball

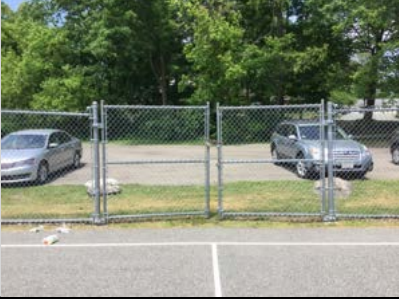
Not connected to accessible route	-	Provide an accessible route from the parking lot to the basketball court north entrance. See Figure 1 in report narrative. (Cost for accessible route included in ID #1.)	1	-	\$0

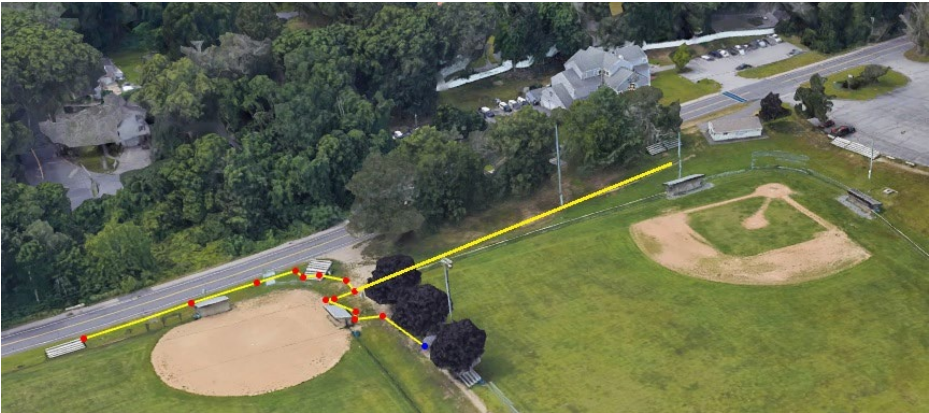
Figure 2: The yellow line shows the approximate suggested location of an accessible route connecting the accessible route at the baseball field shown in Figure 1 to the softball field, the softball field bleachers, dugouts, and the boundary of sport activity at the softball field.

Not connected to an accessible-route No accessible route to all areas of sport activity	- -	Install an accessible route from the accessible route at the baseball field to the boundary of sport activity at the softball field and to both softball field dugouts and each of the bleachers at the softball field. (Cost estimate for a 48" wide min. 570' asphalt route with a max. running slope of 1:20 (5.00%) and a max. cross slope of 1:50 (2.00%). See Figure 2 in narrative.)	1	22800	\$22800

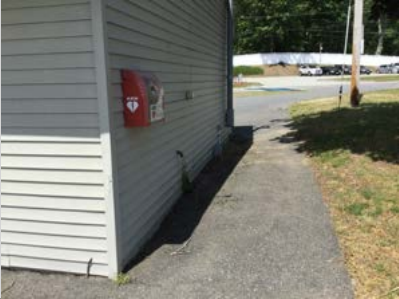
ID	Location	Floor	Room	Element	Type	Photo	Issues	Current Measure	Recommendations	Quantity	Price	Cost Estimation
Approach and Entrance												
Exterior Access Route												
1	North Side of Concessions	Ext		Exterior Access Route	Exterior

Route obstructed by protruding objects	-	Provide a cane-detectable barrier 27" max. above the ground under the defibrillator.	1	306	\$306
2	Route to Track From Parking Lot	Ext		Exterior Access Route	Exterior

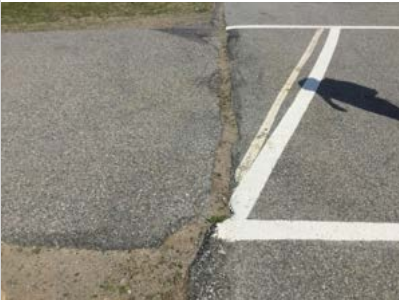
Surface openings > 1/2"	4.5"	Repair surface opening. (Cost based on a 8' wide x 2' deep asphalt patch.)	1	160	\$160
3	Concessions	Ext		Exterior Access Route	Exterior

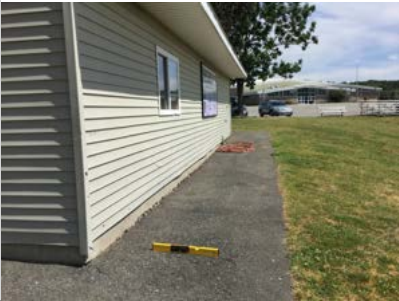
Cross slope > 1:50 (2.00%)	4.5%	Reduce cross slope to be no steeper than 1:50 (2.00%).	1	240	\$240
4	Route to Track From Parking Lot	Ext		Exterior Access Route	Exterior

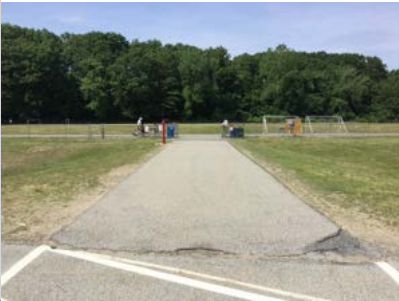
Level changes > 1/4"	-	Alter change in level to be 1/4" high max. (Cost based on an asphalt patch.)	1	160	\$160

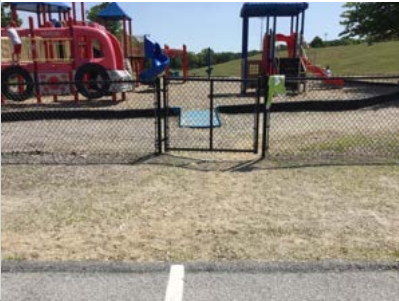
5	Entrance to Playground	Ext		Exterior Access Route	Exterior

Level changes > 1/4" Accessible route not provided	1.25" -	Alter change in level to be 1/4" high max. Ensure an accessible route is provided. (Cost based on a 48" wide min. x 6' asphalt route from parking area to gate.)	1	240	\$240

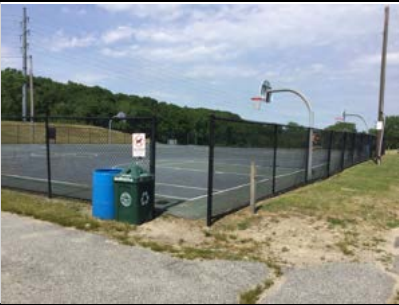
ID	Location	Floor	Room	Element	Type	Photo	Issues	Current Measure	Recommendations	Quantity	Price	Cost Estimation
6	Entrance to Basketball Court	Ext		Exterior Access Route	Exterior

Accessible route not provided	-	Ensure an accessible route is provided to the basketball court entrance. (Cost based on a 48" wide min. x 6' long asphalt route.)	1	240	\$240
Off-Street Parking Lot or Garage												
7	Parking Lot by Baseball Field	Ext		Off-Street Parking Lot or Garage	N/A

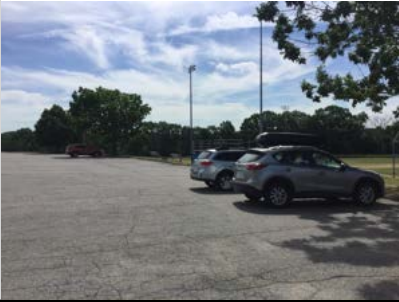
Total # of designated accessible parking spaces Total # of designated van accessible spaces Access aisle not provided Sign not provided	- - - -	Provide one van accessible parking space at least 96" wide with a marked access aisle at least 60" wide. (An 11' space with a 5' access aisle is also permitted.) Provide a sign with the International Symbol of accessibility and the designation "Van Accessible" with the bottom of the sign 60" min. above the ground and the top 96" max. above the ground.	1	1850	\$1850

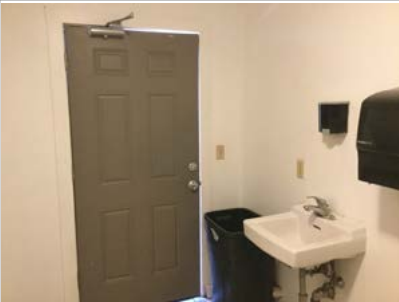
Access to Goods and Services												
Doors, Doorways, & Gates												
8	Women's Toilet Room	Ext		Doors, Doorways, & Gates	Toilet Room

Maneuvering clearance(s) not provided	-	Remove the obstruction to provide maneuvering clearance. (Relocate trash can.)	1	Labor	\$0
9	Men's Toilet Room	Ext		Doors, Doorways, & Gates	Toilet Room

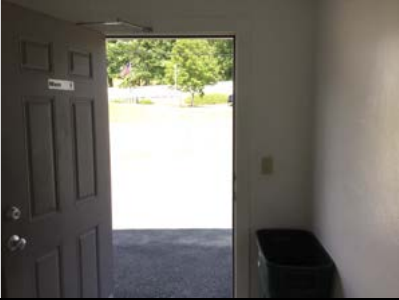
Maneuvering clearance(s) not provided	-	Remove the obstruction. Relocate trash can to provide maneuvering clearance.	1	Labor	\$0
10	Men's and Women's Toilet Rooms	Ext		Doors, Doorways, & Gates	Toilet Room

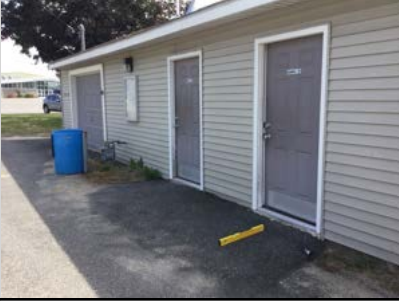
Maneuvering clearance at door > 1:50 (2.00%) (MAAB)	7.2%	Alter so that the slope in all directions is no greater than 1:50 (2.00%).	2	200	\$400

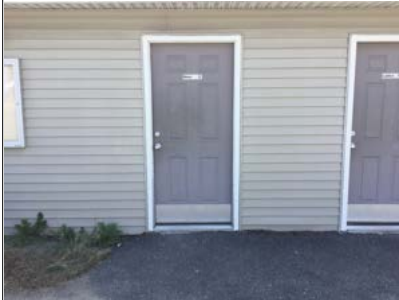
ID	Location	Floor	Room	Element	Type	Photo	Issues	Current Measure	Recommendations	Quantity	Price	Cost Estimation
11	Men's and Women's Toilet Room	Ext		Doors, Doorways, & Gates	Toilet Room

Hardware not operable with a closed fist	-	Provide hardware that can be operable with one hand and not require tight grasping, pinching, or twisting of the wrist.	2	484	\$968
Ramps												
12	Ramp to Tennis Courts From Parking Lot by Playground	Ext		Ramps	Exterior

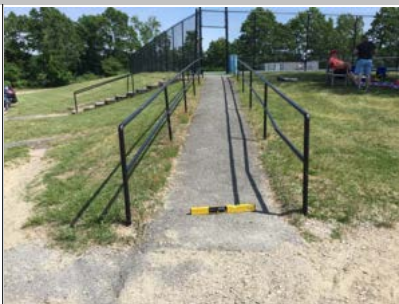
Handrails do not extend 12" past top & bottom Landing has a slope > 1:50 (2.00%) (MAAB)	- 4.6%	Alter handrails to extend horizontally above the landing for 12" min. beyond the top and bottom of ramp runs. Alter so that the slope in all directions is no greater than 1:50 (2.00%). (Cost based on leveling 25' sq. at top and bottom landing and for welding four 12" min. extensions on to top and bottom of the existing railings.)	1	498	\$498

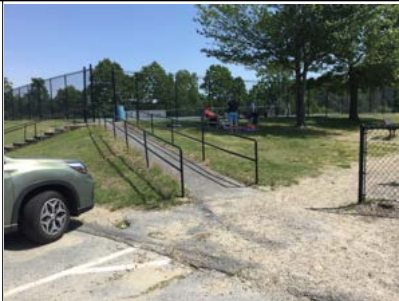
13	Ramp to Tennis Courts From Parking Lot by Playground	Ext		Ramps	Exterior

Surface not stable, firm, and slip-resistant	-	Clean off sand and debris from route to ramp.	1	Labor	
Signage												
14	Men's and Women's Toilet Rooms	Ext		Signage	Designation

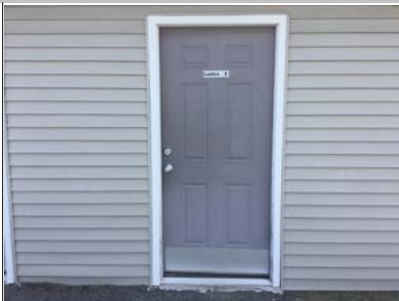
Raised characters not provided Braille not provided Sign not located on the latch side of the door	- - -	Provide text with raised characters duplicated in braille. Locate sign at permanent rooms alongside the door on the latch side.	2	232	\$464
Service Counter												
15	Concessions	Ext		Service Counter	N/A

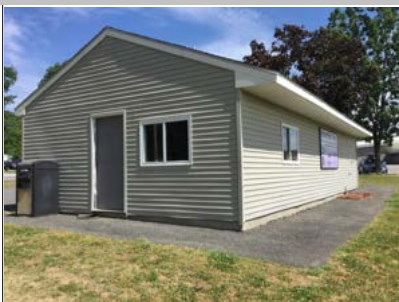
Counter > 36" high	47"	Provide a counter that is 36" max. above the ground.	1	880	\$880

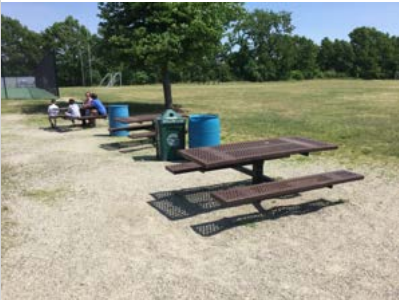
ID	Location	Floor	Room	Element	Type	Photo	Issues	Current Measure	Recommendations	Quantity	Price	Cost Estimation
Picnic Tables												
16	South of Playground	Ext		Picnic Tables	N/A

Toe or knee clearance at table not provided	-	Provide at least one picnic table with top between 28"- 34" above the ground and 27" clear height underneath.	1	1400	\$1400
Benches												
17	Playground - North Side	Ext		Benches	N/A

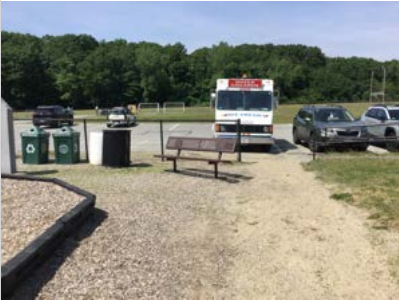
No accessible route to one bench in this area	-	Provide an accessible route to at least one bench in this area. (Relocate one bench on an accessible route by new stone dust path around playground once it is completed.)	1	Labor	\$0
18	South of Basketball Court	Ext		Benches	N/A

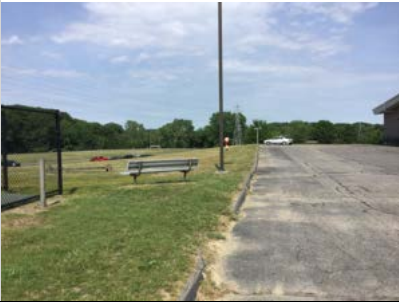
No accessible route to one bench in this area	-	Provide an accessible route to at least one bench in this area.	1	240	\$240
Bike Racks												
19	North of Concessions	Ext		Bike Racks	N/A

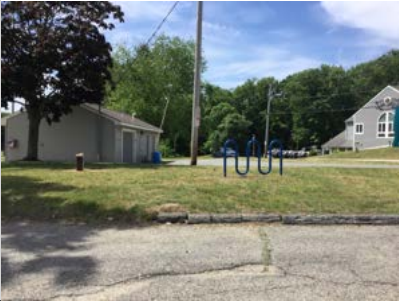
Not connected to an accessible route	-	Ensure bike racks are connected to an accessible route. (Relocate bike rack.)	1	Labor	\$0

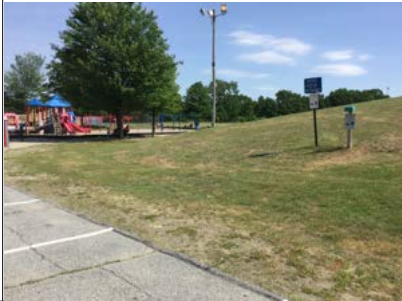
ID	Location	Floor	Room	Element	Type	Photo	Issues	Current Measure	Recommendations	Quantity	Price	Cost Estimation
Trash / Recycling												
20	Parking Lot by Playground	Ext		Trash / Recycling	N/A

Trash container not connected to an accessible route	-	Ensure trash container is located on an accessible route. (Relocate.)	1	Labor	\$0
Toilet & Bathing Rooms												
Overall Access												
21	Women's Toilet Room	Ext		Overall Access	Toilet Room

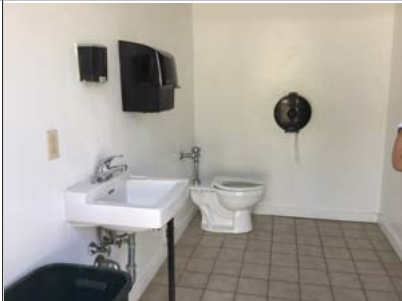
Audible and visible alarms not provided	-	When fire system is updated, ensure that a visible and audible fire alarm is installed.	1	-	\$0
22	Men's Toilet Room	Ext		Overall Access	Toilet Room

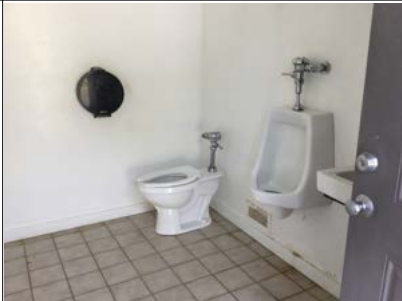
Audible and visible alarms not provided	-	When fire system is updated, ensure that a visible and audible fire alarm is installed.	1	-	\$0
Lavatory												
23	Men's and Women's Toilet Room	Ext		Lavatory	N/A

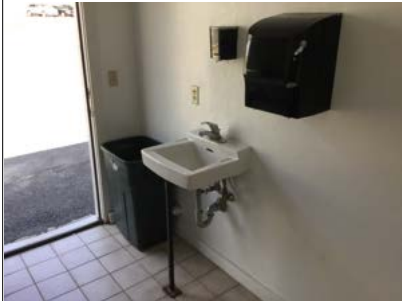
Exposed plumbing underneath Dispenser acts as a protruding object Dispensers not within reach range	- -	Insulate or otherwise configure pipes to prevent contact for at least one lavatory. Relocate paper towel dispenser out of circulation path or provide a cane-detectible barrier under the dispenser 27" max. above the floor Lower paper towel and soap dispensers to 42" max. above the floor.	2	604	\$1208

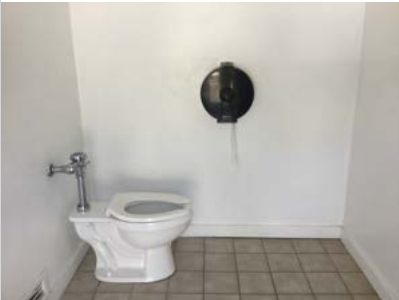
ID	Location	Floor	Room	Element	Type	Photo	Issues	Current Measure	Recommendations	Quantity	Price	Cost Estimation
Single-User Toilet												
24	Women's Toilet Room	Ext		Single-User Toilet	N/A

Flush control not on open side Grab bar not provided Non-compliant toilet cover dispenser	- - -	Relocate the flush control to the open side. Provide one grab bar on the side wall of the toilet and one on the rear wall. Relocate toilet cover dispenser so the operable parts are no higher than 42" on the side of the toilet, positioned below the grab bar per MAAB.	1	1528	\$1528
25	Men's Toilet Room	Ext		Single-User Toilet	N/A

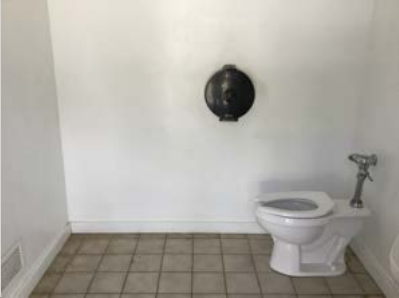
Grab bar not provided Non-compliant toilet paper dispenser	- -	Provide one grab bar on the side wall of the toilet and one on the rear wall. Relocate toilet paper so that it is located under the grab bar and higher than 15" above the finished floor; and between 7" and 9" from the front of the toilet and positioned below the grab bar per MAAB.	1	1154	\$1154

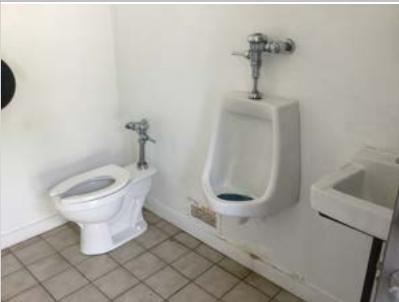
Urinal												
26	Men's Toilet Room	Ext		Urinal	N/A

Rim > 17" high	-	Provide at least one urinal with the rim no higher than 17" above the finished floor.	1	3248	\$3248
Portable Toilet												
27	Near Playground - Northwest Corner	Ext		Portable Toilet	N/A

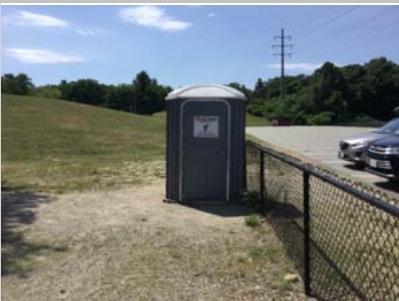
Not located on an accessible route	-	Locate portable toilet on an accessible route. (Place toilet along the stone dust path around the exterior of the playground when it is complete or elsewhere that is on an accessible route.)	1	Labor	\$0
28	Near Playground - Northwest Corner	Ext		Portable Toilet	N/A

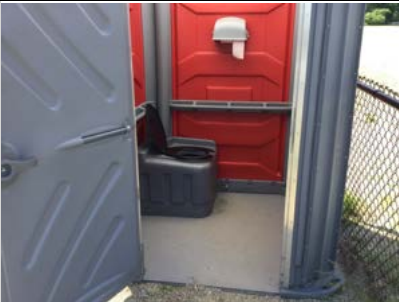
Non-compliant toilet paper dispenser	-	Relocate toilet paper so that it is 24" min. high, located under the grab bar, and between 7" and 9" from the front of the toilet, and below the grab bar (MAAB).	1	256	\$256

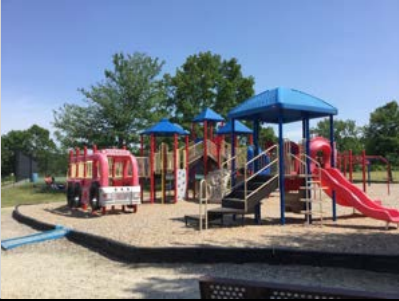
ID	Location	Floor	Room	Element	Type	Photo	Issues	Current Measure	Recommendations	Quantity	Price	Cost Estimation
Play and Sport Areas												
Play Areas												
29	Rocketland Playground	Ext		Play Areas	N/A

Accessible route not provided around playground	-	Install an accessible route around the playground. (Cost estimate for a 48" wide min. x 330' long stone dust path around the exterior of the playground) (Cost based on a 48" wide min. x 330' long stone dust path around the exterior of the playground.)	1	10560	\$10560
30	Playground	Ext		Play Areas	N/A

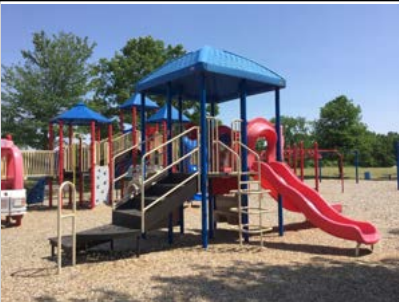
Accessible route not provided at play components	-	Provide a compliant impact-attenuating surface under and around the play components. (Cost estimate for 4,000 sq. ft. of poured in place rubber surface.)	1	56000	\$56000
31	Entrance to Playground	Ext		Play Areas	N/A

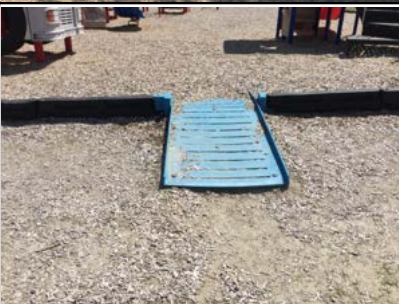
Not connected to an accessible route	-	Provide an accessible route to play areas. (Cost based on a 48" wide min. x 6' stone dust route from new route to gate to playground entry.)	1	192	\$192

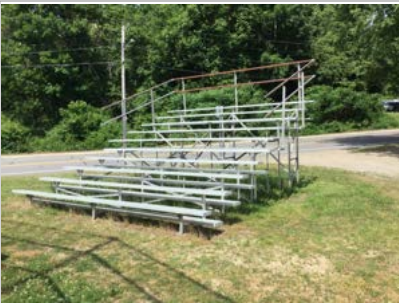
Field												
32	Bleachers - West of Softball Field	Ext		Field	Softball

Accessible spaces not provided at sidelines seating	-	Provide a 36" x 48" firm, stable and slip resistant clear floor space at each of the three bleachers at the softball field. (Cost included in ID #39. See Figure 2 in narrative.)	3	-	\$0
33	Bleachers - West of Baseball Field	Ext		Field	Baseball

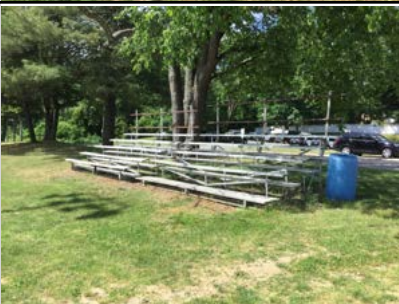
Accessible spaces not provided at sidelines seating Not connected to an accessible-route	- -	Provide a 36" x 48" clear floor space at sidelines seating. Provide a 48" wide min. asphalt route to first and third base side bleachers with a max. running slope of 1:20 (5.00%) and a max. cross slope of 1:50 (2.00%). (Cost included in ID #38. See Figure 1 in narrative.)	2	-	\$0

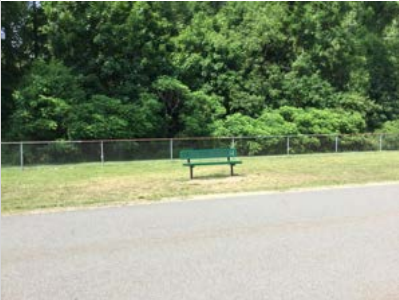
ID	Location	Floor	Room	Element	Type	Photo	Issues	Current Measure	Recommendations	Quantity	Price	Cost Estimation
34	Track/Soccer Field	Ext		Field	Soccer

Not connected to an accessible-route	-	Provide an accessible route to the bench. (Cost estimate for a 48" wide min. x 6' asphalt route.)	1	240	\$240
35	Route From Concessions to Baseball Field	Ext		Field	Baseball

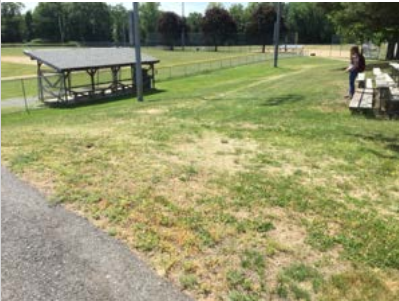
Not connected to an accessible-route No accessible route to all areas of sport activity	- -	Provide an accessible route to the field. Install an accessible route between all areas of sports activity. (Provide a 48" min. wide accessible asphalt route connecting parking, a bench by the parking lot, both team seating dugouts, both bleachers and the boundary of sport activity. See Figure 1 in narrative.) (Cost based on a 48" wide min. x 330' long asphalt route.)	1	13200	\$13200
36	Softball Field	Ext		Field	Softball

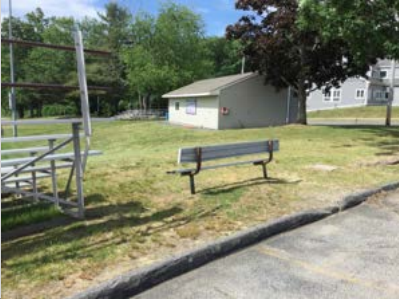
Bleachers												
37	Baseball Field	Ext		Bleachers	N/A

Min. # of designated wheelchair spaces not provided Seats not connected by accessible route	- 6"	Provide an accessible wheelchair space alongside bleachers. Provide an accessible route to the seating area (bleachers and bench). (Cost for an accessible route from the parking lot to the bleachers and bench and a 36" min. x 48" min. stable, firm and slip resistant clear floor space by the bleachers.)	1	240	\$240

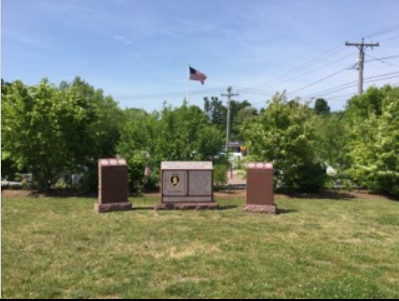
ID	Location	Floor	Room	Element	Type	Photo	Issues	Current Measure	Recommendations	Quantity	Price	Cost Estimation
Approach and Entrance												
Exterior Access Route												
1	Route 12 at Prospect Street Memorial Markers	Ext.		Exterior Access Route	Exterior

Accessible route not provided	-	Ensure an accessible route is provided to the memorial markers that is 48" wide min. with a max. cross slope of 1:50 (2:00%) and max. running slope of 1:20 (5.00%). (Cost based on a 48" wide x 30' long asphalt route.)	1	1200	\$1200
2	Route 12 at Route 20	Ext.		Exterior Access Route	Exterior

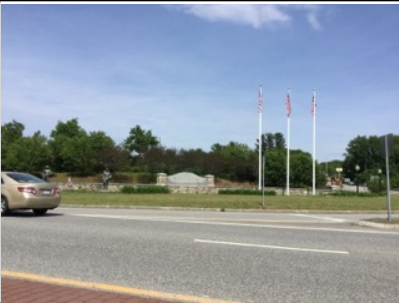
Accessible route not provided	-	This is a drive-by memorial that is not designed for visitors to stop and inspect the facility. As a result, no accessibility modifications are required.	1	-	\$0
Best Practice												
Bench												
3	Route 12 at Water Street Bench	Ext.		Bench	N/A

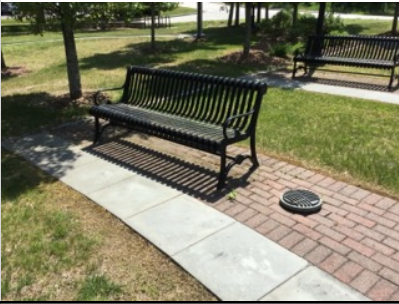
Recommend providing a 36"x48" clear floor space by at least one bench in each area.	1	-	\$0

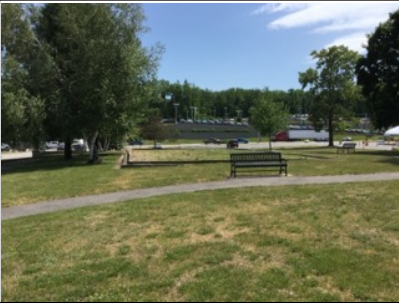
4	Route 12 at Prospect Street Bench	Ext.		Bench	N/A

Recommend providing a 36" x 48" clear space adjacent to at least one (1) bench in this area.	1	-	\$0

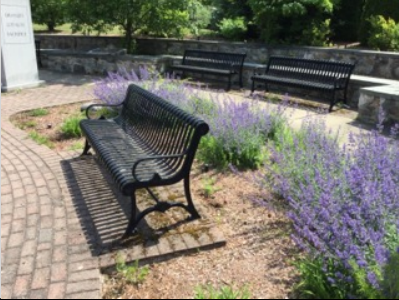
ID	Location	Floor	Room	Element	Type	Photo	Issues	Current Measure	Recommendations	Quantity	Price	Cost Estimation
5	Route 12 at Prospect Street Bench	Ext.		3ench	N/A

Recommend providing a 36" x 48" clear space adjacent to at least one (1) bench in this area.	1	-	\$0
6	Route 12 at Water Street Bench	Ext.		3ench	N/A

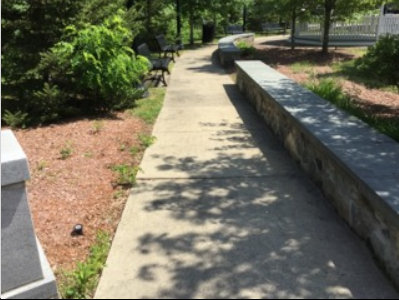
Recommend providing a 36" x 48" clear space adjacent to at least one (1) bench in this area.	1	-	\$0
7	Route 12 at Water Street Bench	Ext.		3ench	N/A

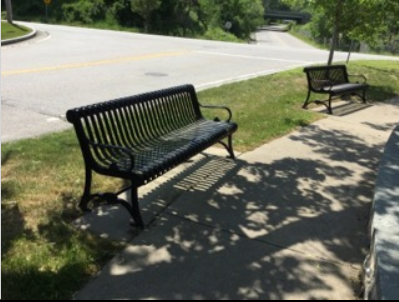
Recommend providing a 36" x 48" clear space adjacent to at least one (1) bench in this area.	1	-	\$0
Parking												
8	Route 12 at Church Street	Ext.		Parking	N/A

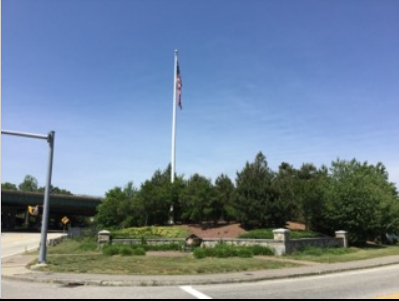
Recommend providing one (1) van accessible parking space that is connected by an accessible route to the existing walkway on the north side of Church Street by the memorial. (At present there is no accessible route to the park.)	1	-	\$0
9	Route 12 at Water Street Driving Range Parking Lot by Memorial	Ext.		Parking	N/A

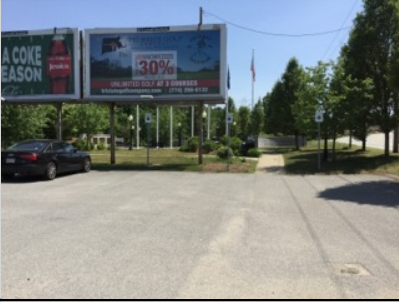
Recommend providing one compliant van accessible parking space with a marked access aisle and sign with the International Symbol of Accessibility and the designation "Van Accessible" on the border of the memorial at the driving range parking lot.	1	-	\$0

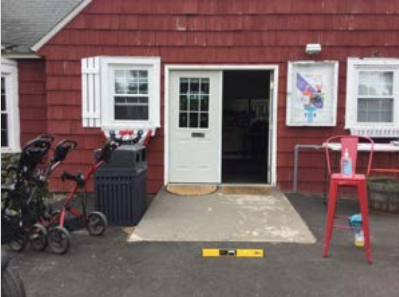
ID	Location	Floor	Room	Element	Type	Photo	Issues	Current Measure	Recommendations	Quantity	Price	Cost Estimation
Approach and Entrance												
Exterior Access Route												
1	Pro Shop Entrance	Ext		Exterior Access Route	Exterior

Cross slope > 1:50 (2.00%)	3.2%	Reduce cross slope to be no steeper than 1:50 (2.00%). (Cost based on adding asphalt to correct slope.)	1	240	\$240
2	Pro Shop Entrance	Ext		Exterior Access Route	Exterior

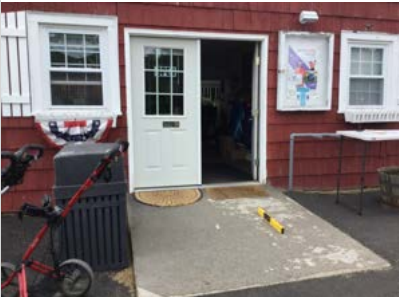
Running slope > 1:20 (5%)	8.0%	Reduce running slope to be no steeper than 1:20 (5%). (Cost based on adding 7'x7' of concrete to reduce running slope.)	1	784	\$784
Off-Street Parking Lot or Garage												
3	Parking Lot	Ext		Off-Street Parking Lot or Garage	Visitor

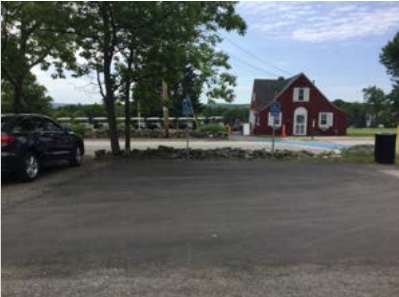
Total # of parking Total # of designated accessible parking spaces Total # of designated van accessible spaces Access aisle not provided	45 1 1 -	Provide a marked van accessible access aisle that is at least 96" wide.	1	300	\$300

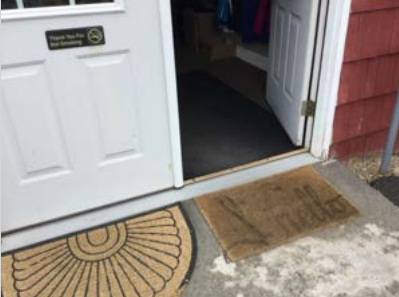
Entrance												
4	Pro Shop Entrance	Ext		Entrance	Main Entrance

Mat not securely attached Threshold > 3/4" high	- 1.5"	Secure the mat. Alter threshold to be 3/4" high max.	1	150	\$150

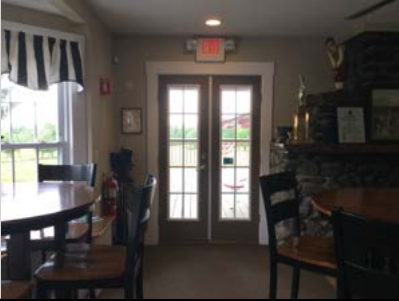
ID	Location	Floor	Room	Element	Type	Photo	Issues	Current Measure	Recommendations	Quantity	Price	Cost Estimation
Emergency Exit												
5	Door to Pro Shop Deck	1		Emergency Exit	N/A

Tactile sign not provided at emergency exit Directional sign to accessible emergency exit not provided	- -	Provide a sign with raised characters ad braille at the emergency exit. Provide a directional sign indicating the location of the nearest accessible emergency exit.	1	232	\$232
6	Pro Shop	1		Emergency Exit	N/A

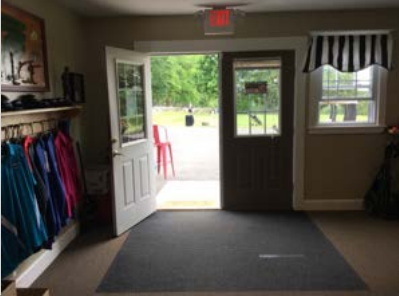
Tactile sign not provided at emergency exit Illuminated International Symbol of Acc. not provided (MAAB)	- -	Provide a sign with raised characters ad braille at the emergency exit. Provide an illuminated sign with the International Symbol of Accessibility (ISA).	1	432	\$432
Access to Goods and Services												
Doors, Doorways, & Gates												
7	Door to Pro Shop Deck	1		Doors, Doorways, & Gates	Other

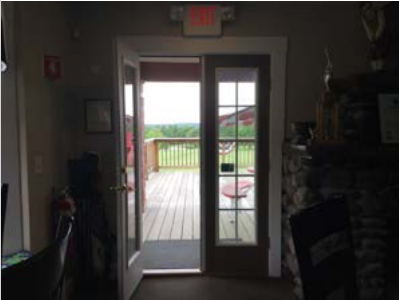
Clear width at door < 32" If double-leaf doors, neither compliant Threshold > 3/4" high	22.5" - 1.5"	Ensure that the door has a clear width of 32 inches. (The closed door could not be opened.) Alter the threshold to be 3/4" high max.	1	150	\$150

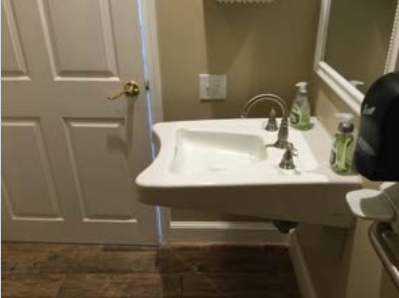
8	Women's Toilet Room	1		Doors, Doorways, & Gates	Toilet Room

Maneuvering clearance(s) not provided	-	Provide an automatic door opener. (The lavatory obstructs the pull side maneuvering clearance at the toilet room exit door.)	1	3060	\$3060
9	Men's Toilet Room	1		Doors, Doorways, & Gates	Toilet Room

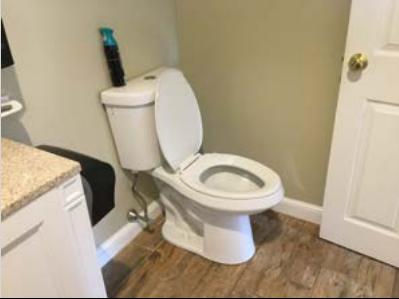
Hardware not operable with a closed fist	-	Provide hardware that can be operable with one hand and not require tight grasping, pinching, or twisting of the wrist.	1	484	\$484

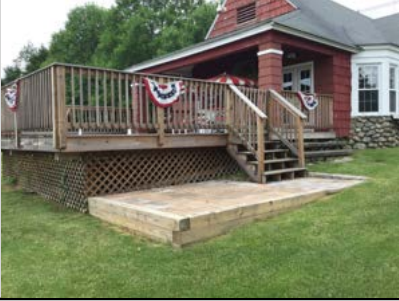
ID	Location	Floor	Room	Element	Type	Photo	Issues	Current Measure	Recommendations	Quantity	Price	Cost Estimation
Stairways												
10	Pro Shop Patio	Ext		Stairways	Exterior

Stair has open risers	-	Ensure stairs have closed risers. (Cost based on closed wooden open risers.)	1	128	\$128
Signage												
11	Men's Toilet Room	1		Signage	Designation

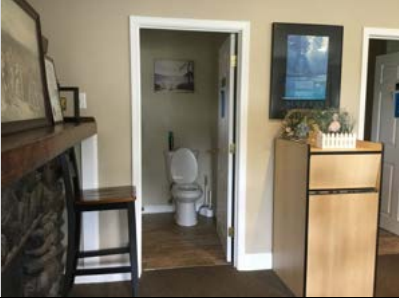
Raised characters not provided Braille not provided Sign not located on the latch side of the door	- - -	Provide a sing that has text with raised characters duplicated in braille and the words 'Toilet Room' or 'All Gender' mounted on the latch side of the door. (The current men's toilet room has many accessibility issues. Address them by making the women's toilet room accessible and designating both single-user toilet rooms as "Toilet Room" or "All Gender".	1	232	\$232
Service Counter												
12	Pro Shop Counter	1		Service Counter	N/A

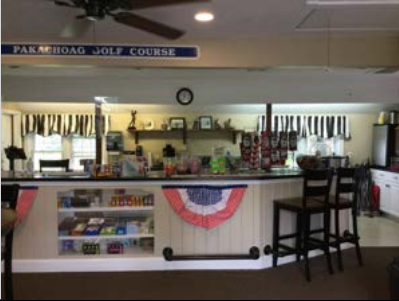
Counter > 36" high	41"	Provide a counter that is 36" max. above the ground.	1	880	\$880

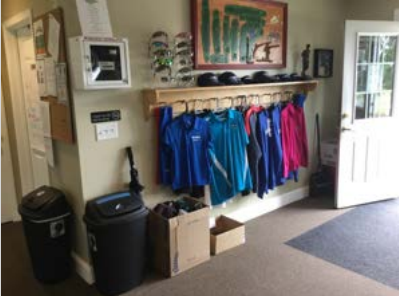
Operable Parts												
13	Pro Shop	1		Operable Parts	N/A

Side reach > 54"	64"	Relocate AED so that controls are between 15" - 48" above the finished floor.	1	256	\$256

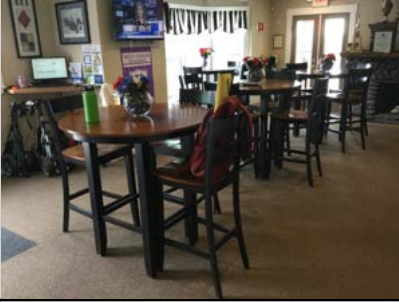
ID	Location	Floor	Room	Element	Type	Photo	Issues	Current Measure	Recommendations	Quantity	Price	Cost Estimation
Picnic Tables												
14	Pro Shop	1		Picnic Tables	N/A

Number of accessible seating spaces Top of picnic table < 28" or > 34	- 42"	Provide at least one table with top between 28"-34" above the ground and 27" clear height underneath. (Cost based on a new dining surface.)	1	1100	\$1100
15	Pro Shop Deck	1		Picnic Tables	N/A

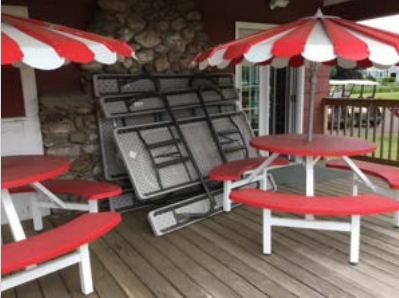
30" clear width not provided Toe or knee clearance at table not provided	- -	Provide at least one picnic table with top between 28"- 34" above the ground and 27" clear height underneath.	1	1400	\$1400
Toilet & Bathing Rooms												
Overall Access												
16	Women's Toilet Room	1		Overall Access	Toilet Room

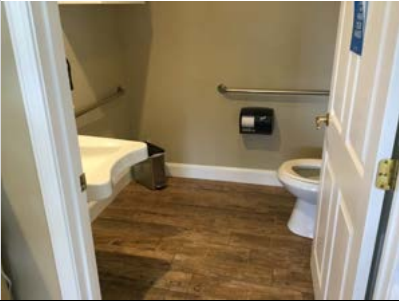
Raised characters not provided Braille not provided Sign not located on the latch side of the door International Symbol of Acc. not provided	-	Once the women's single-user toilet room is made accessible, provide a sign with raised characters and braille, the International Symbol of Accessibility (ISA) and the words 'Toilet Room' or 'All Gender' mounted on the latch side of the door.	1	232	\$232

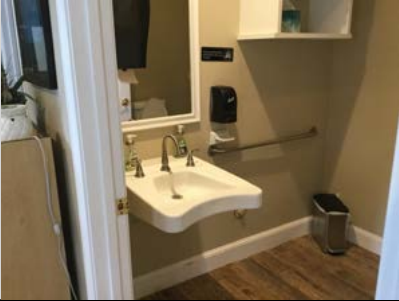
Lavatory												
17	Women's Toilet Room	1		Lavatory	N/A

Exposed plumbing underneath Mirror above lavatory w/reflective surface > 40"	- 42.75"	Insulate or otherwise configure pipes to prevent contact for at least one lavatory. Lower mirror so that the bottom surface is at 40" max. above the finished floor. (Cost included in renovation costs to make the women's single-user toilet room accessible.)	1	-	\$0

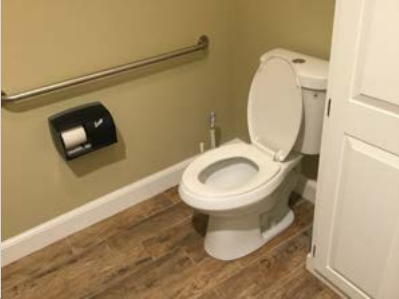
ID	Location	Floor	Room	Element	Type	Photo	Issues	Current Measure	Recommendations	Quantity	Price	Cost Estimation
Single-User Toilet												
18	Women's Toilet Room	1		Single-User Toilet	N/A

Turning space not provided Flush control not on open side Grab bar not provided	- -	Renovate toilet room to provide turning space. (Cabinet reduces room depth to 66", 72" min. is required.) Relocate the flush control to the open side. Provide one grab bar on the side wall of the toilet and one on the rear wall.	1	24604	\$24604
Portable Toilet												
19	Portable Toilet - Hole 2	Ext		Portable Toilet	N/A

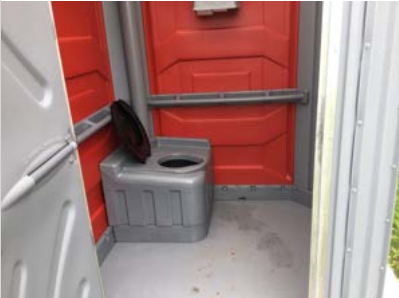
Accessible portable toilets not provided	-	Provide a portable toilet with a minimum clear floor space of 60" x 72". (Cost for an accessible portable toilet is not included because Auburn rents portable toilets each year/)	1	-	\$0
20	Portable Toilet in Parking Lot	Ext		Portable Toilet	N/A

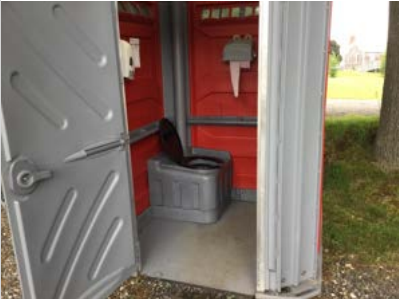
Item mounted over grab bar (MAAB) Accessible portable toilets not provided	-	Provide a portable toilet with a minimum clear floor space of 60" x 72". (Cost for an accessible portable toilet is not included because Auburn rents portable toilets each year.)	1	-	\$0

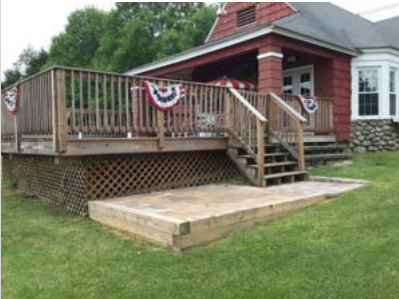
Best Practice												
Stairs												
21	Pro Shop Patio	Ext		Stairs	N/A

Recommend, at the stairs on the pro=shop deck, altering so the handrails are 34"- 38" high above the ground with handrails that have a 1 1/4" - 2" circular cross section extending 12" min. beyond the bottom nosing.	1	-	\$0

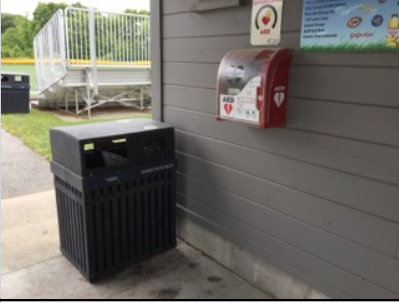
ID	Location	Floor	Room	Element	Type	Photo	Issues	Current Measure	Recommendations	Quantity	Price	Cost Estimation
Approach and Entrance												
Exterior Access Route												
1	Thompson Concession Stand AED	Ext.		Exterior Access Route	Walkway

Route obstructed by protruding objects	43.5"	Provide a cane-detectable barrier 27" max. above the ground below defibrillator.	1	306	\$306
2	Dugout to Camosse Field	Ext.		Exterior Access Route	Exterior

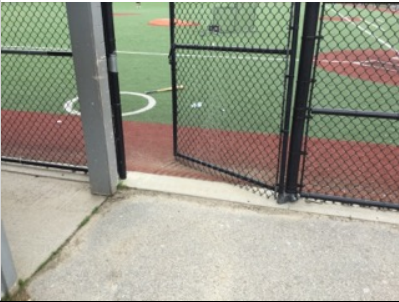
Surface openings > 1/2"	1"	Repair surface opening. (Cost based on a concrete patch.)	1	256	\$256
3	Route to Soccer Field	Ext.		Exterior Access Route	Exterior

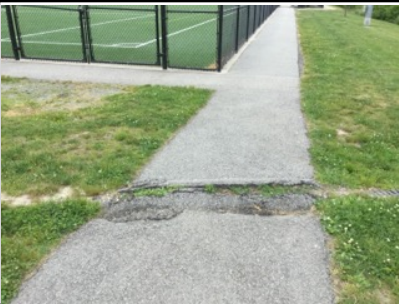
Surface openings > 1/2" Level changes > 1/4"	6" 4"	Alter change in level to be 1/4" high max. (Cost based on a 4'x4' asphalt patch.)	1	160	\$160
4	Path to Softball Bleachers and Accessible Path to Bleachers	Ext.		Exterior Access Route	Exterior

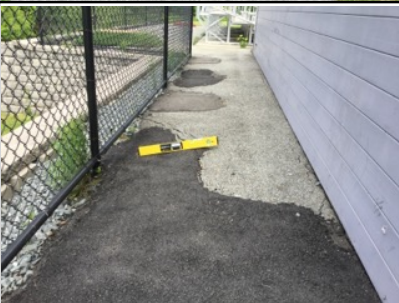
Cross slope > 1:50 (2.00%) Level changes > 1/4" Surface is not stable, firm, and slip-resistant	13.1 5" -	Reduce cross slope to be no steeper than 1:50 (2.00%). Alter change in level to be 1/4" high max. Repair surface. (Cost based on 30'x36" of asphalt to repair slopes and changes in level.)	1	900	\$900

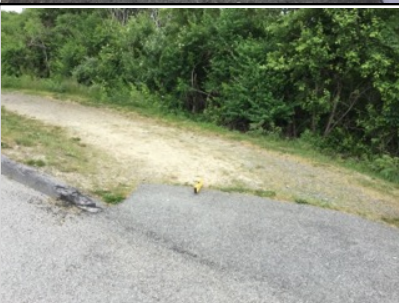
5	Entrance to Trail	Ext.		Exterior Access Route	Exterior

Running slope > 1:20 (5%)	12.4%	Reduce running slope to be no steeper than 1:20 (5%). (Cost based on 6'x4' of asphalt to correct slope.)	1	240	\$240

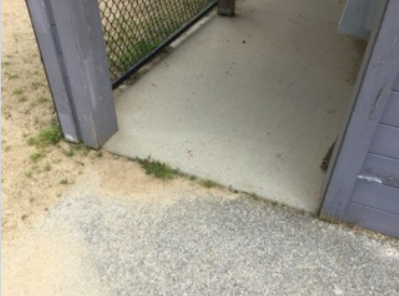
ID	Location	Floor	Room	Element	Type	Photo	Issues	Current Measure	Recommendations	Quantity	Price	Cost Estimation
6	Pappas Softball Team Seating	Ext.		Exterior Access Route	Exterior

Level changes > 1/4"	1"	Alter change in level to be 1/4" high max. (Cost based on an asphalt patch.)	1	90	\$90
7	Path to Softball Bleachers and Accessible Path to Bleachers	Ext.		Exterior Access Route	Exterior
