Town of Auburn, Massachusetts

ADA Self-Evaluation and Transition Plan

September 2020

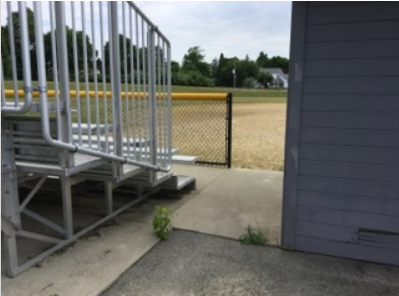
Level changes > 1/4"	1"	Alter change in level to be 1/4" high max. (Cost based on an asphalt patch.)	1	90	\$90
8	Soccer Field	Ext.		Exterior Access Route	Exterior

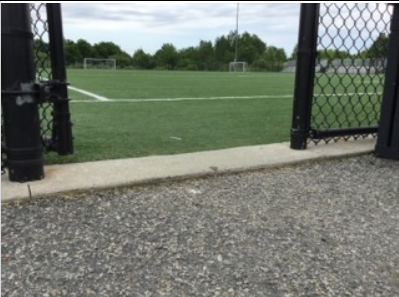
Level changes > 1/4"	1"	Alter change in level to be 1/4" high max. (Cost based on a 3'x3' concrete patch.)	1	144	\$144
9	Path to Softball Field	Ext.		Exterior Access Route	Exterior

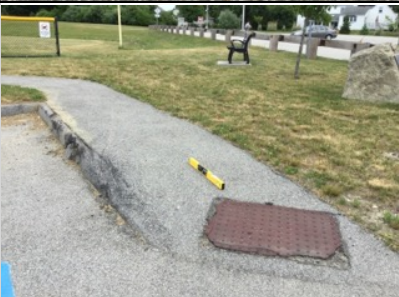
Route not maintained in operable working condition	-	Ensure the detectable warning is maintained in operable working condition. (Cost based on replacing the detectible warning.)	1	360	\$360

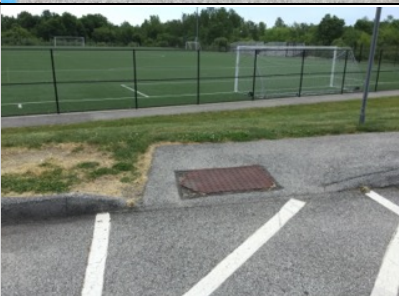
10	Access Route to Soccer Field	Ext.		Exterior Access Route	Exterior

Route not maintained in operable working condition	-	Ensure the detectable warning is maintained in operable working condition. (Cost based on replacing the detectible warning.)	1	360	\$360

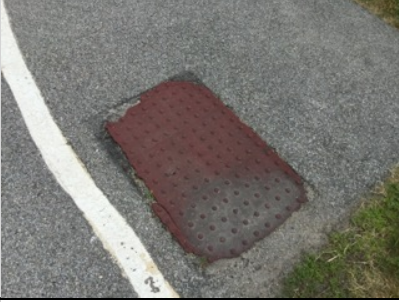
ID	Location	Floor	Room	Element	Type	Photo	Issues	Current Measure	Recommendations	Quantity	Price	Cost Estimation
11	Walkway	Ext.		Exterior Access Route	Exterior

Route not maintained in operable working condition	-	Ensure the detectable warning is maintained in operable working condition. (Cost based on replacing the detectable warning.)	1	360	\$360
12	Path to Playground	Ext.		Exterior Access Route	Exterior

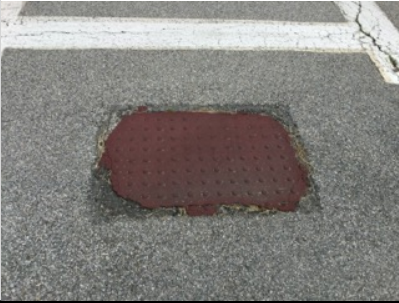
Route not maintained in operable working condition	-	Ensure the detectable warning is maintained in operable working condition. (Cost based on replacing the detectable warning.)	1	360	\$360
13	Path to Playground	Ext.		Exterior Access Route	Exterior

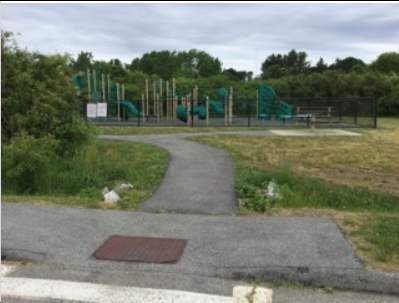
Route not maintained in operable working condition	-	Ensure the detectable warning is maintained in operable working condition. (Cost based on replacing the detectable warning.)	1	360	\$360
14	Path to Playground	Ext.		Exterior Access Route	Exterior

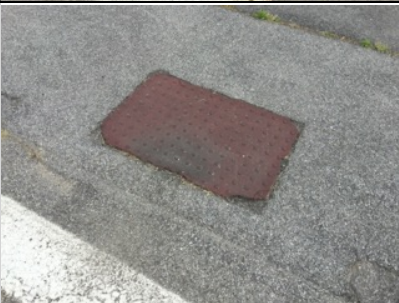
Route not maintained in operable working condition	-	Ensure the detectable warning is maintained in operable working condition. (Cost based on replacing the detectable warning.)	1	360	\$360

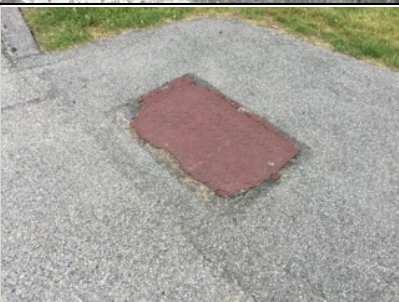
15	Towards Camosse Field	Ext.		Exterior Access Route	Exterior

Route not maintained in operable working condition	-	Ensure the detectable warning is maintained in operable working condition. (Cost based on replacing the detectable warning.)	1	360	\$360

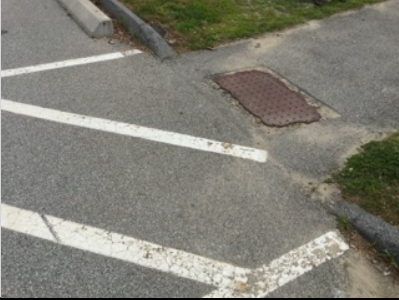
ID	Location	Floor	Room	Element	Type	Photo	Issues	Current Measure	Recommendations	Quantity	Price	Cost Estimation
16	Parking to Concession by Picnic Pavilion	Ext.		Exterior Access Route	Exterior

Route not maintained in operable working condition	-	Ensure the detectable warning is maintained in operable working condition. (Cost based on replacing the detectible warning.)	1	360	\$360
17	Ping-Pong Behind Bleachers	Ext.		Exterior Access Route	Exterior

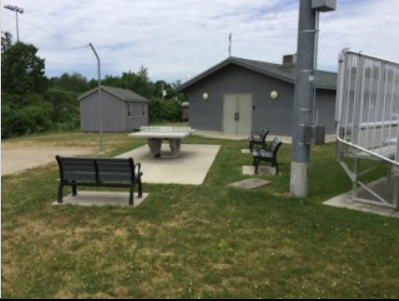
Accessible route not provided	-	Ensure a 48" wide min. accessible route is provided to the Ping-Pong area and to at least one bench. (Cost based on a 48" wide min. by 12' long concrete route.)	1	768	\$768
18	Near Ping-Pong	Ext.		Exterior Access Route	Exterior

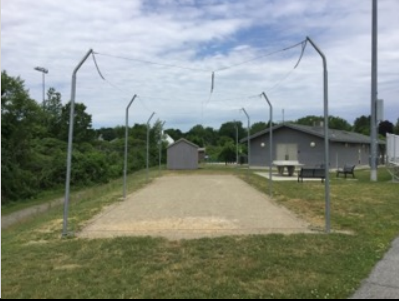
Accessible route not provided	-	Ensure a 48" wide min. accessible route is provided to this amenity. (Cost based on a 48" wide min. by 6' long concrete route.)	1	384	\$384
19	Entrance to Trail	Ext.		Exterior Access Route	Exterior

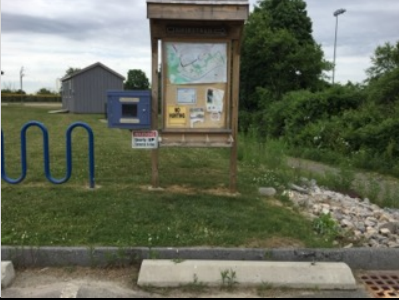
Accessible route not provided	-	Ensure an accessible route is provided from existing path to bike rack and wayside. (Cost based on a 48" wide min. x 24' stone dust path leading to the bike rack and wayside.)	1	768	\$768

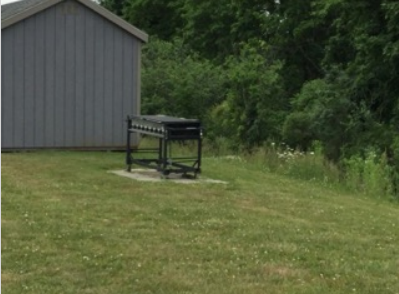
20	Barbecue at Concession Stand by Picnic Pavilion	Ext.		Exterior Access Route	Exterior

Accessible route not provided	-	Ensure an accessible route is provided to the grill. (Cost estimate for a 48" wide min. x 12' long stone dust pathway to the grill.)	1	576	\$576

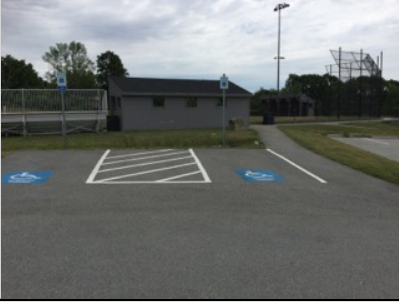
ID	Location	Floor	Room	Element	Type	Photo	Issues	Current Measure	Recommendations	Quantity	Price	Cost Estimation
Off-Street Parking Lot or Garage												
21	Camosse Baseball Field Parking	Ext.		Off-Street Parking Lot or Garage	Visitor

Total # of designated accessible parking spaces Total # of designated van accessible spaces Access aisle < 96" wide at van space	1 1 88"	Provide a marked access aisle that is at least 96" wide. (Re-stripe.)	1	300	\$300
Access to Goods and Services												
Picnic Tables												
22	Concession Stand Picnic Pavilion	Ext.		Picnic Tables	N/A

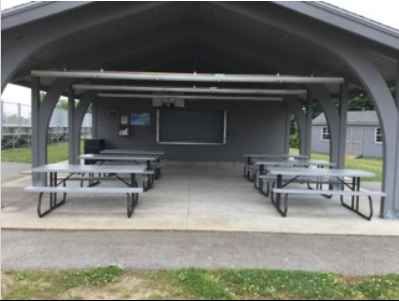
Toe or knee clearance at table not provided	-	Provide at least one picnic table with top between 28"- 34" above the ground and 27" clear height underneath.	1	1400	\$1400
Benches												
23	Pavilion Bench	Ext.		Benches	N/A

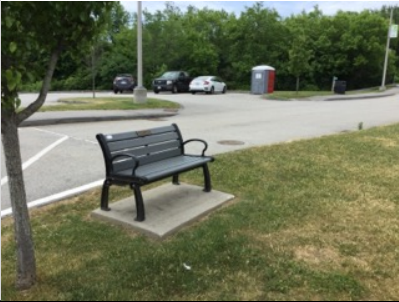
No accessible route to one bench in this area	-	Provide an accessible route to at least one bench in this area. (Cost based on a 48" wide min. x 6' concrete route to bench.)	1	384	\$384

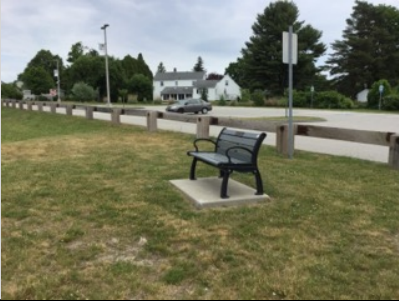
24	Softball Bench	Ext.		Benches	N/A

No accessible route to one bench in this area	-	Provide an accessible route to at least one bench in this area. (Cost based on a 48" wide min. x 12' concrete route to bench.)	1	768	\$768
Toilet & Bathing Rooms

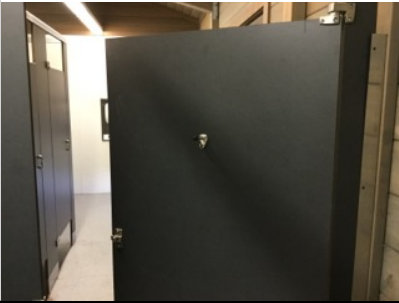
ID	Location	Floor	Room	Element	Type	Photo	Issues	Current Measure	Recommendations	Quantity	Price	Cost Estimation
Toilet Compartment												
25	Women's Toilet Room at Concession Stand	Ext.		Toilet Compartment	Accessible Compartment

Door with malfunctioning self-closing hinge	-	Repair hinge.	1	Labor	\$0
26	Men's Toilet Room at Concession Stand	Ext.		Toilet Compartment	Accessible Compartment

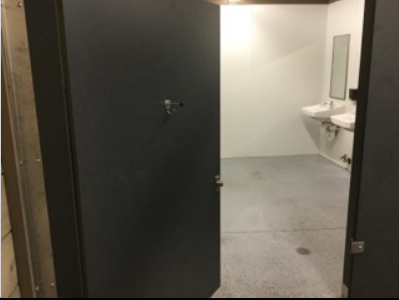
Door with malfunctioning self-closing hinge	-	Repair hinge.	1	Labor	\$0
27	Women's Toilet Room at Concession Stand	Ext.		Toilet Compartment	Accessible Compartment

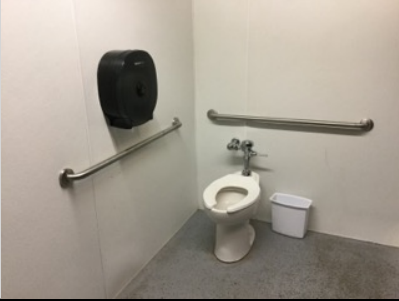
Non-compliant toilet paper dispenser	-	Relocate toilet paper so that it is located under the grab bar and higher than 15" above the finished floor; and between 7" and 9" from the front of the toilet.	1	256	\$256
28	Men's Toilet Room at Concession Stand	Ext.		Toilet Compartment	Accessible Compartment

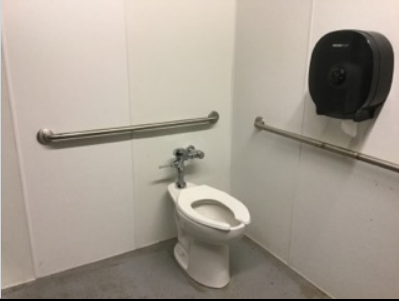
Non-compliant toilet paper dispenser	-	Relocate toilet paper so that it is located under the grab bar and higher than 15" above the finished floor; and between 7" and 9" from the front of the toilet.	1	256	\$256

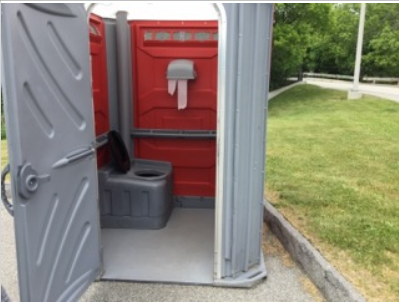
Portable Toilet												
29	Soccer Field Parking Portable toilet	Ext.		Portable Toilet	N/A

Accessible portable toilets not provided	-	Provide a portable toilet with 60" min. turning radius. (Cost for an accessible portable toilet is not included because Auburn rents portable toilets each year for approximately 8 months a year.)	1	-	\$0
Play and Sport Areas

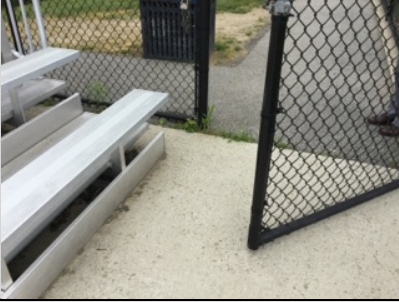
ID	Location	Floor	Room	Element	Type	Photo	Issues	Current Measure	Recommendations	Quantity	Price	Cost Estimation
Bleachers												
30	Soccer Field Bleachers	Ext.		Bleachers	N/A

Seats not connected by accessible route	-	Provide an accessible route to the seating area (adjust gate to open 32" min clear).	1	Labor	\$0
Best Practice												
Exterior												
31	Stairs Between Baseball and Trail	Ext.		Exterior Stairs	N/A

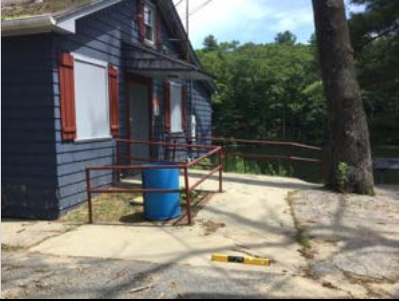
ID	Location	Floor	Room	Element	Type	Photo	Issues	Current Measure	Recommendations	Quantity	Price	Cost Estimation
Approach and Entrance												
Exterior Access Route												
1	Building Entrance	Ext.		Exterior Access Route	Exterior

Cross slope > 1:50 (2.00%) Running slope > 1:20 (5%)	3.0% 6.6%	Reduce cross slope to be no steeper than 1:50 (2.00%). Reduce running slope to be no steeper than 1:20 (5%). (Cost based on adding 12' of concrete to reduce slope.)	1	480	\$480
2	Northside of Building	Ext.		Exterior Access Route	Exterior

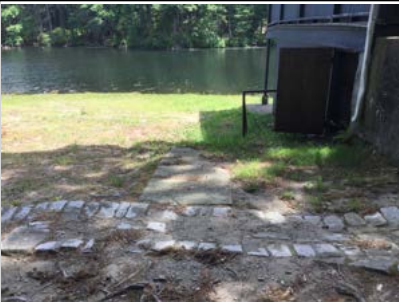
Cross slope > 1:50 (2.00%) Running slope > 1:20 (5%)	3.0% 8.0%	Reduce cross slope to be no steeper than 1:50 (2.00%). Reduce running slope to be no steeper than 1:20 (5%). (Cost based on 4' x 12' of asphalt to correct slope.)	1	480	\$480
3	Northside of Building	Ext.		Exterior Access Route	Exterior

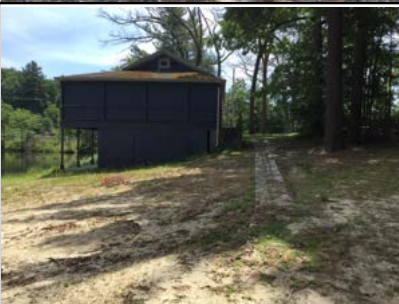
Cross slope > 1:50 (2.00%) Running slope > 1:20 (5%) Accessible route not provided	8.4% 4.0% -	Reduce cross slope to be no steeper than 1:50 (2.00%). Reduce running slope to be no steeper than 1:20 (5%). Ensure an accessible route is provided. (Cost based on a 48" wide min. x 60' long stone dust path.)	1	1920	\$1920

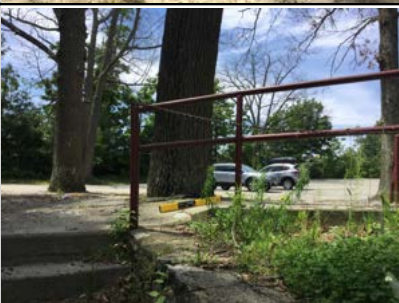
4	Top of Stairs on Southside of Building	Ext.		Exterior Access Route	Exterior

Running slope > 1:20 (5%)	20.1%	Reduce running slope before stair landing to be no steeper than 1:20 (5%).	1	240	\$240
Beach Access Routes												
5	Northside of Building	Ext.		Beach Access Routes	Removable

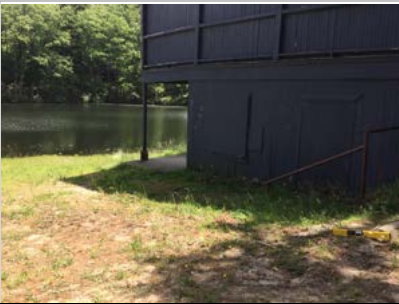
Beach route not provided Surface is not firm and stable	- -	Provide an accessible route that is firm and stable. Ensure the accessible route extends to the recreation water level (if lake, pond and reservoir beach). (Cost based on a 78" wide x 30' long beach mat.)	1	1909	\$1909

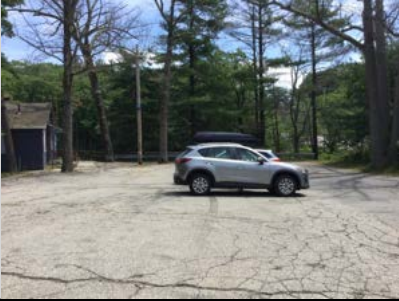
ID	Location	Floor	Room	Element	Type	Photo	Issues	Current Measure	Recommendations	Quantity	Price	Cost Estimation
Off-Street Parking Lot or Garage												
6	Parking Lot	Ext.		Off-Street Parking Lot or Garage	Visitor

Total # of designated accessible parking spaces Total # of designated van accessible spaces Access aisle not provided Sign not provided Sign does not have the designation "Van Accessible"	- - - - -	Provide a van accessible parking space 96" wide min. with a marked access aisle that is at least 96" wide.(An 11' min. space with a 5' min. access aisle is also permitted.) Provide a sign with the International Symbol of Accessibility (ISA) with the bottom of the sign 60" min. above the ground. Add the designation "Van Accessible" to the sign located at the van accessible space.	1	1850	\$1850
Access to Goods and Services												
Doors, Doorways, & Gates												
7	Building Entrance	Ext.		Doors, Doorways, & Gates	N/A

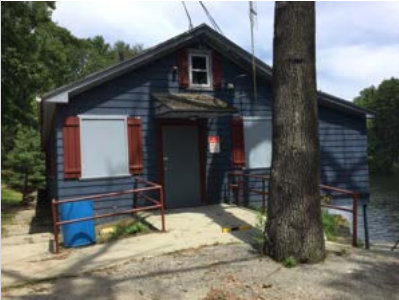
Maneuvering clearance at door > 1:50 (2.00%) (MAAB)	5.5%	Alter so that the slope in all directions at the door landing is no greater than 1:50 (2.00%).	1	200	\$200

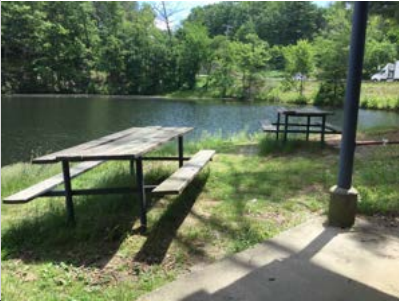
Picnic Tables												
8	East of Bottom of Stairs	Ext.		Picnic Tables	N/A

Toe or knee clearance at table not provided Picnic table not on an accessible route	- -	Provide at least one picnic table with top between 28"- 34" above the ground and 27" clear height underneath. Ensure that the dining surface is connected to an accessible route.	1	1400	\$1400
Play and Sport Areas												
Play Areas												
9	Northwest of Building	Ext.		Play Areas	N/A

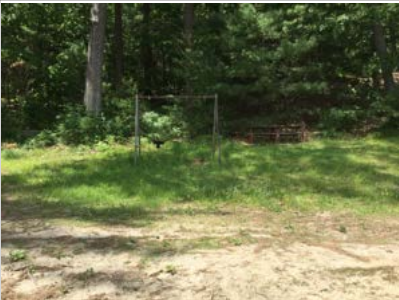
Surface not stable, firm, and slip-resistant Accessible route not provided at play components	- -	Relocate swing set to an accessible route.	1	Labor	\$0
Best Practice

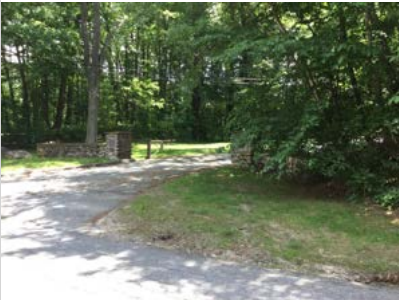
ID	Location	Floor	Room	Element	Type	Photo	Issues	Current Measure	Recommendations	Quantity	Price	Cost Estimation
Camp Entrance												
10	Entrance From Central Street	Ext.		Camp Entrance	N/A

Recommend providing signs on both sides of Central Street alerting visitors that they are approaching the entrance to the camp.	2	-	\$0
Entrance												
11	Entrance From Central Street	Ext.		Entrance	N/A

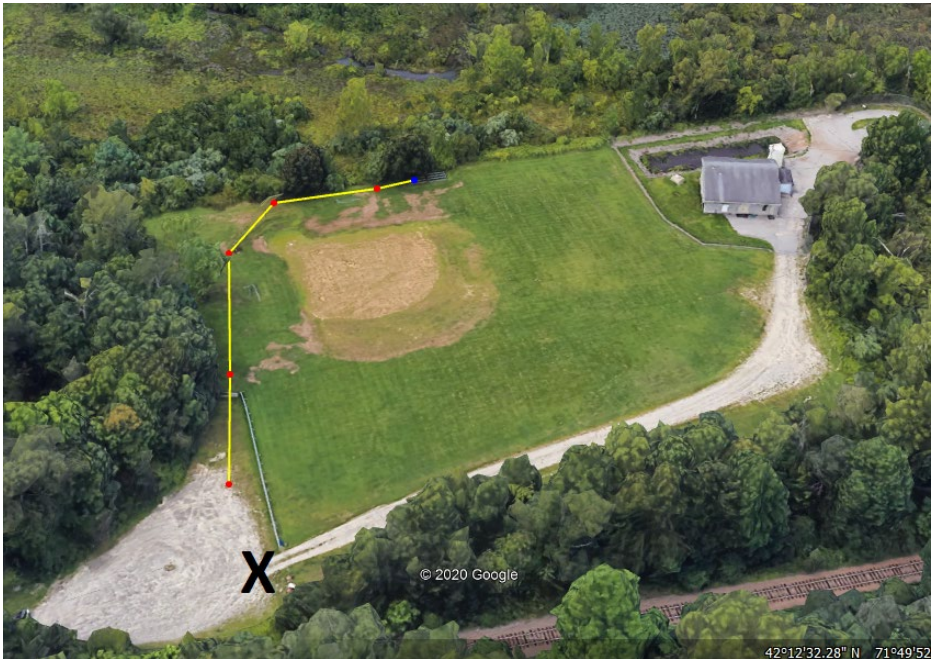
Figure 1: The yellow line shows the approximate location of the suggested accessible route connecting the parking area to the team seating, the boundary of sport activity and the fan seating at the bleachers.

Note: Where the black “X” is located in the image, there is a gate that is sometimes locked by the water department. That entry point and road is not available to be part of an accessible route.

No accessible route to all areas of sport activity	- -	Install an accessible route between all areas of sports activity. (Provide an accessible route 48" wide min. with a max. running slope of 1:20 (5.00%) and a max. cross slope of 1:50 (2.00%) connecting the parking area to the team seating, the boundary of sport activity and the fan seating at the bleachers.) (Cost based on a 48" wide x 330' long stone dust path.)	1	10560	\$10560

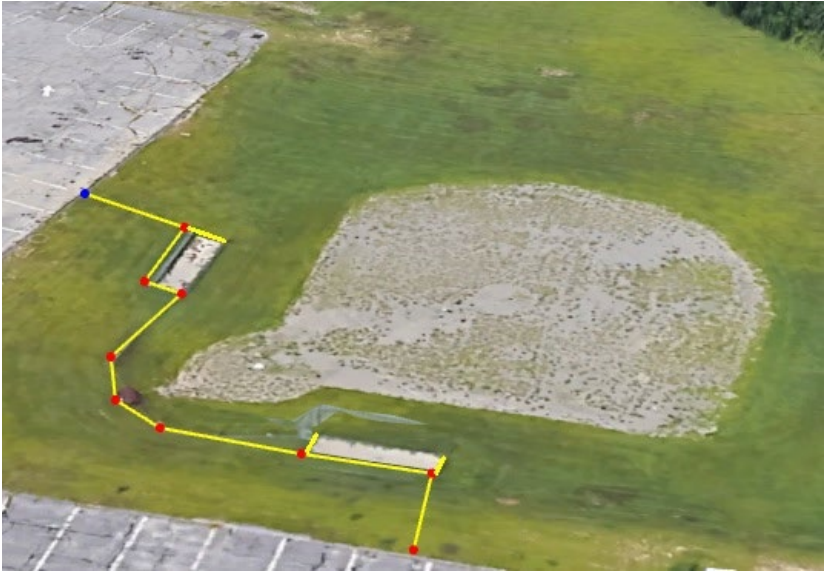
Figure 2: The following figure uses yellow lines to show the approximate suggested location of an accessible route to the boundary of sport activity at the softball field including to the two (2) fenced team seating areas.

Not connected to an accessible-route No accessible route to all areas of sport activity	- -	Provide an accessible route to the boundary of sport activity at the softball field and to the fenced team seating areas. See Figure 2 in the narrative. (Cost estimate for 48" wide min. x 200' long stone dust path with a max. running slope of 1:20 (5.00%) and a max. cross slope of 1:50 (2.00%).)	1	6400	\$6400

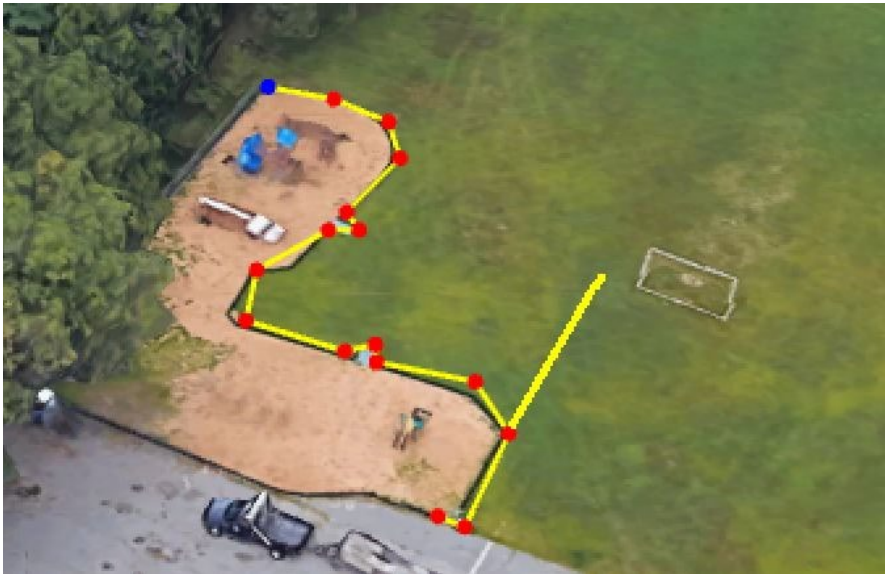
Figure 1: The following figure uses yellow lines to show the approximate suggested location of an accessible route to and around the playground and to the boundary of sport activity at the soccer field.

Not connected to an accessible route	-	Provide an accessible route. (Relocate trash can and provide an accessible route to and around the playground and to the boundary of the area of sport activity at the soccer field 48" wide min. with a 1:20 (5.00%) max. running slope and a 1:50 (2.00%) max. cross slope and a firm, stable and slip resistant surface.) Cost based on a 48" wide min. x 275 foot stone dust path. See Figure 1 in narrative.	1	8800	\$8800
