## **Second Five-Year Review Report**

**Tibbetts Road Superfund Site**

**Town of Barrington**

**August 2008**

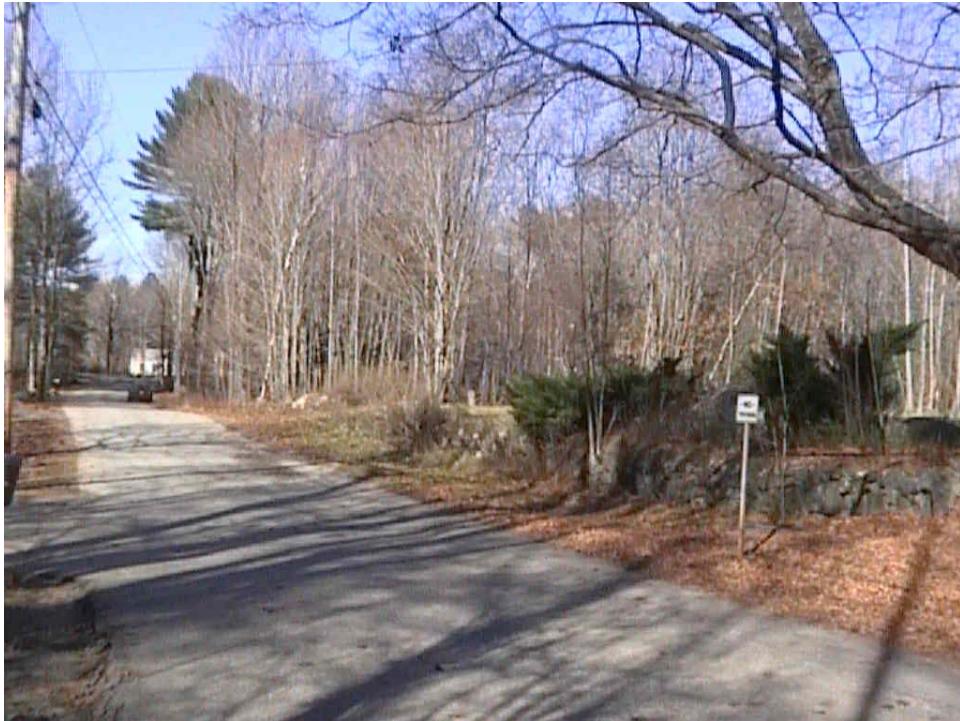
**SCENE:** Tibbetts Road facing west, the site is on the right hand side behind the stone wall.

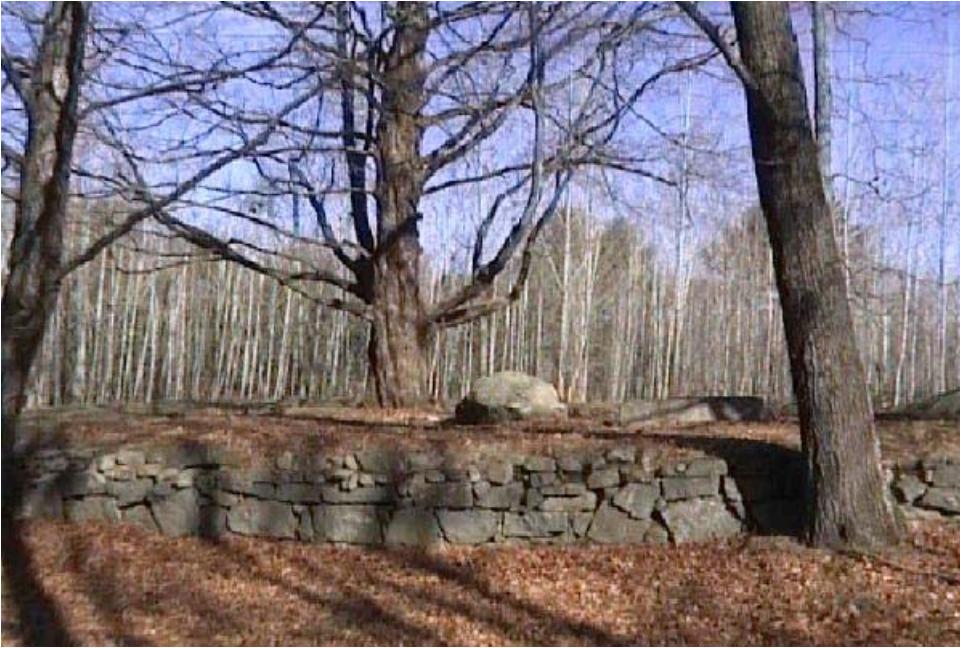
**SCENE:** Standing on Tibbetts Road looking northward into the site. The former Johnson residence stood behind the Sugar Maple before it was removed in 1995.
