**HAZARDOUS BUILDING MATERIALS ASSESSMENT
FORMER L.W. PACKARD MILL
MAIN MILL BUILDING AND BOILER HOUSE
Lots 17-4-16 and 17-7-7
Hill Avenue and Mechanic Street
Ashland, New Hampshire**

**NHDES Site No. 200009045
NHDES Project No. 36187**

HAZARDOUS BUILDING MATERIALS ASSESSMENT

**FORMER L.W. PACKARD MILL
ASHLAND, NEW HAMPSHIRE**

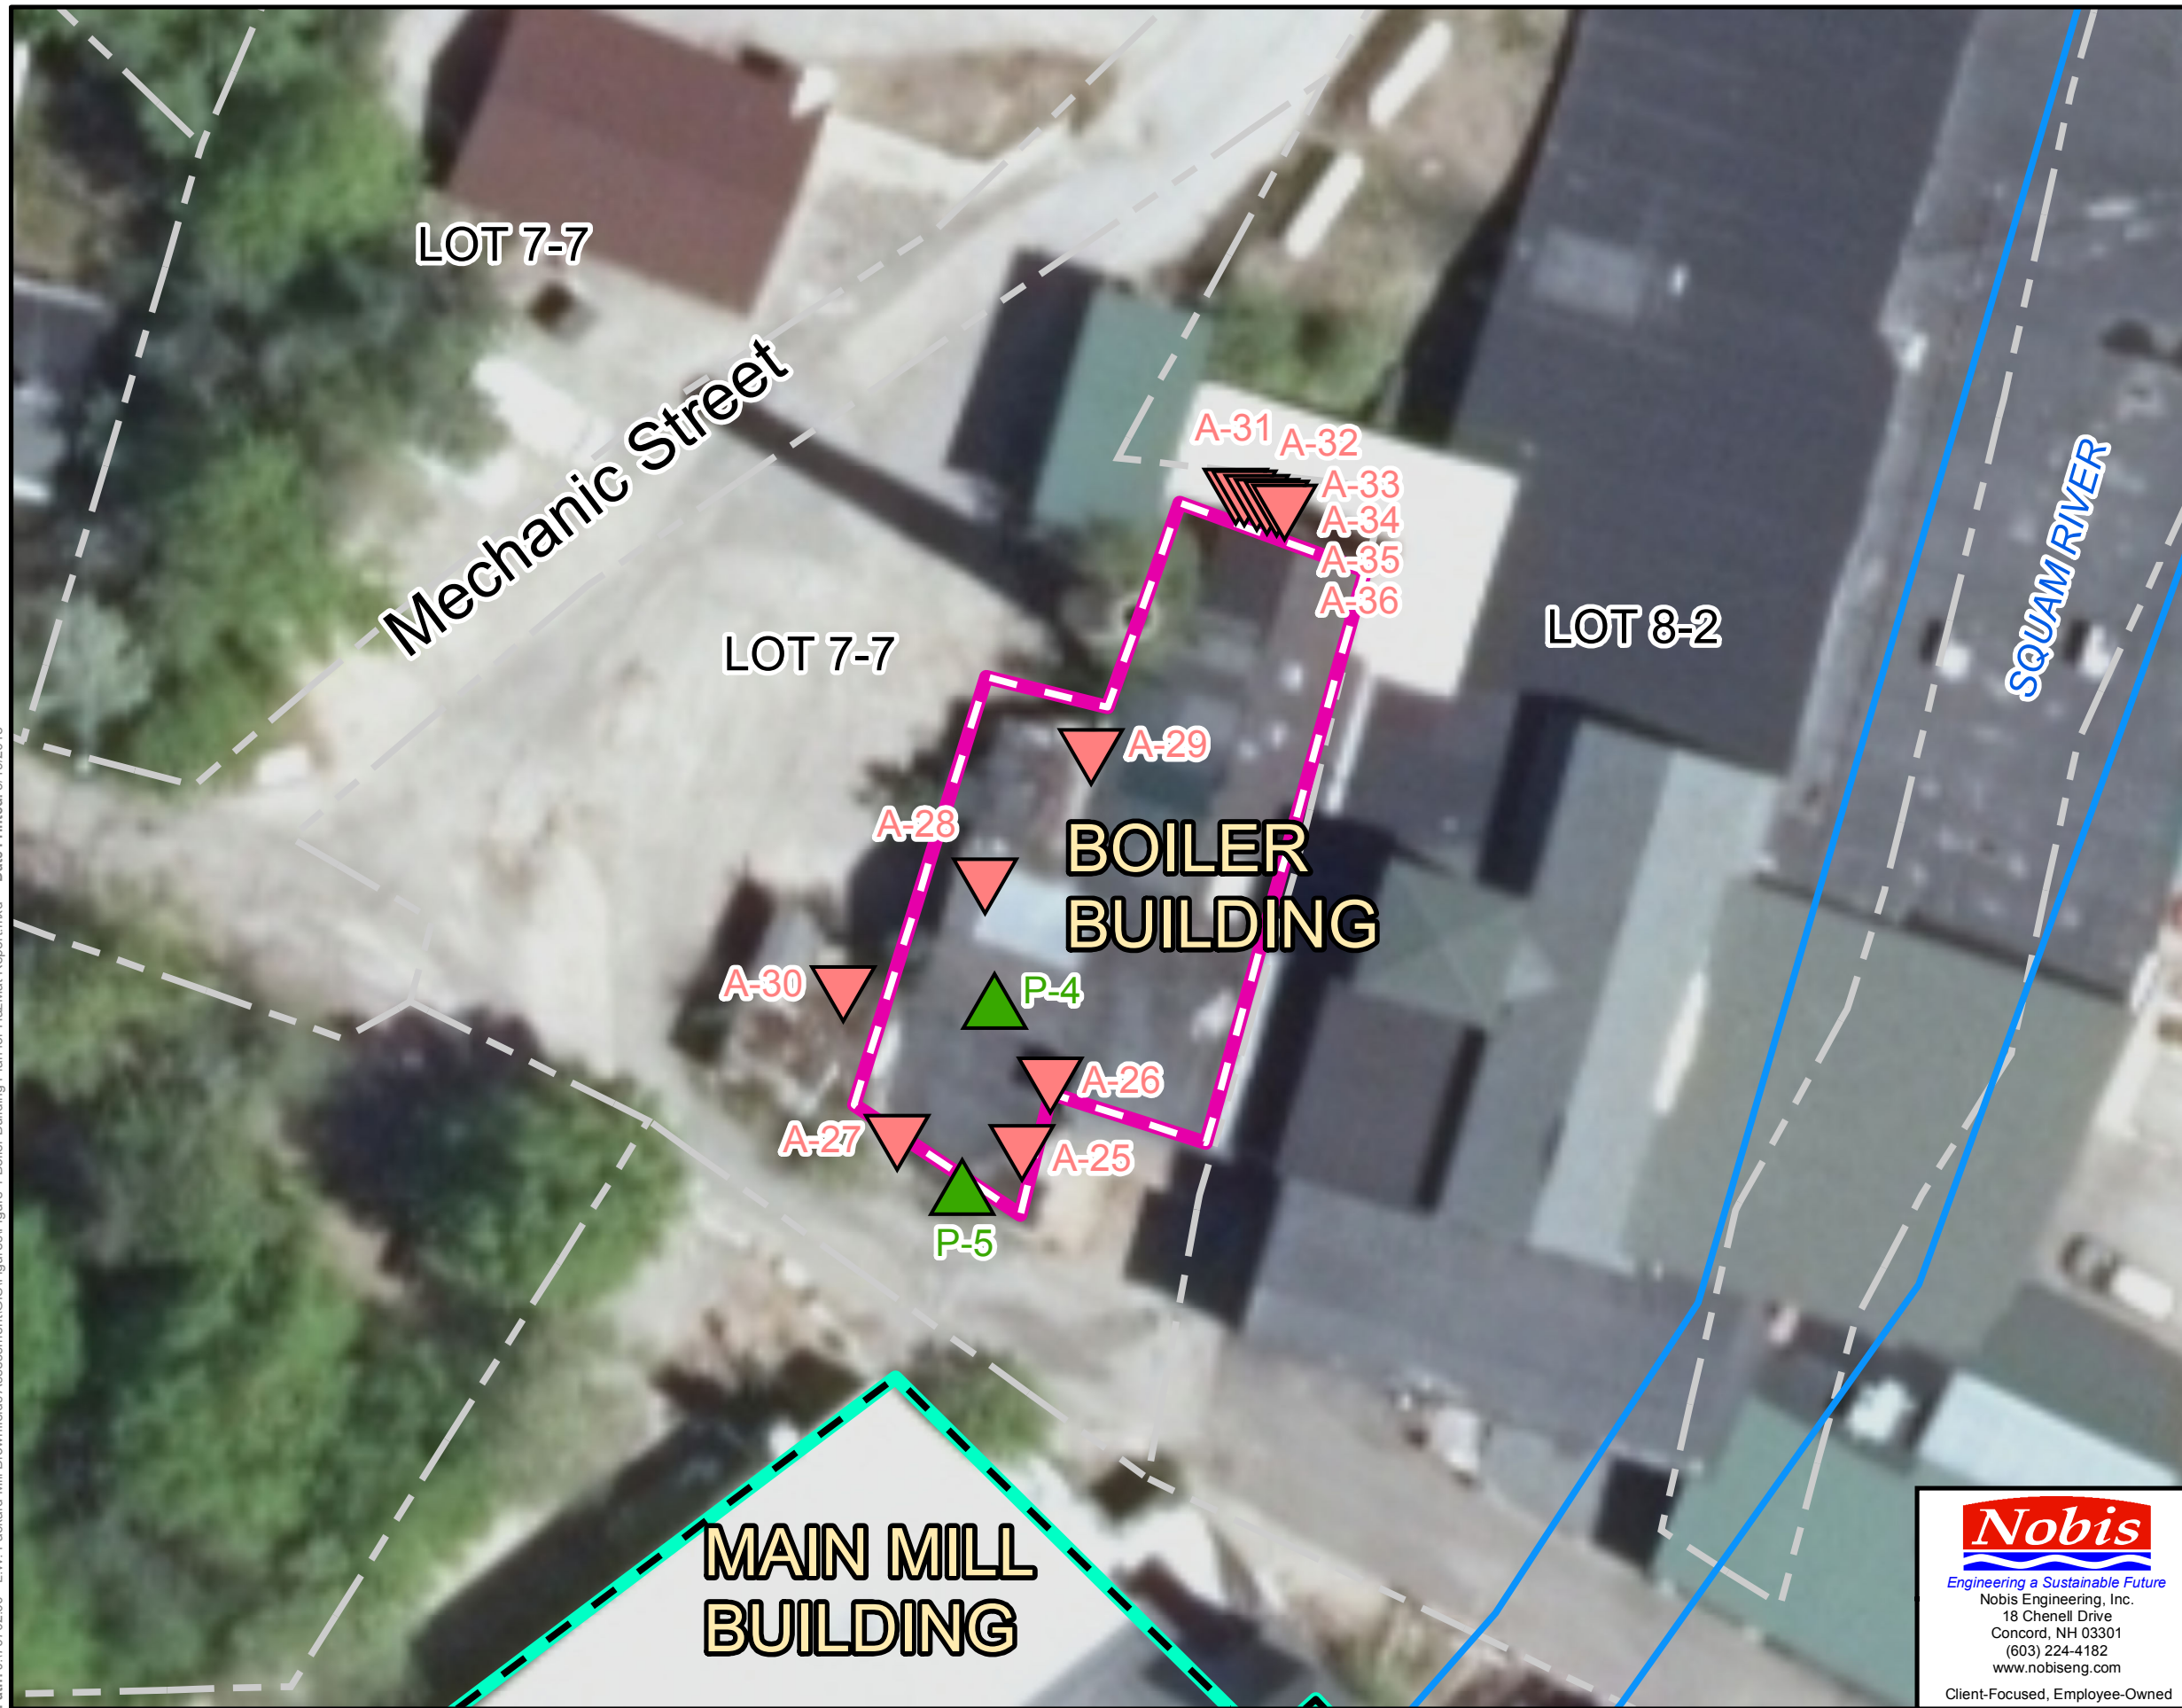
FIGURE 4	
BOILER BUILDING DETAIL WITH SAMPLE LOCATIONS L.W. PACKARD MILL ASHLAND, NEW HAMPSHIRE	
PREPARED BY: JRS	CHECKED BY: TA
PROJECT NO. 93002.00	DATE: MARCH 2018

1. Site Plan was developed from several sources including, City of Ashland Tax Map 17, observations made by Nobis, and from the aerial photography provided by New Hampshire GRANIT.
2. Refer to Table 1 for exact sample location and material sampled.
3. Locations of site features depicted hereon are approximate and given for illustrative purposes only.

Figures 3 and 4 depict the approximate bulk sample locations for asbestos and PCBs samples collected at the Main Mill Building and the Boiler Building, respectively. The laboratory reports for the asbestos and PCB samples are included as Appendix B. A copy of the LBP report is included as Appendix C.
